Comprehensive Recreational Use-Attainability
Analysis
Of the Arroyo Colorado Above Tidal
Segment 2202

Report to TMDL Program
Texas Commission on Environmental Quality
Project Work Order Number
582-11-11308-1

Nueces River Authority
September 16, 2011

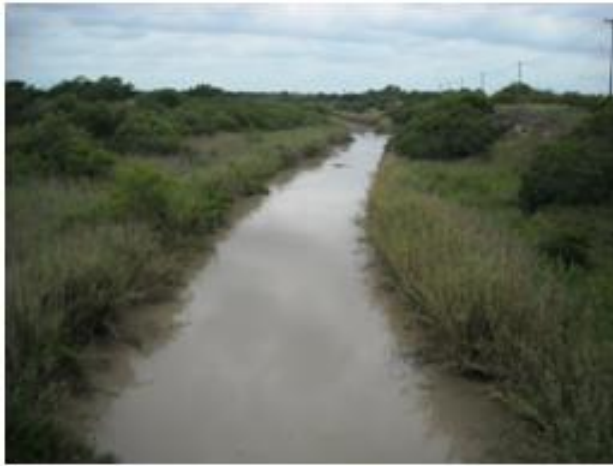
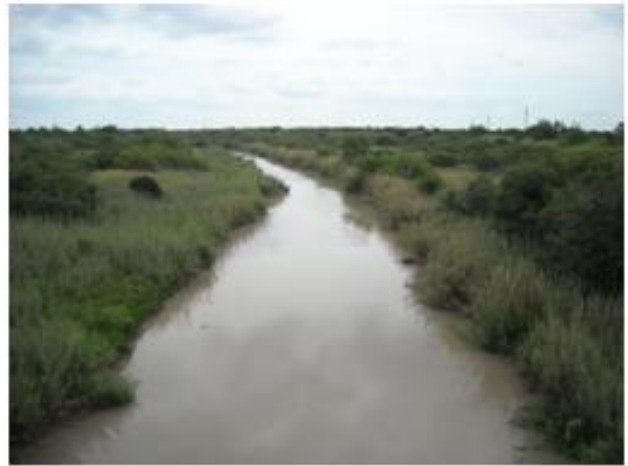
Site #2, 16446 FM509

Site #2 TCEQ Station 16446 is located at FM 509 in northeast Harlingen. This site was chosen based on its proximity to a golf course (Treasure Hills Golf Club) and the City of Harlingen. The bank is steep and wooded; access is limited and the current is swift.

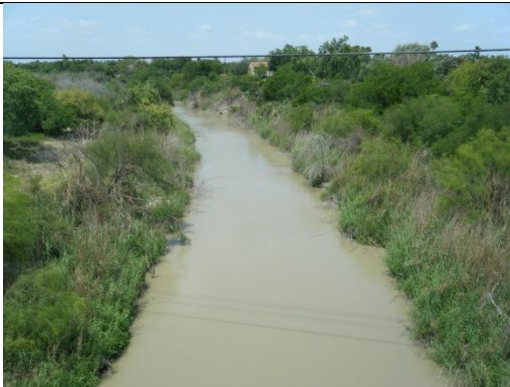
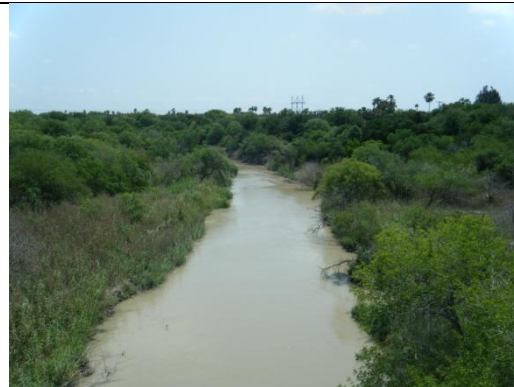
Site #3, 13077 Loop 499 Bridge

Site #3 TCEQ Station 13077 is located at Loop 499 bridge in northeast Harlingen. This site was chosen due to its proximity to McCullough and Ramsey Parks. The bank is steep and wooded; access is limited and the current is swift.

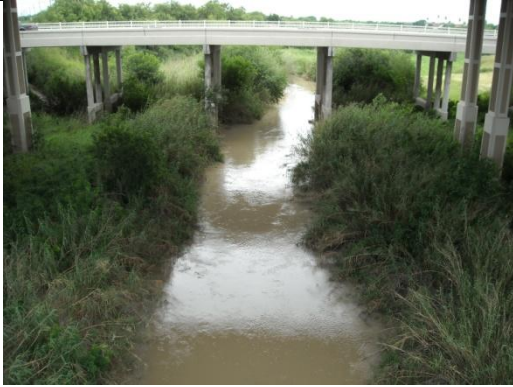
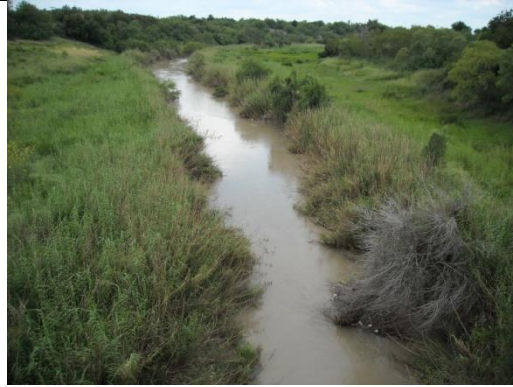
Site #4, 13079 US 77 in SW Harlingen

Site #4 TCEQ Station 13079 is located at US 77 in southwest Harlingen. This site was chosen due to its proximity to Harlingen Municipal Golf Course. In addition, there is a walking trail along the steep and wooded stream bank.

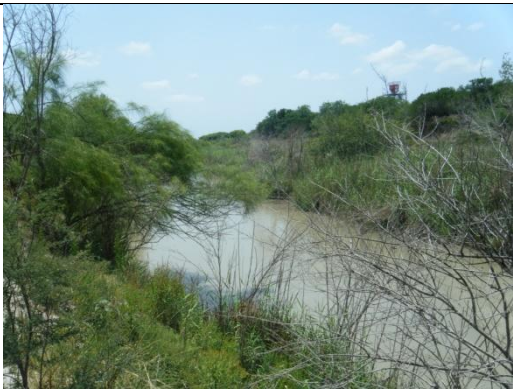
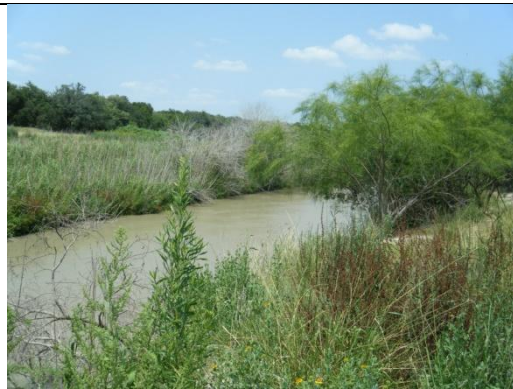
Site #5, Montana Dr. in Rangerville

Site #5 Arroyo Colorado at Montana Dr. is located in Rangerville. This site was selected for spatial representativeness within the segment and its proximity to Harlingen Municipal Golf Course, using Google Earth, which indicates possible accessibility.

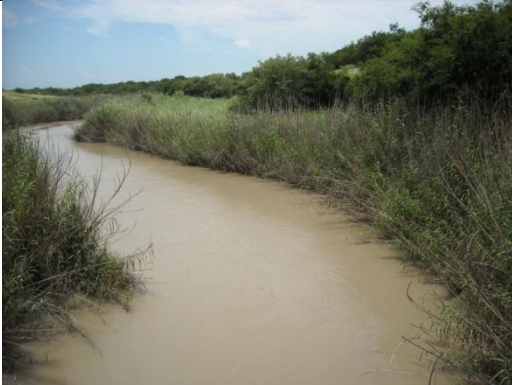
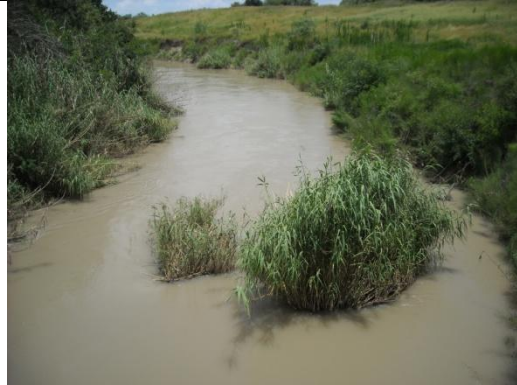
Site #6, 16445 Dilworth Rd.

Site #6 TCEQ Station 16445 is located at the crossing of Dilworth Road. The area has elements of both rural and urban development. The site was selected for spatial representativeness. The stream bank is well vegetated and the current is swift. Access is limited.

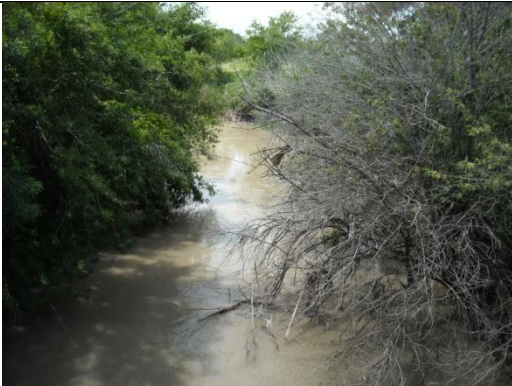
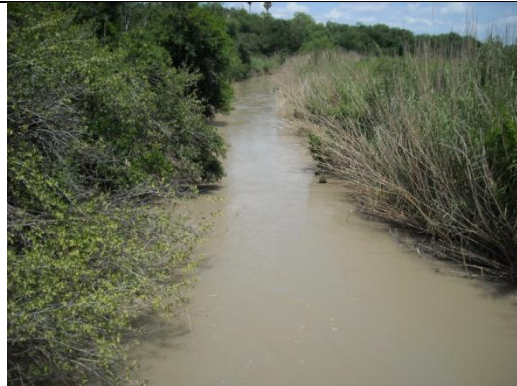
Site #7, FM 800

Site #7 Arroyo Colorado at FM 800 was chosen due to its proximity to a large subdivision and the Lower Rio Grande Valley National Wildlife Reserve. FM 800 becomes narrow at the crossing and the bank is heavily wooded and steep with large rocks lining the bridge. This site is in close proximity to the Lower Rio Grande National Wildlife Refuge. Access is limited but evidence of fishing is apparent.

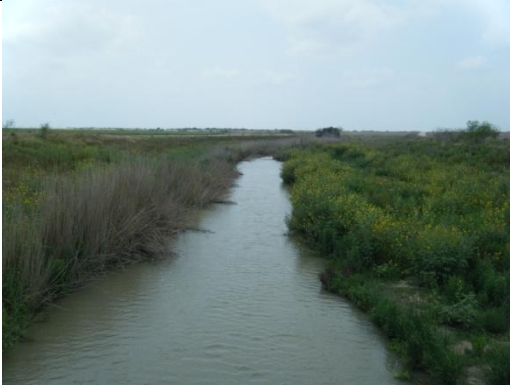
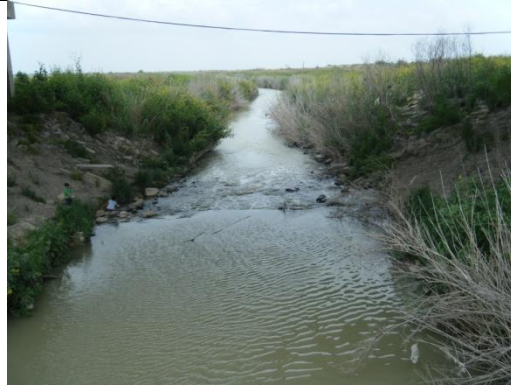
Site #17, 13084 US281 South of Pharr

Site #17 TCEQ Station 13084 is located at the crossing of US 281 south of Pharr. This is an extremely busy area. The Arroyo Colorado in this run of the river is part of the main floodway and is bordered by a large grassy floodplain. The stream banks are relatively short and moderately vegetated, and there is a significant riffle zone made of concrete rubble just downstream. The thalweg depth is approximately 1.0 and is approximately 150 cfs under normal flow conditions.

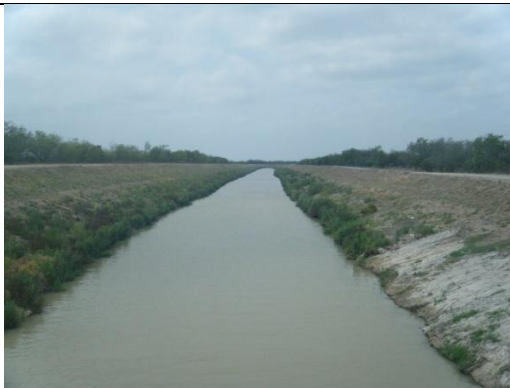
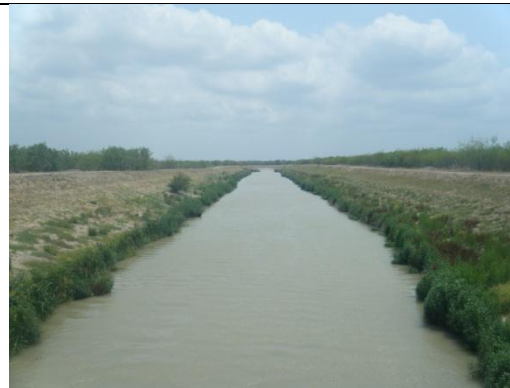
Site #18, 13085 @ 2061 SE of McAllen

Site #18 TCEQ Station 13085 is located in an urban area at FM 2061 southeast of McAllen. This site was chosen for spatial representativeness. This site has little vegetation.

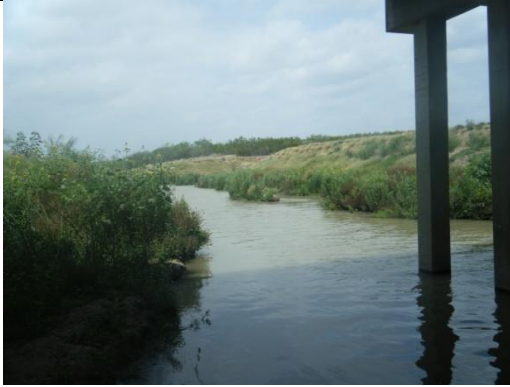
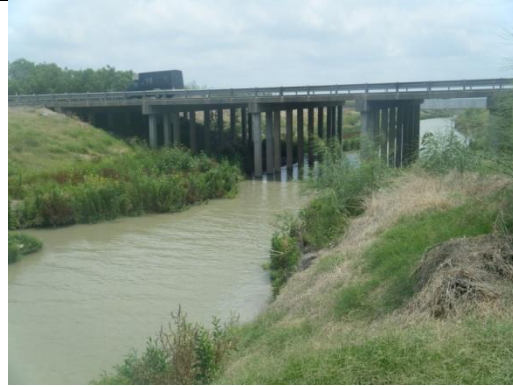
Site #19, 13086 FM 336 South of McAllen

Site #19 TCEQ Station 13086 is located at the crossing of FM 336 South of McAllen. The site is near the McAllen Motorcycle Park. This is an extremely busy area. The banks of the Arroyo Colorado are very steep but not wooded. The thalweg depth is approximately 0.3 to 0.6 meters under normal flow conditions are approximately 20-40 cfs.

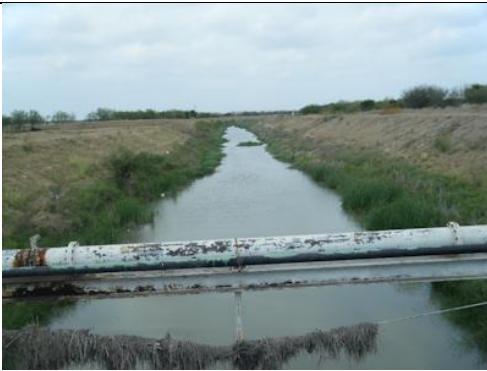
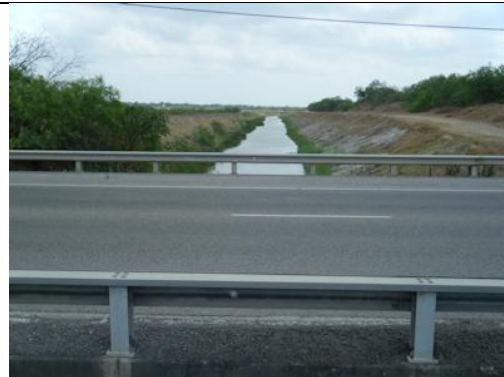
Site #20 13087 FM 115 South of McAllen

Site #20 TCEQ Station 13087 is located at the crossing of FM 115 south of McAllen near Spring Fest Park and Soccer Field in an urban area. This site was chosen for spatial representativeness. The water had a biofilm or oiled scum layer and did not appear desirable for contact recreation.

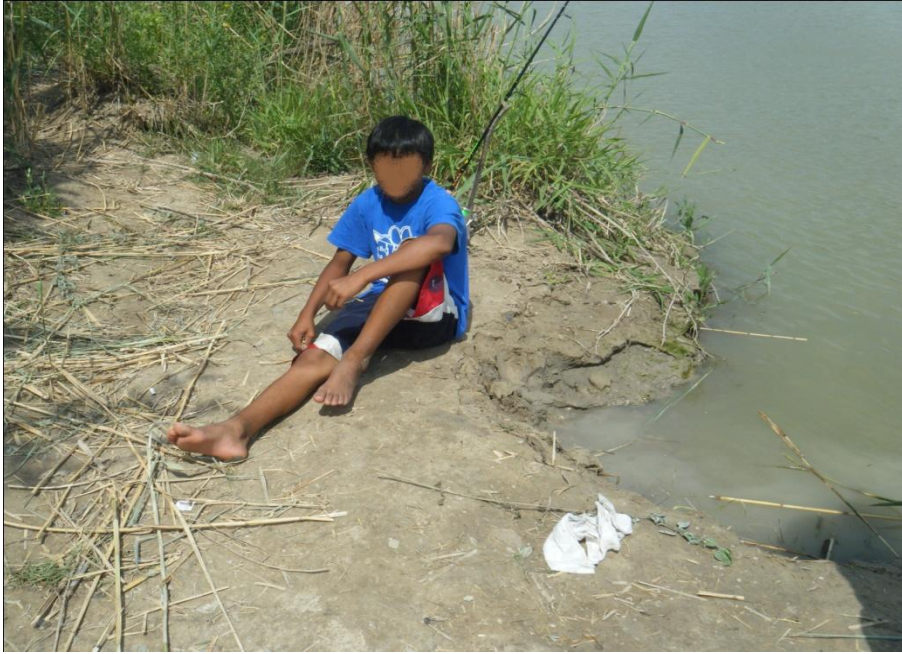
Primary contact recreation activities were observed at stations 13074 on AU_01 and 13084 on AU_ 04. Both observations of primary contact recreation were of children wading in the river. Eleven children were observed wading at the above sites, and additional families with children arrived as the NRA field crew finished sampling at station 13084 . Secondary contact 1 recreation activities, primarily related to fishing, were observed at 11 stations on all AUs.

Figure 17: Site 13074 AU_01 at Cemetery Rd. Bridge.

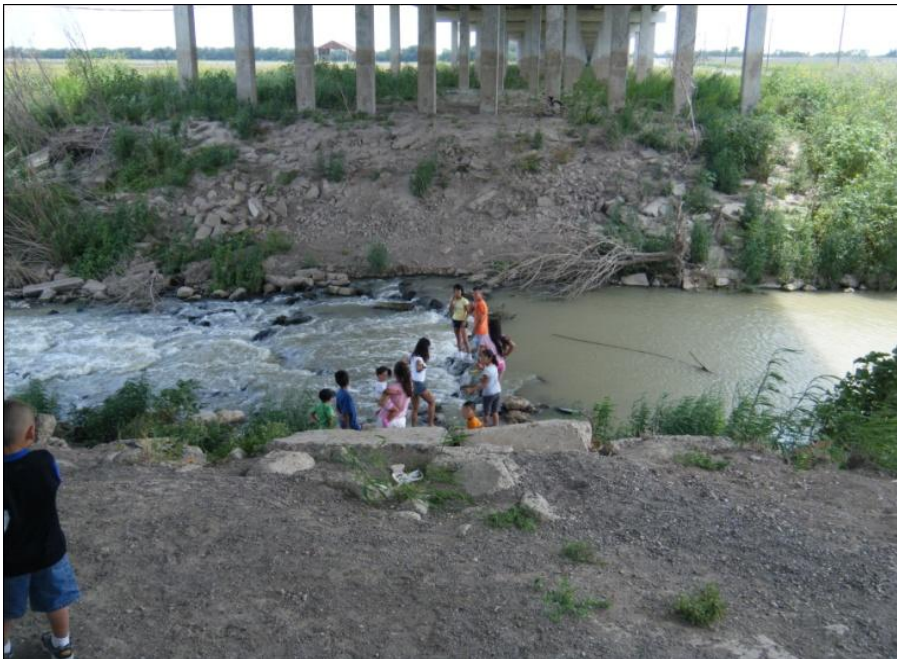
Figure 18: Site 13084 AU_04 at US 281 South of Pharr.

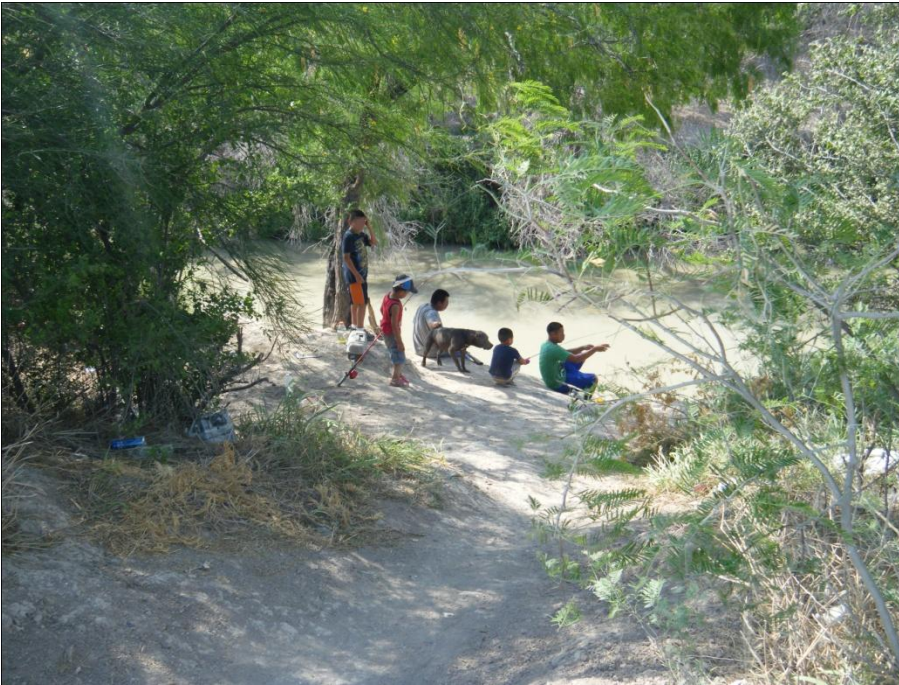
Figure 19: Site 16444 AU_03 at FM 491 SE of Mercedes.
