# Riparian Evaluation Report: Tributaries of Baffin Bay

August 30, 2019

**Water Body:** Baffin Bay 2492 Tributaries

**Contract No:** CBBEP 1907

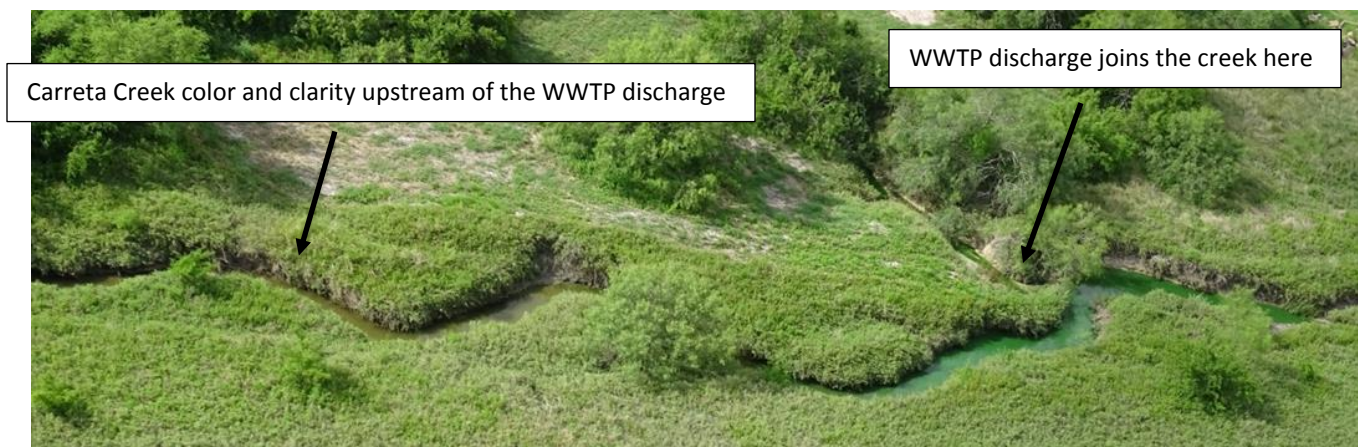
**Figure 13** At the discharge location for the Bishop WWTP there is a distinct change in the water's color and clarity. An algal bloom was observed beginning at this location.

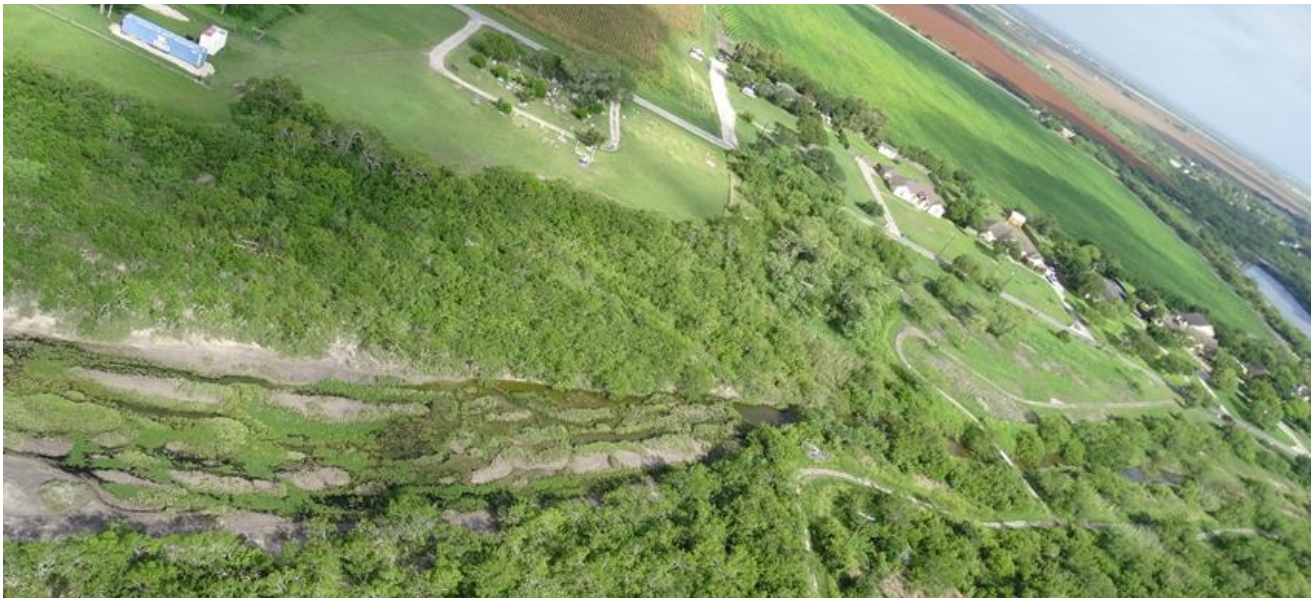
**Figure 14** The creek's riparian area remains remarkably functional and well vegetated as it runs through the town of Bishop. The channel braiding could be indicative of excessive sediment runoff in the past, but the creek seems to be managing its sediment now — most braids have well-vegetated perimeters

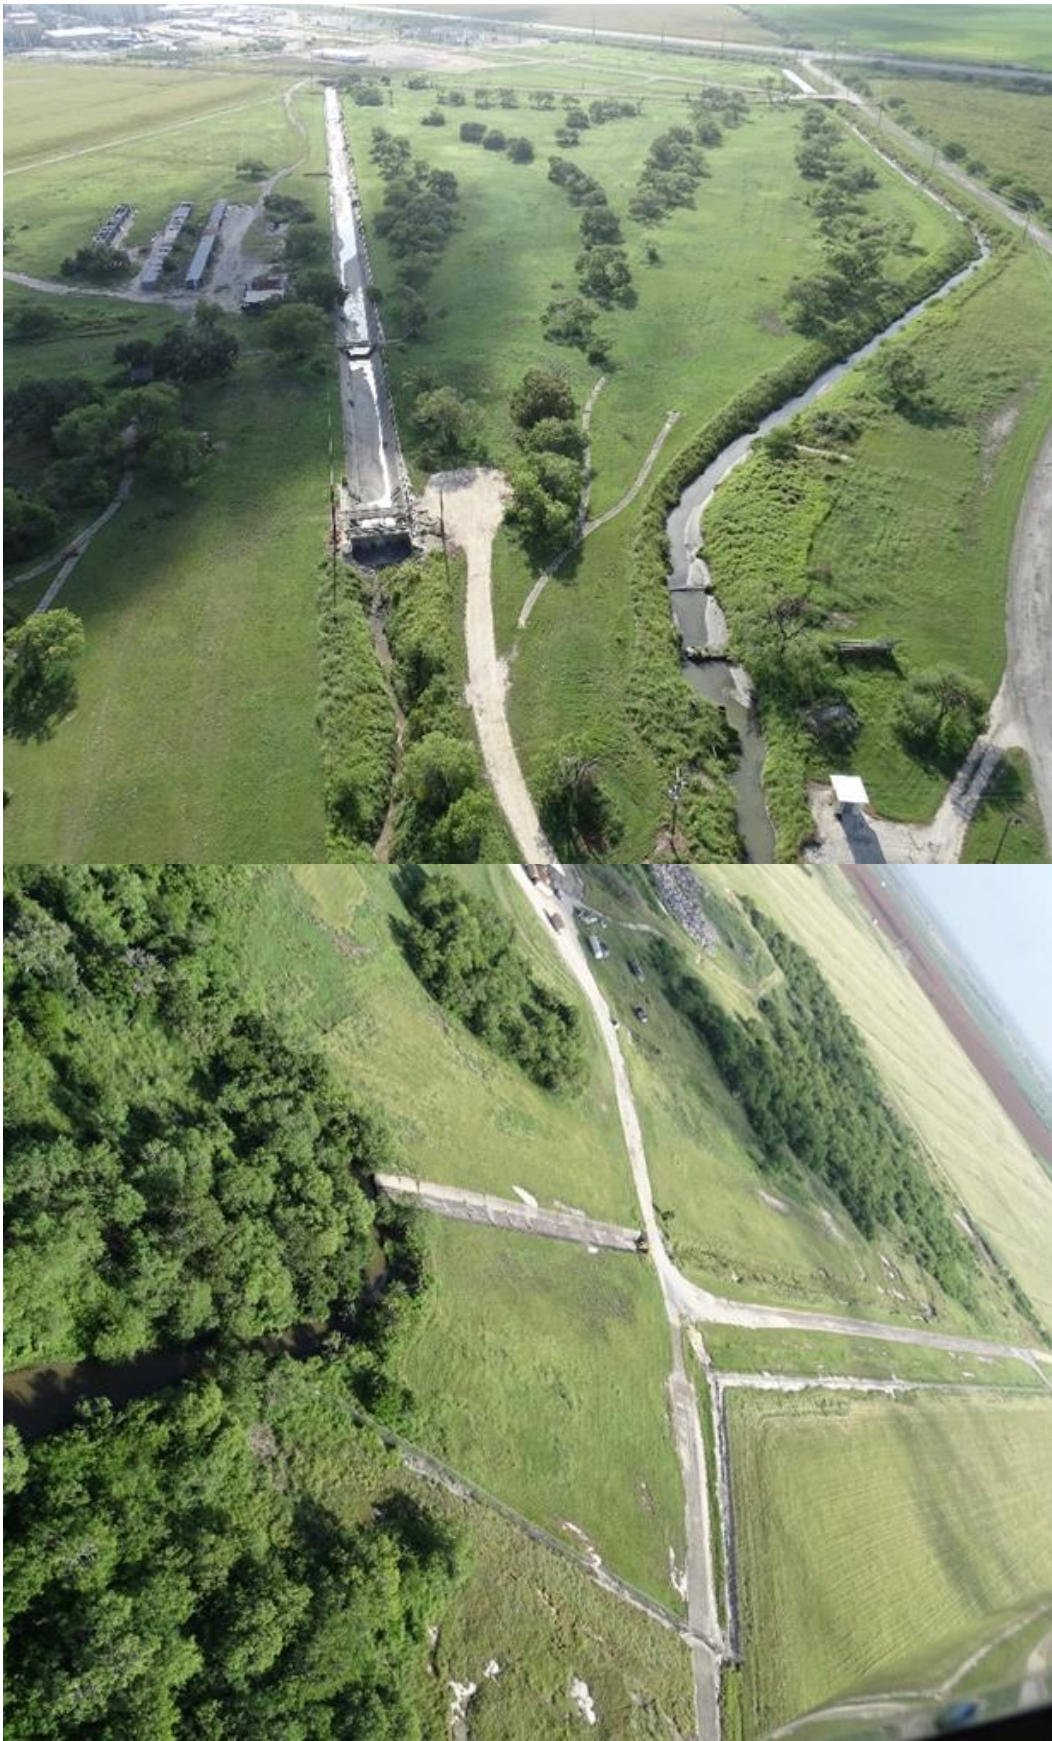
**Figure 27** Stormwater runoff ditches entering the creek.

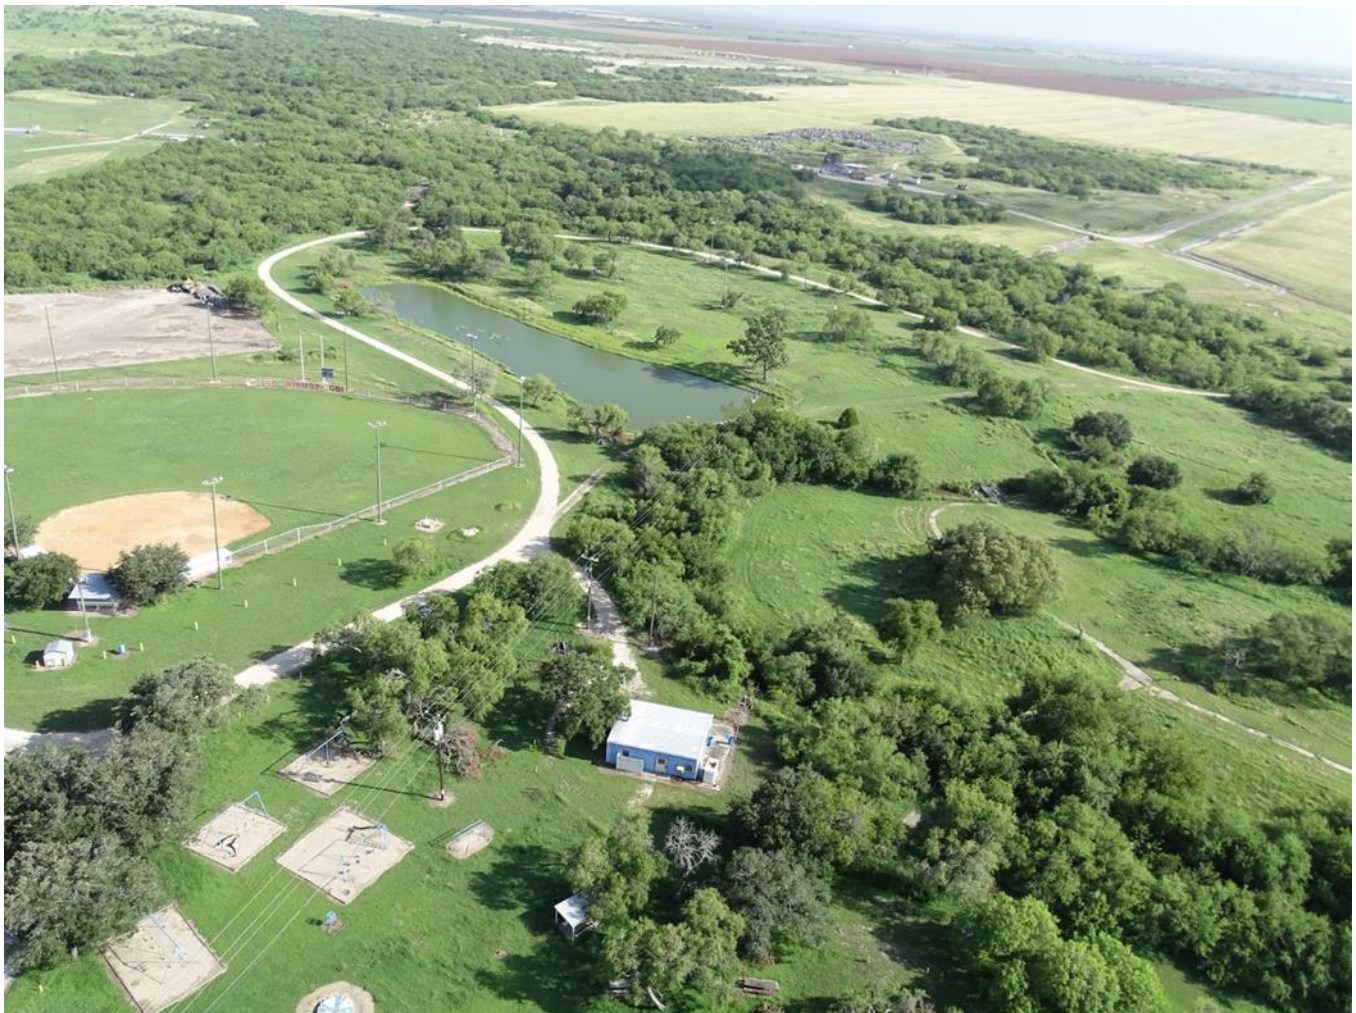
**Figure 29** Community park with manicured grounds and off-channel pond.

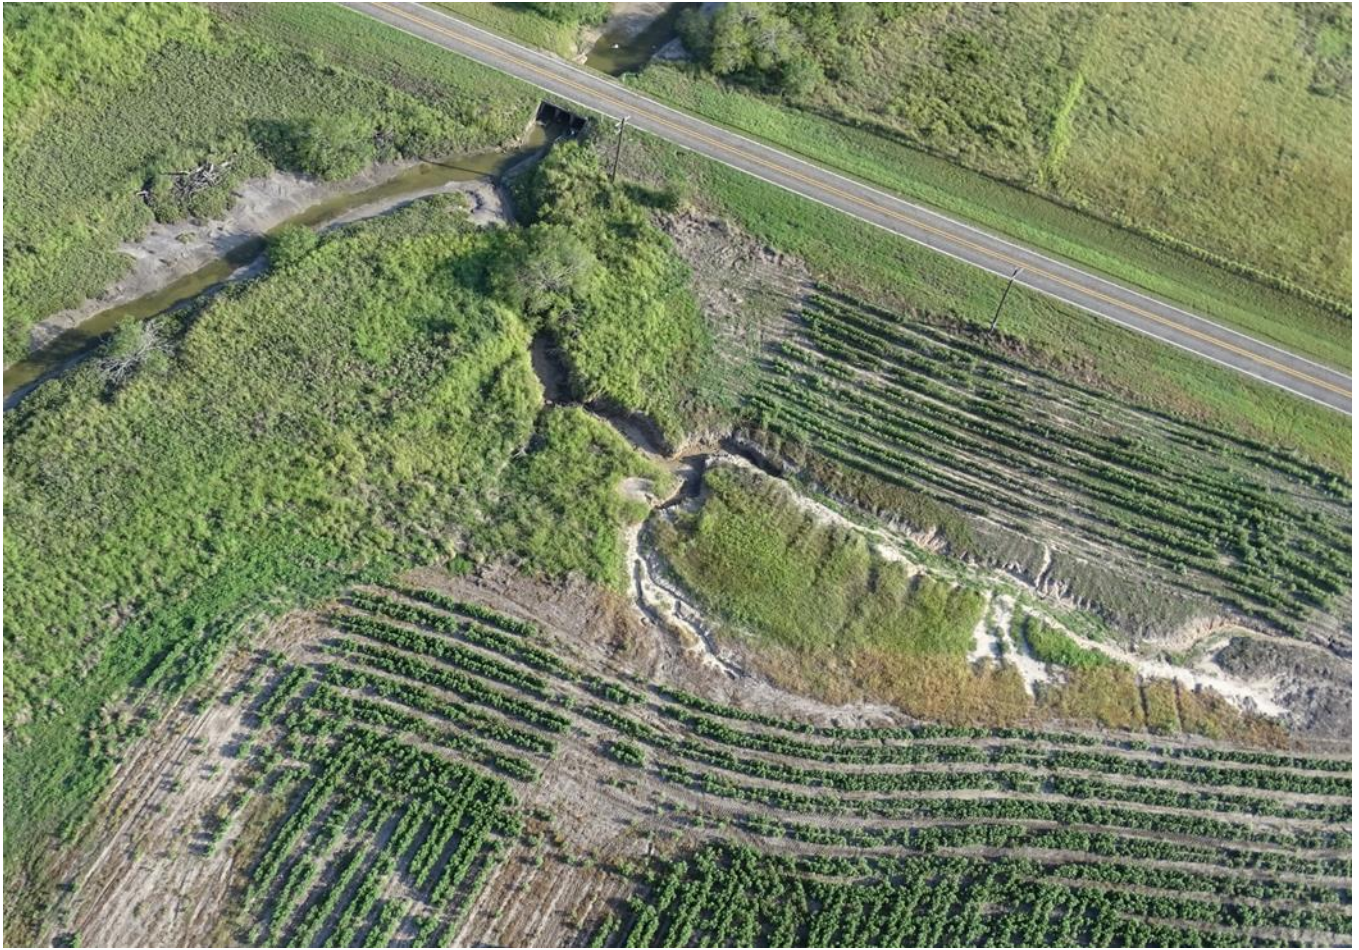
**Figure 35** Image illustrates the most common hindrance on the creek and gully formation.

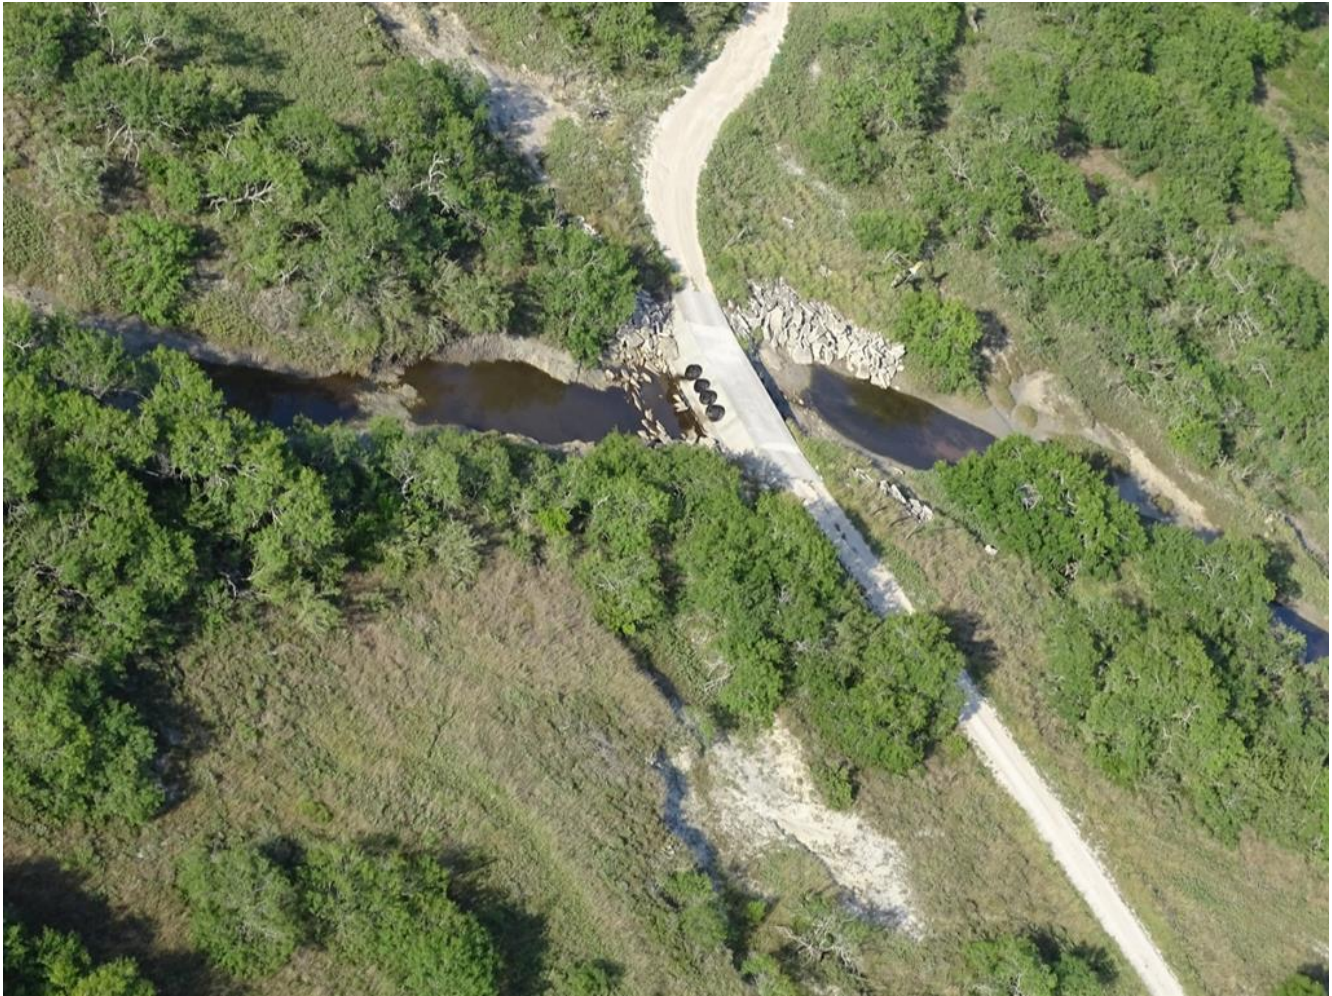
**Figure 37** This image shows a poorly designed crossing on Jaboncillos Creek. It appears that the creek has down cut around the crossing and left its conduits high and dry. Piles of cement debris can be seen dumped along the channel around the crossing in an apparent attempt to dissipate stream energy. Stream crossings should always be located on a straight section of channel to avoid excessive stream energy being directed at the crossing.

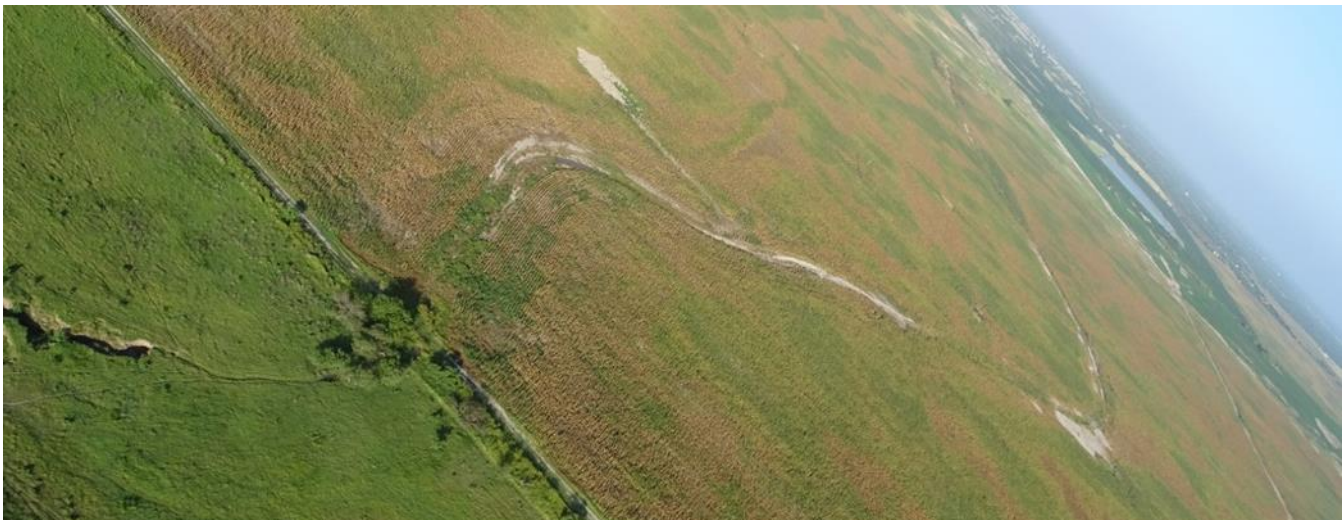
**Figure 46** Looking west at Trib A to Radicha Creek south of FM 2220. This image illustrates the hindrance of farming too close to a drain way and the opportunity for enhanced function with a setback of disturbance.

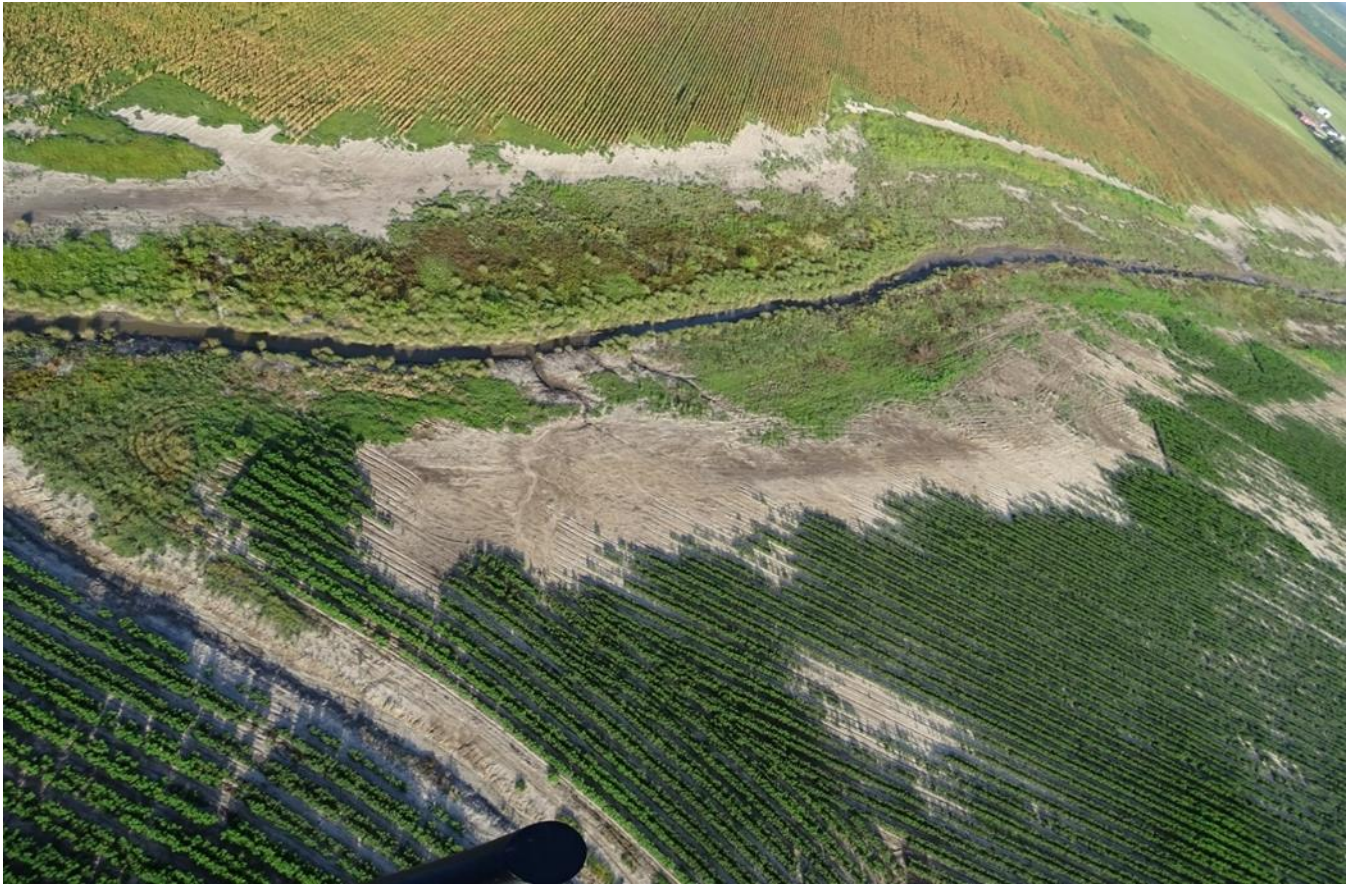
**Figure 52** This image shows a fairly well vegetated riparian area with Cordgrass and Spiny aster despite the farming infringement on the riparian area and the gully formation. This small area of functional condition seems to indicate the creek's readiness for recovery.

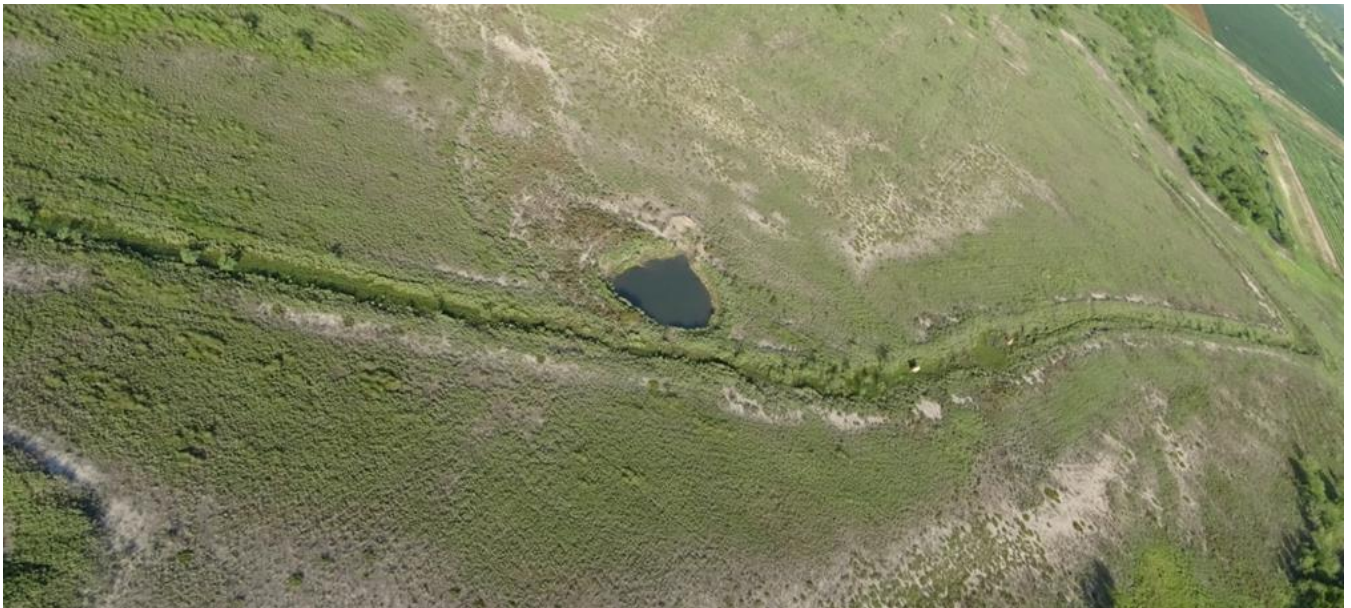
**Figure 53** In this image the riparian area is hindered by farming/grazing too close. Further upstream, near the top of the image, the channel has been manipulated and straightened.

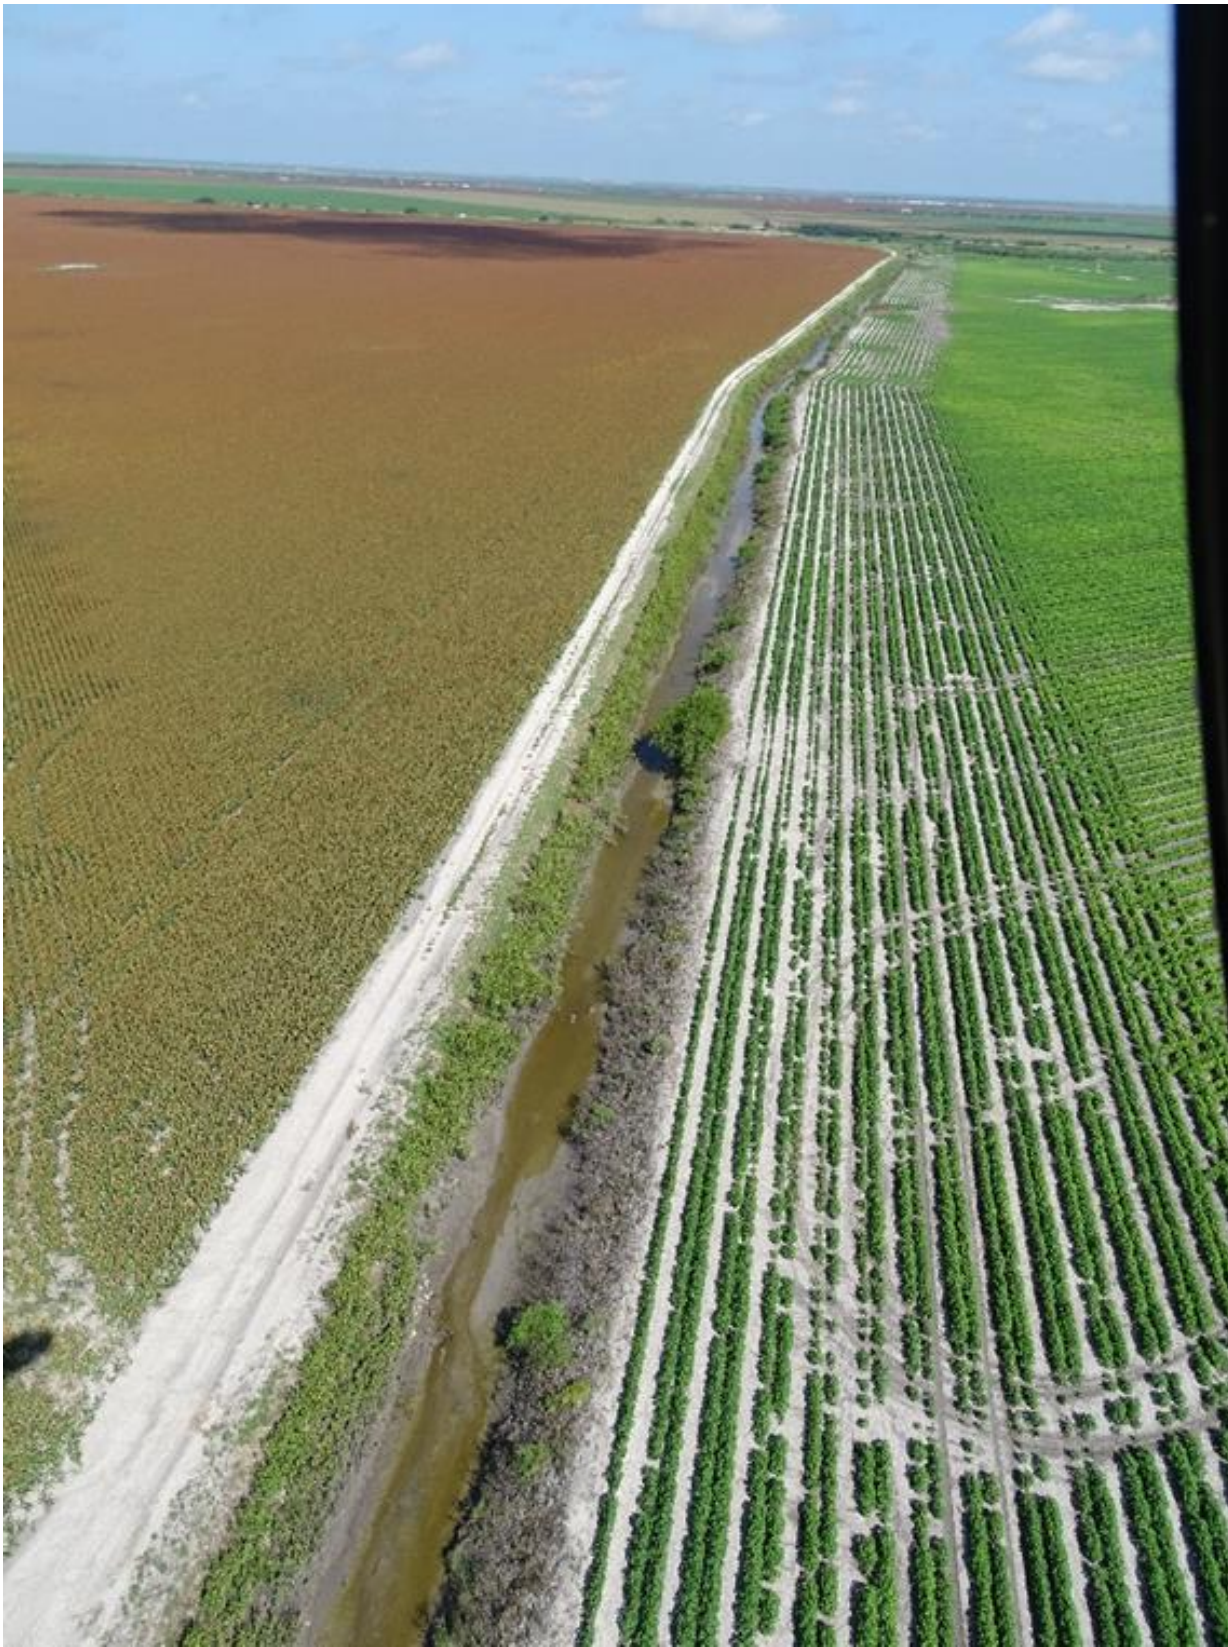
**Figure 68** In this image you can see the Lost Creek Ditch as it runs through farmland. The creek appears to be attempting to recover by growing vegetation, trapping sediments, and holding water, but may be hindered by attempts to curtail vegetation. In the image, vegetation on the right appears to have been sprayed with herbicide.

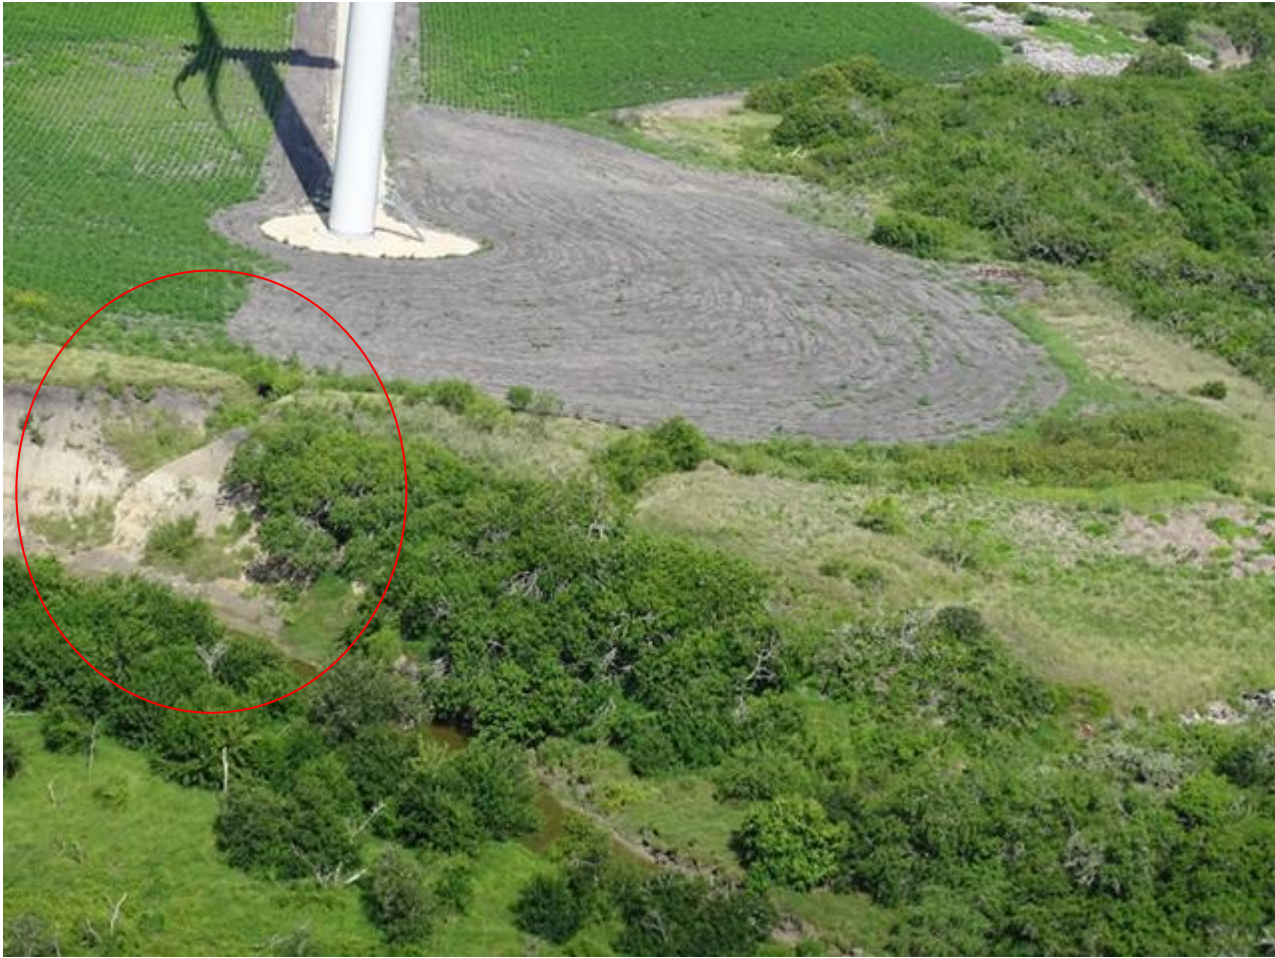
**Figure 74** Wind-farm development too close to the creek can also hinder riparian recovery by increasing and focusing runoff. This image shows the bank erosion apparently as a result of enhanced runoff from a tower cited too close to the creek bank without an adequate buffer.

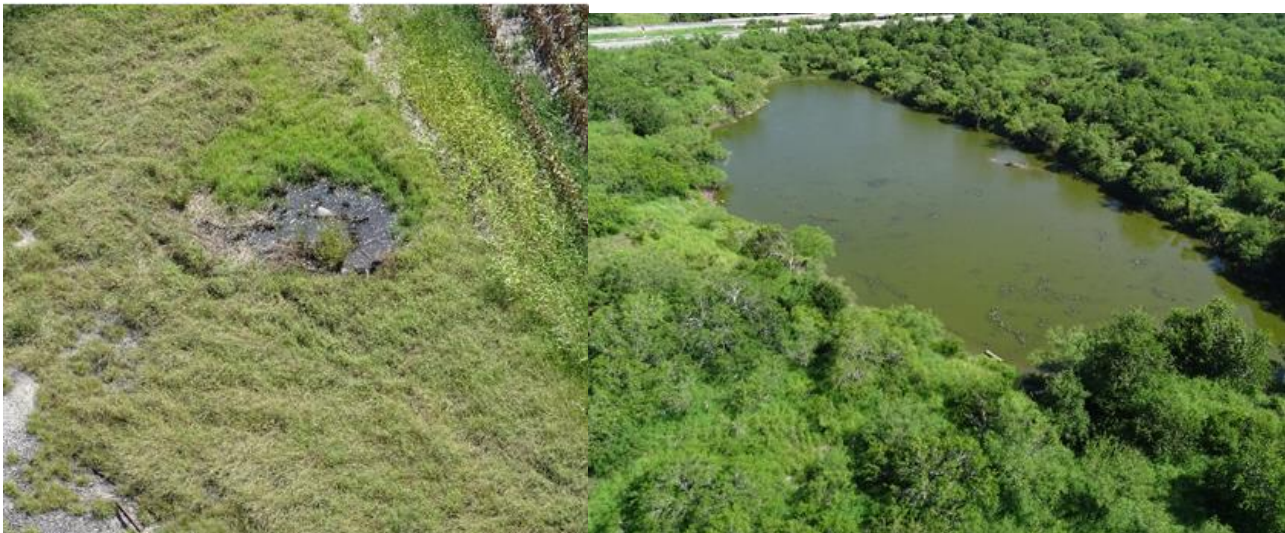
**Figure 75** Both a new and older, dismantled waste water treatment plant (WWTP) were observed near Driscoll on the bank of Petronila Creek. The discharge location for newer WWTP was not distinctly visible in the creek, however a pond and a seep (pictured here) are located adjacent to the creek near the site of the dismantled plant and appear to be experiencing an algal bloom.

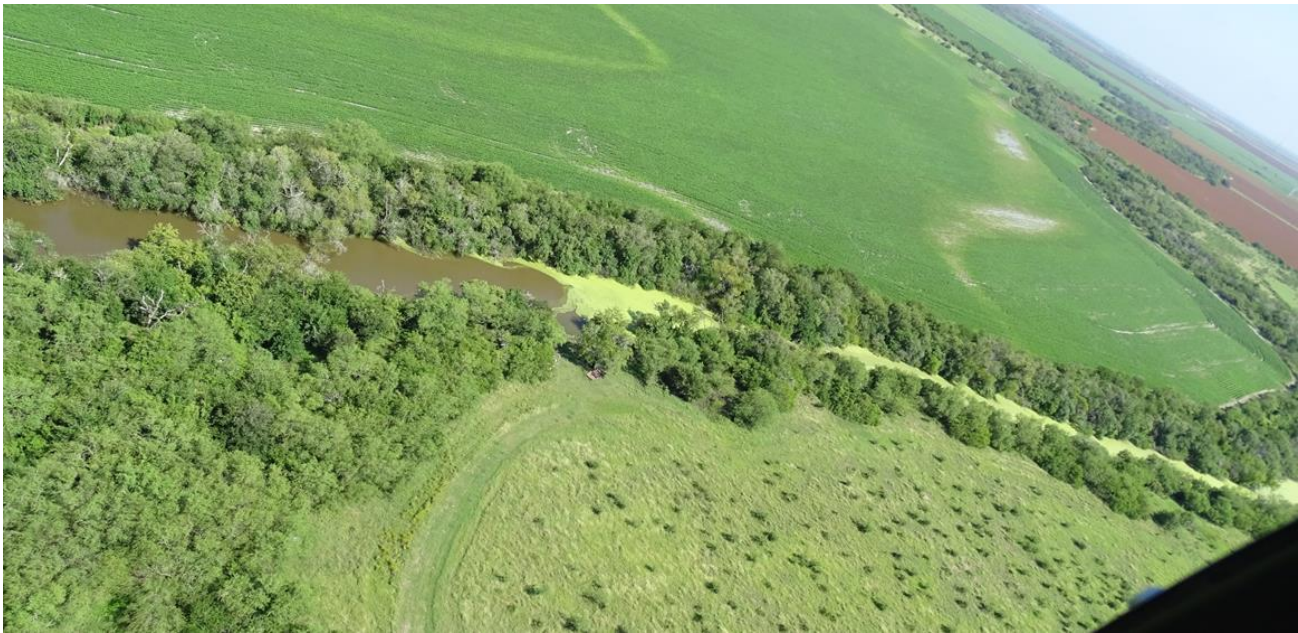
**Figure 82** Towards the top of the reach, a thick cover of Duck weed covers the creek's surface.

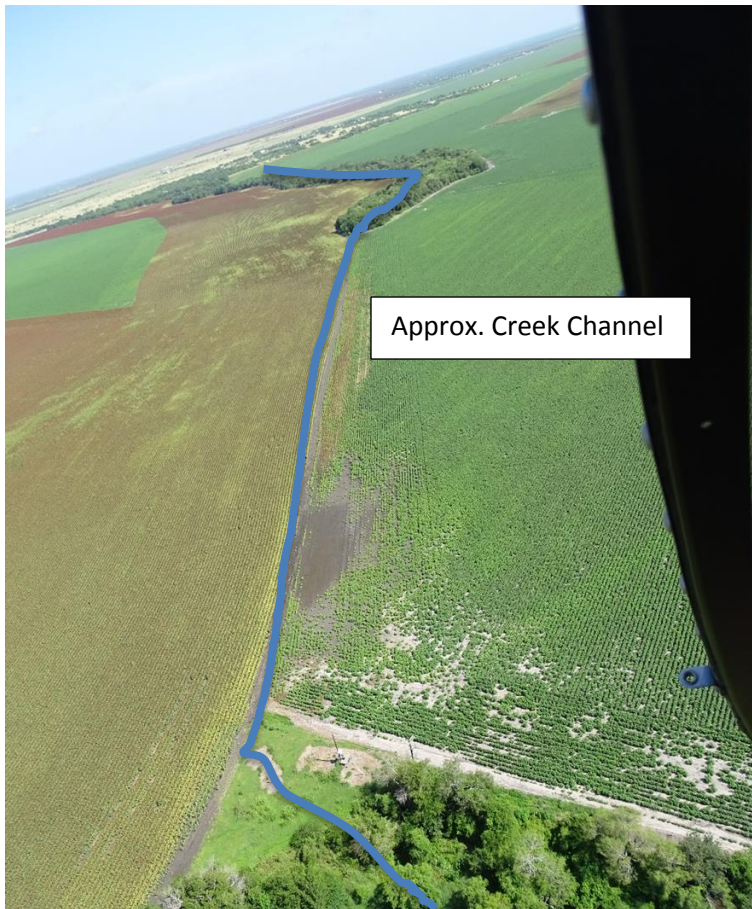
**Figure 90** This image illustrates the riparian recovery hindered by farming too close to the creek.

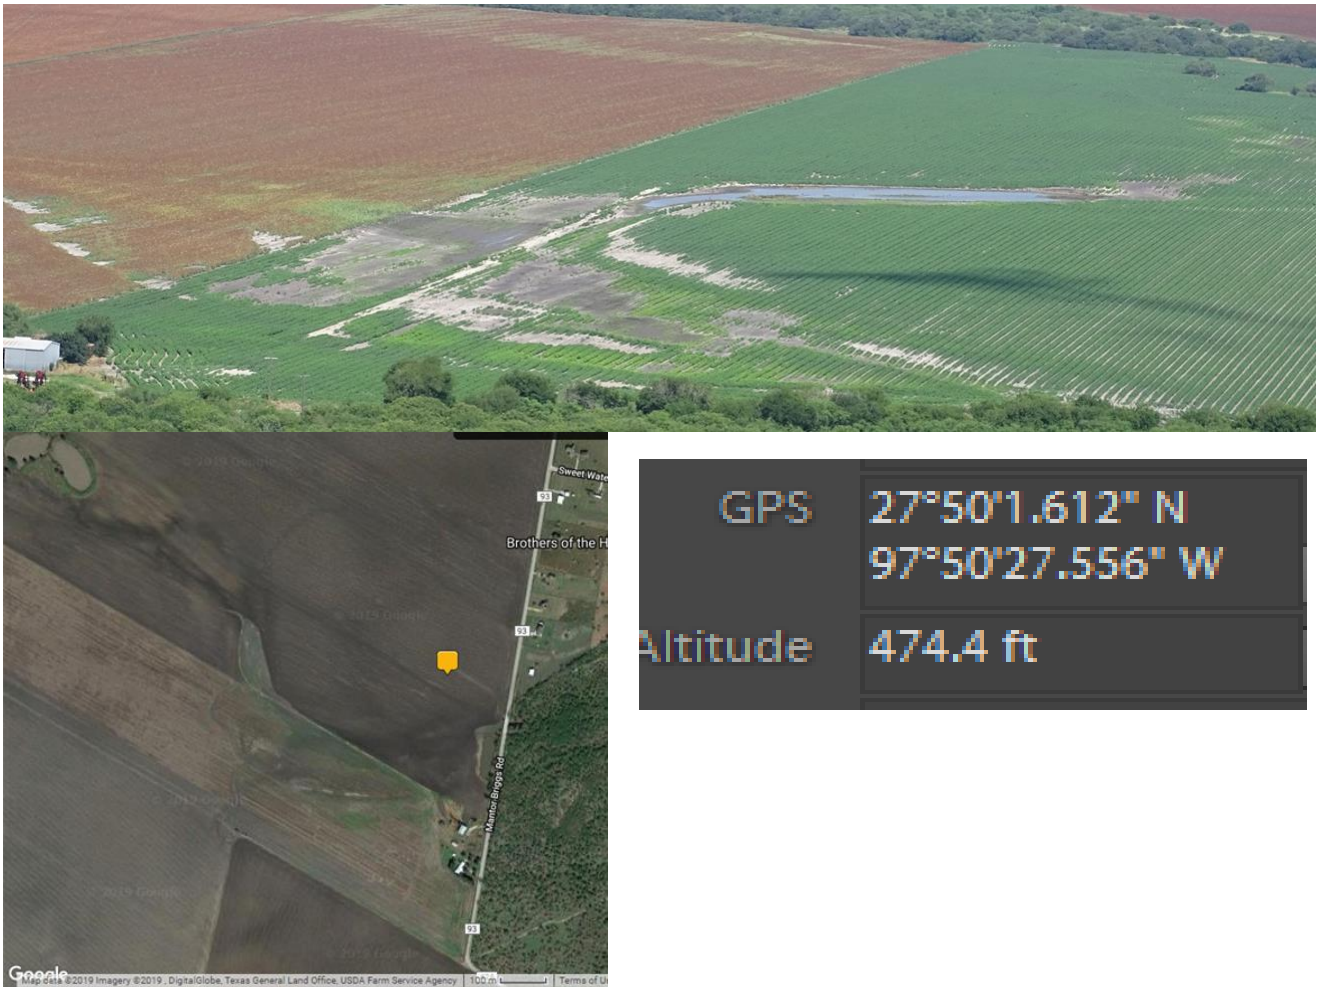
**Figure 91** This image is a possible aerial photo point. It shows a meander bend of the creek included in a field. Visible in the distance is the tree lined Aqua Dulce Creek. If the identified hindrance, i.e. farming too close, was addressed here, riparian recovery could be expected along with water quality benefits.

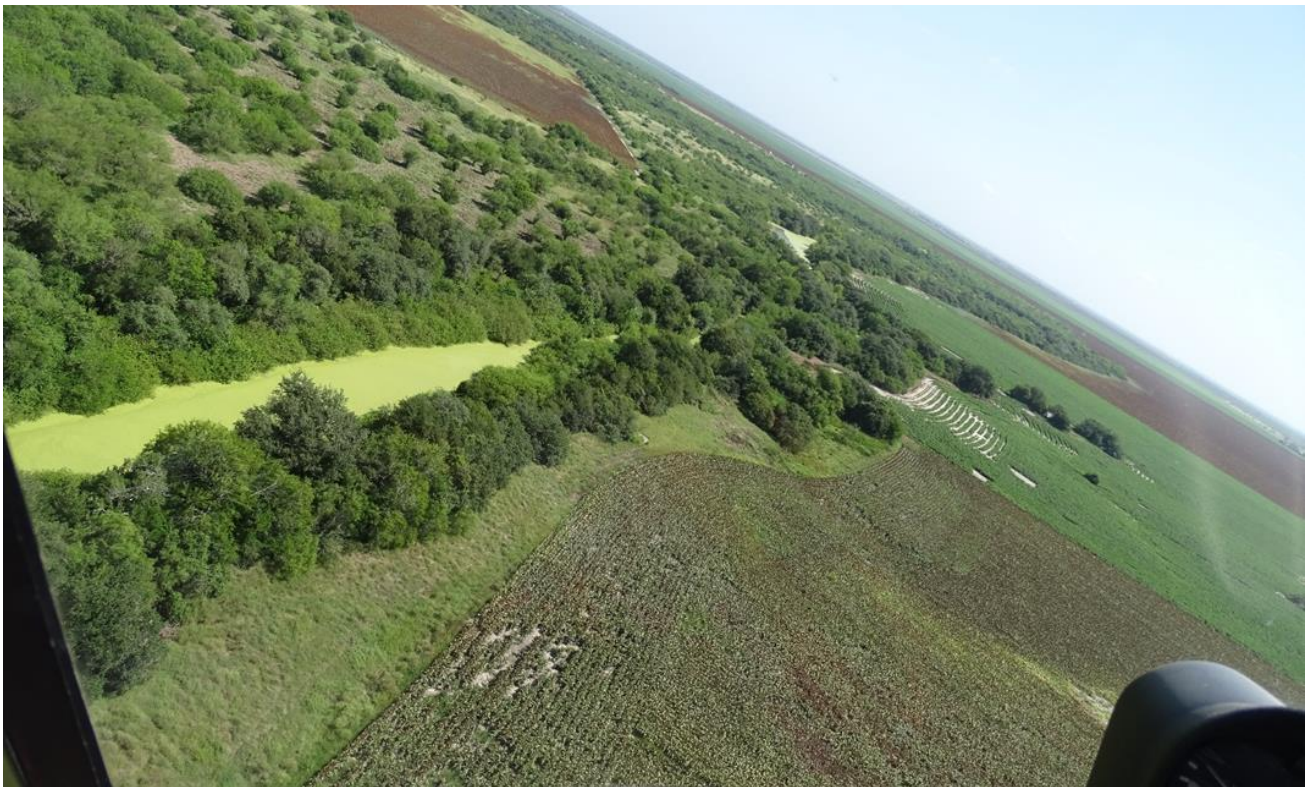
**Figure 95** Further upstream on the lower reach of Aqua Dulce Creek, Duck weed covers the water's surface. Duck weed is quick to respond to nutrients in a stream and could indicate some nutrient addition. It is actually an aquatic plant and can

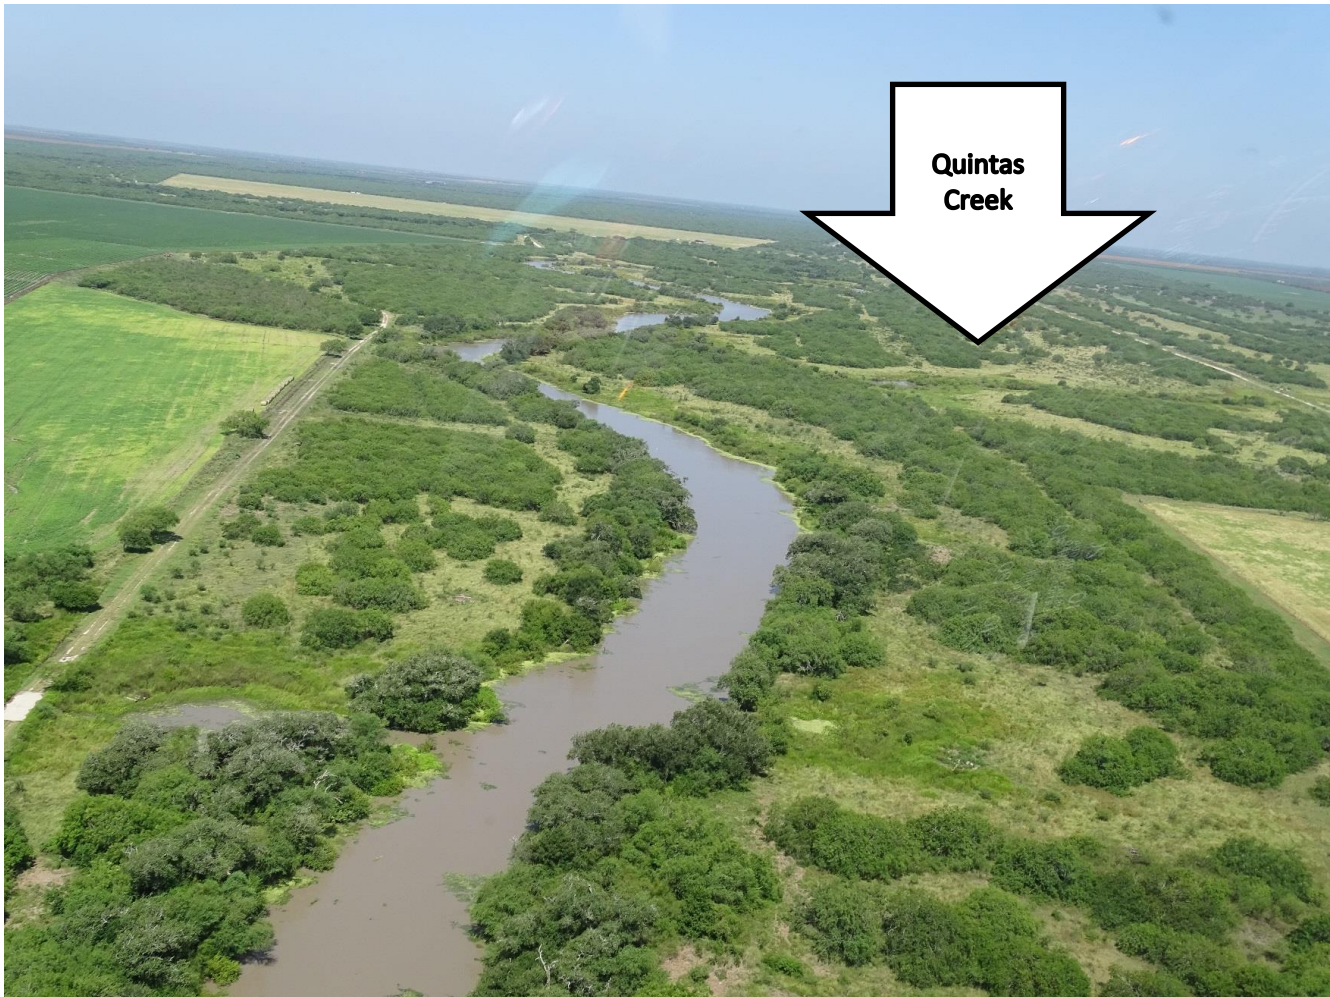
**Figure 96** Further upstream on Aqua Dulce Creek, shown in this image, the water becomes brown and cloudy and Duck weed can be seen colonizing the surface. This photo was taken near the confluence with Quintas Creek, a tributary that may deliver treated effluent from the town of Orange Grove.

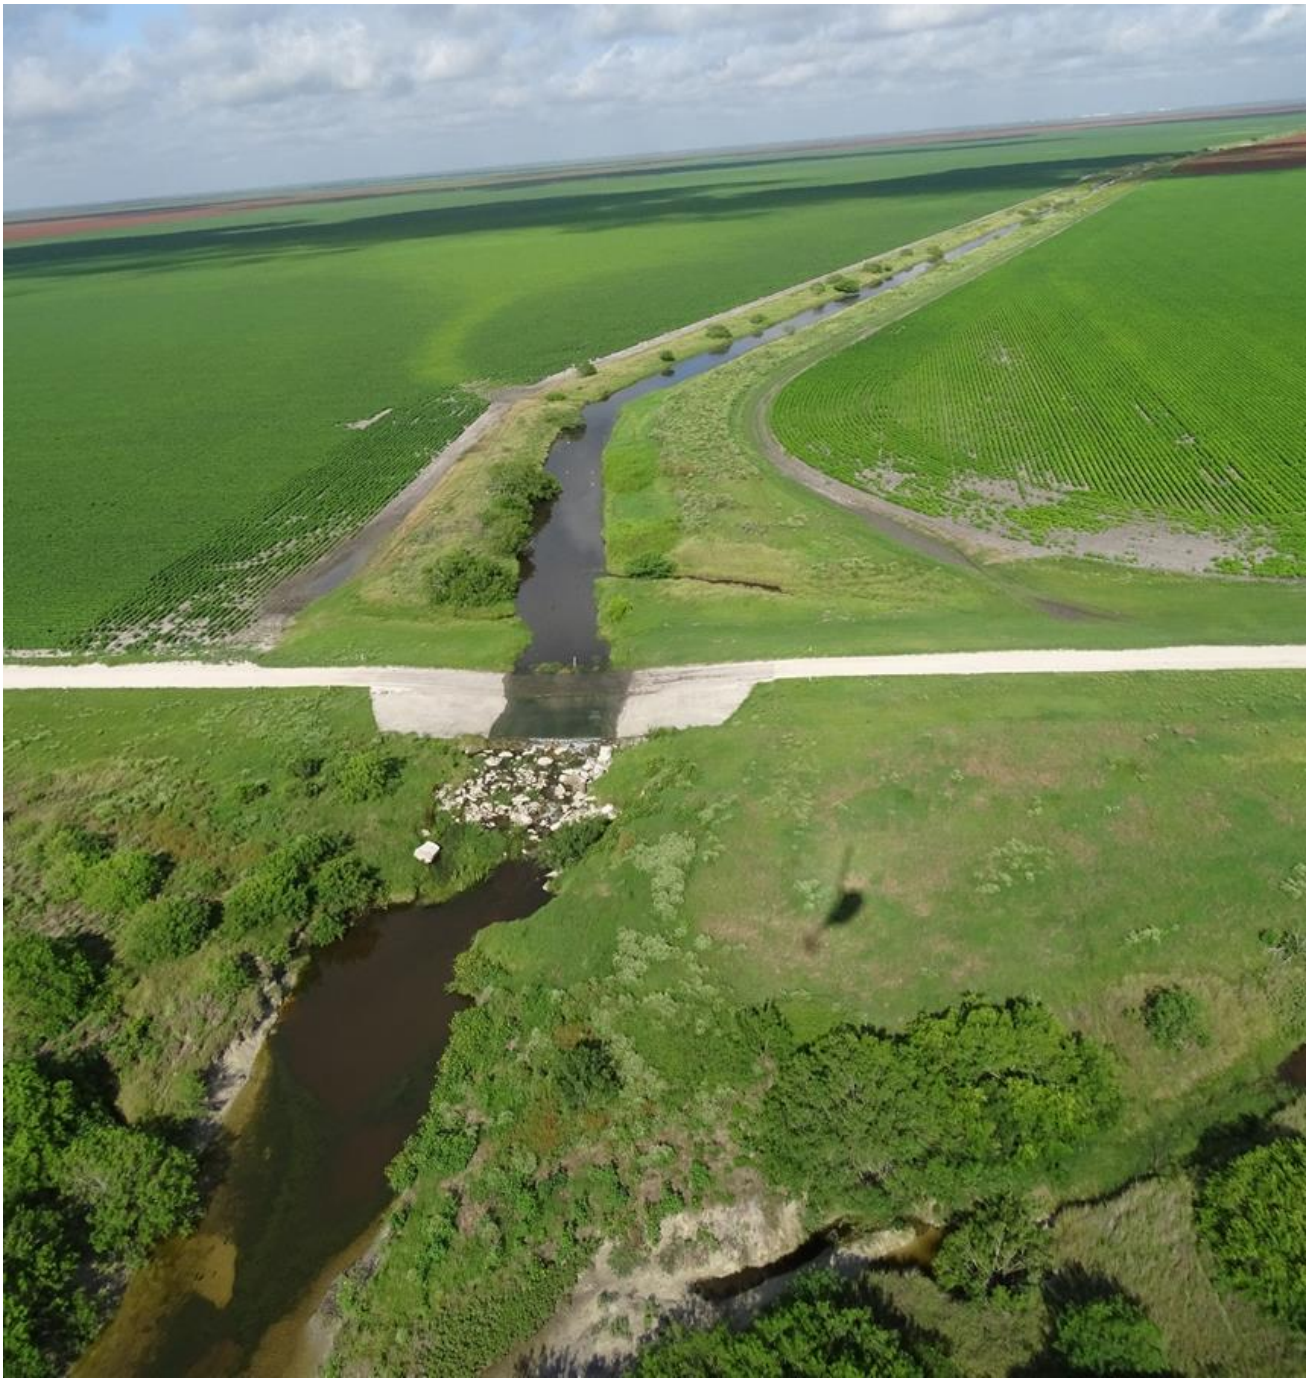
**Figure 112** Upstream the creek has been channelized and is more ditch like, straight and narrow. Still the riparian area is marginally functional and well vegetated. Farming activities are beginning to encroach on the creek and its floodplain. The poorly designed crossing pictured here is acting as a gradient control structure and is a source of erosive energy evidenced by a scour pool and head cut.
