# Riparian Evaluation Report: Tributaries of Baffin Bay

August 30, 2019

**Water Body:** Baffin Bay 2492 Tributaries

**Contract No:** CBBEP 1907

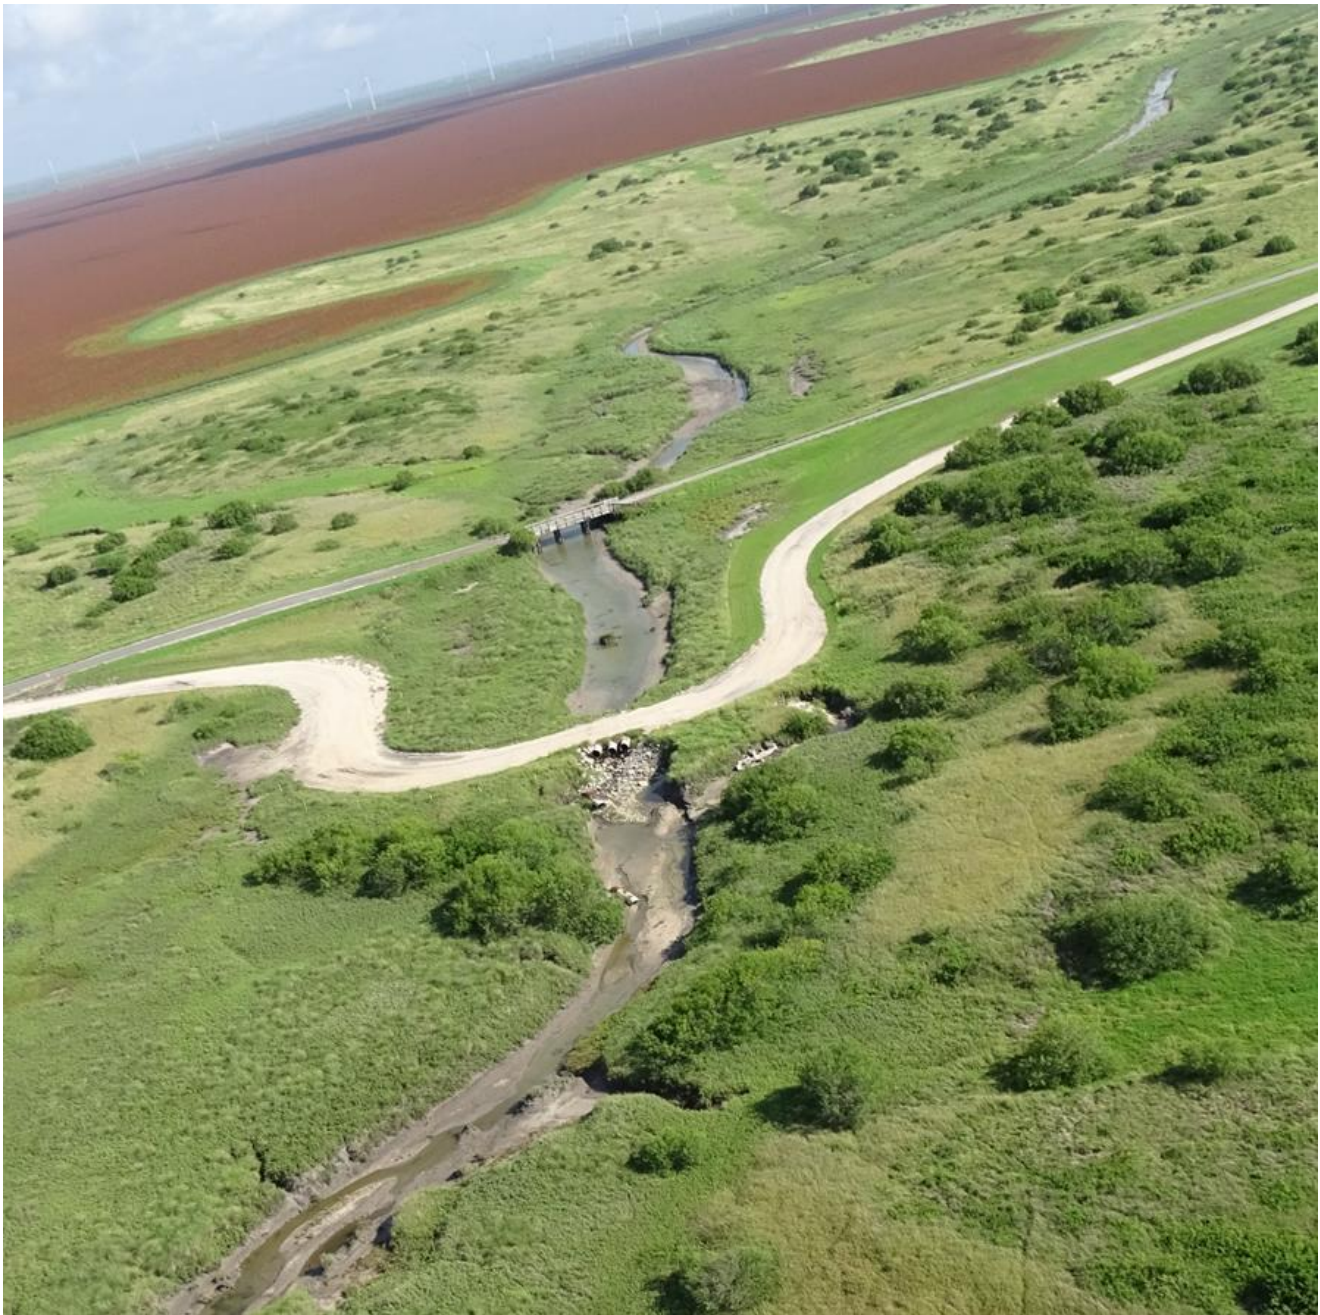
**Figure 118** The poorly designed crossing pictured in the foreground is acting as a gradient control structure and is a source of erosive energy evidenced by scoured banks and gully formation. In contrast, the crossing pictured in the background is well designed to allow passage of sediment and water without enhancing the streams erosive energy.

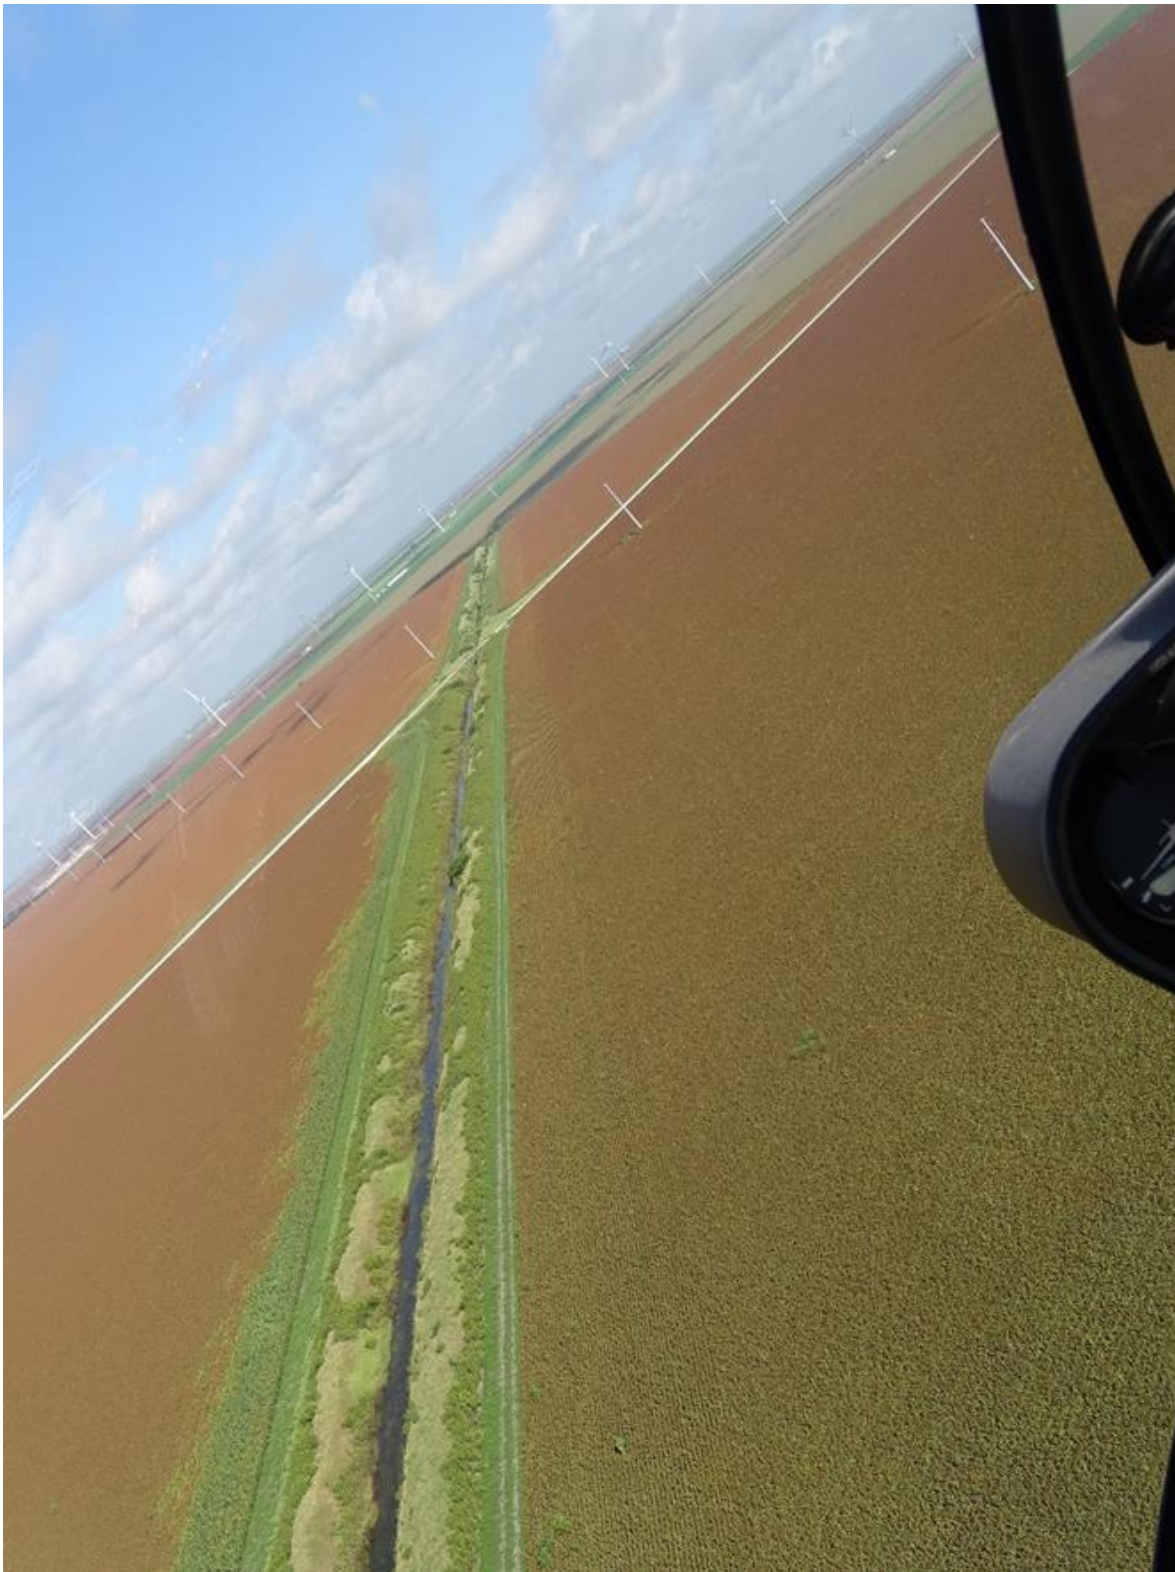
**Figure 119** Upstream, the creek has been channelized and is more ditch-like, straight and narrow. Still the riparian area is marginally functional and well vegetated. Farming activities are beginning to encroach on the creek and its floodplain.

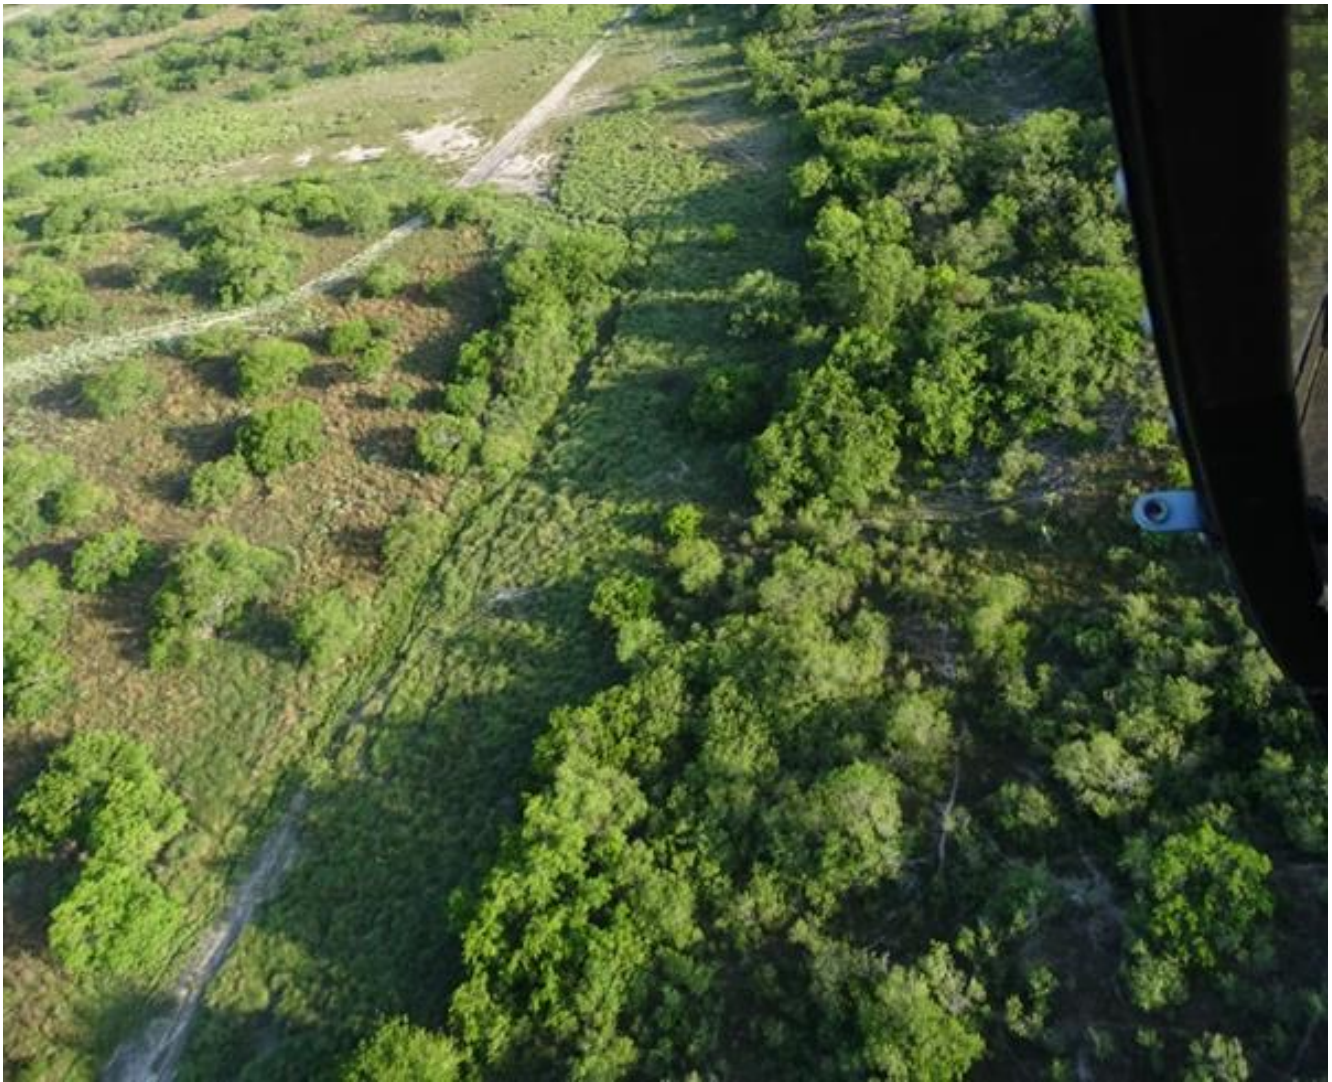
**Figure 127** Further upstream, the creek appears to have the good riparian vegetation present (Cordgrass, Spiny aster were identifiable), but the plant vigor appears to be hampering its contribution.
