Nueces River Authority

Baffin Bay Tributaries Study

Final Report for
CMP Project # 20-029-000-B736

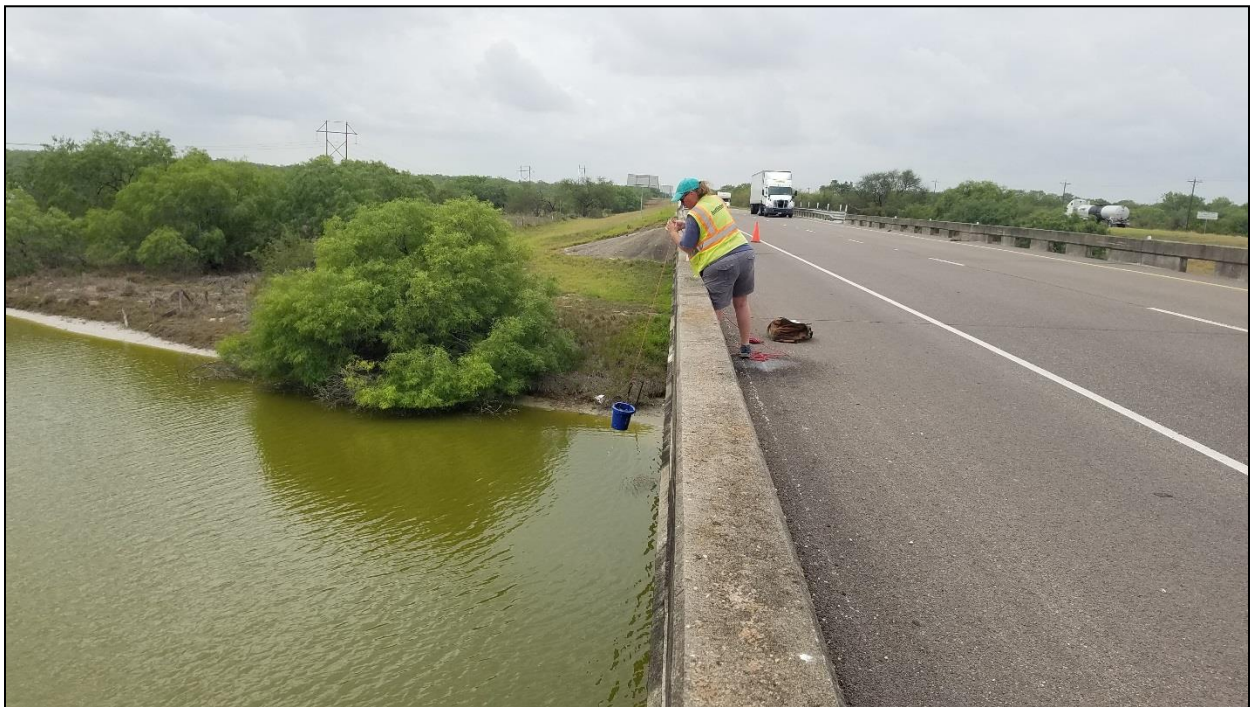
Sample collection - Surface water quality data including field and laboratory data were collected on a monthly basis from January 2020 through December 2020 at Los Olmos Creek Tidal Station 13034. Rain event sampling took place over two days immediately following a rain event on May 16th and 17th. Field data including water depth, water temperature, pH, dissolved oxygen and specific conductance were obtained using a Hydrolab MS5 datasonde according to the latest version of the TCEQ SWQM Procedures Manual (RG-415, 2012). The datasonde was calibrated before each sampling event and post calibrated immediately after returning from the field. Water samples were taken from the centroid of flow (point of maximum flow) at each station using a sample bucket that was pre-rinsed with site sample water. Surface water quality samples were collected, preserved with acid when applicable, stored on ice, and delivered to the laboratories that afternoon for analysis.

Figure 13. Sampling from the bridge at Los Olmos Creek Tidal Station 13034

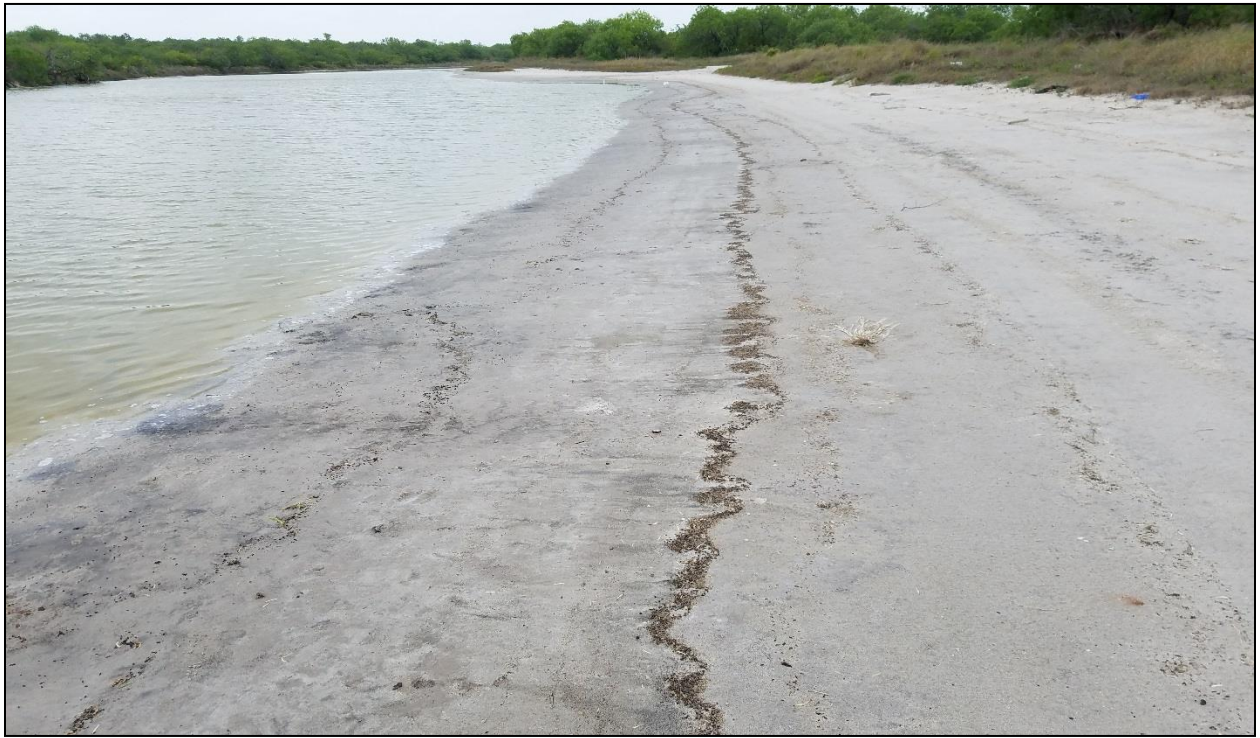
Site Observations – Bat guano was observed on the bank of Los Olmos Creek Tidal during site visits contributing bacteria and nutrients (nitrogen and phosphorus) to the waterbody.

Figure 14. Bat guano droppings on the high tide lines on Los Olmos Creek Tidal

Bacteria – Bacteria concentrations over the course of the study were highly elevated and likely at least partially attributed to the bat colony that resides under the bridge.

NRA recommends a continuation of data collection efforts on Los Olmos Creek Tidal to further characterize the water quality to account for seasonal and climactic variability. Due to the proximity of the bat colony to the sampling location, it is recommended that the sampling station be moved away from the bridge crossing.

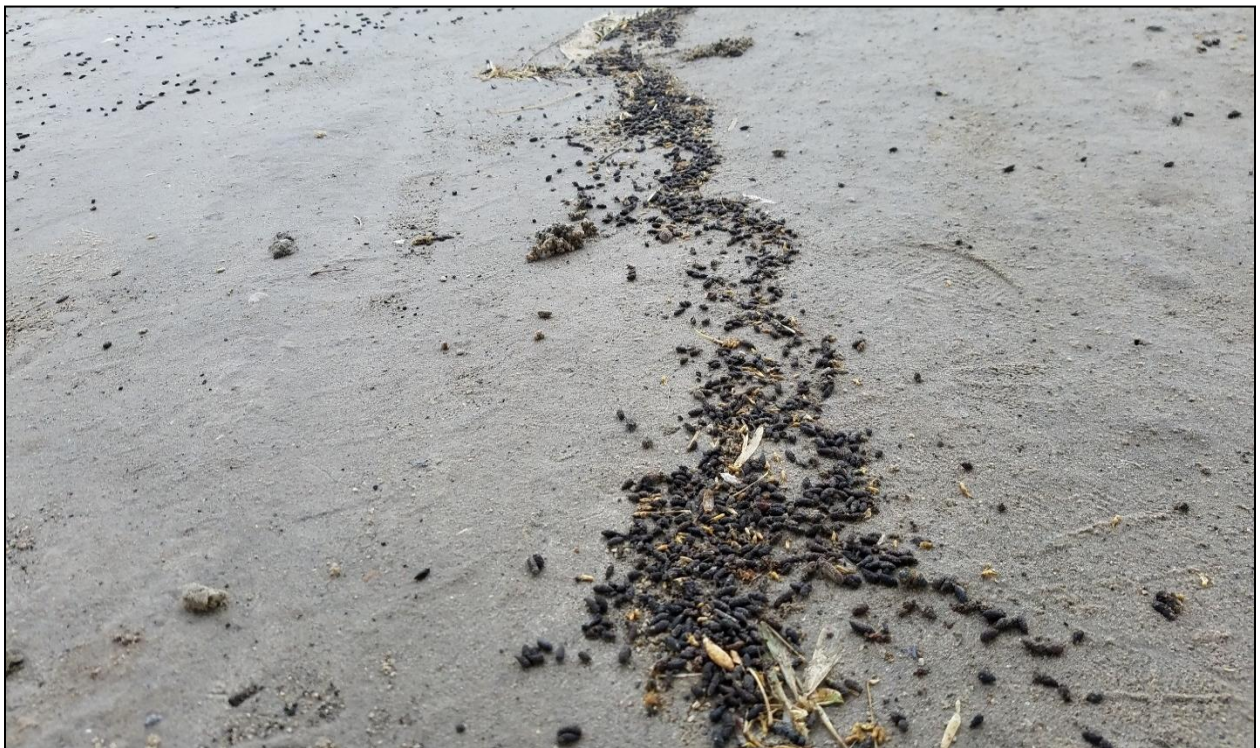
Figure 15. Bat guano droppings on the bank of Los Olmos Creek Tidal

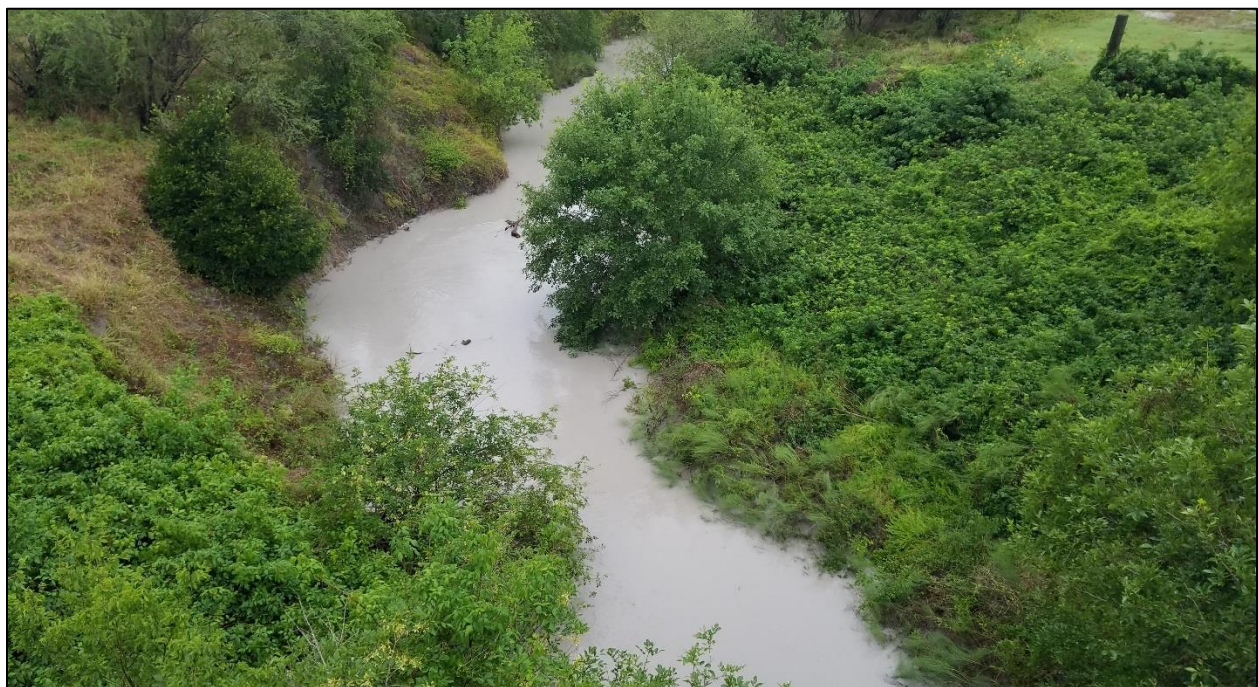
Figure 30. Petronila Creek Above Tidal at approx. 170 ft³/sec on May 16th

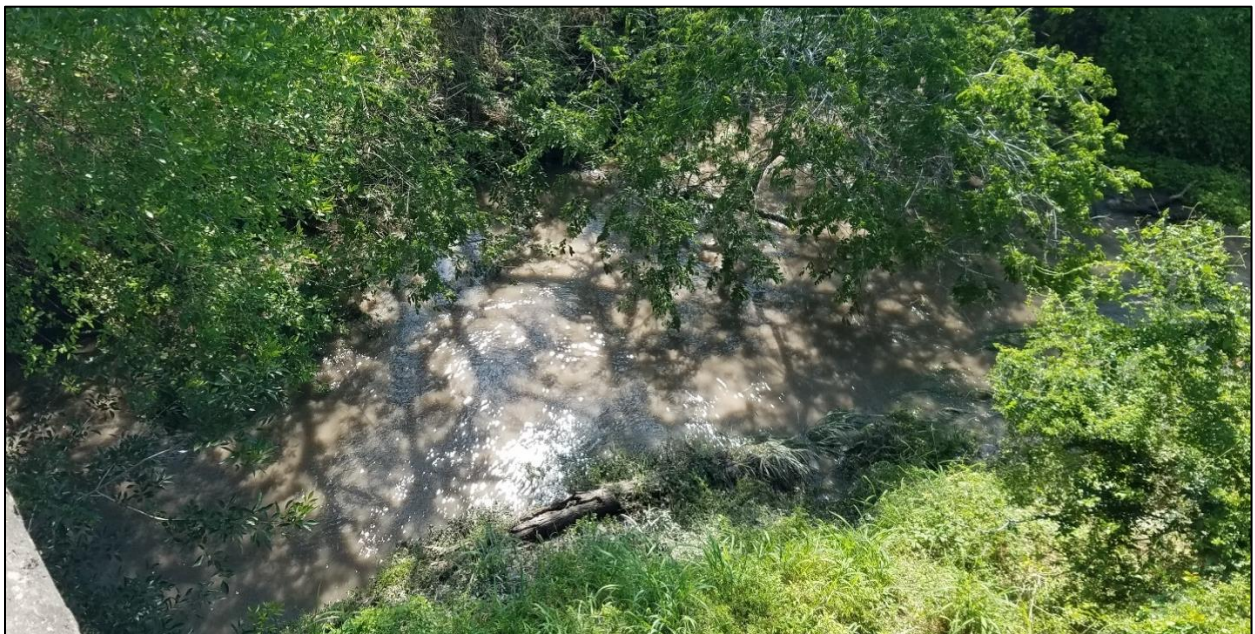
Figure 32. San Fernando Creek Above Tidal at approx. 200 ft³/sec on May 17th

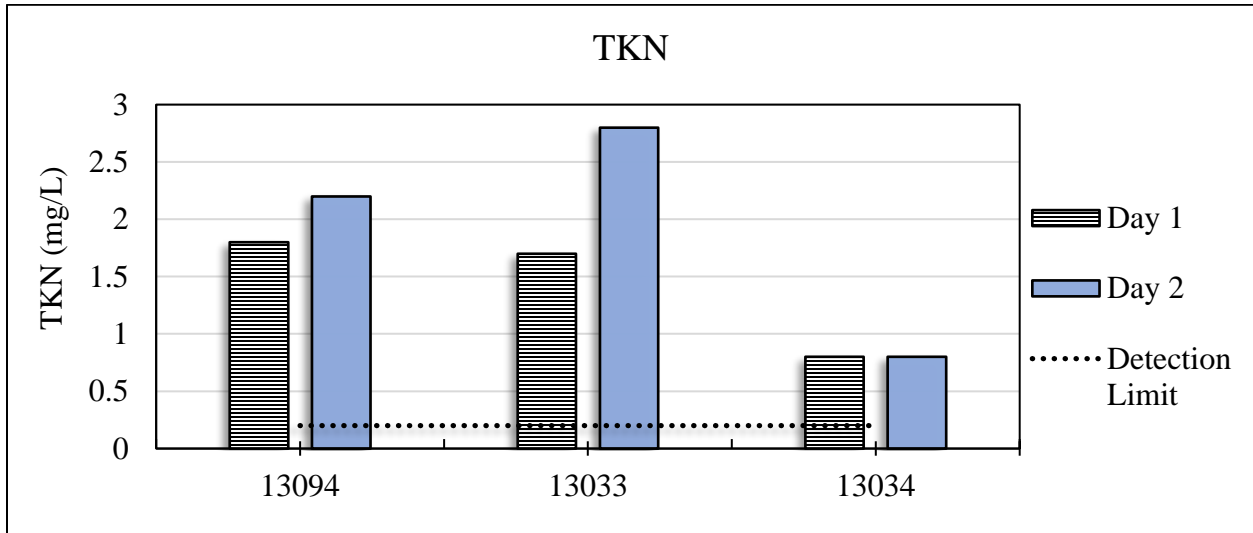
Figure 38. High flow event data for TKN

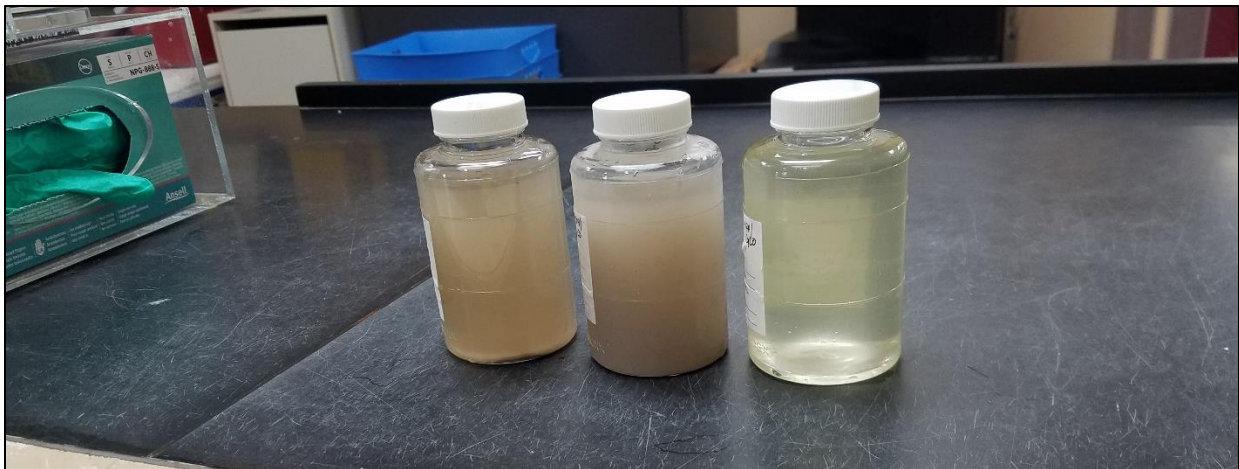
Figure 46. High flow event samples from Petronila, San Fernando and Los Olmos creeks
