NUTRIENT SAMPLING IN PETRONILA CREEK

Final Report

CBBEP Project No. 2333
August 2023

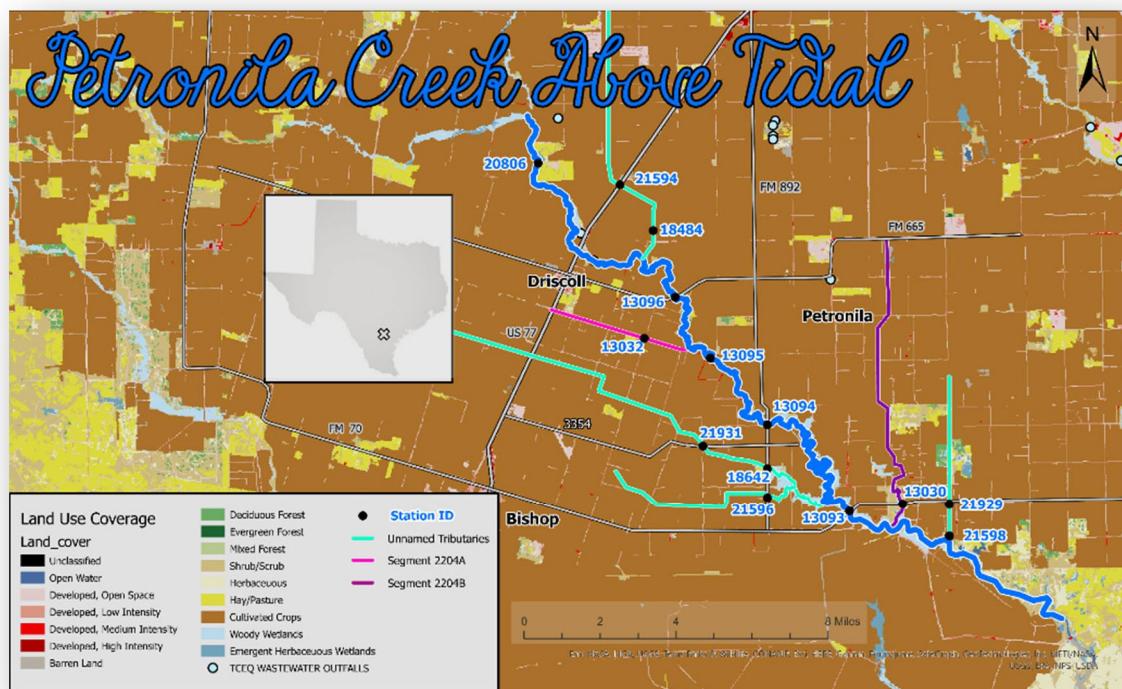
Figure 4. Petronila Creek Watershed

Description - Petronila Creek Above Tidal (TCEQ Segment 2204) is a shallow creek (< 2.0 m depth) that flows 44 miles from the confluence of Aqua Dulce and Banquete creeks in Nueces County Laureles Ranch in Northern Kleberg County. The watershed area is 675 square miles. The receiving water bodies for Segment 2204 include Petronila Creek Tidal Segment (TCEQ Segment 2203), Cayo Del Mazón, Alazan Bay, and Baffin Bay (TCEQ Segment 2492). The study area is located east of US 77 in the southeastern portion of the watershed. Land use is dominated by cultivated cropland with cotton, corn and sorghum being the most common crops observed. The northwestern end of the watershed is a mixture of cultivated cropland, hay or pasture, shrub or scrub and mixed forest. There are nine regulated dischargers of effluent to Petronila Creek and/or the tributaries of the creek (See Appendix B).

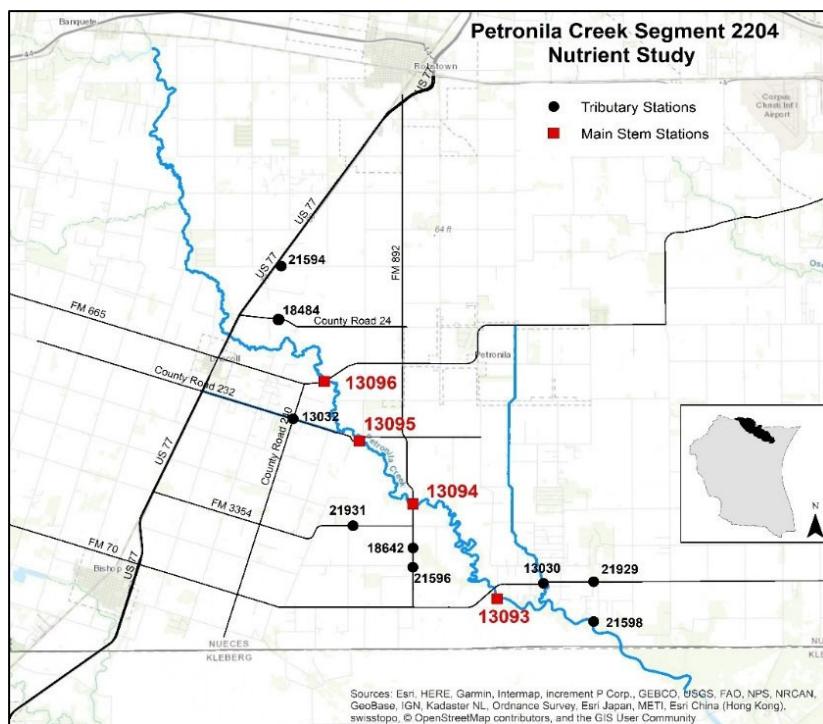
Figure 5. Map of sampling stations in Petronila Creek Above Tidal Segment 2204

sulfate, and total dissolved salts (TDS). There are six tributaries sampled for the project. Three of the tributaries have two sampling stations each including 21594 & 18484, 21931 & 18642, and 21929 & 21598. The other three tributaries (13030, 21596, and 13032) are monitored by a single sampling site. Four stations (13093, 13094, 13095, and 13096) are located on the main stem of the creek.

Hydrological - Streamflow is typically very low in the segment, often measuring between 0.5 and 3.0 ft³/s during dry weather on the main stem of the creek. Streamflow is measured by a USGS stream gauge located on FM 665. This location also serves Station 13096, the uppermost sampling location on the main stem of the creek. Station 13096 is also closest in proximity to the Driscoll WWTP (WQ0011541-001 – City of Driscoll: <100,000 gpd treated domestic wastewater via Petronila Creek). Streamflow at the tributary locations is estimated due to low flow conditions that are of insufficient depth (< 0.05 m) for the operation of a flow meter. A map of sampling stations is provided.

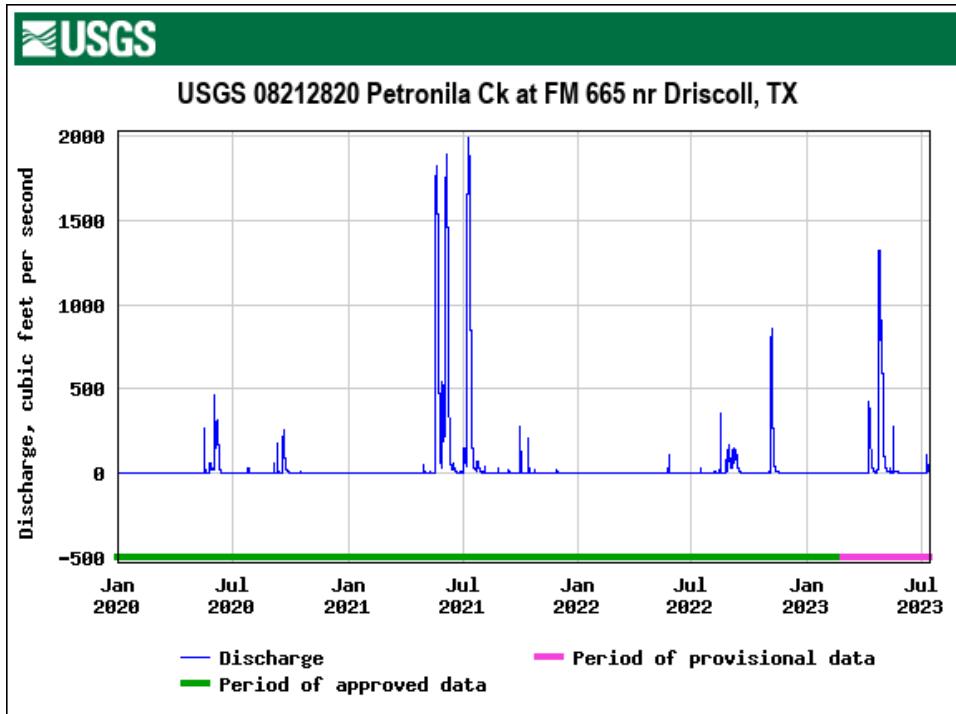
Figure 9. Streamflow at Petronila Creek Above Tidal

Streamflow – The Petronila Creek watershed experienced multiple precipitation events throughout the study period. In 2020, the highest precipitation event resulting in streamflow rates spiking to approximately 316 ft³ /sec in late June. During 2021, there were quite a few heavy precipitation events occurring between late May and early July. The highest stream flow for 2021 occurred during early July resulting in stream flow rate spiking to approximately 1,980 ft³ /sec. For 2022, the highest precipitation event occurred during Early November resulting in streamflow spiking to approximately 858 ft³ /sec. In 2023, so far there have been three precipitations events that have occurred between Jan 2023 and July 2023. The first resulted in a spike to approximately 480 ft³ /sec and then the second one had a rate of approximately 1450 ft³ / sec. Then lastly the third precipitation event had a discharge rate of approximately 260 ft³ / sec.

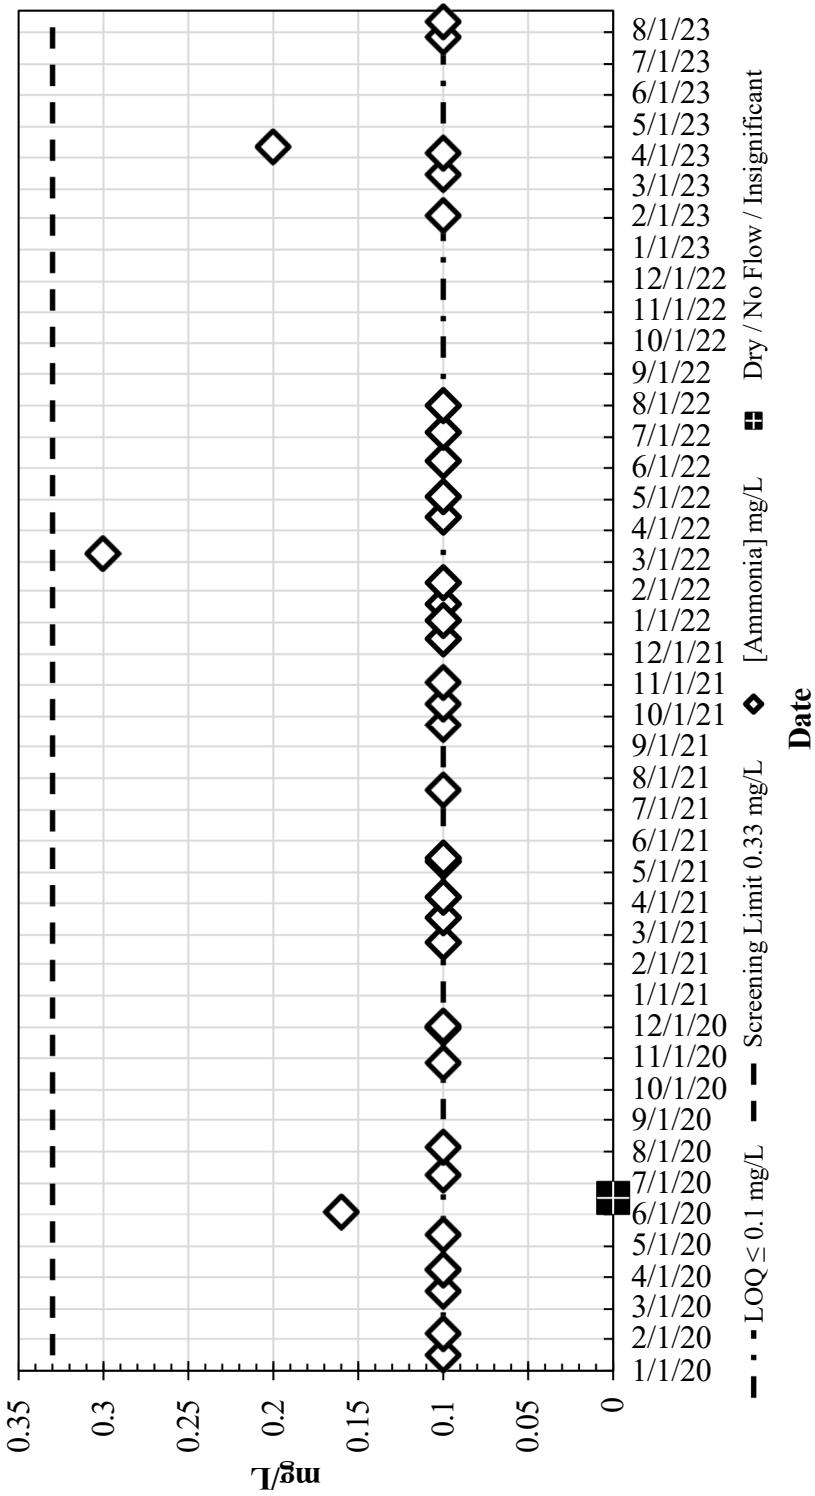
13093 Ammonia

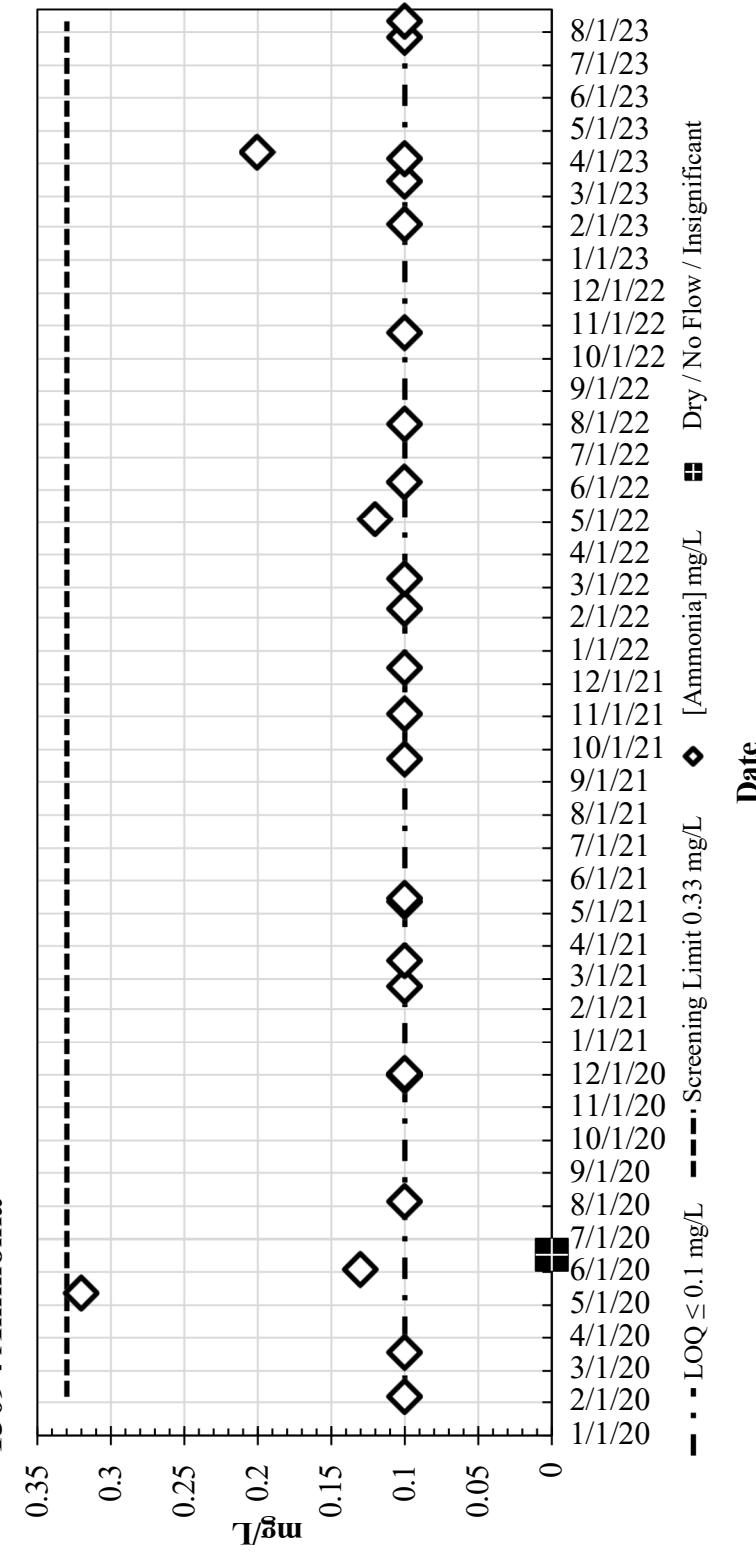
13094 Ammonia

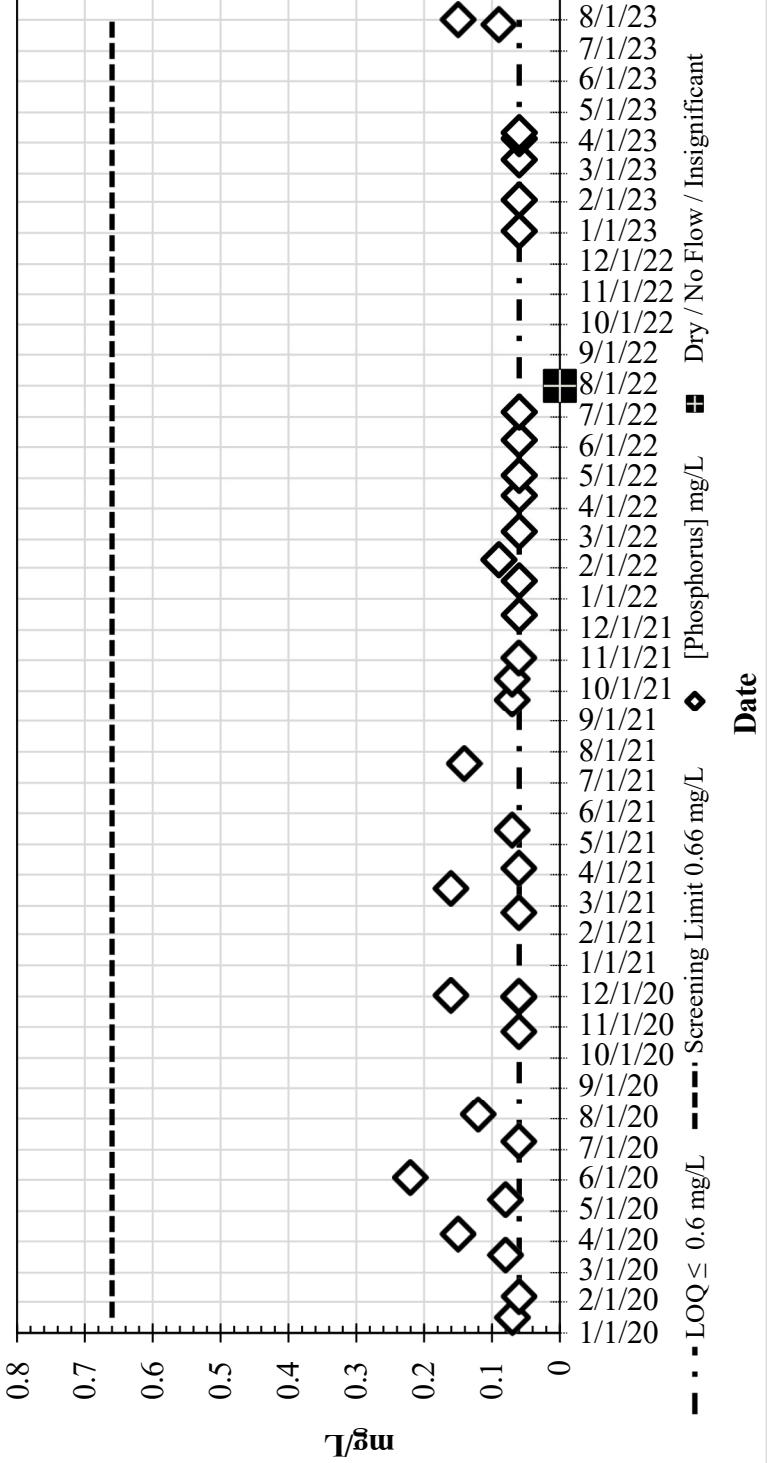
13030 Total Phosphorus

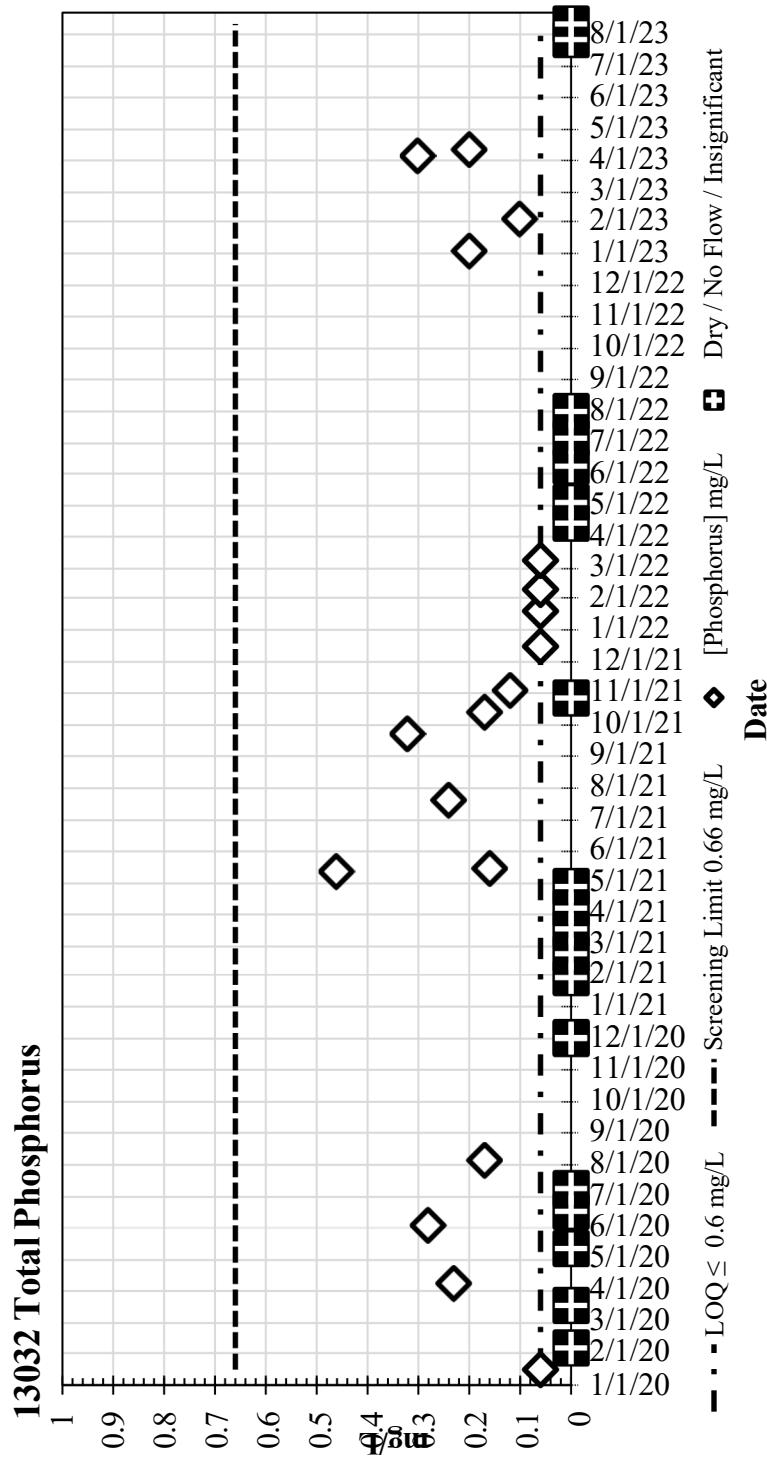
13032 Total Phosphorus

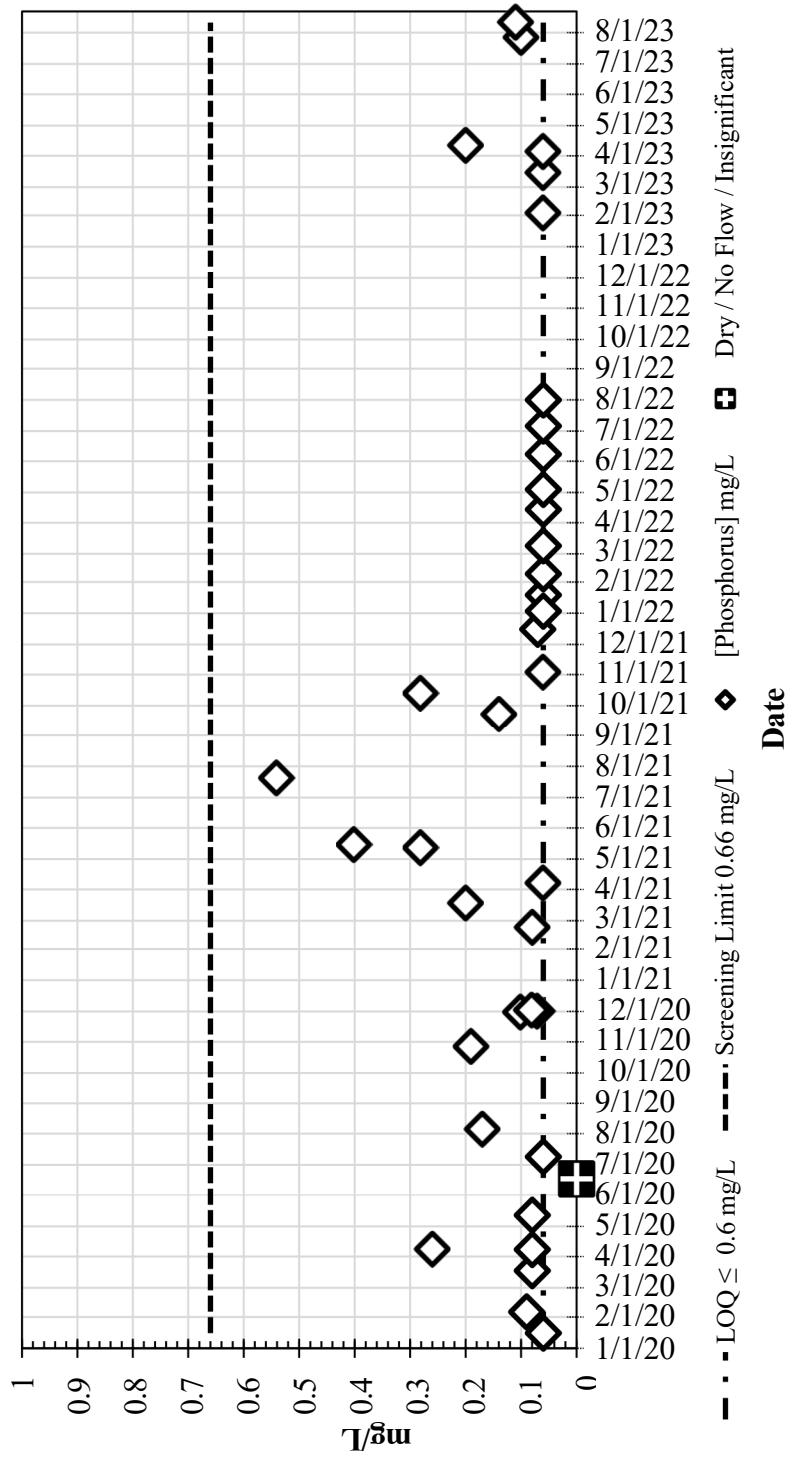
13093 Total Phosphorus
