# Atascosa River Recreational Use-Attainability Analyses

Report to TMDL Program  
Texas Commission on Environmental Quality  
Project and Work Order Number  
582-6-70859-26

Tim Jones  
Jeff Stroebel  
Larry Hauck  
Texas Institute for Applied Environmental Research  
Tarleton State University  
Stephenville, Texas

December 2010

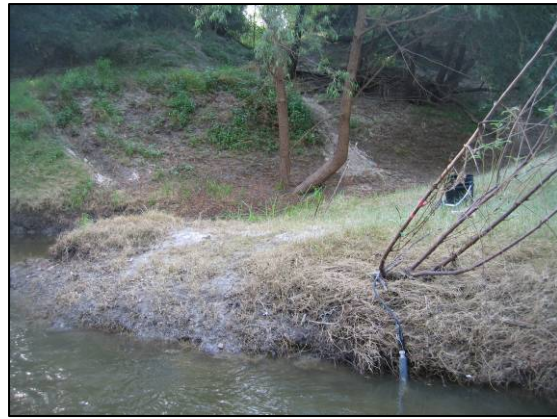
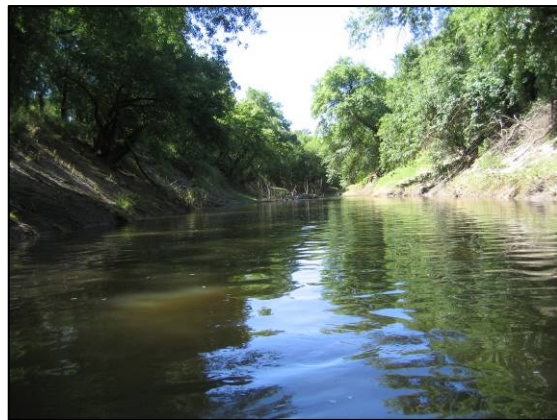
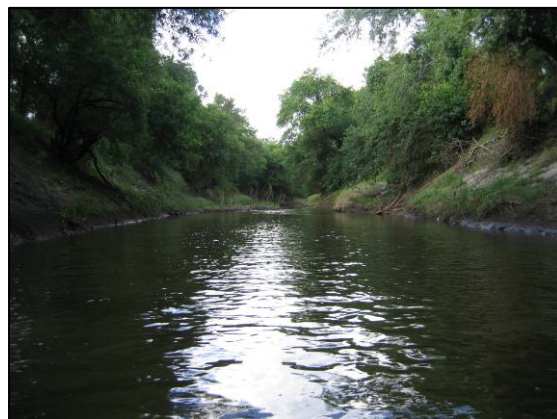
**Photogroup 3-1** Atascosa River Site AR1\_01 depicting access and the general appearance of the stream. [\[Return to Text\]](#)

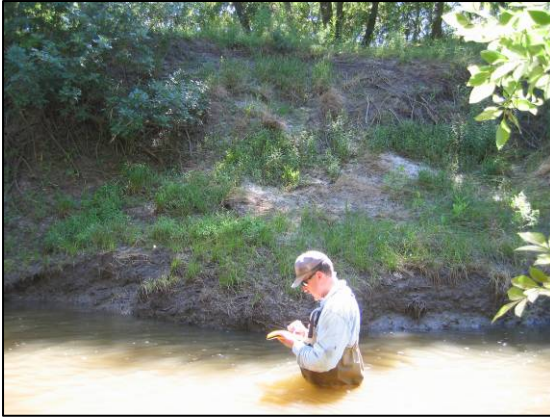
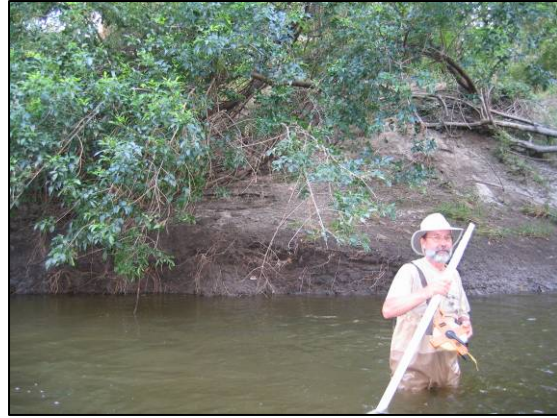
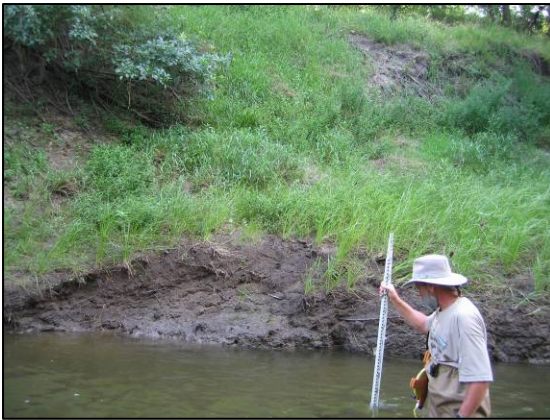
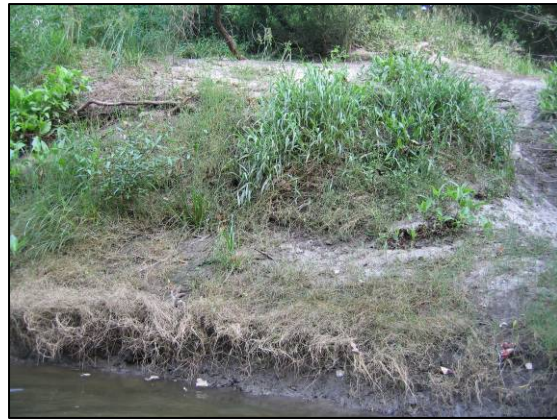
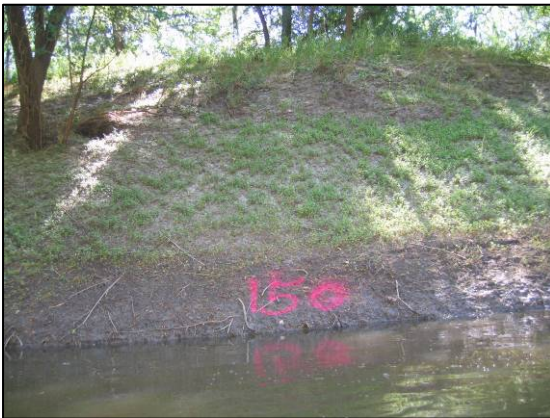
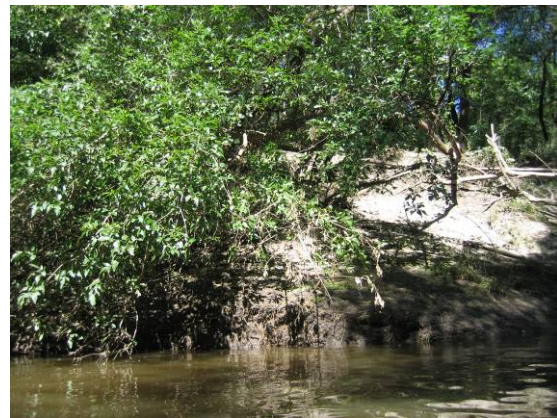
**Photogroup 3-2**

Atascosa River Site AR1\_01 depicting field staff wading in the stream and streambank access. [\[Return to Text\]](#)

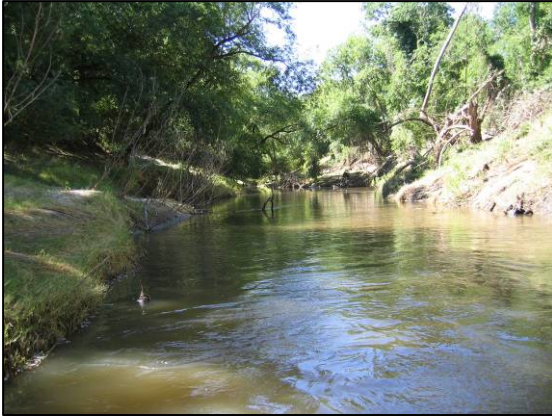
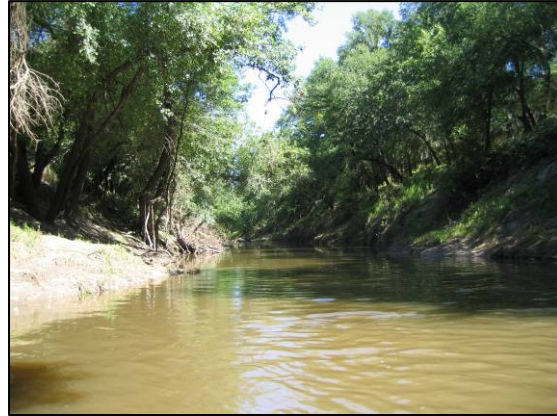
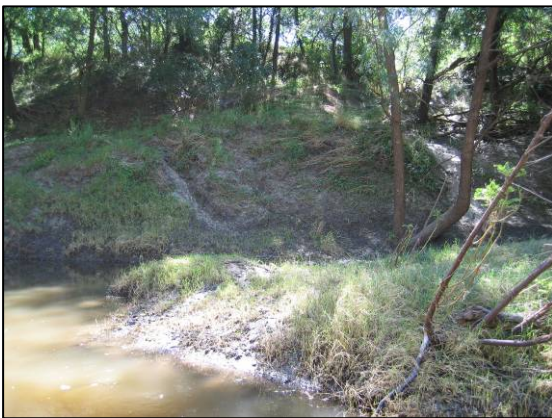
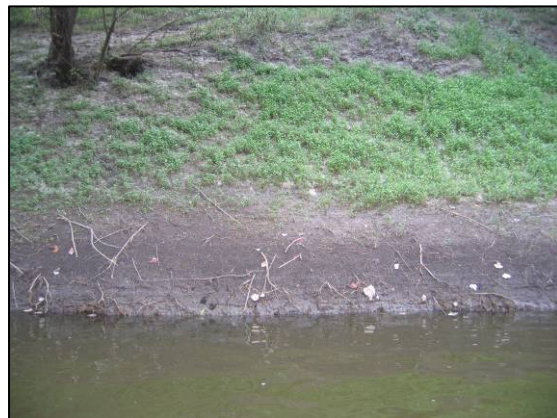
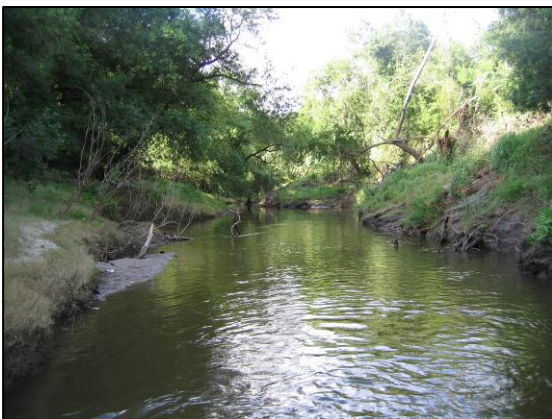
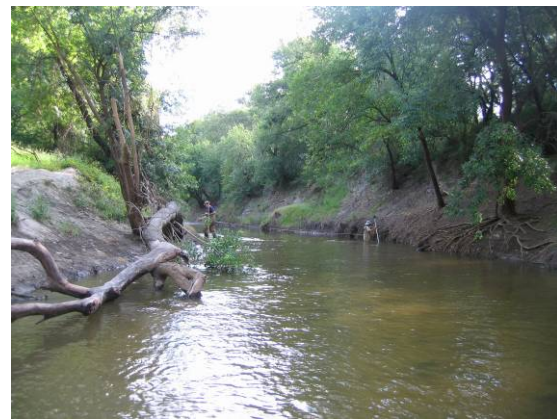
**Photogroup 3-3**

Atascosa River Site AR1\_01 illustrating the water color, general appearance and clarity of the water surface at AR1\_01. [\[Return to Text\]](#)

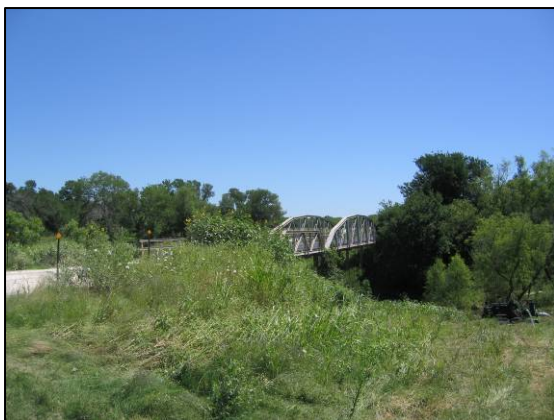
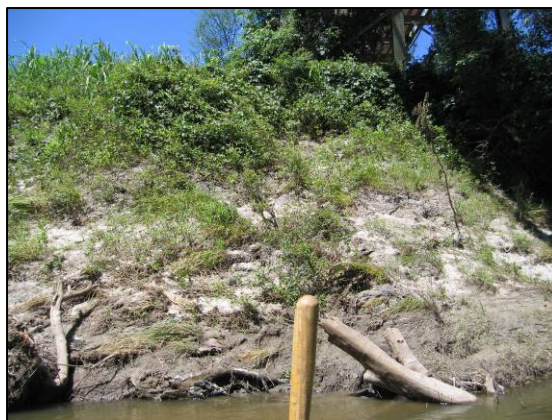
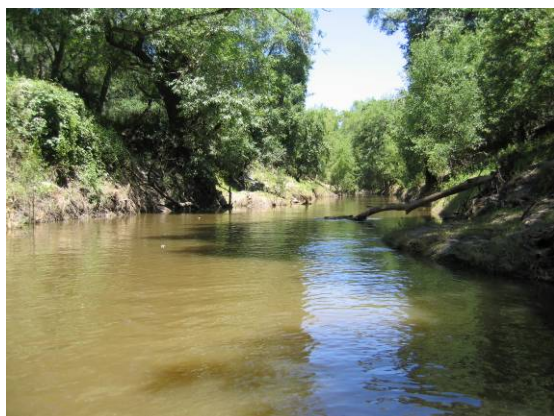
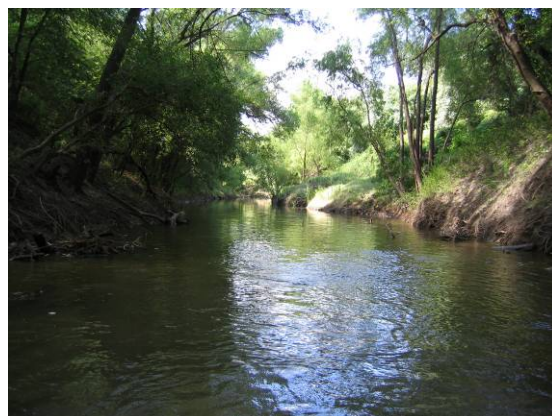
**Photogroup 3-4**

Atascosa River Site AR1\_02 depicting stream access and typical setting. [Return to Text](#)

The Atascosa River at Site AR1\_02 was visited on May 5 and June 24, 2010. This site was accessible from a public bridge crossing on Goodhope Road north of Three Rivers, Texas in Live Oak County. This access point was difficult to negotiate due to dense vegetation and a steep, eroded high bank. At the river, access to the water was moderately difficult due to depth of water, steepness of the bank, and unsure footing. The location under the bridge (300-m transect) was the narrowest point (5.8 m) encountered and was the point at which flow data were collected. No other access point was observed along the remainder of the 300-m reach. Table 3-2 describes the stream channel and riparian zone appearance of this site. [Photogroup 3-4](#) depicts the access and typical setting of Site AR1\_02.

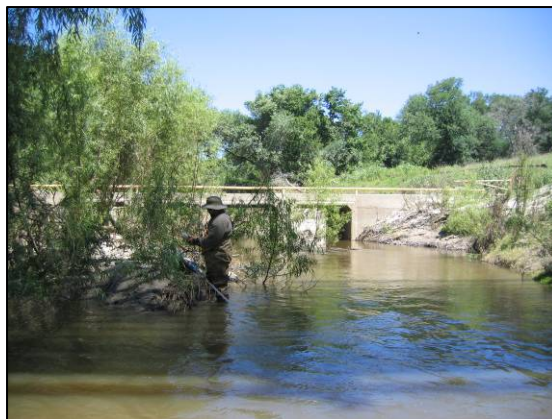
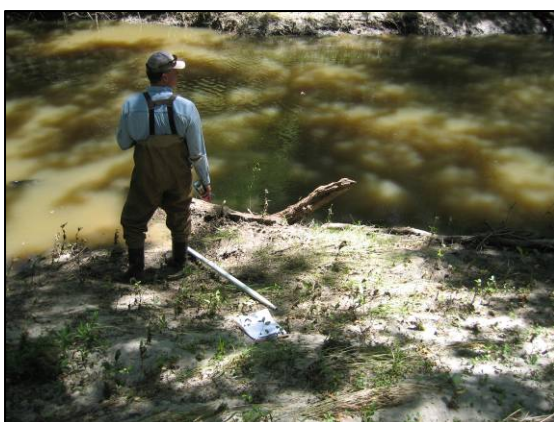
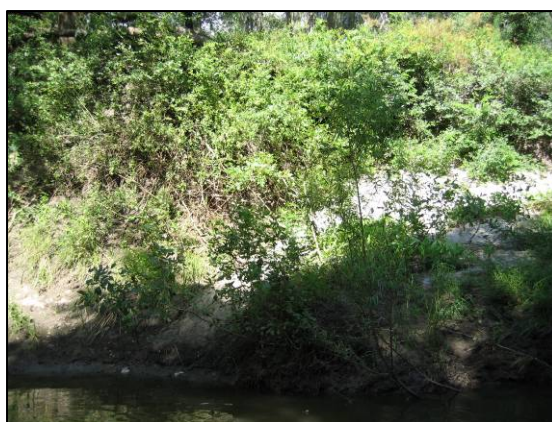
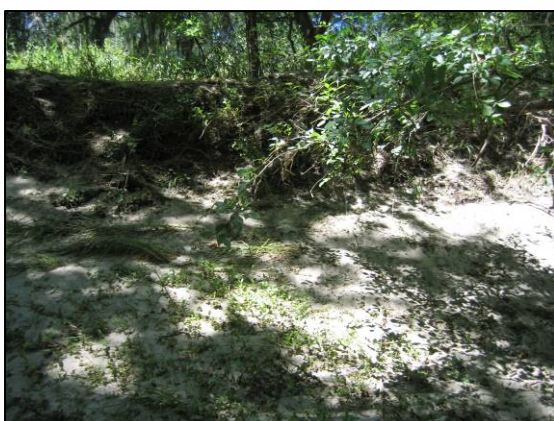
**Photogroup 3-5** Atascosa River Site AR1\_02 depicting field staff wading and bank access. [\[Return to Text\]](#)

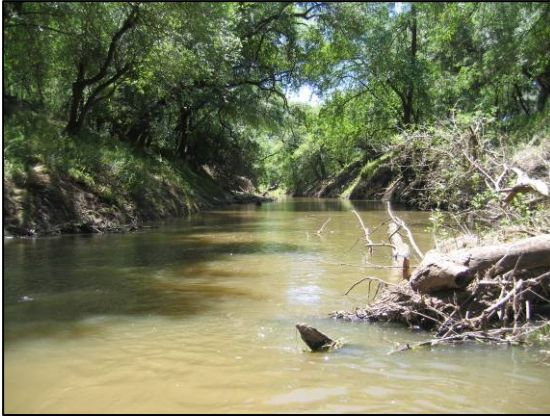
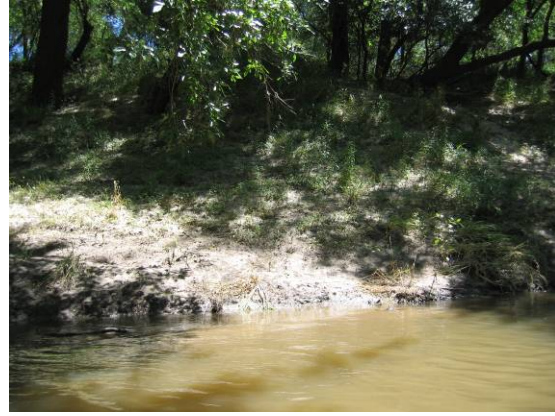
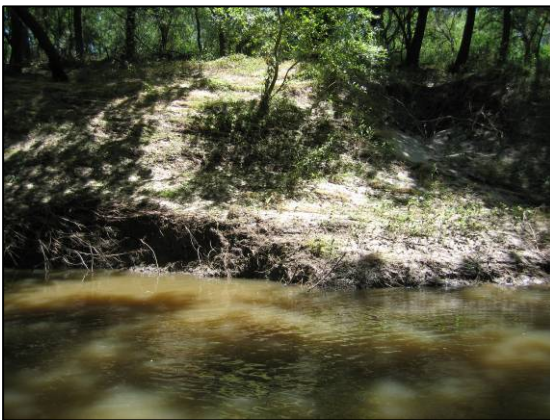
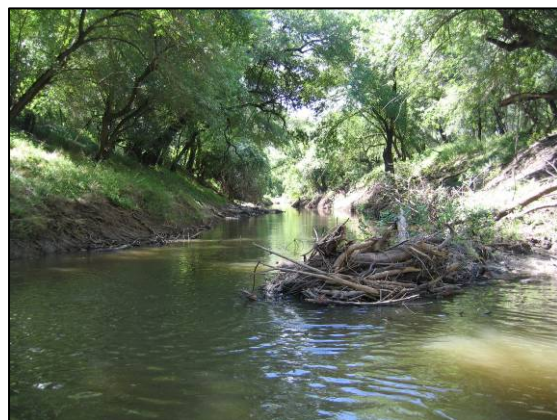
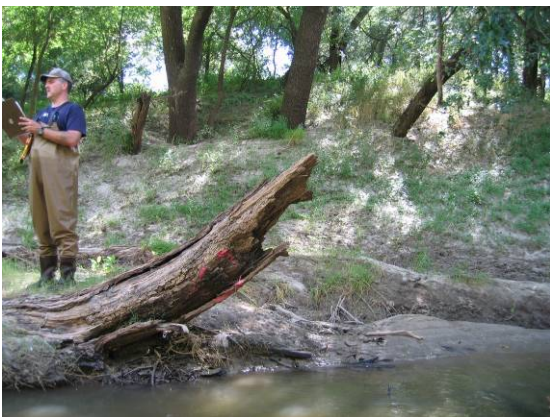
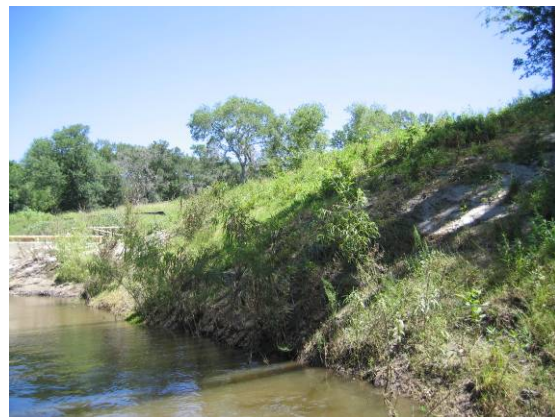
**Photogroup 3-6**

Atascosa River Site AR1\_02 depicting water color and clarity of surface. (Field staff in lower left photograph.) [[Return to Text](#)]

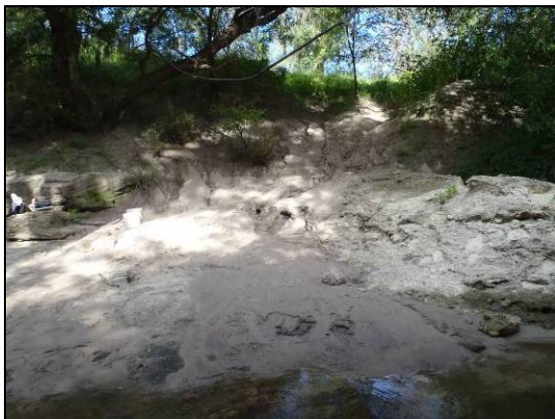
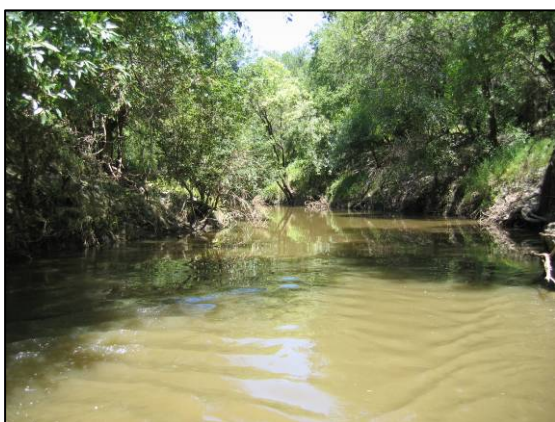
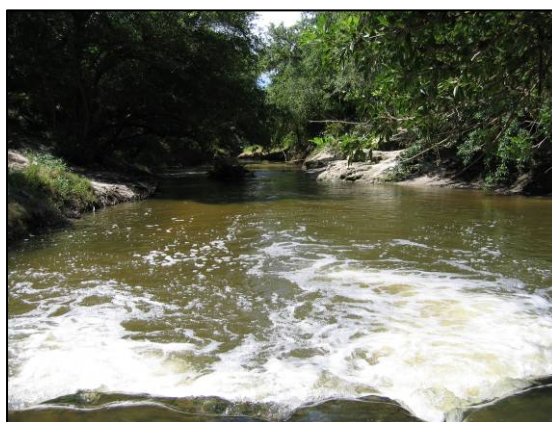
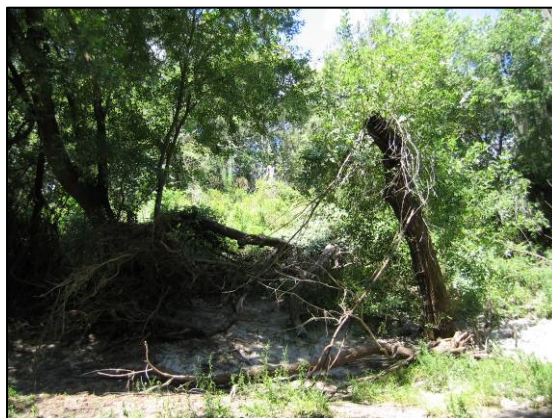
**Photogroup 3-7**

Atascosa River Site AR1\_03 depicting stream access and general appearance of stream. [[Return to Text](#)]

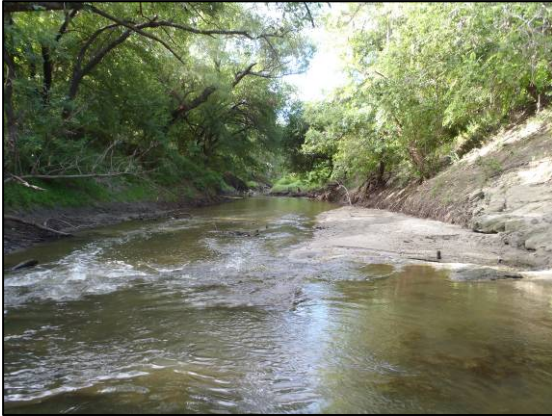
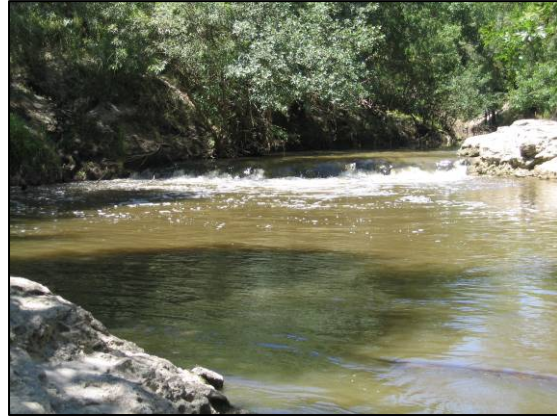
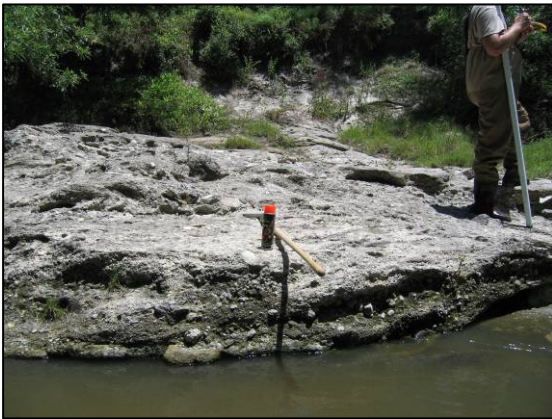
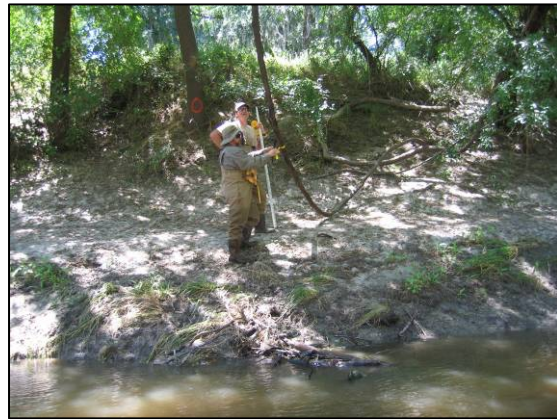
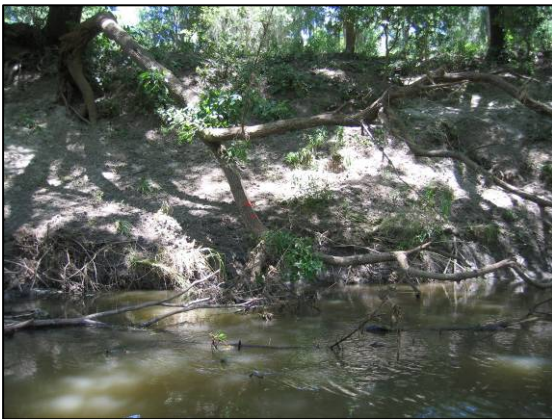
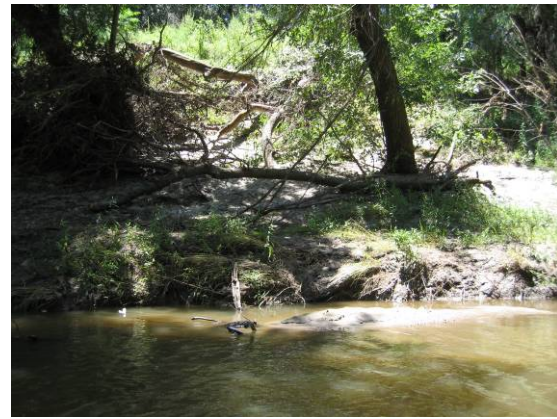
**Photogroup 3-8** Atascosa River Site AR1\_03 depicting the area of the falls and riffle as well as the steep banks and dense vegetation. (All persons in photographs are field staff.) [\[Return to Text\]](#)

The surveyed reach at Site AR1\_03 was wadeable for the entire 300-m reach. Downstream of the entry point (150-m transect) walking was fairly easy with a firm sand bottom for most of the reach, though pockets of loose sand were encountered. Upstream of the 150-m transect, there was a small waterfall with a spill pool that was fairly deep. To access upstream of the 150-m transect, the stream had to be forded and the rocks making up the falls traversed. Once upstream, a bedrock bottom gave way to a packed sand substrate. Other than the small falls, no obstructions were encountered. [Photogroup 3-8](#) depict the area of the falls and riffle as well as the steep banks and dense vegetation.

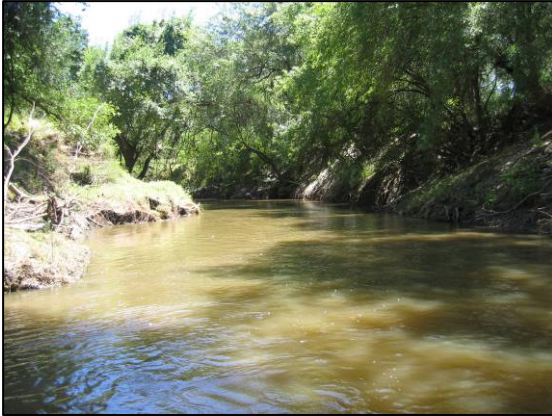
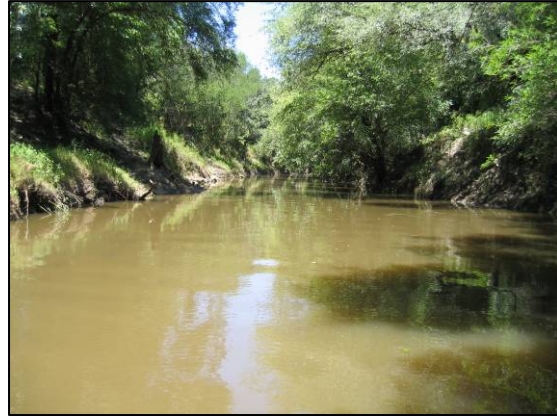
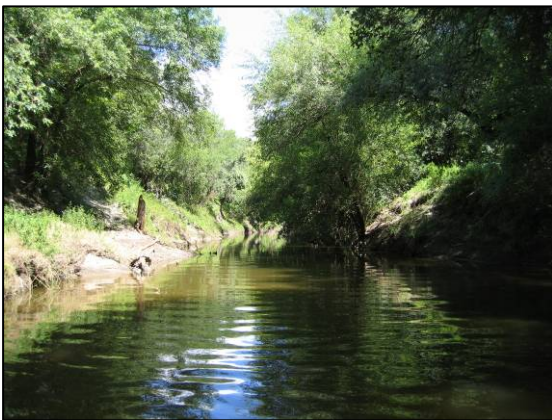
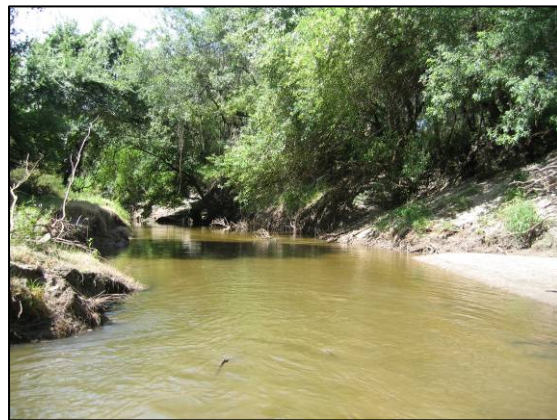
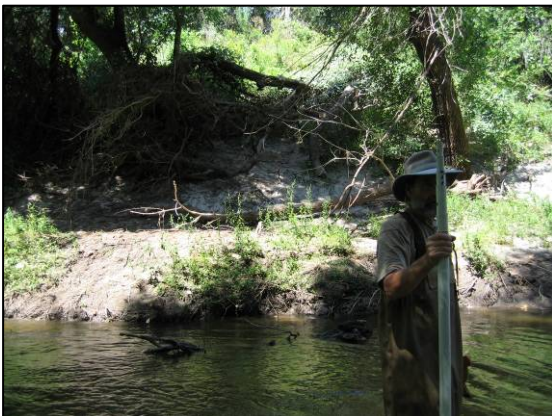
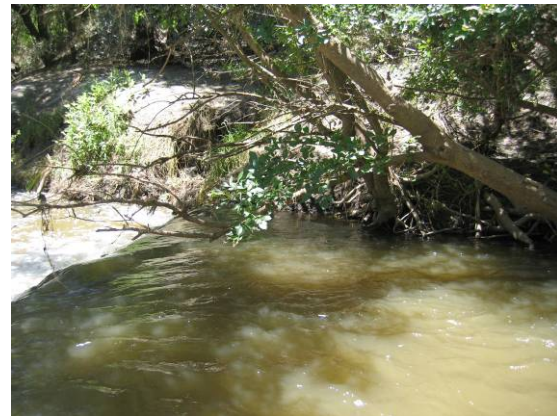
**Photogroup 3-9**

Atascosa River Site AR1\_03 illustrating the water color and surface clarity of the water. (All persons in photographs are field staff.) [\[Return to Text\]](#)

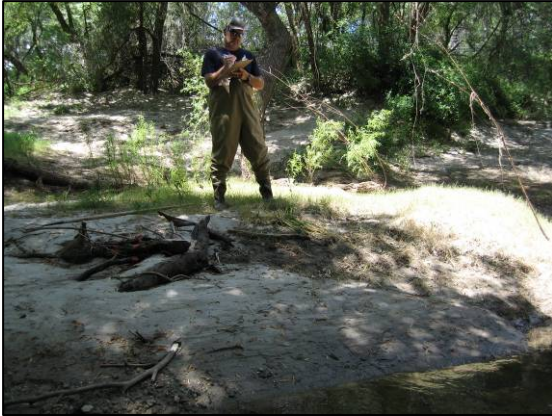
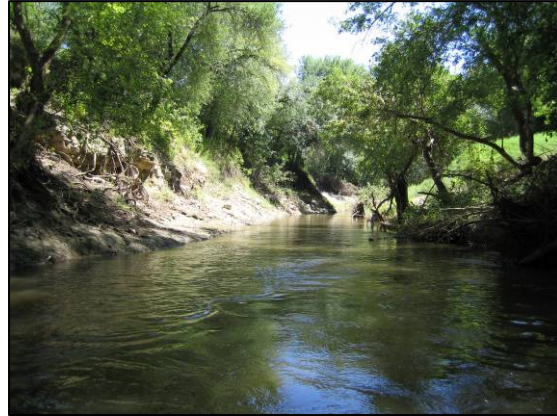
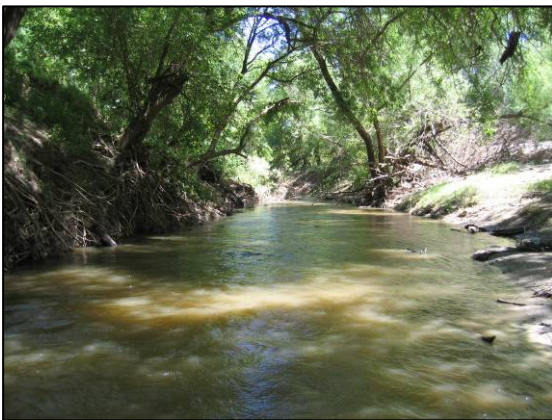
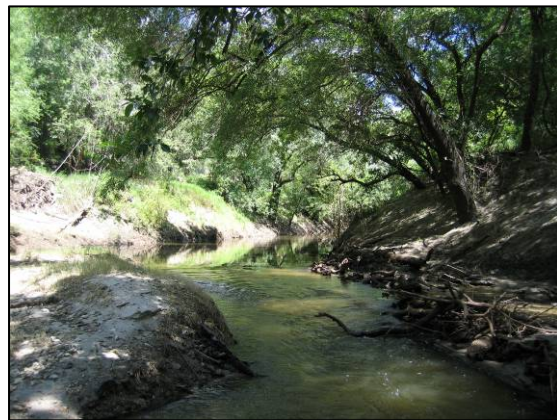
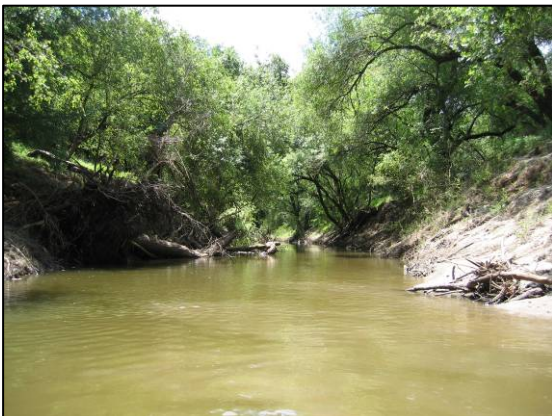
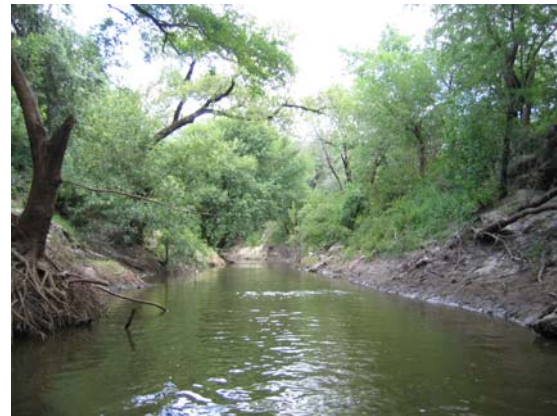
**Photogroup 3-10** Atascosa River Site AR1\_04 depicting stream access and general appearance of the stream at AR1\_04. (Field staff shown in upper left photograph.) [\[Return to Text\]](#)

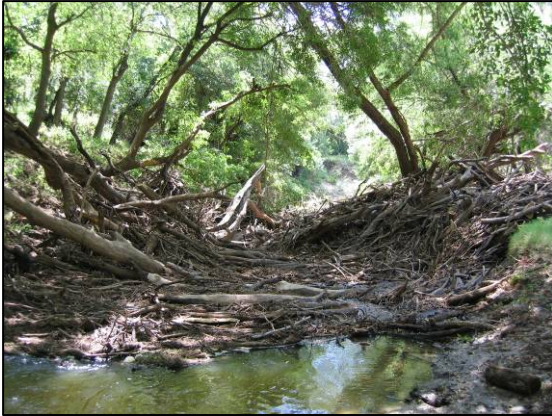
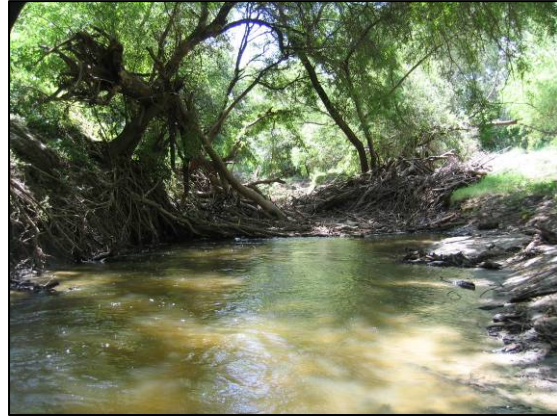
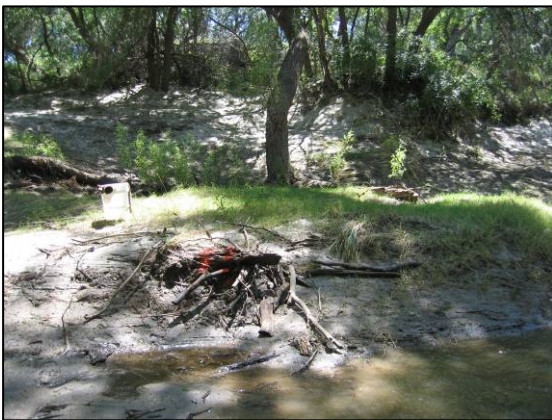
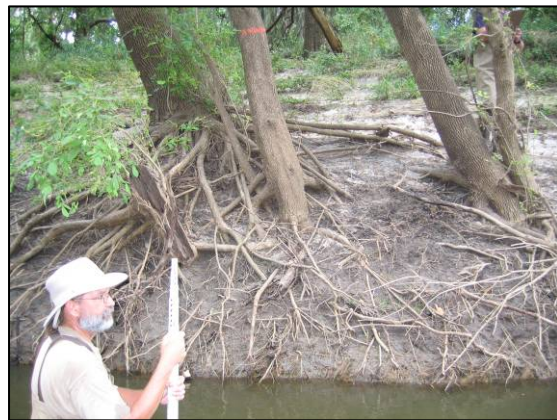
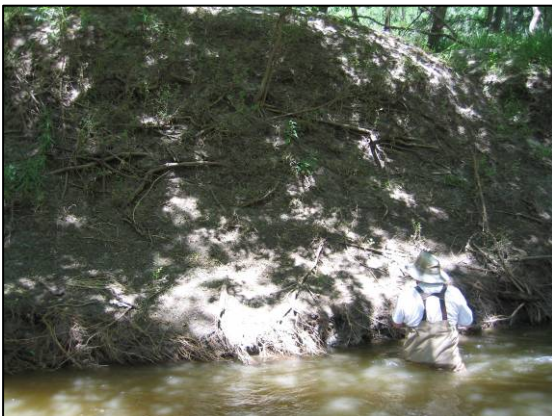
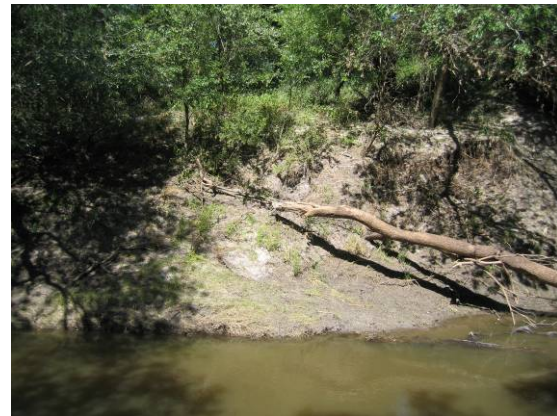
Site AR1\_04 was waded, but not easily wadeable, for the entire 300-m reach during the May 5 survey. During the June 24 survey water levels had receded sufficiently to comfortably allow measurements and wading. Where water levels were not too deep, walking was fairly easy with a firm sand bottom for most of the reach, though pockets of loose sand were encountered. On May 5 no obstructions were encountered that impeded passage in the stream; however, on June 24 a large log jam was encountered immediately downstream of the 150-m transect, presumably a result of heavy rains that occurred upstream in late May and early June. [Photogroup 3-11](#) depicts the June obstruction, steep banks and dense vegetation at Site AR1\_04.

**Photogroup 3-11** Atascosa River Site AR1\_04 depicting the June obstruction, steep banks and dense vegetation. (All persons in photographs are field staff.) [\[Return to Text\]](#)

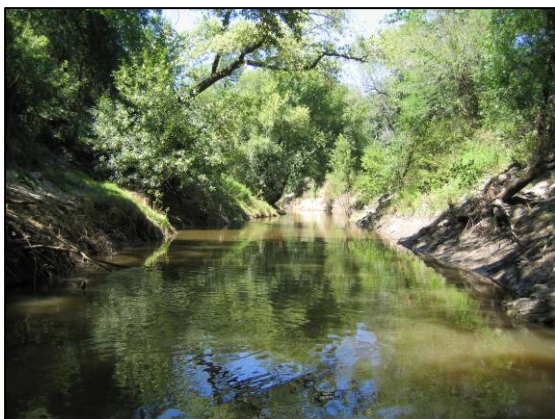
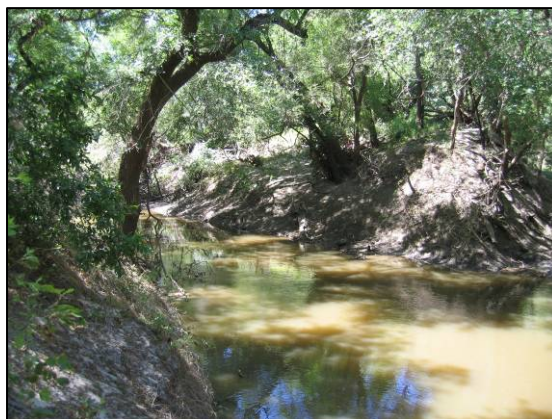
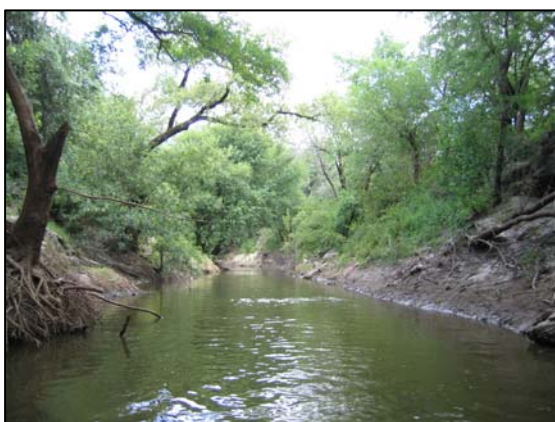
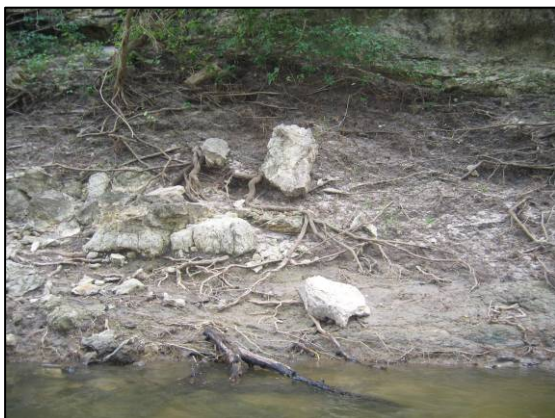
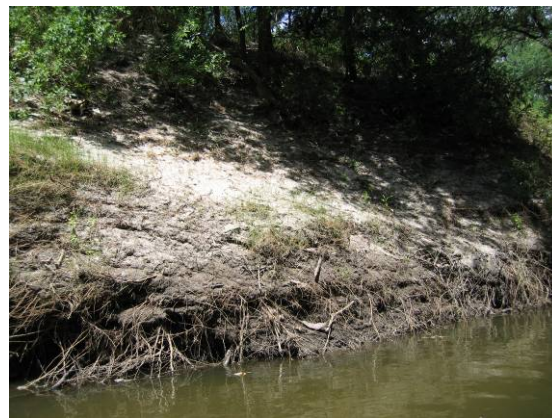
**Photogroup 3-12** Atascosa River Site AR1\_04 depicting water color and clarity of the surface. [\[Return to Text\]](#)

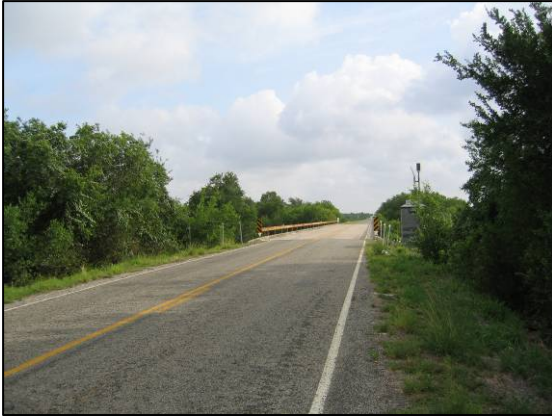
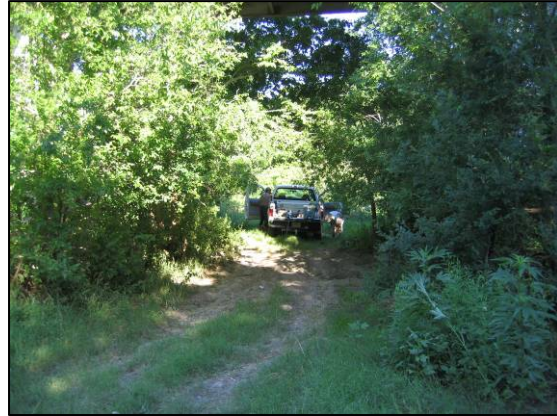
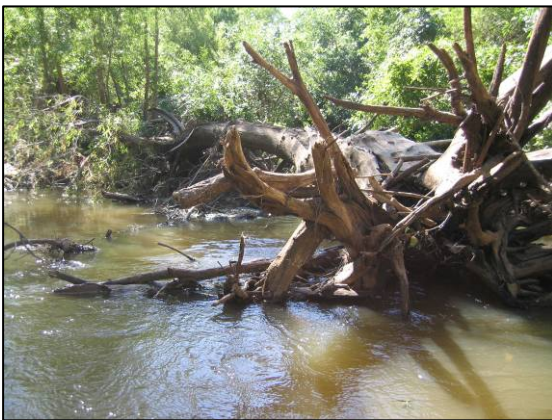
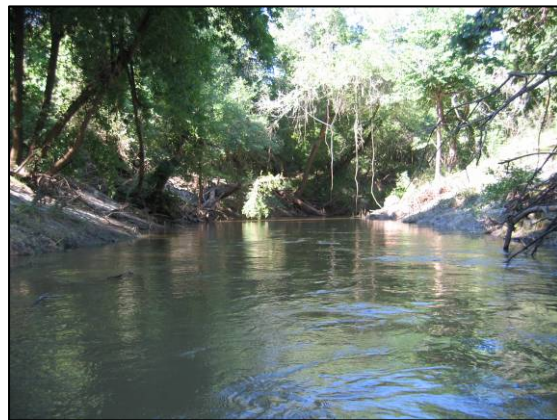
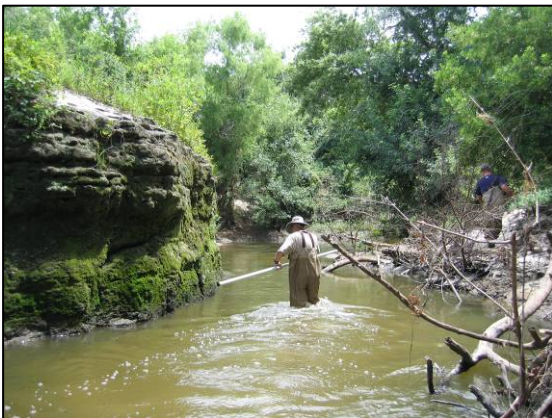
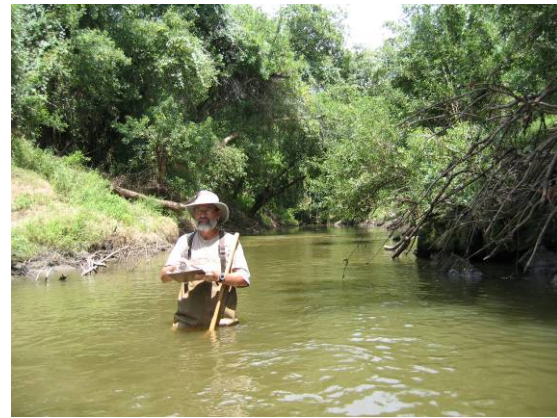
The Atascosa River at Site AR1\_05 was monitored on May 5 and June 24, 2010. This site was accessible from the FM 99 bridge crossing west of Whitsett, Texas in Live Oak County. Although the river is accessible, landowner permission was required to access the 300-m reach required for the RUAA surveys. It is possible, under dry conditions, to drive under the bridge and park on the northeast side of the river. There is a remnant of a barbed wire fence across this area but it is easily crossed and in some locations is down completely. The main hindrance to stream access is waist high and very dense vegetation, including abundant poison ivy. The bank is steep and the sandy soil makes footing uncertain to hazardous. Access to the water is limited and can be tricky due to the depth of the water at the bank. A log jam and dense vegetation immediately downstream of the bridge made it necessary to perform the survey upstream of the bridge with the 0-m transect beginning at the bridge. There was no sign of stream usage at this location either from paths or evidence of fishing tackle. To field staff it appeared that the accessible “drive” area under the bridge was used more for parking and alcohol consumption than accessing the river. Table 3-2 describes the stream channel and riparian zone of this site. [Photogroup 3-13](#) depicts road crossing, lane under bridge, and general appearance of stream.

**Photogroup 3-13** Atascosa River Site AR1\_05 depicting road crossing, lane under bridge, and general appearance of stream. (All persons in photographs are field staff.) [\[Return to Text\]](#)

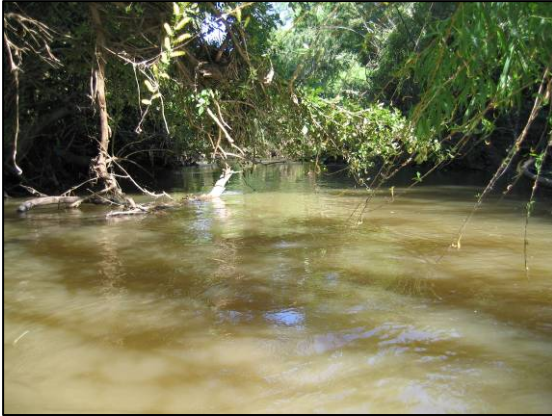
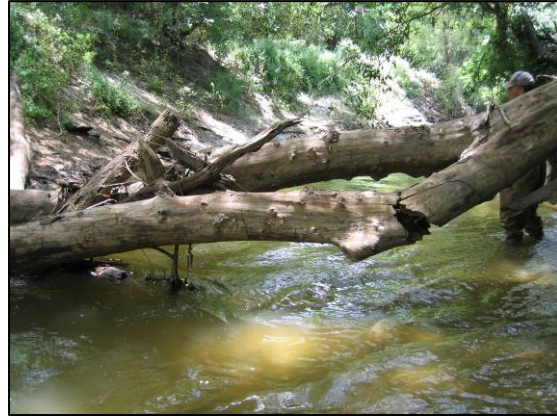
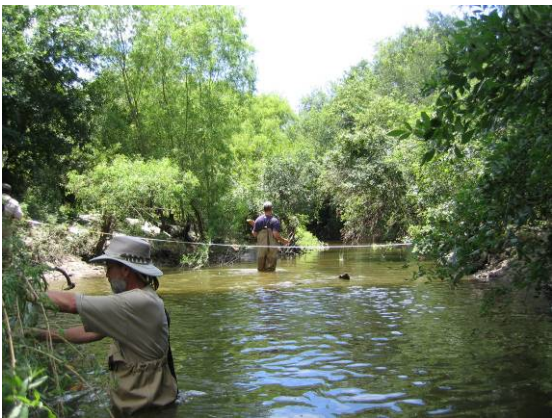
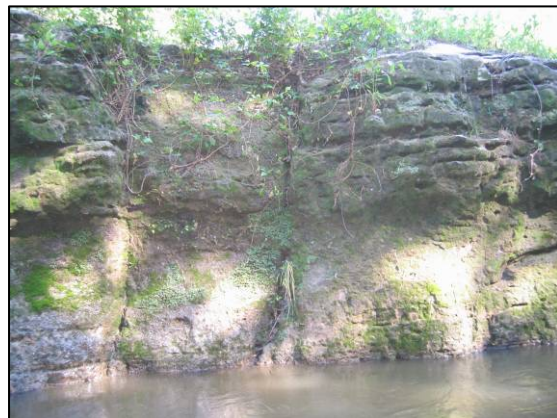
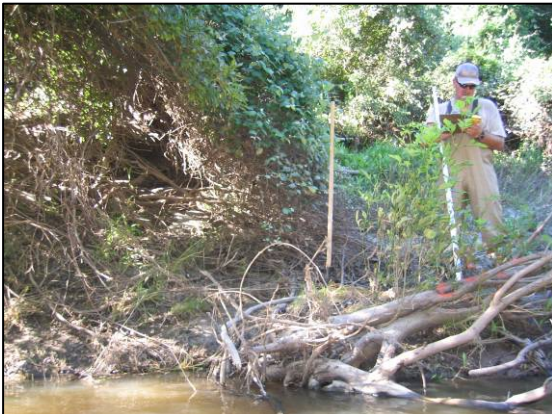
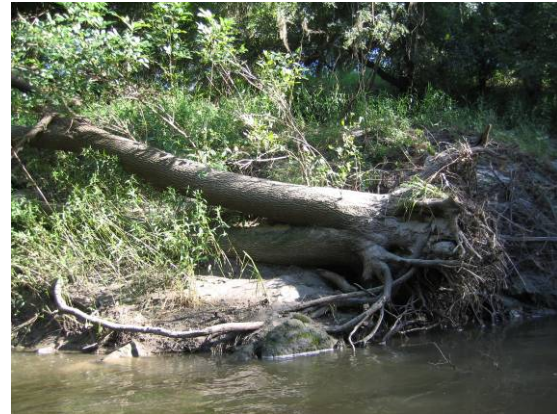
**Photogroup 3-14** Atascosa River Site AR1\_05 depicting obstructions and bank accesses. (All persons in photographs are field staff.) [Return to Text](#)

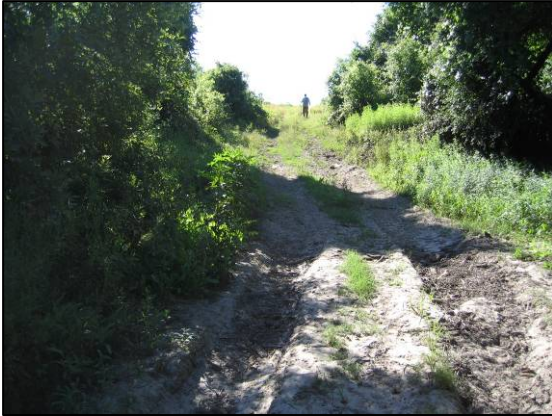
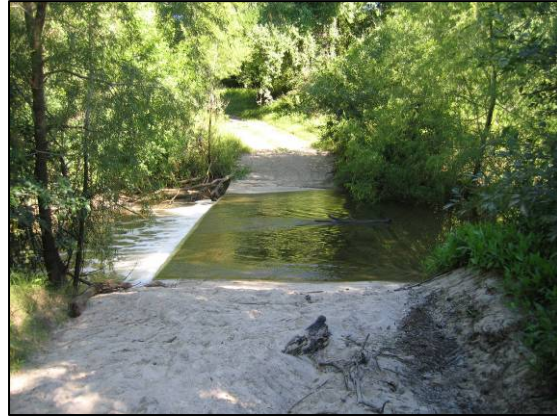
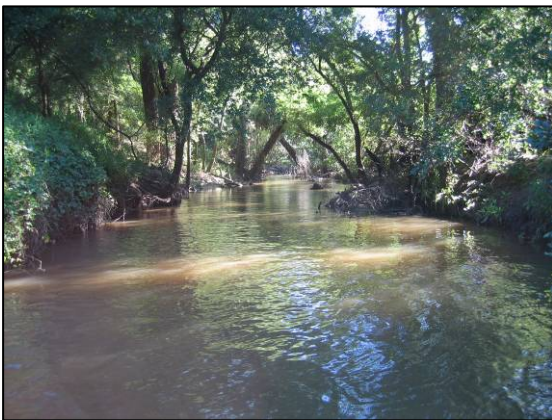
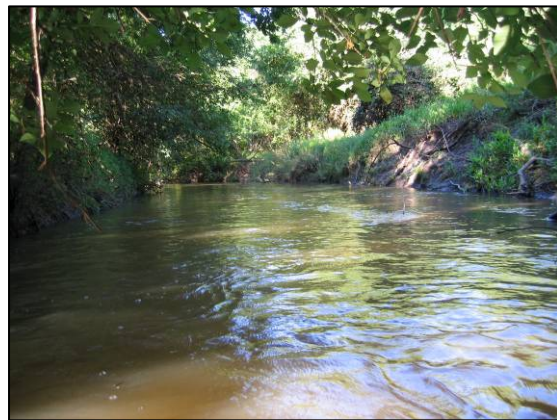
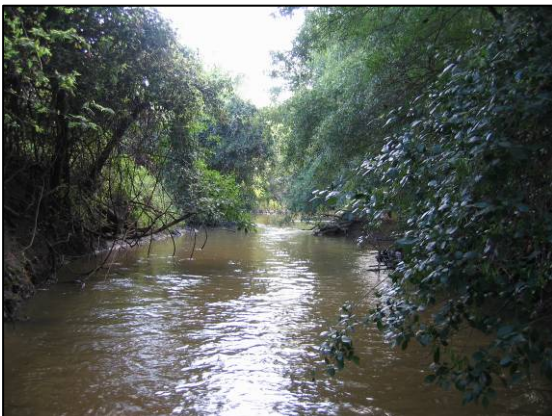
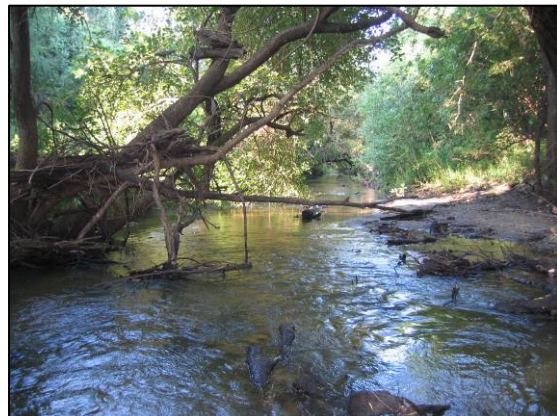
**Photogroup 3-15** Atascosa River Site AR1\_05 depicting water color and clarity of the surface of the water. [\[Return to Text\]](#)

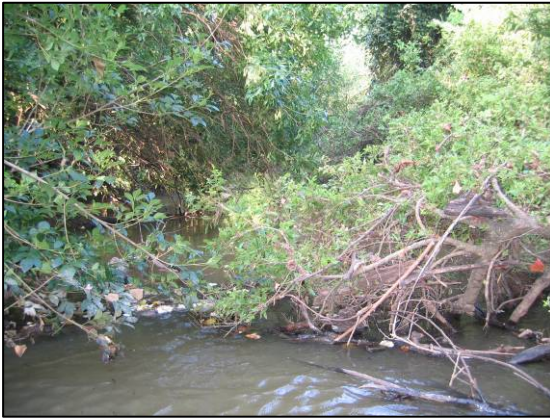
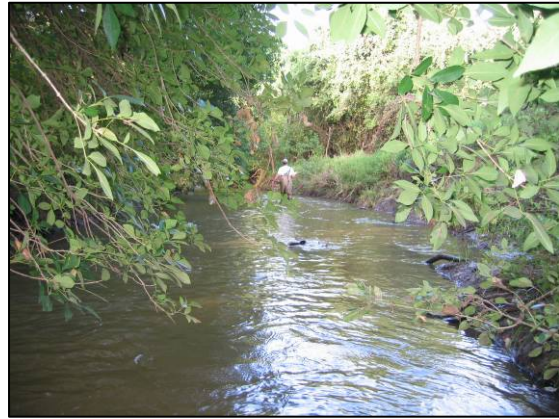
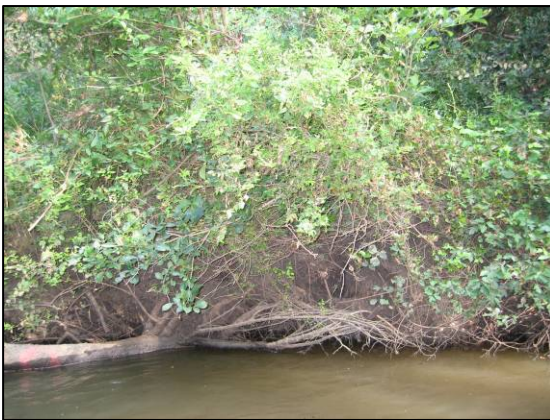
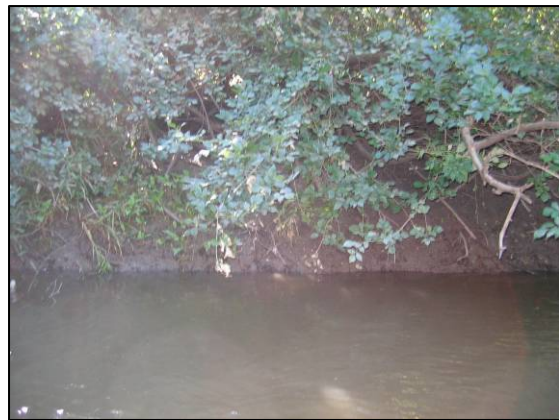
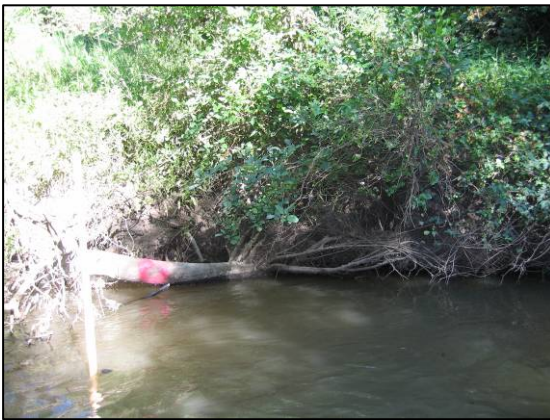
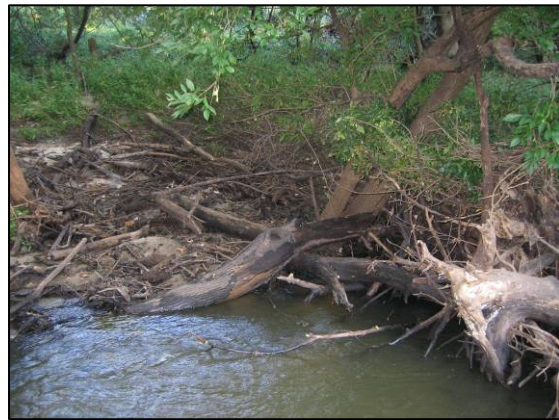
**Photogroup 3-17** Atascosa River Site AR1\_06 depicting obstructions, wading and bank access. (All persons in photographs are field staff.) [\[Return to Text\]](#)

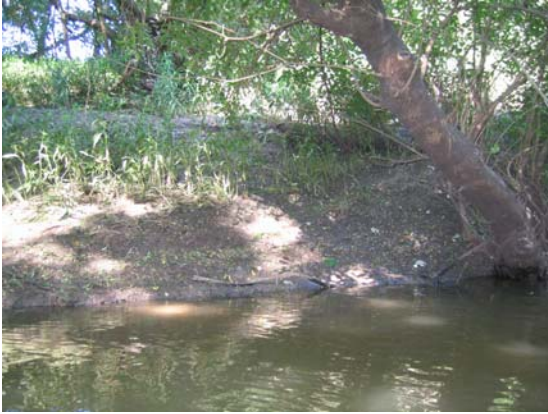
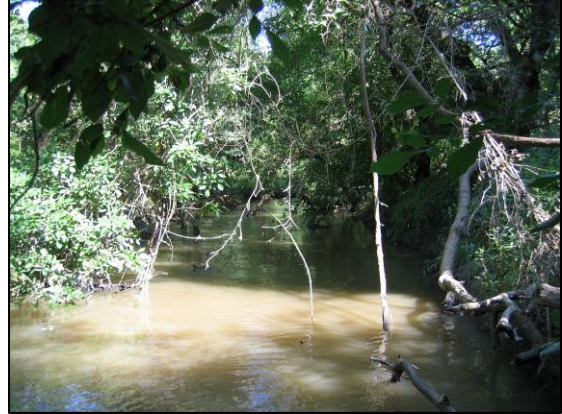
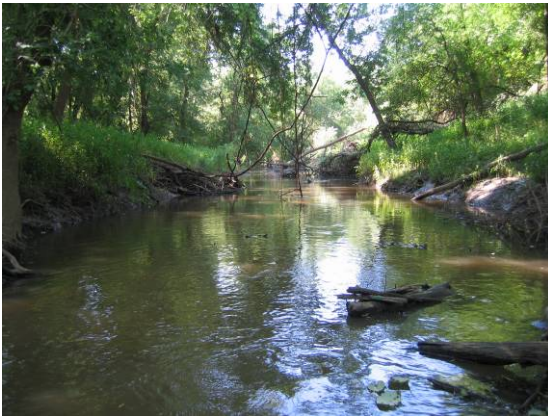
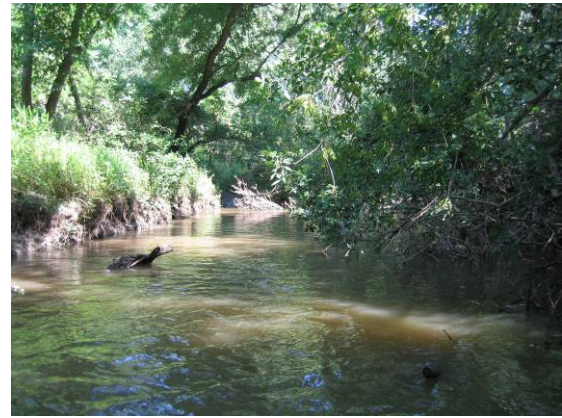
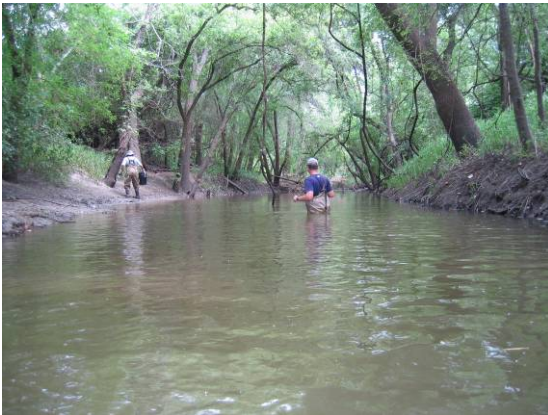
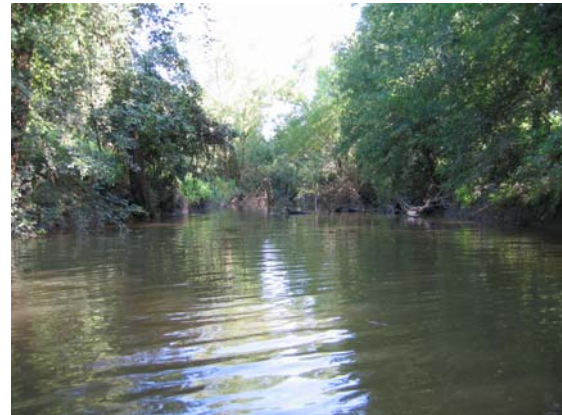
**Photogroup 3-18** Atascosa River Site AR1\_06 depicting water color and clarity of the water surface. (Person in upper right photograph is field staff.)  
[Return to Text](#)
