# Atascosa River Recreational Use-Attainability Analyses

Report to TMDL Program  
Texas Commission on Environmental Quality  
Project and Work Order Number  
582-6-70859-26

Tim Jones  
Jeff Stroebel  
Larry Hauck  
Texas Institute for Applied Environmental Research  
Tarleton State University  
Stephenville, Texas

December 2010

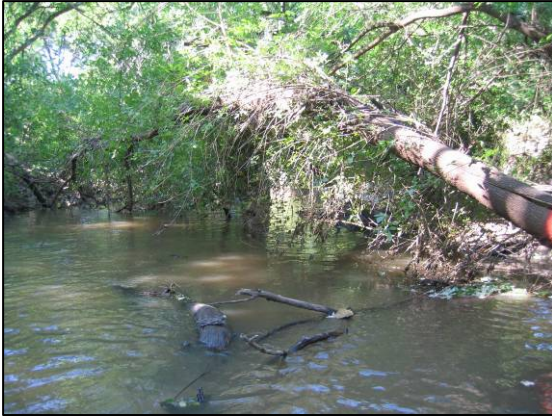
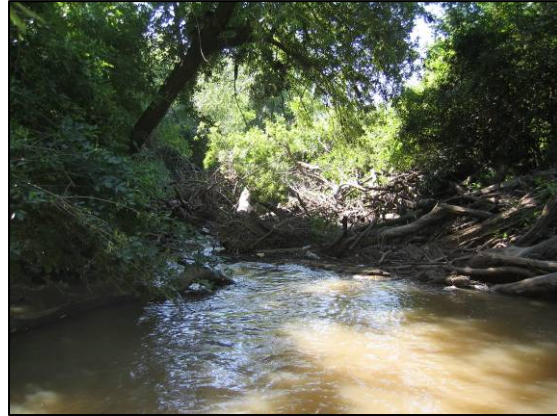
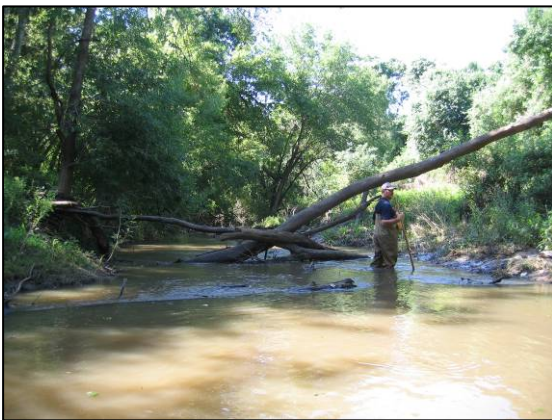
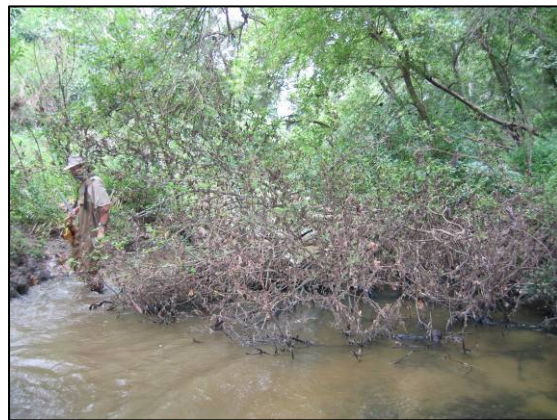
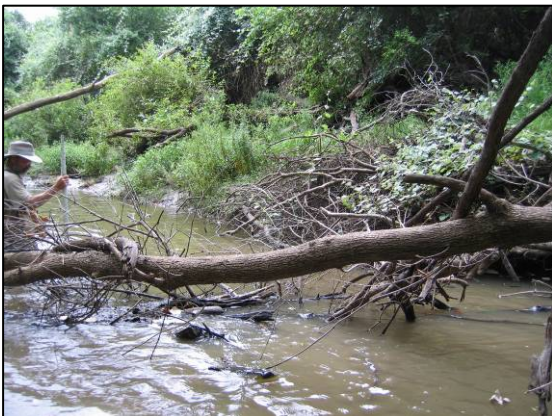
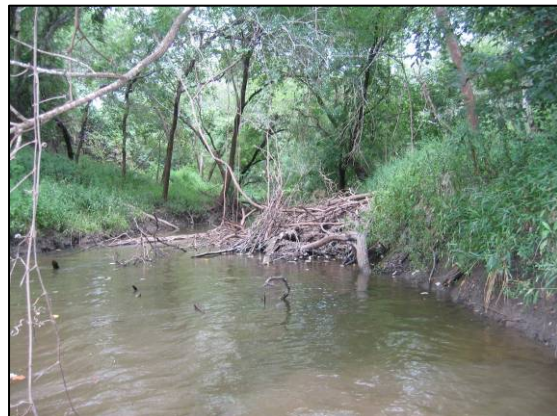
**Photogroup 3-19**

Atascosa River Site AR1\_07 depicting bank access and general appearance of stream. (Persons depicted in lower left photograph are field staff.) [\[Return to Text\]](#)

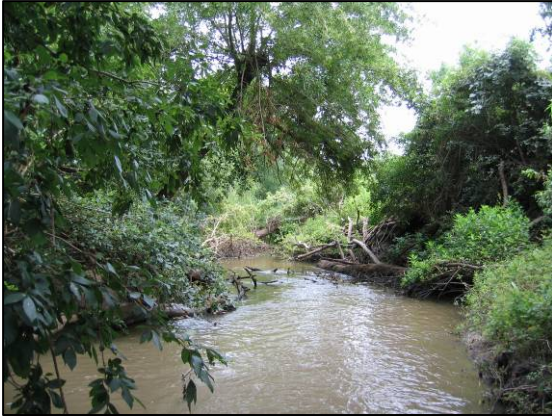
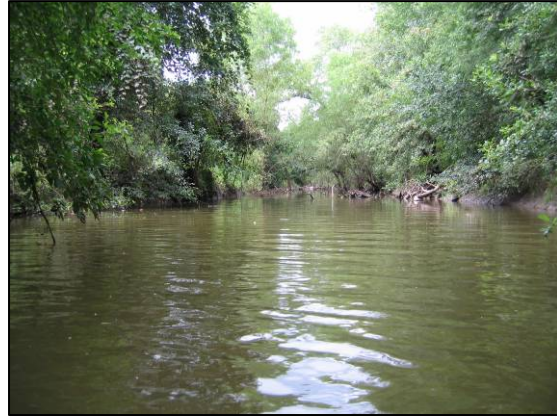
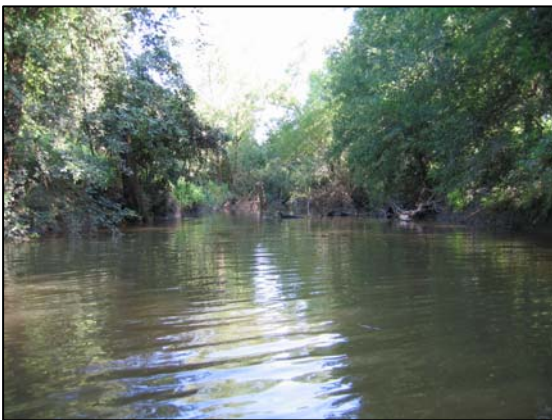
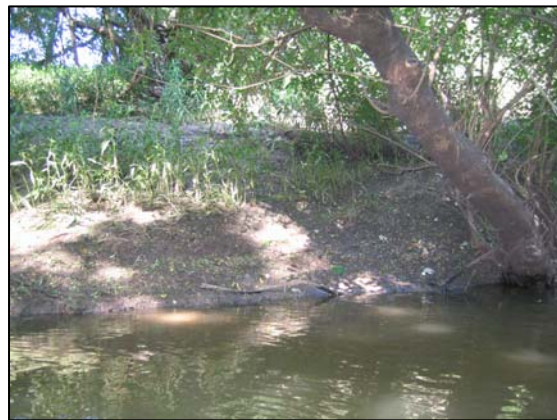
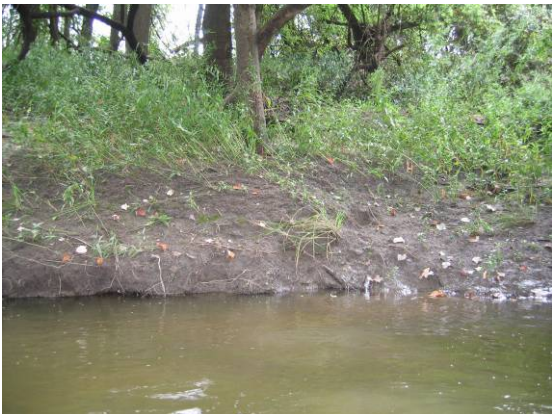
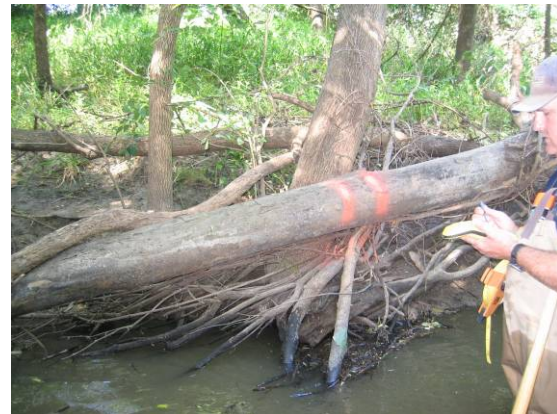
**Photogroup 3-21**

Atascosa River Site AR1\_07 depicting the water color and clarity of the surface. (Person in lower right photograph is field staff.)

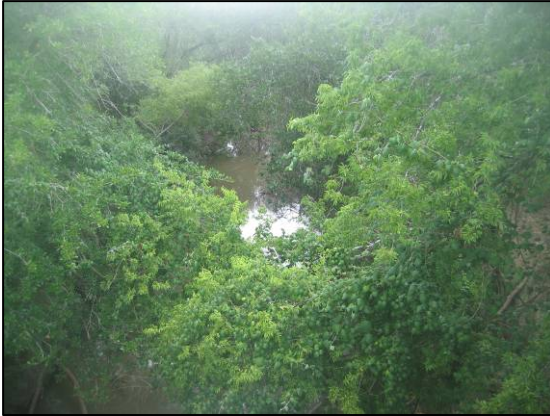
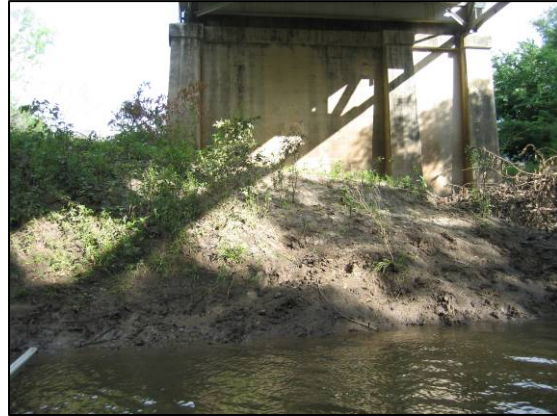
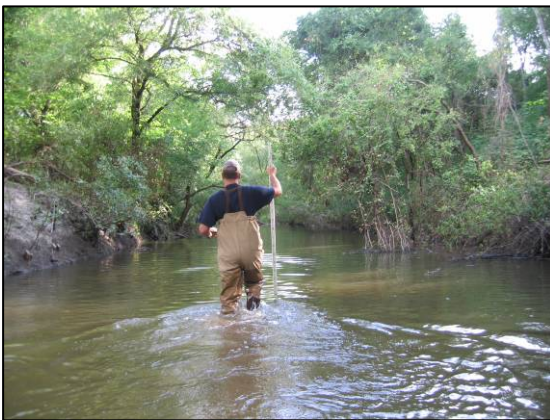
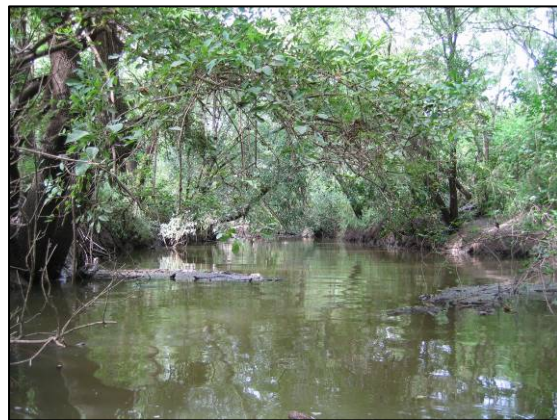
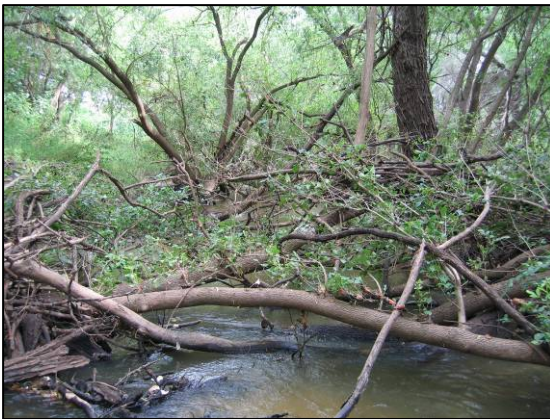
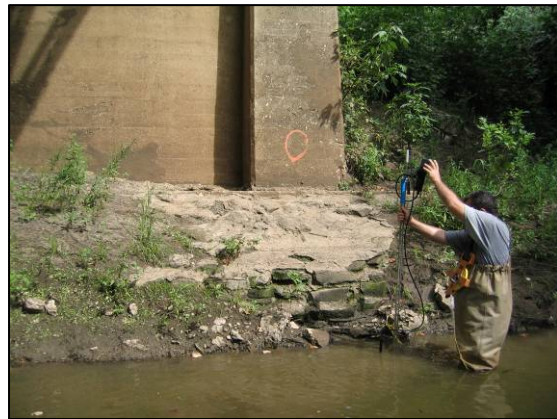
**Photogroup 3-22** Atascosa River Site AR1\_08 depicting a view from the U.S. Hwy. 281 bridge and the general appearance of the river. (All persons in photographs are field staff.) [\[Return to Text\]](#)

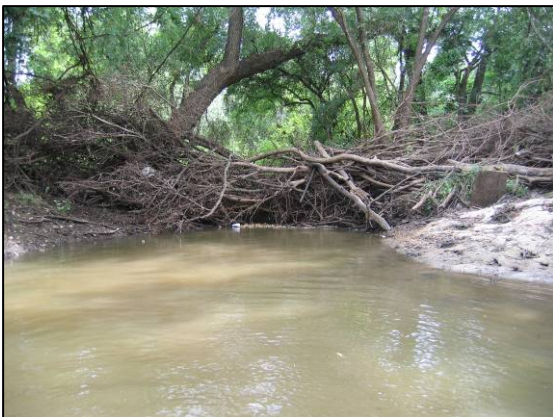
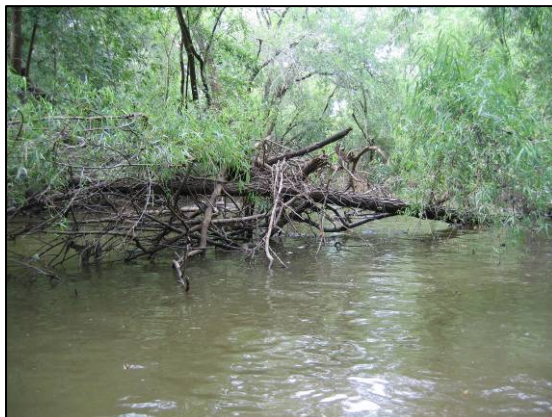
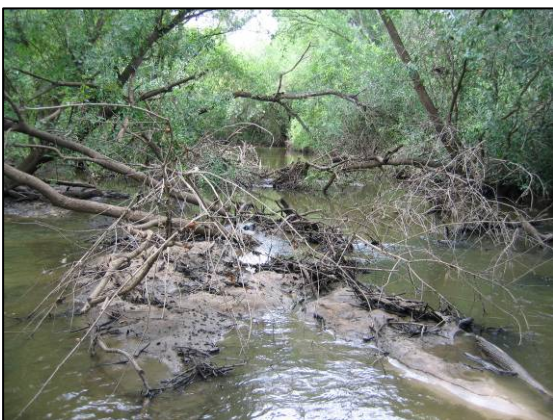
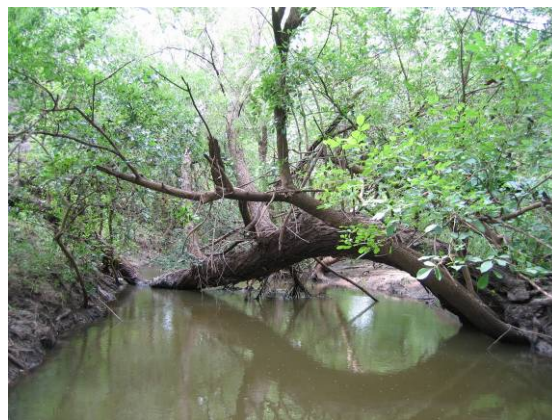
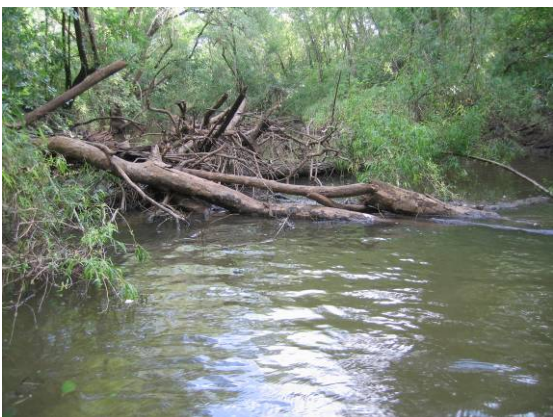
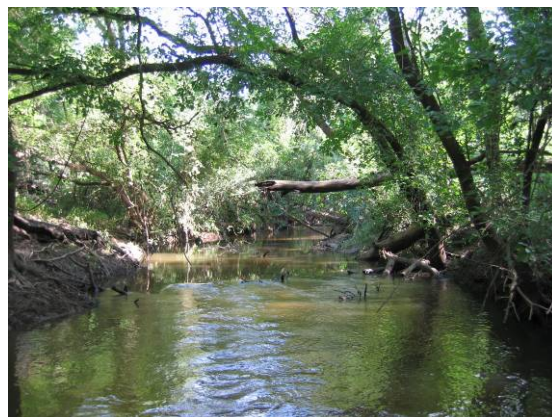
**Photogroup 3-23** Atascosa River Site AR1\_08 depicting obstructions encountered.  
[\[Return to Text\]](#)

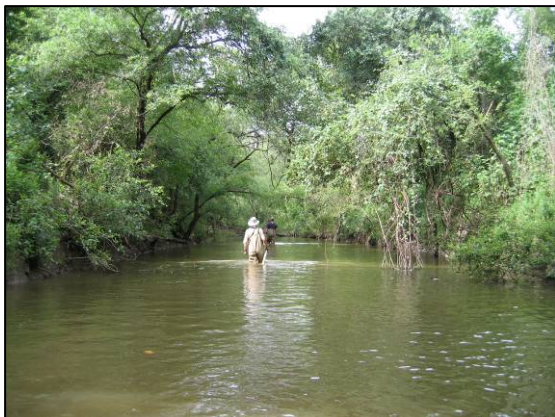
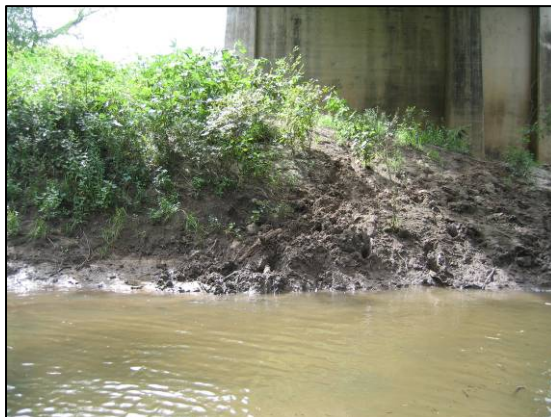
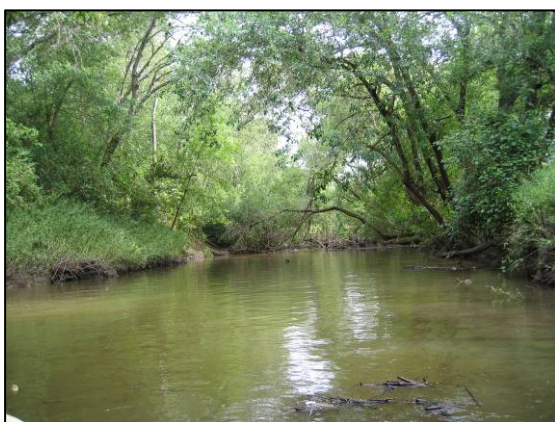
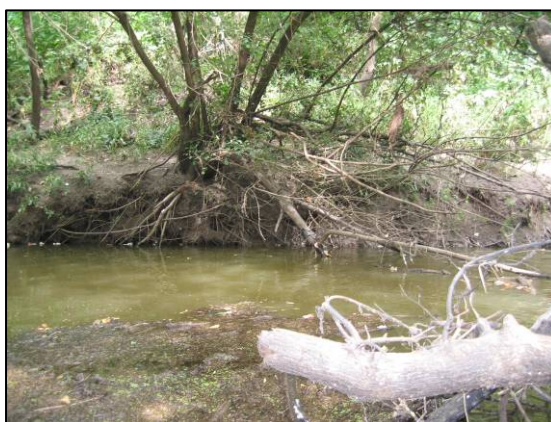
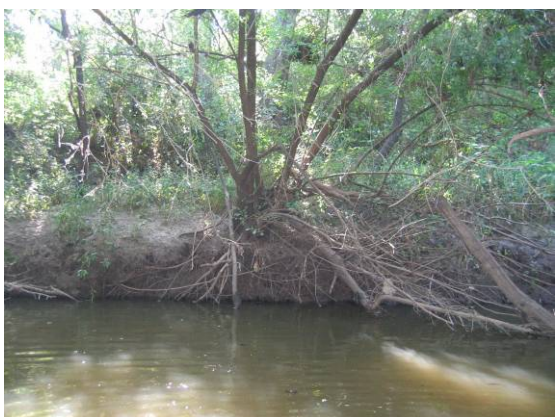
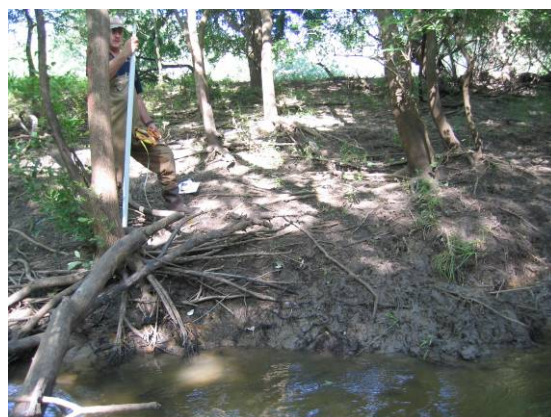
**Photogroup 3-24** Atascosa River Site AR1\_08 depicting water color and surface clarity. (All persons in photographs are field staff.) [\[Return to Text\]](#)

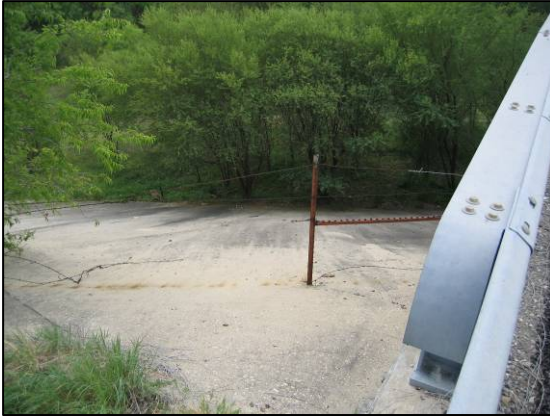
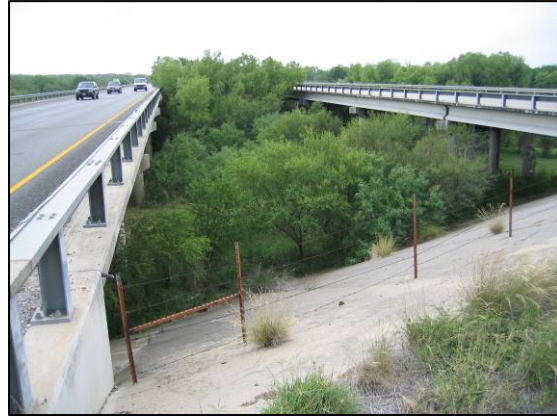
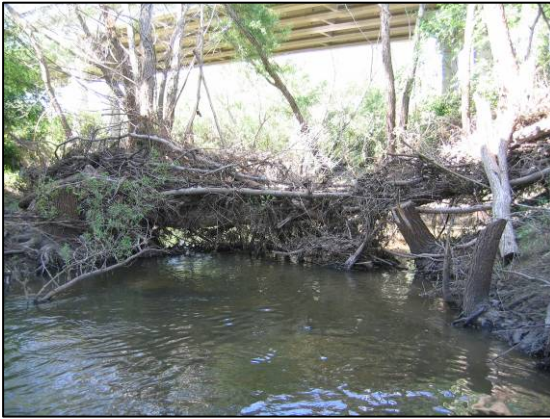
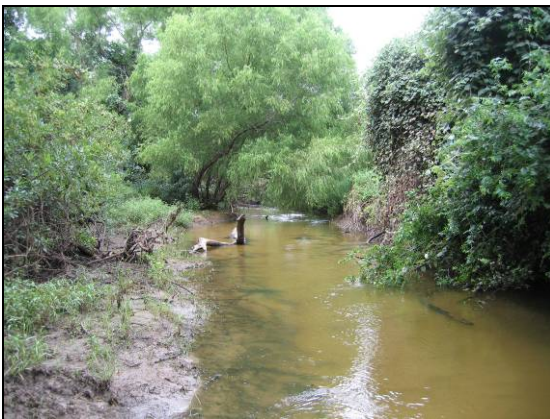
**Photogroup 4-1**

Atascosa River Site AR2\_01 showing access from the highway bridge, the downstream log jam, and general appearance of stream and immediate riparian vegetation (Individual in lower right photo is field staff.) [\[Return to Text\]](#)

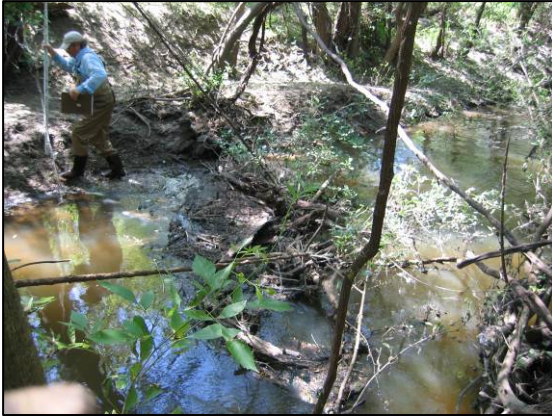
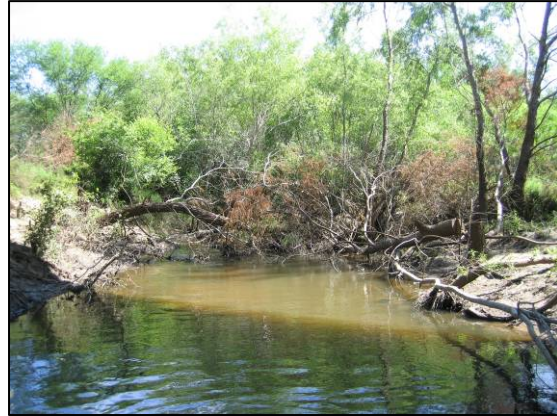
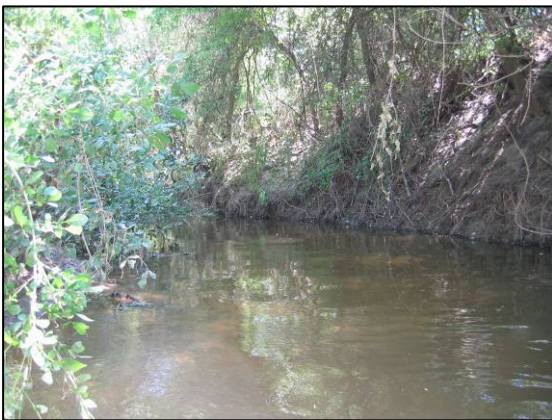
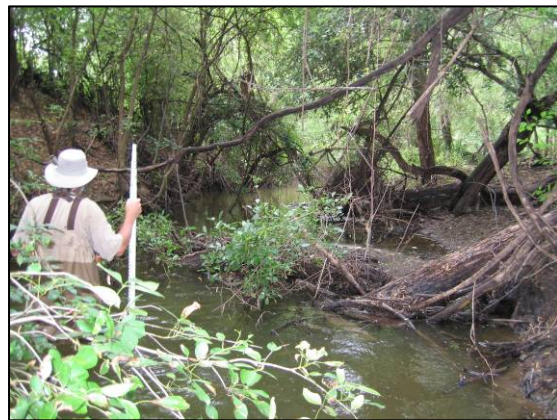
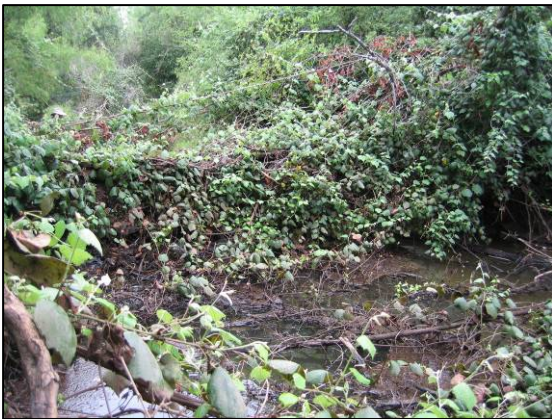
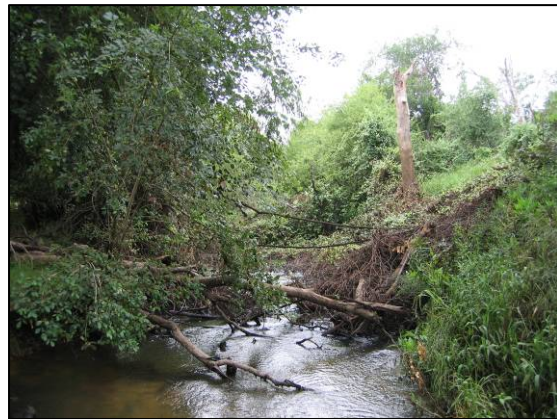
**Photogroup 4-2**

Atascosa River Site AR2\_01 showing obstructions encountered in the stream. (All individuals pictured are field staff.) [\[Return to Text\]](#)

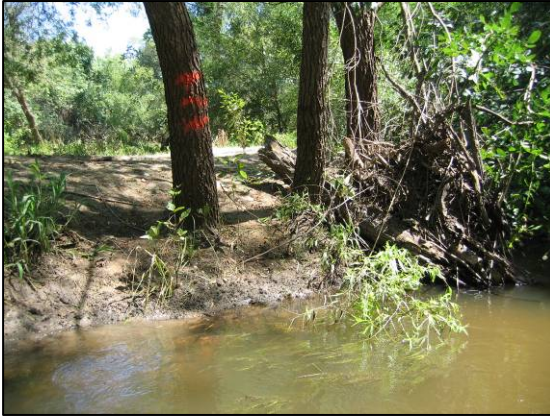
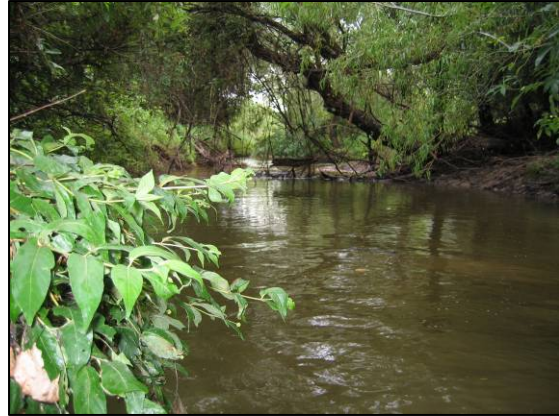
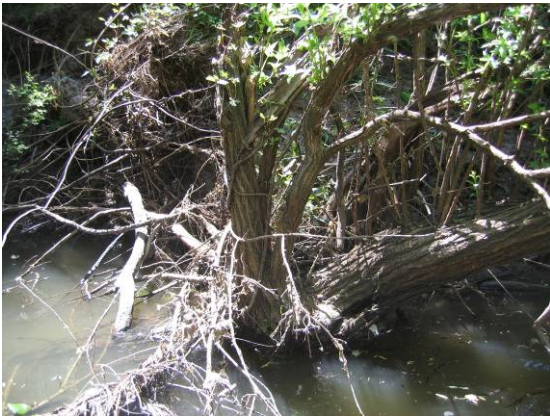
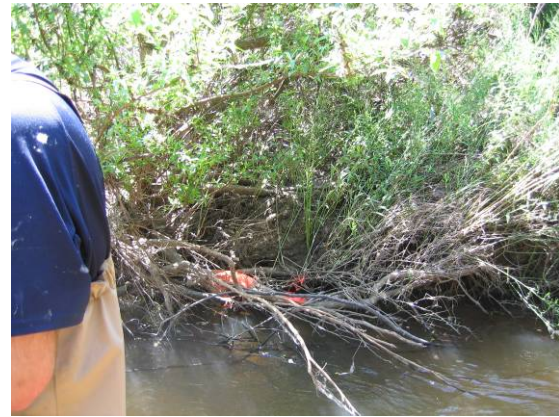
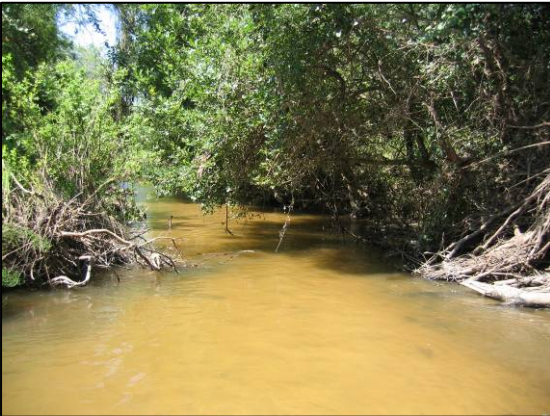
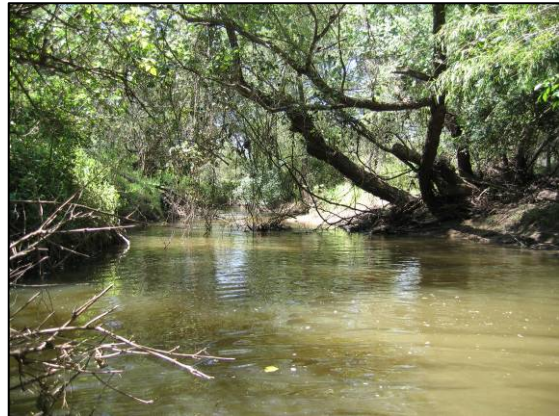
**Photogroup 4-3**

Atascosa River Site AR2\_01 depicting color and clarity of water surface. (Individual in center right photo is field staff.) [[Return to Text](#)]

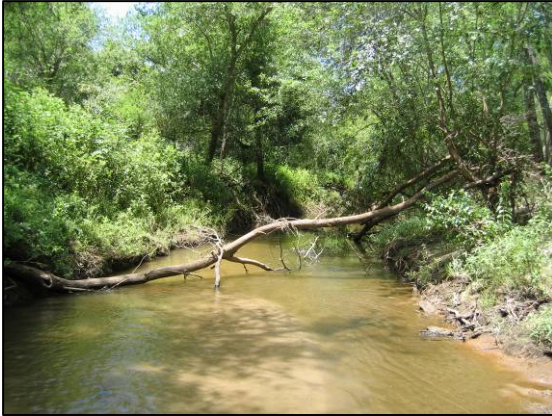
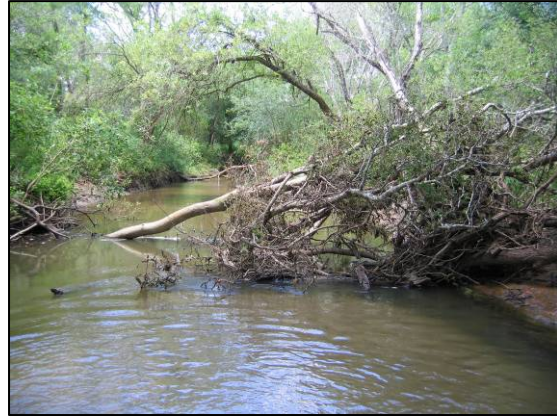
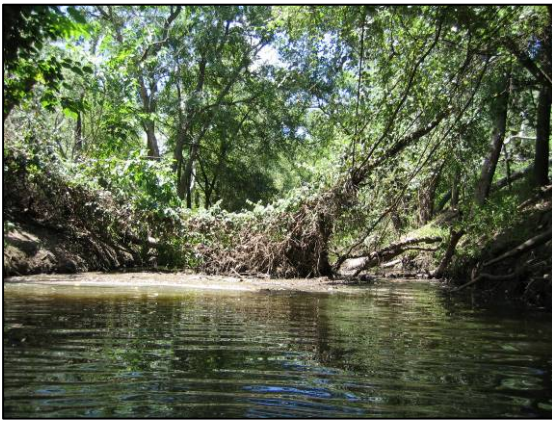
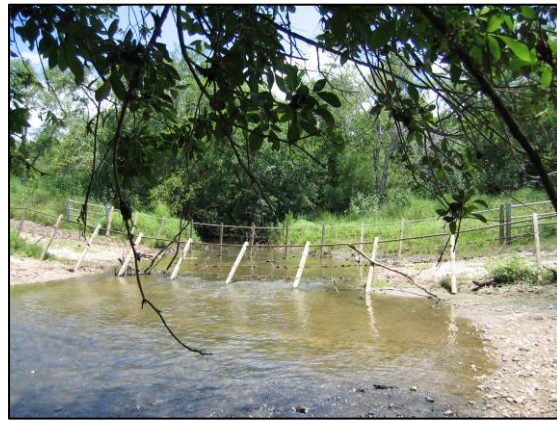
**Photogroup 4-4**

Atascosa River Site AR2\_02 illustrating the general appearance of the river and immediate riparian zone. (Individual in lower right picture is field staff.) [\[Return to Text\]](#)

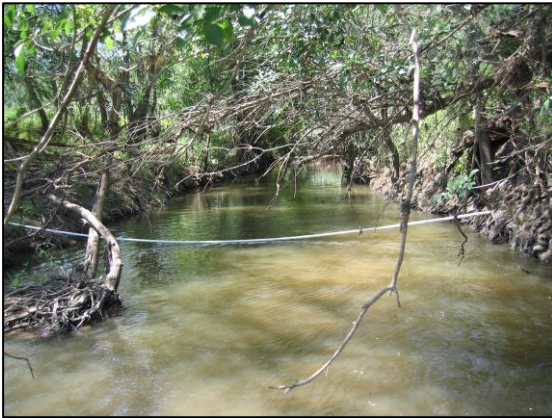
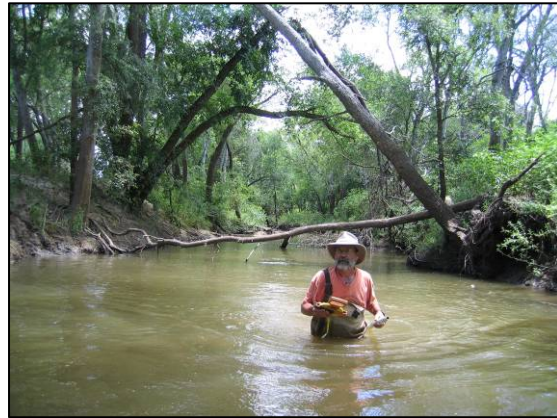
**Photogroup 4-5**

Atascosa River Site AR2\_02 illustrating obstructions encountered.

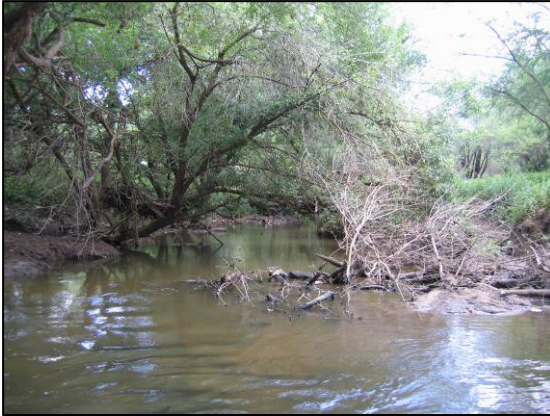
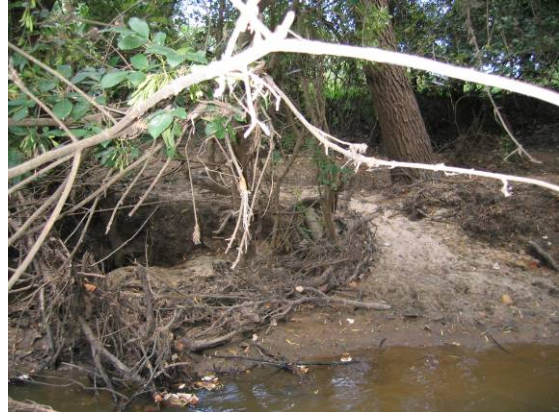
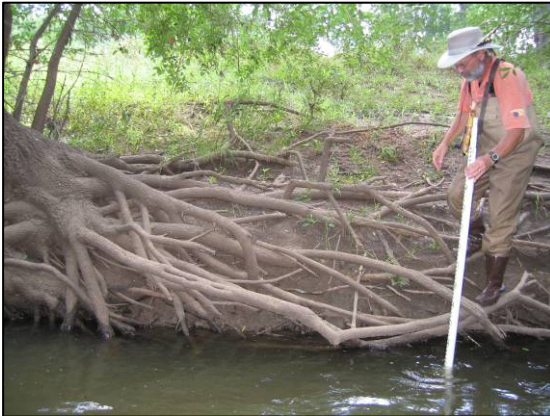
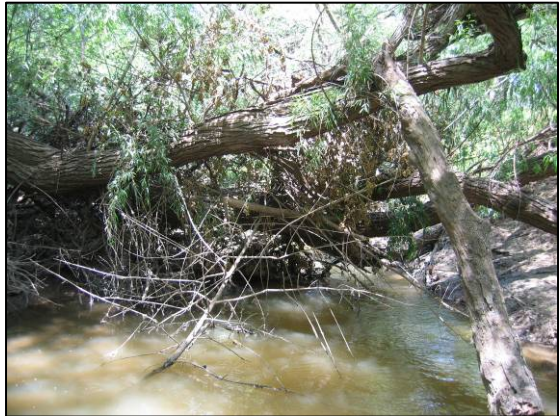
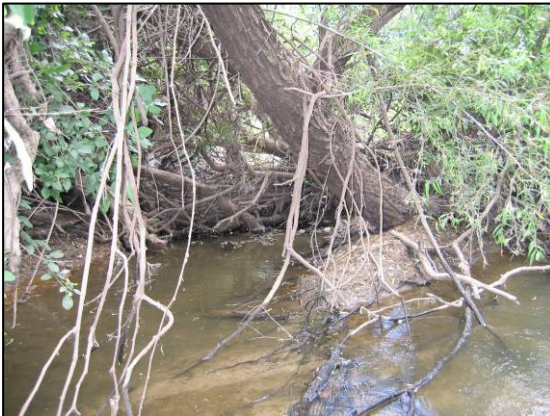
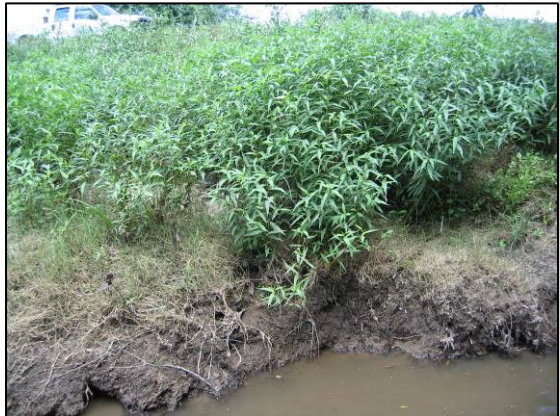
**Photogroup 4-8**

Atascosa River Site AR02\_03 showing obstructions encountered in reach. (Individual in lower left picture is field staff.) [[Return to Text](#)]

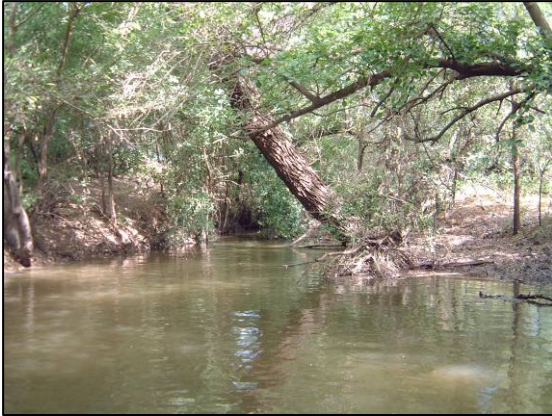
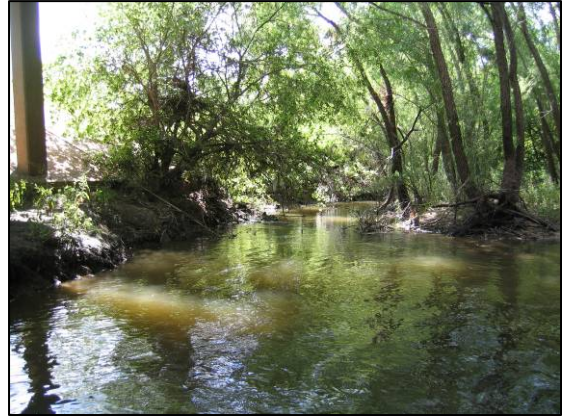
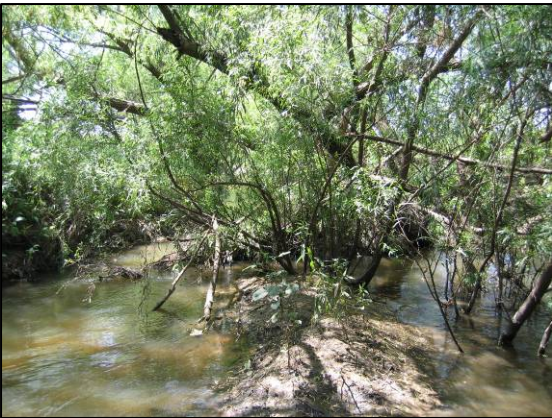
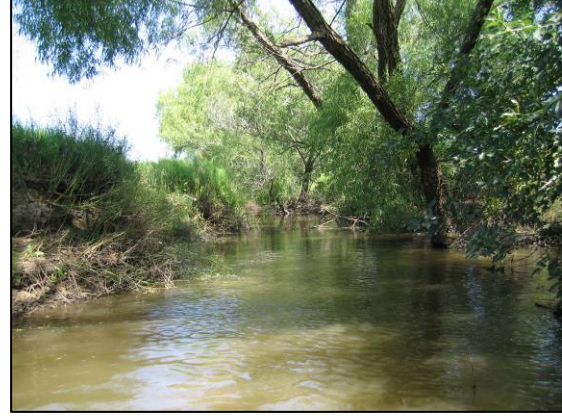
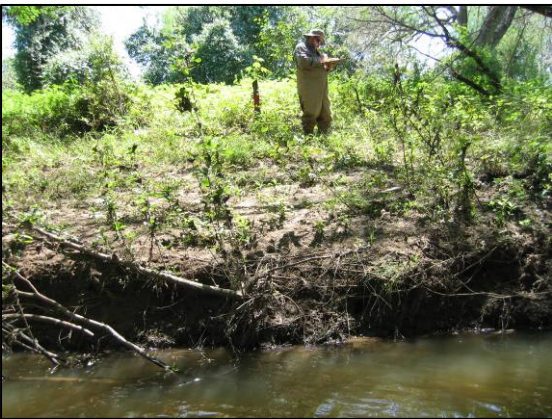
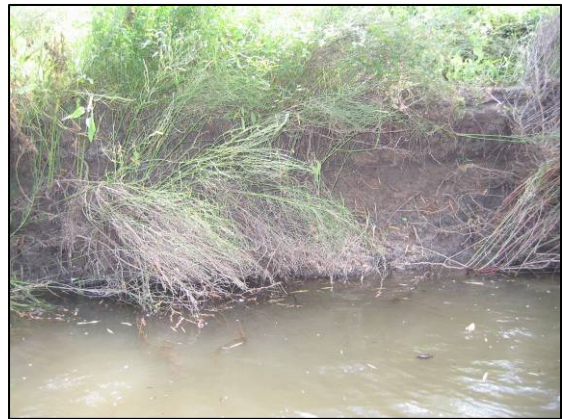
**Photogroup 4-9**

Atascosa River Site AR2\_03 depicting water color and stream clarity. (Individual in center left picture is field staff.) [\[Return to Text\]](#)

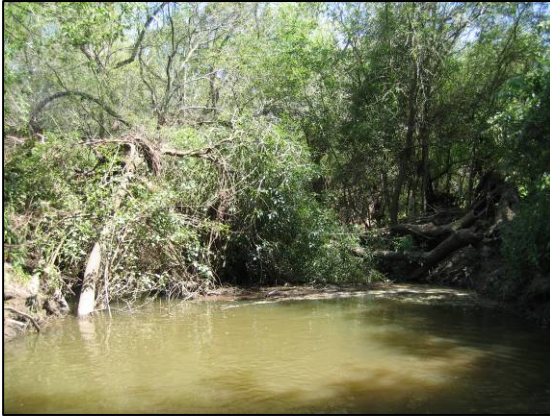
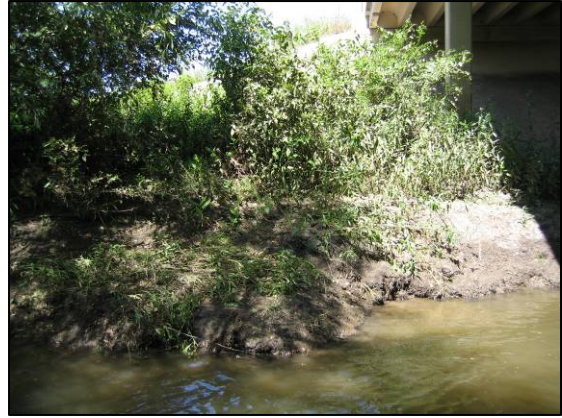
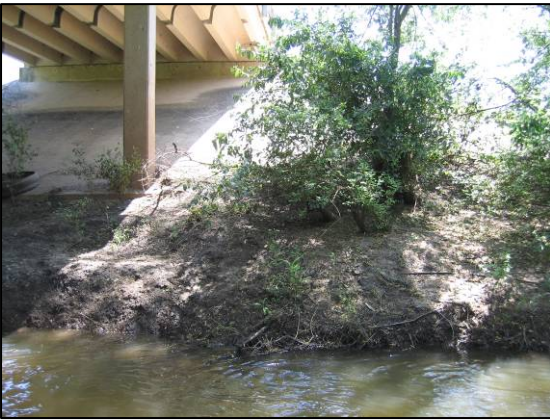
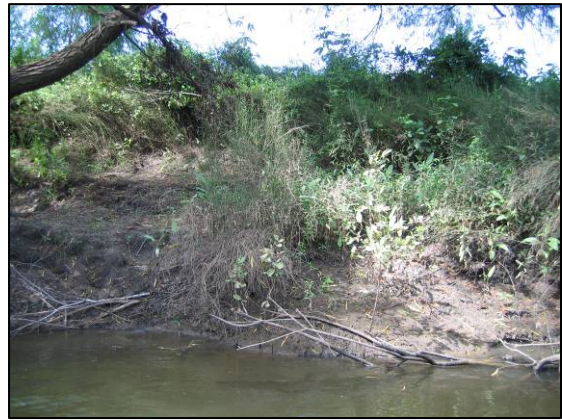
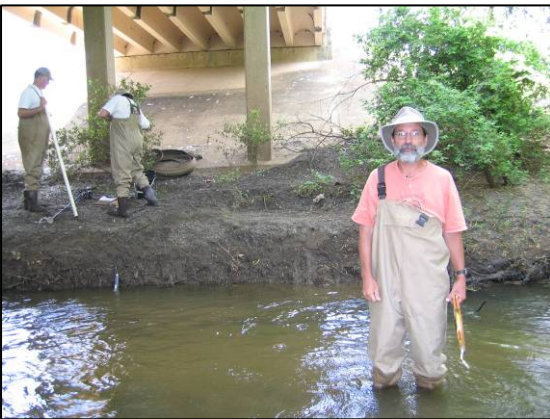
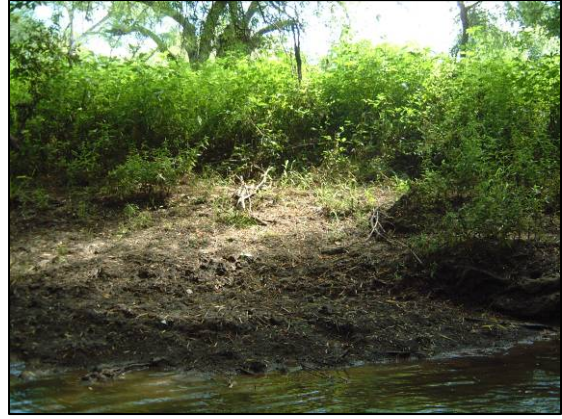
**Photogroup 4-11** Atascosa River Site AR2\_04 depicting an obstruction (upper left photograph) and bank accesses. (All individuals pictured are field staff.) [\[Return to Text\]](#)

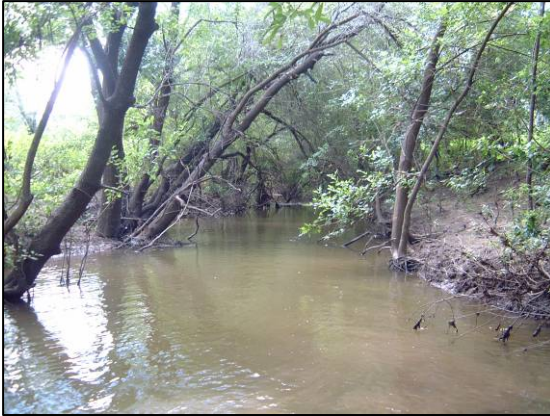
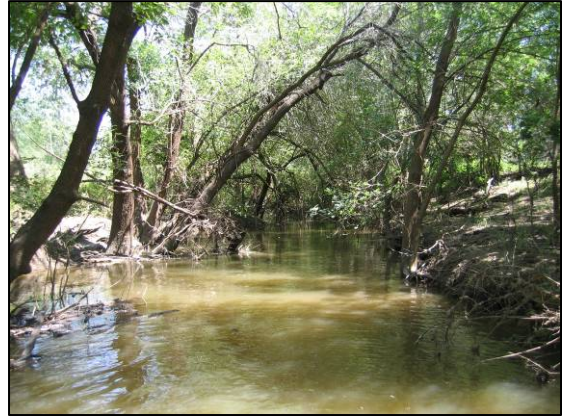
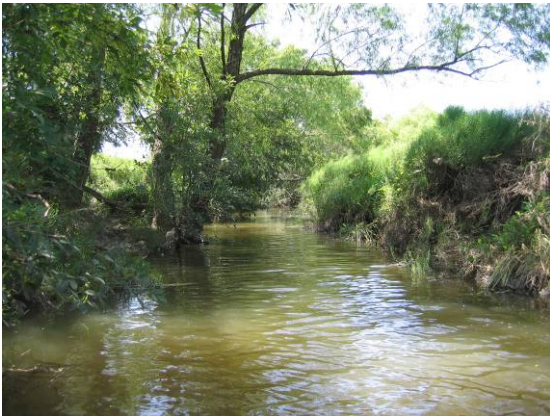
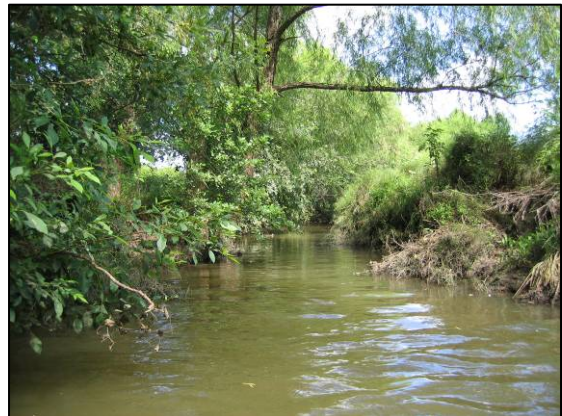
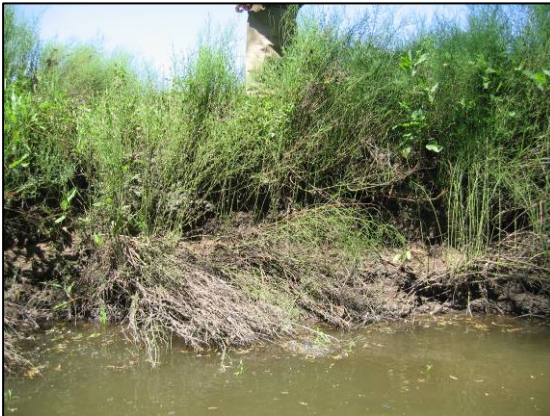
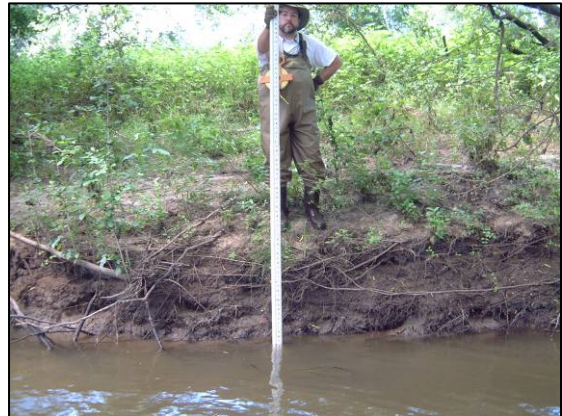
**Photogroup 4-12** Atascosa River Site AR2\_04 depicting general stream characteristics, and water color and surface clarity. (Individual in lower right picture is field staff.) [\[Return to Text\]](#)

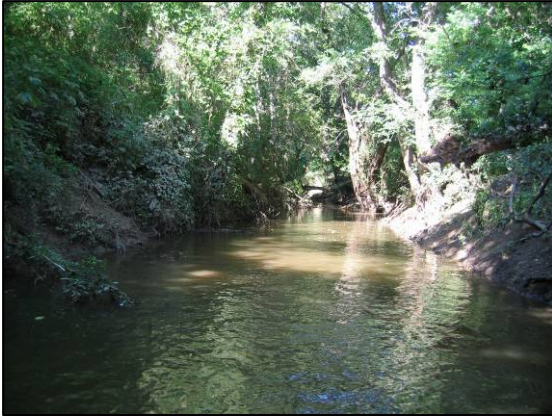
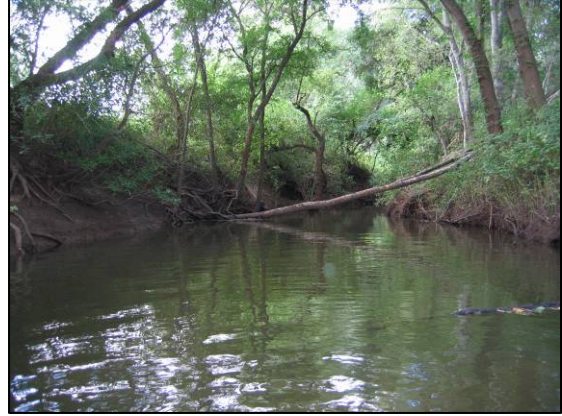
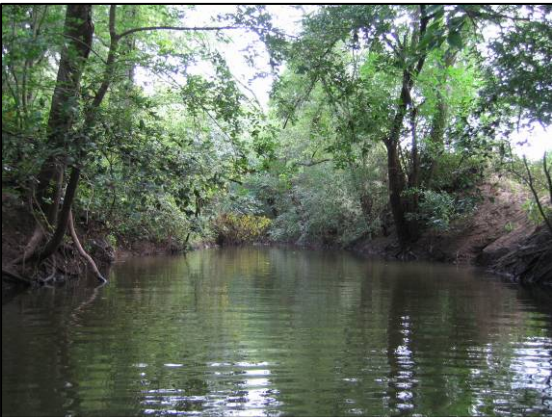
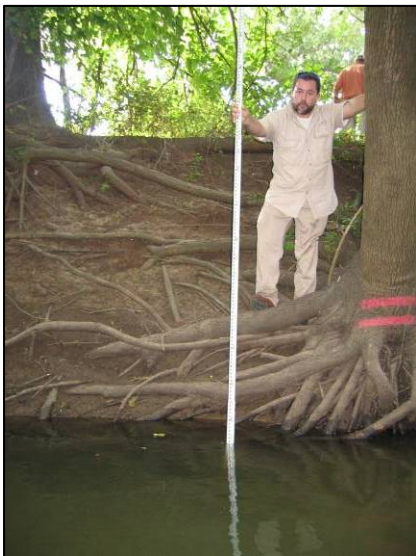
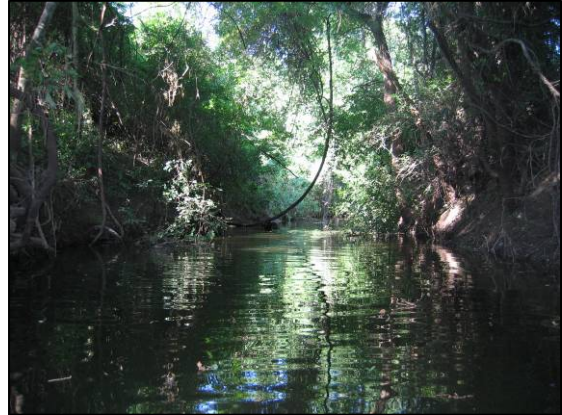
**Photogroup 4-13** Atascosa River Site AR2\_05 showing general appearance of stream and bank access. (Individual in lower left picture is field staff.) [\[Return to Text\]](#)

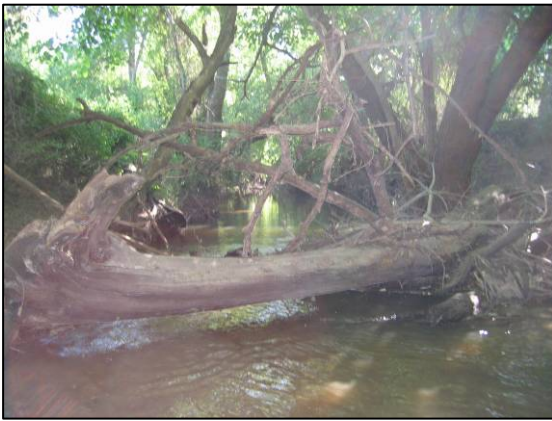
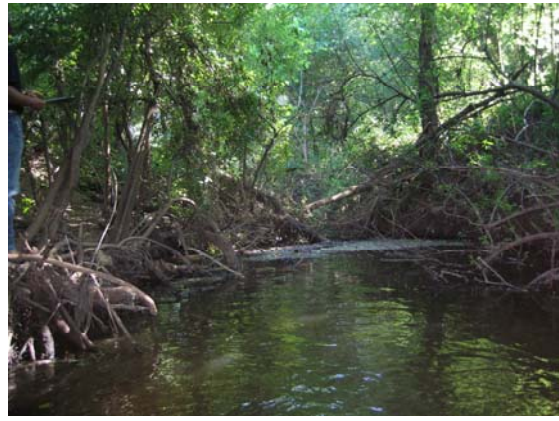
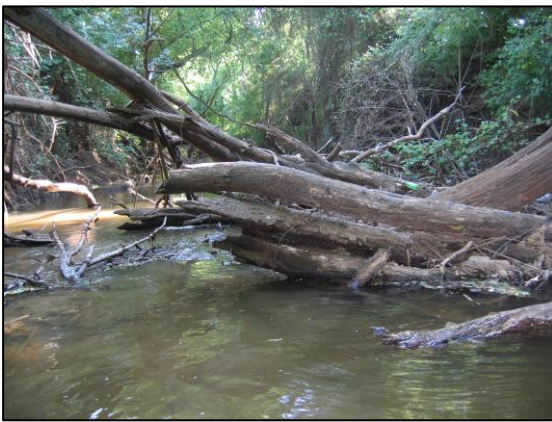
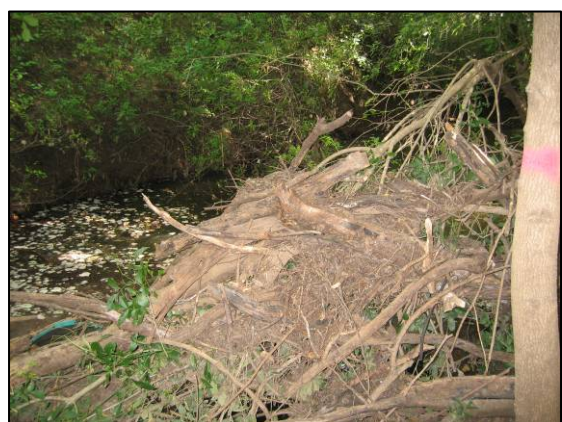
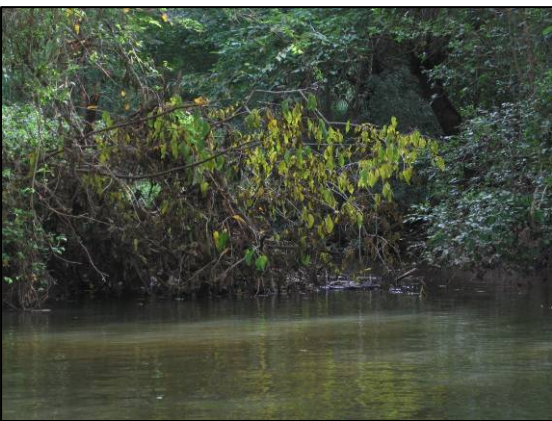
**Photogroup 4-14** Atascosa River Site AR2\_05 showing obstructions encountered in the reach. [\[Return to Text\]](#)

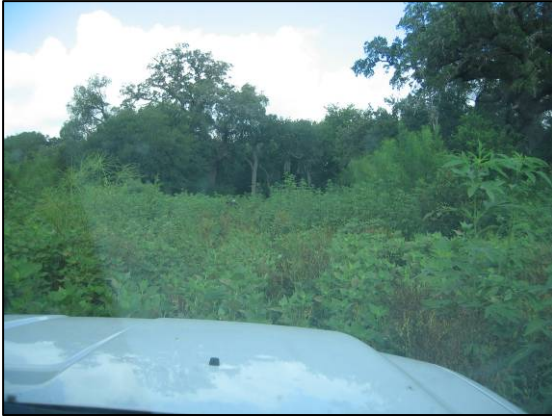
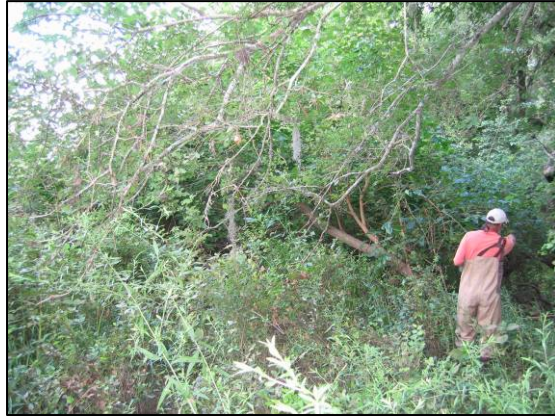
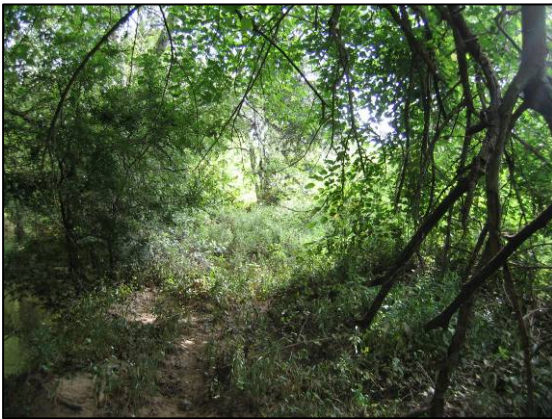
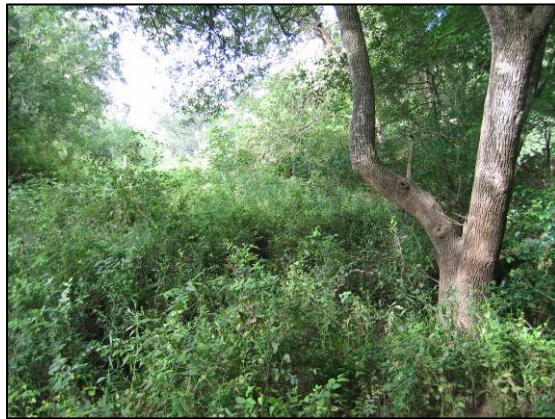
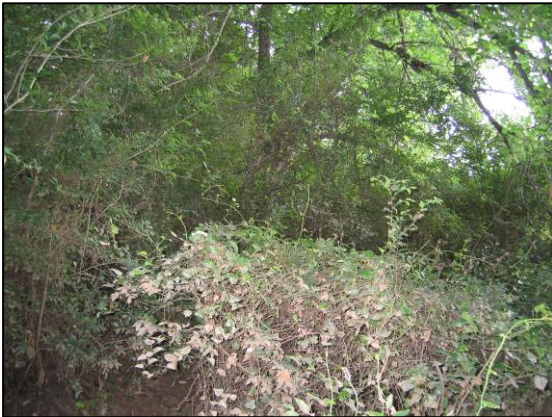
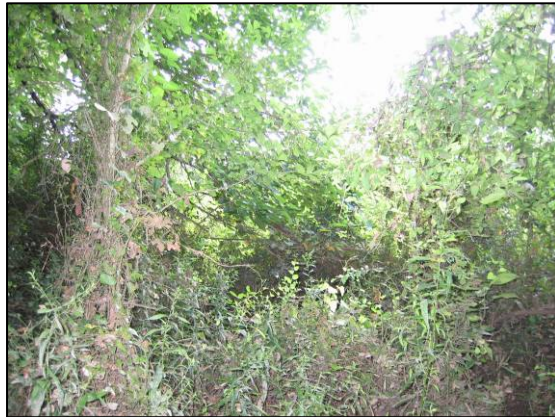
The surveyed reach at Site AR2\_05 was waded, but water depths and soft substrate made surveying the reach difficult and hazardous. The bottom substrate was generally firm sand but pockets of soft sediments were encountered that combined with the depth of the water, made data collection difficult. There was no easy egress point throughout the entire reach. This area was dominated by a steep bank of loose sand and dense vegetation. During the May survey thick brush and vines choked passage along the rim of the river and chest high vegetation was encountered further from the bank. The vegetation along the bank by June was even worse, and water depths were greater preventing wading for safety reasons. During June efforts to gain access to most transects proved futile as the vegetation, including shoulder high poison ivy and head high ragweed, blocked any access to the bank away from the original access point. Only the 180-m and 210-m transects could be reached from the bank and depths were taken at these locations. [Photogroup 4-14](#) illustrates the obstructions encountered and [Photogroup 4-15](#) shows the dense vegetation that limited access from the bank.

**Photogroup 4-15** Atascosa River Site AR2\_05 showing the dense vegetation that limited access from the bank. (Individual in upper right picture is field staff.) [\[Return to Text\]](#)
