# Atascosa River Recreational Use-Attainability Analyses

Report to TMDL Program  
Texas Commission on Environmental Quality  
Project and Work Order Number  
582-6-70859-26

Tim Jones  
Jeff Stroebel  
Larry Hauck  
Texas Institute for Applied Environmental Research  
Tarleton State University  
Stephenville, Texas

December 2010

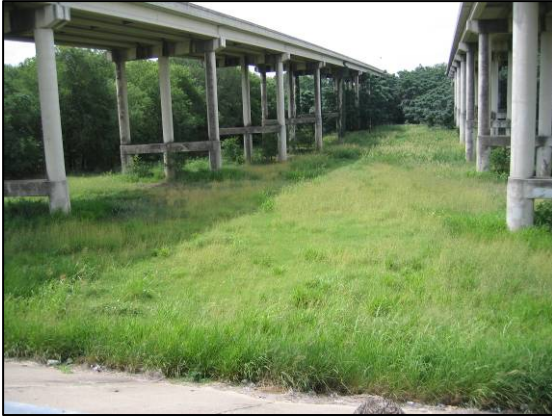
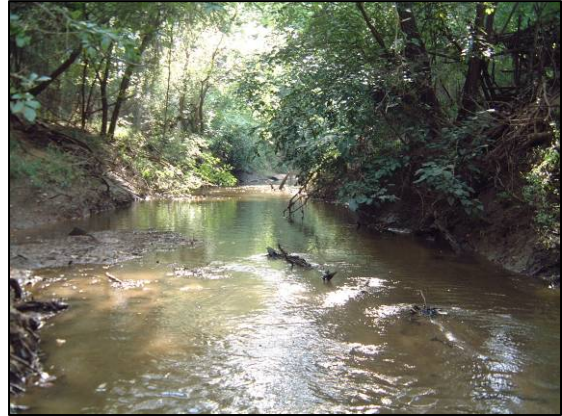
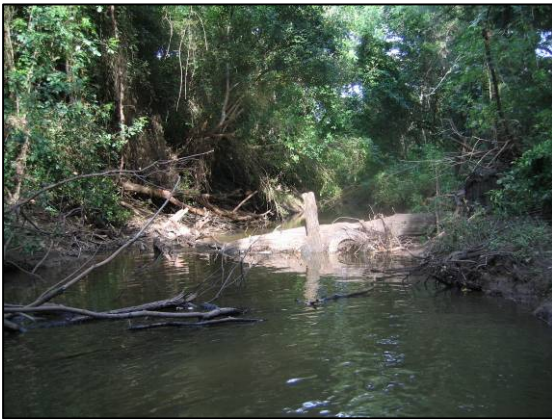
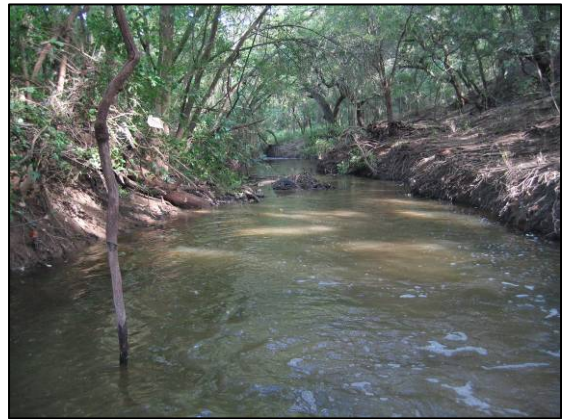
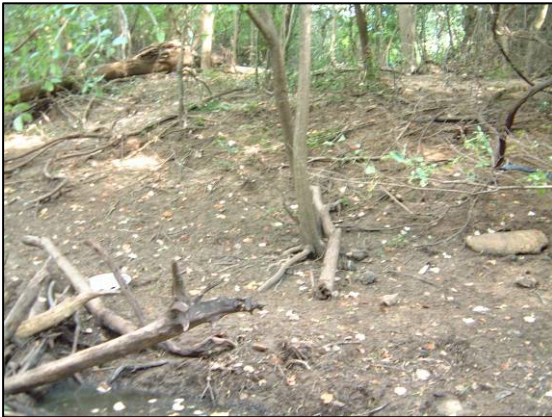
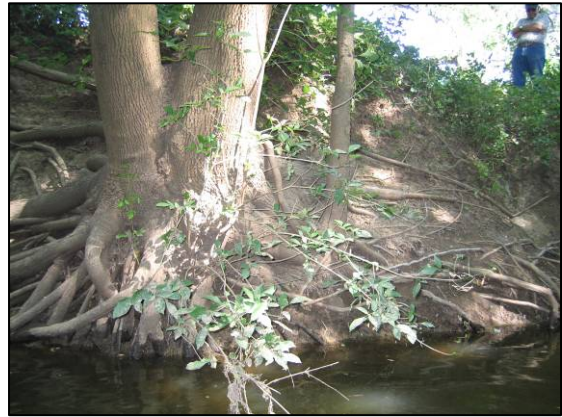
**Photogroup 4-16** Atascosa River Site AR2\_06 depicting access to the site, general appearance of the stream and bank access. (Individual in lower right picture is field staff.) [\[Return to Text\]](#)

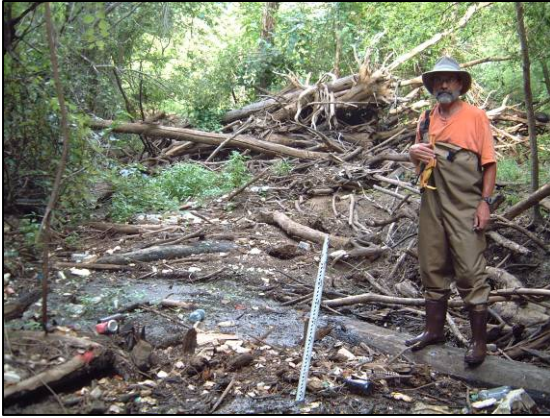
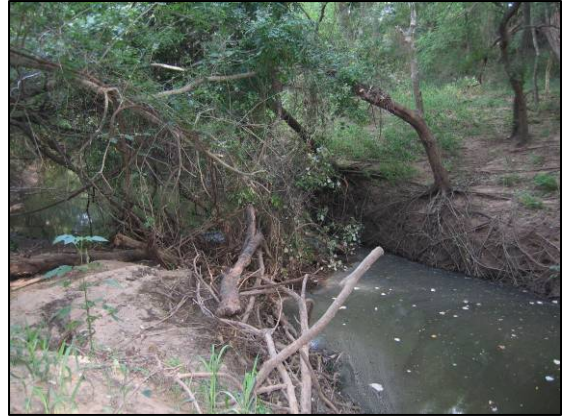
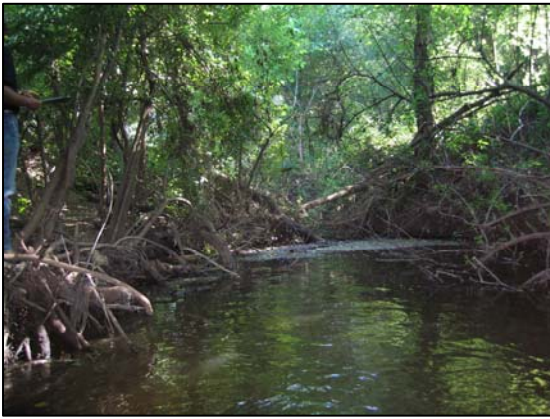
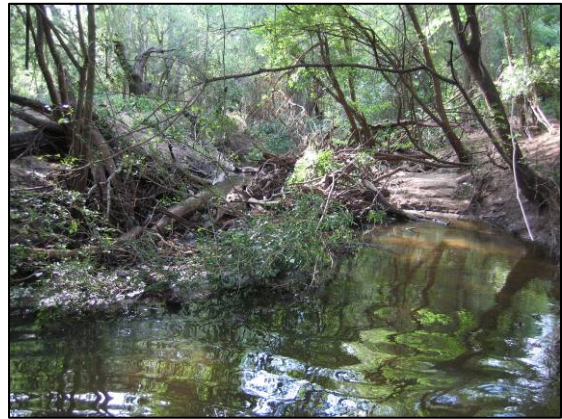
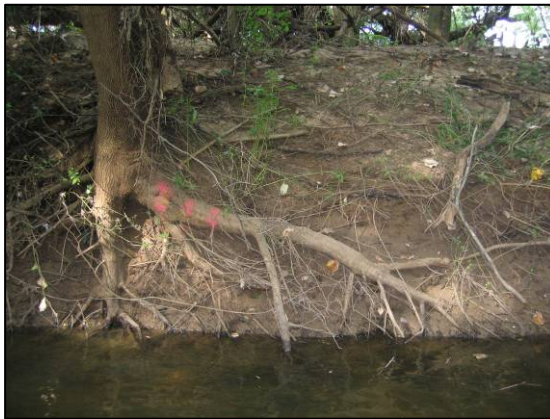
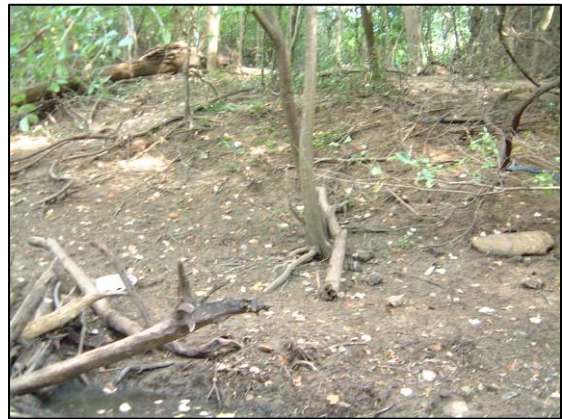
**Photogroup 4-17** Atascosa River Site AR2\_06 illustrating the obstructions encountered and bank access along the reach. (Individual in upper left picture is field staff.) [[Return to Text](#)]

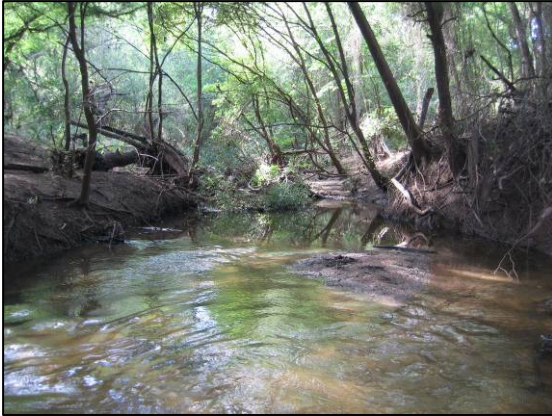
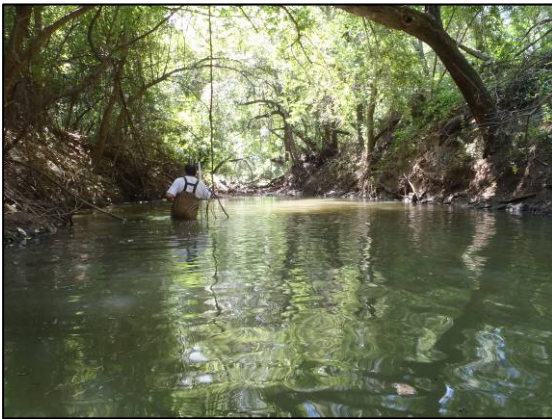
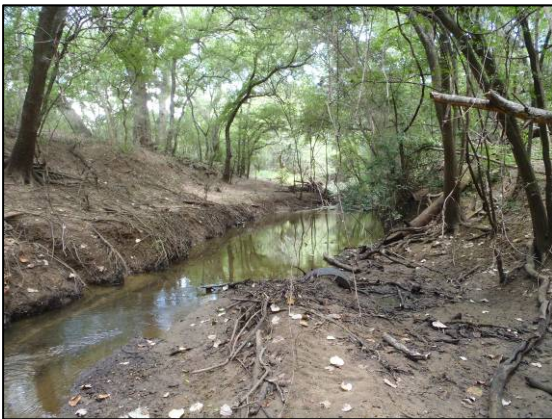
**Photogroup 4-18** Atascosa River Site AR2\_06 depicting general stream conditions, water color, and water surface clarity. (Individual in center left picture is field staff.) [\[Return to Text\]](#)

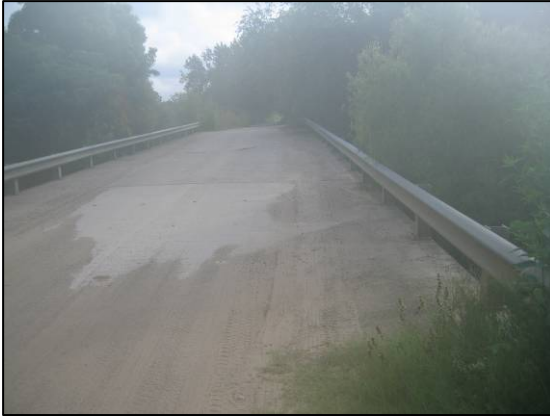
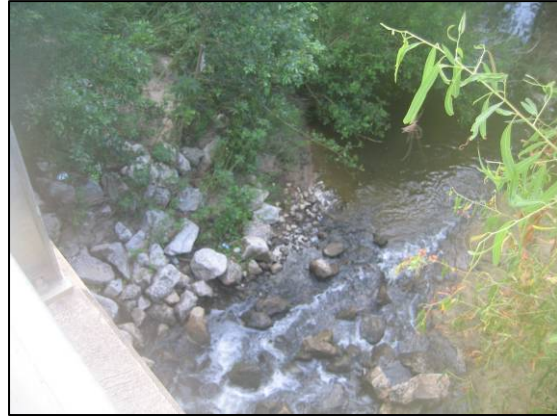
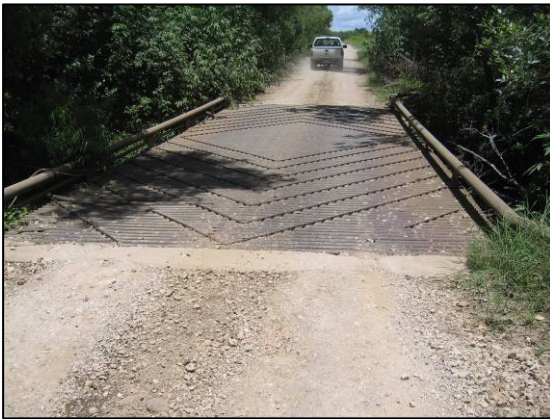
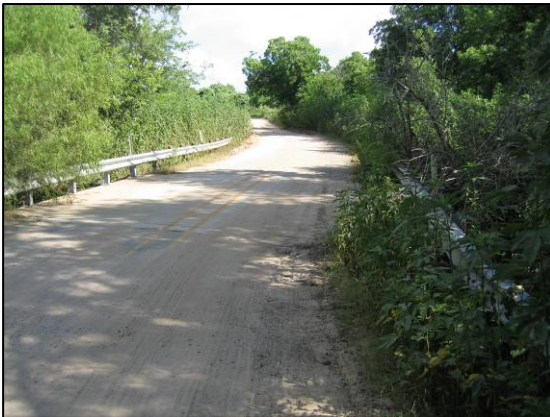
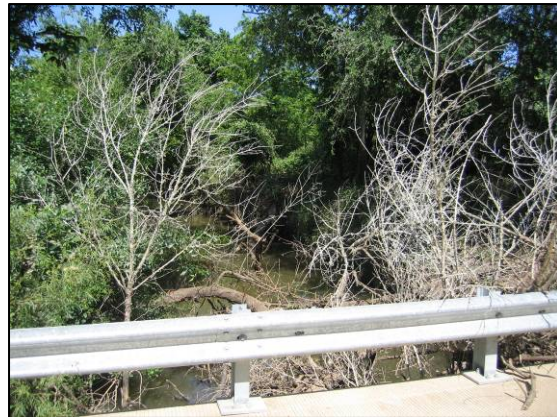
**Photogroup 4-19** Atascosa River AU 2107\_02 depicting observations at each crossing not formally surveyed. Top to bottom: Coughran Road, Leal Road, and Jim Brite Road. (TIAER vehicle in center left picture.) [\[Return to Text\]](#)

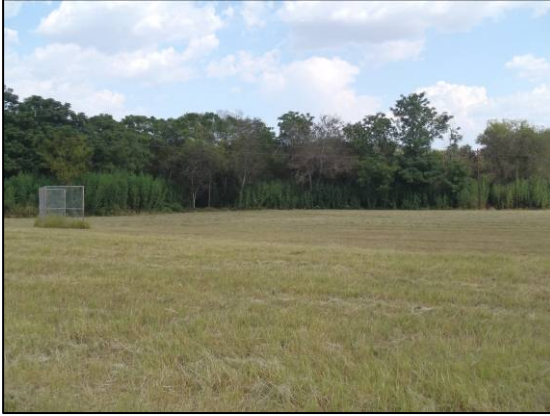
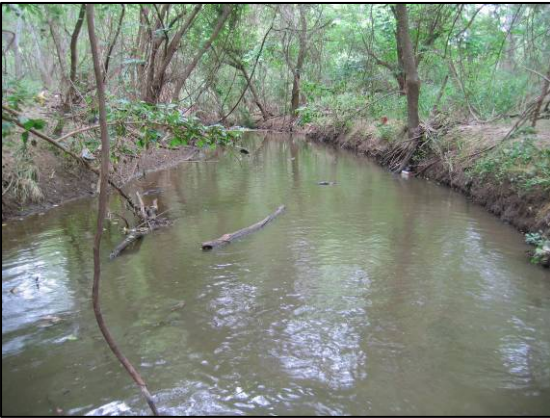
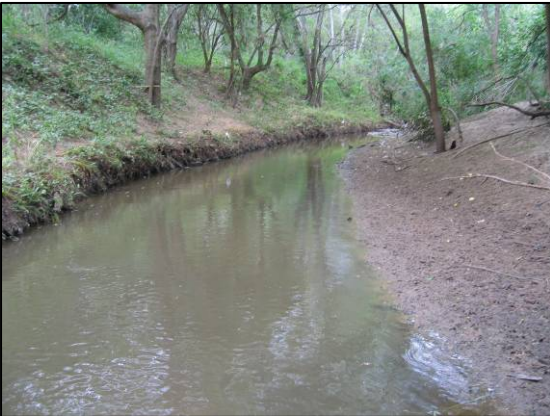
**Photogroup 5-1**

Atascosa River Site AR3\_01 depicting the access and general appearance of the river and immediate riparian zone (All individuals pictured are field staff.) [[Return to Text](#)]

The Atascosa River at Site AR3\_01 was surveyed on May 8 and June 22, 2010. This site was accessible through city property off E. Hunt Street downstream from the Pleasanton WWTF and TCEQ Station 12981. The area adjacent to the riparian zone of the river was mown acreage with two baseball backstops at either end. It appeared to be more of a practice area than an official ball field as was observed in the park near Site AR3\_02. It is possible to drive along the edge of the field and park near the bank of the river. Tall riparian grass and ragweed prevent visual scrutiny of the river from the field, but there were openings through the weeds that were presumed to be foot paths. At the river, the bank is relatively low and the slope is sufficiently gentle to allow easy entrance into the river. The entry point near the path used to access the stream was set as the 300-m transect. Measures at 30-m increments were made downstream to attain the 300-m reach required. Flow was measured at a narrow stream width near the 300-m transect. Table 5-2 describes the stream channel and riparian zone appearance of this site. [Photogroup 5-1](#) depicts the access and general appearance of the stream at Site AR3\_01.

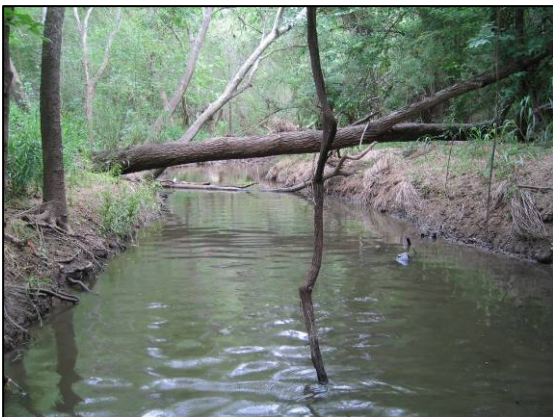
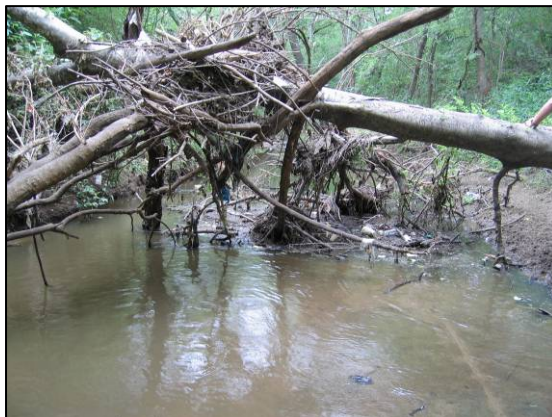
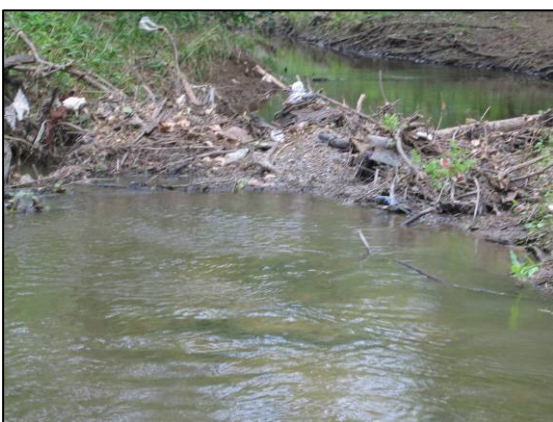
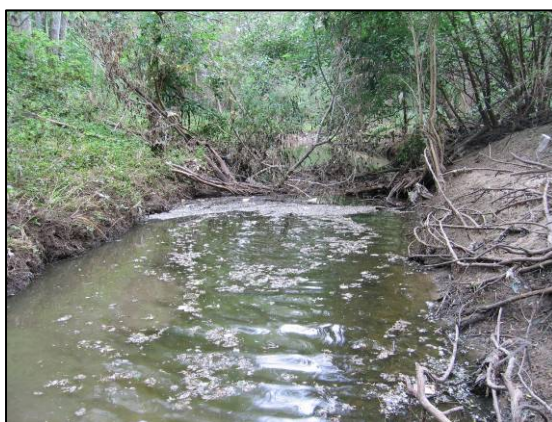
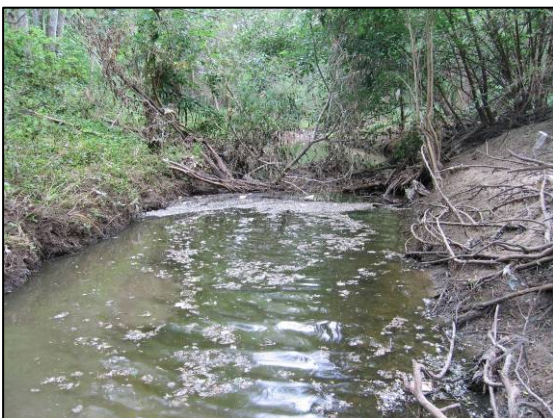
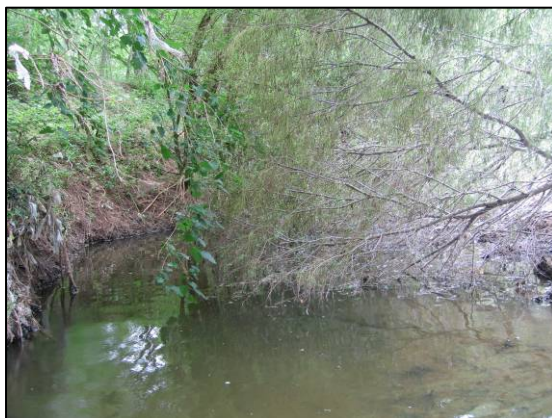
**Photogroup 5-2**

Atascosa River Site AR3\_01 depicting obstructions encountered.

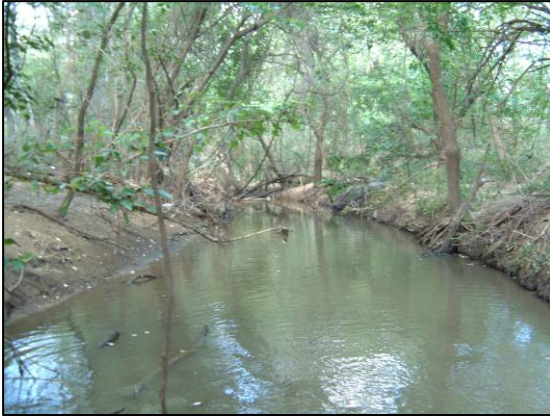
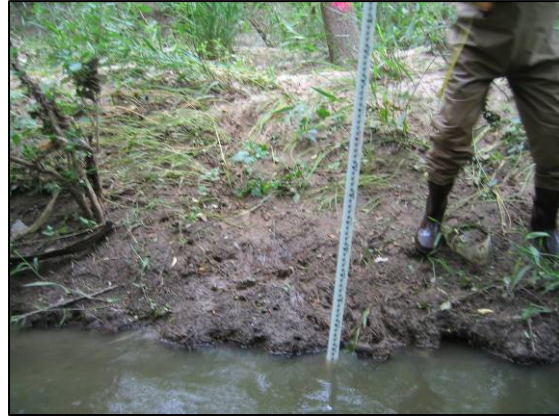
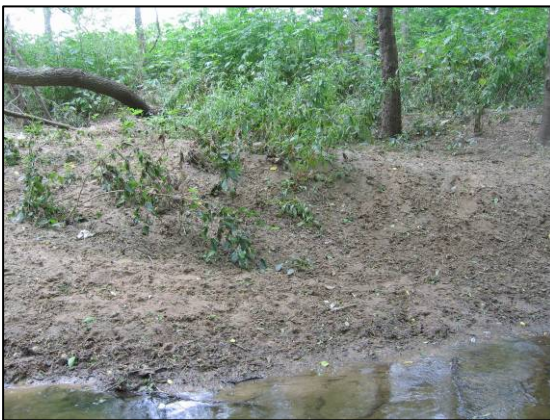
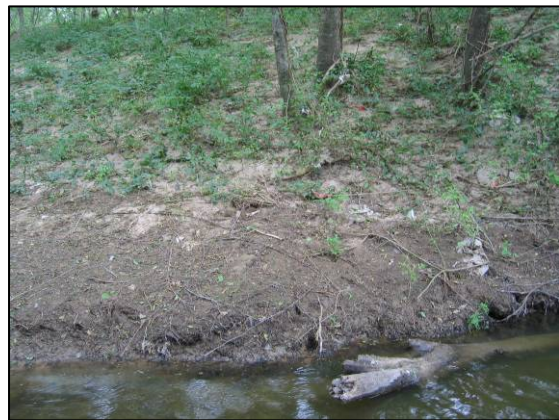
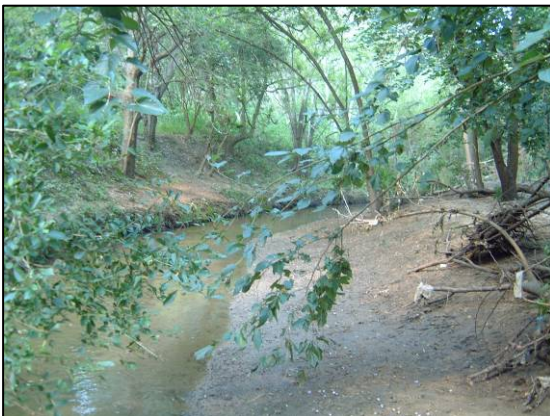
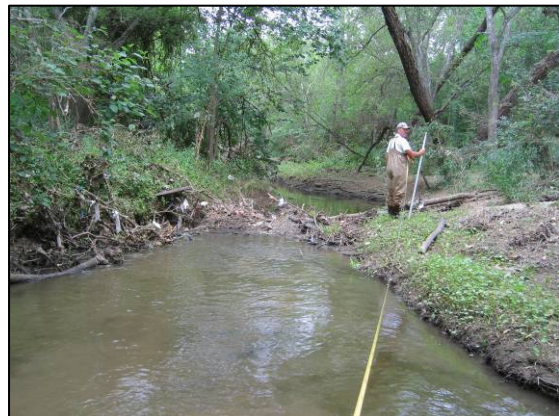
**Photogroup 5-3**

Atascosa River Site AR3\_01 depicting water and surface clarity.  
(All individuals pictured are field staff.) [\[Return to Text\]](#)

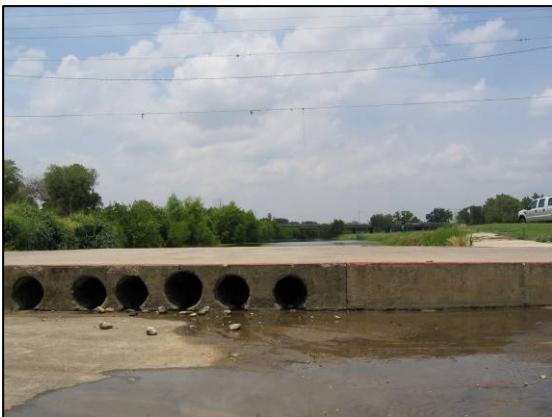
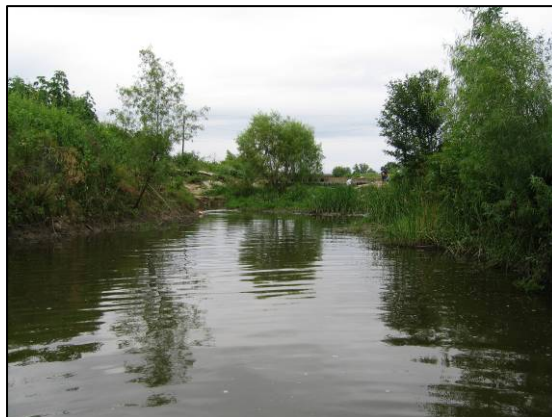
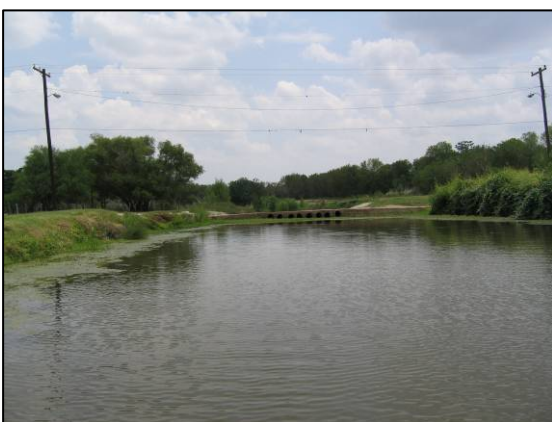
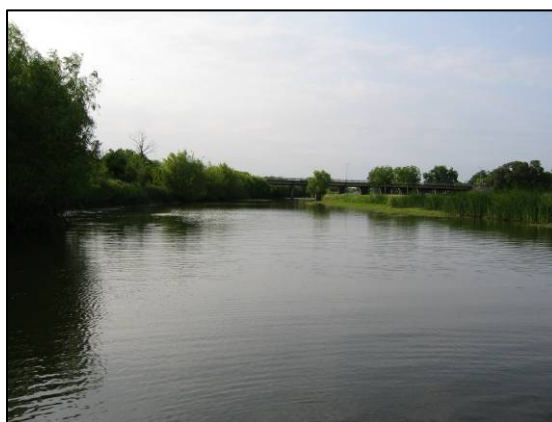
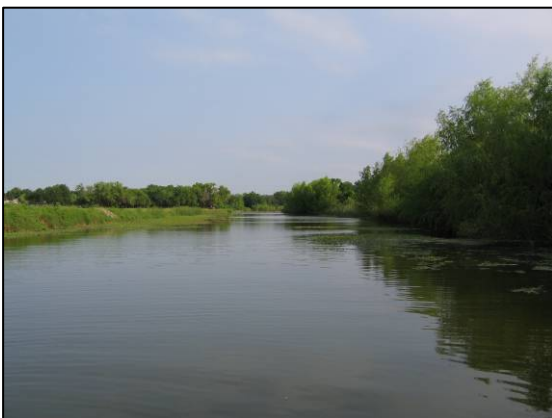
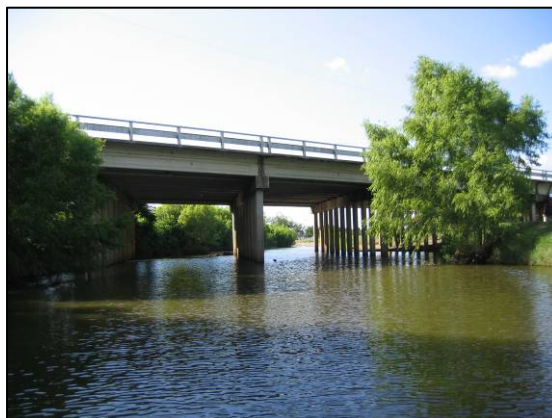
**Photogroup 5-4**

Atascosa River Site AR3\_02 depicting access and general appearance of river. [[Return to Text](#)]

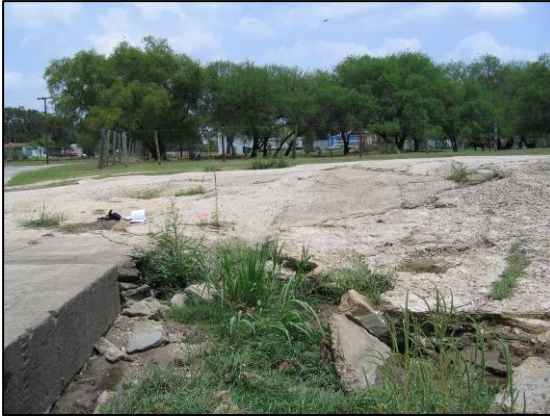
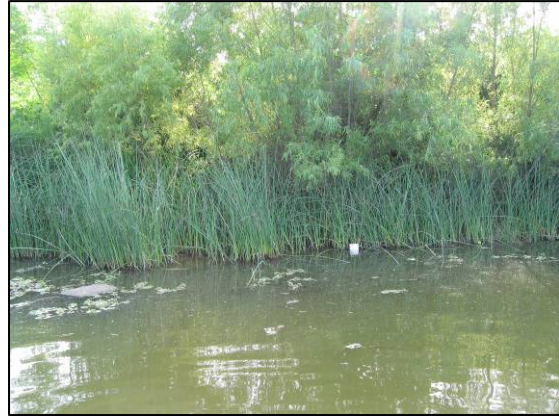
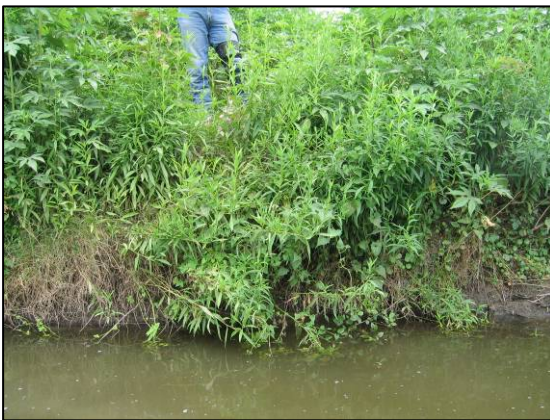
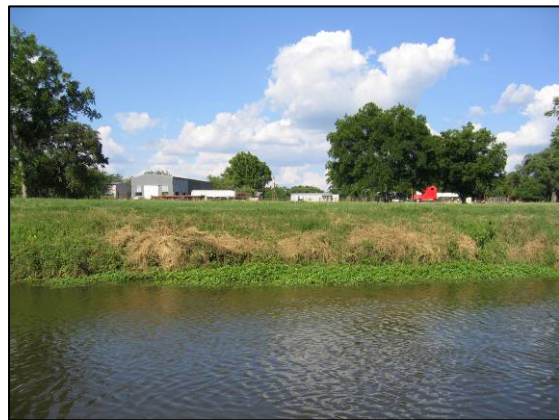
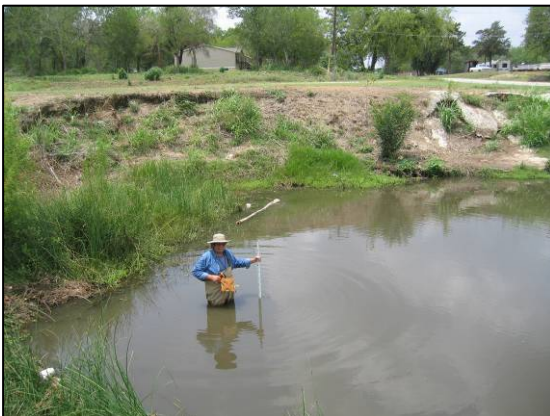
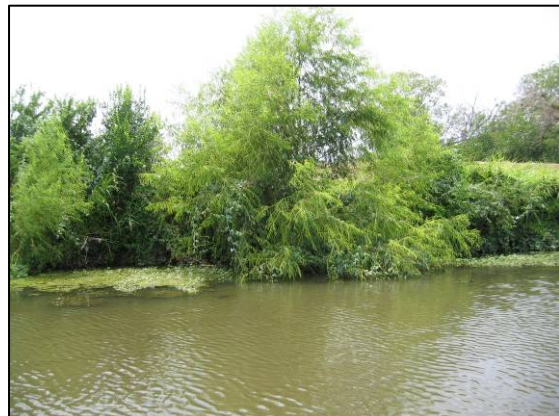
**Photogroup 5-5**

Atascosa River Site AR3\_02 depicting some views of the left and right banks, as well as the pool below E. Hunt Street. (All individuals pictured are field staff.) [[Return to Text](#)]

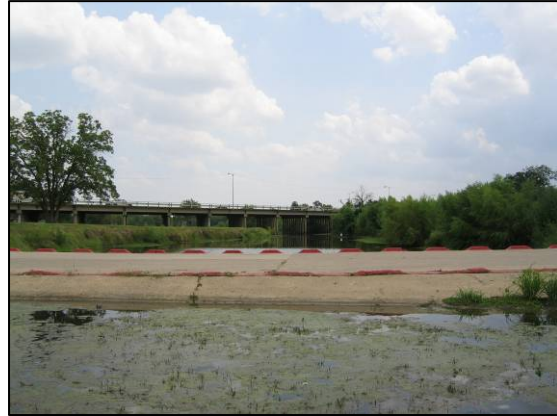
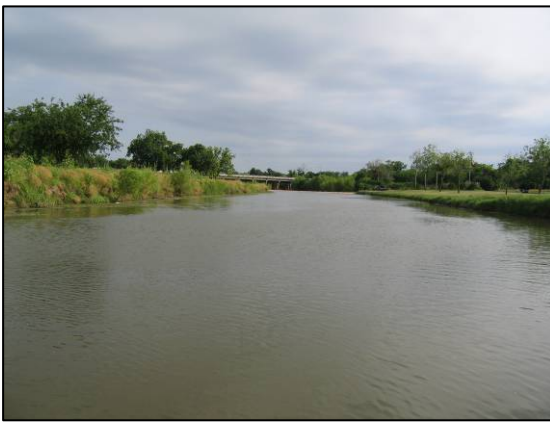
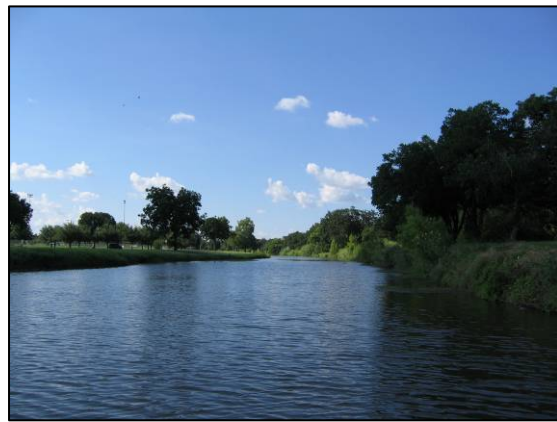
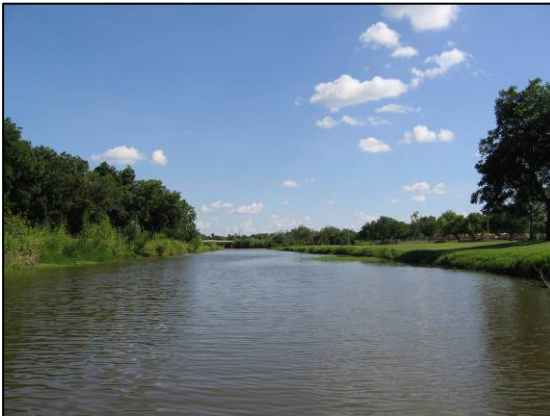
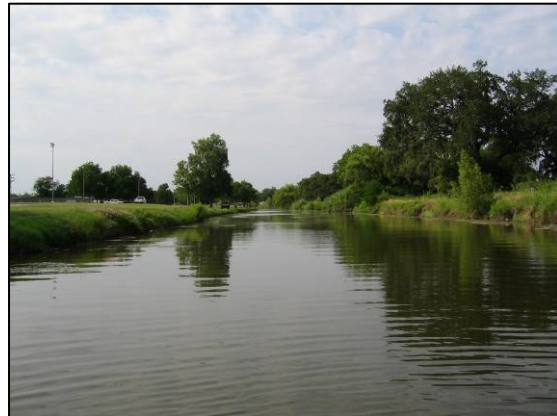
**Photogroup 5-6**

Atascosa River Site AR3\_02 depicting water color and vegetation on the surface. [\[Return to Text\]](#)

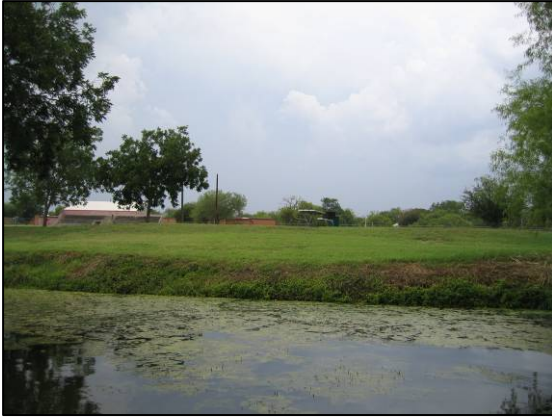
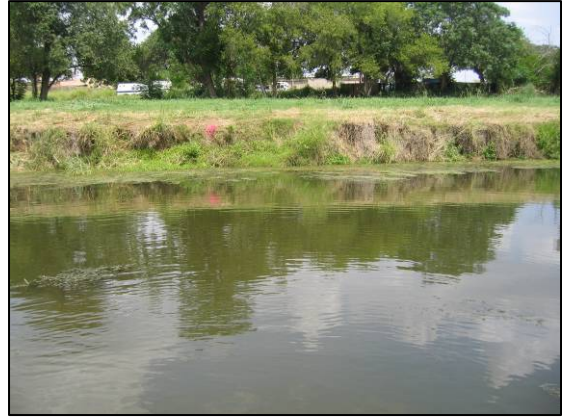
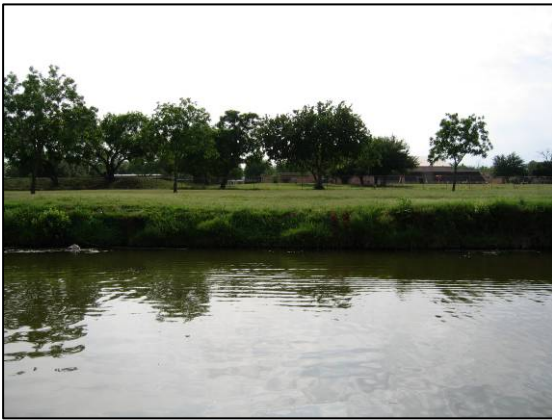
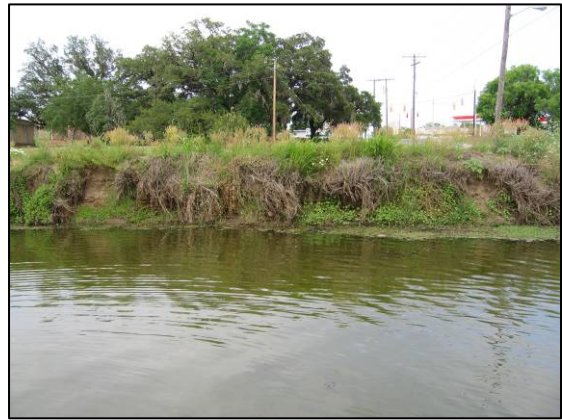
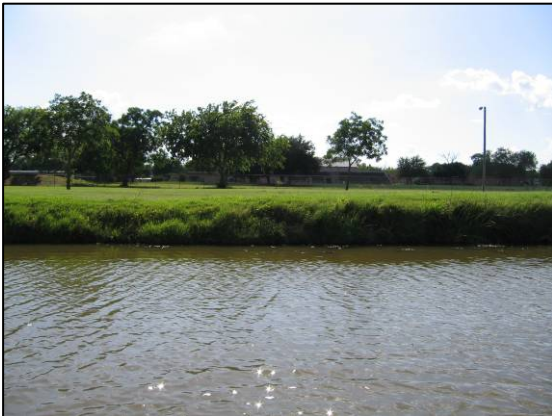
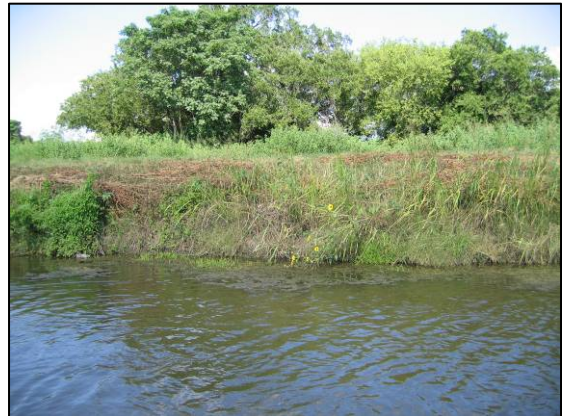
**Photogroup 5-7**

Atascosa River Site AR3\_03 depicting sign of park rules sign, access crossing and general appearance. [\[Return to Text\]](#)

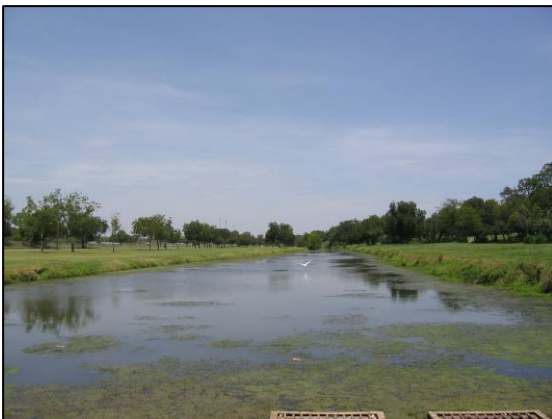
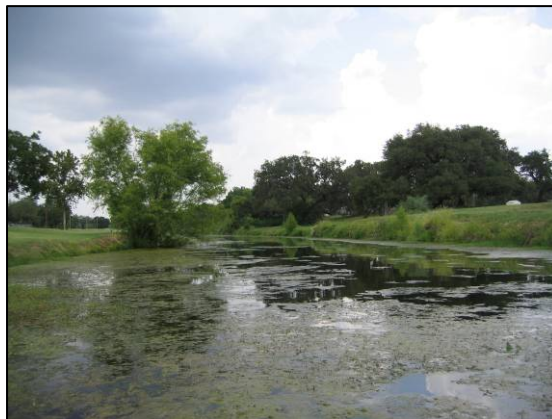
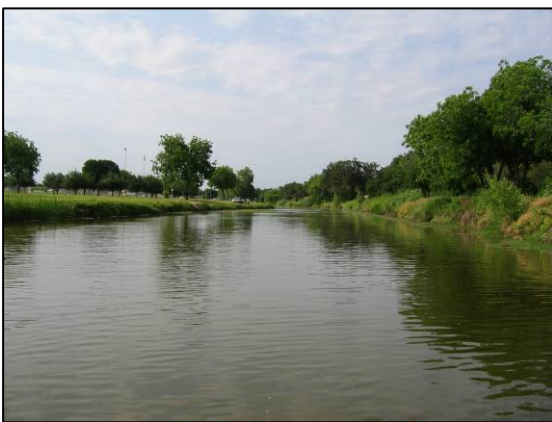
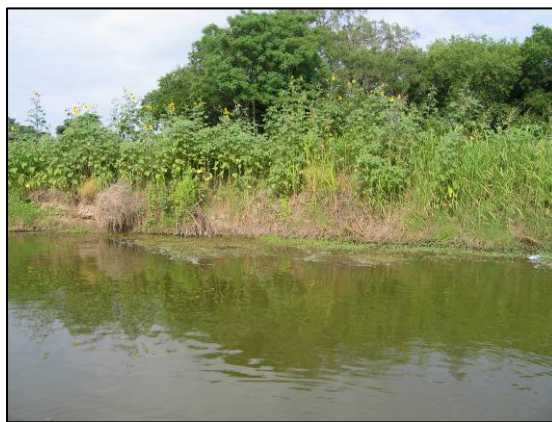
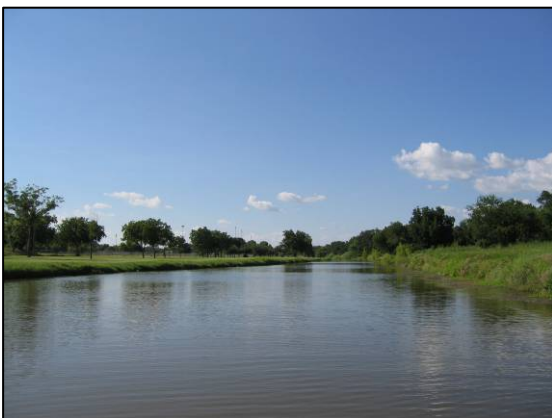
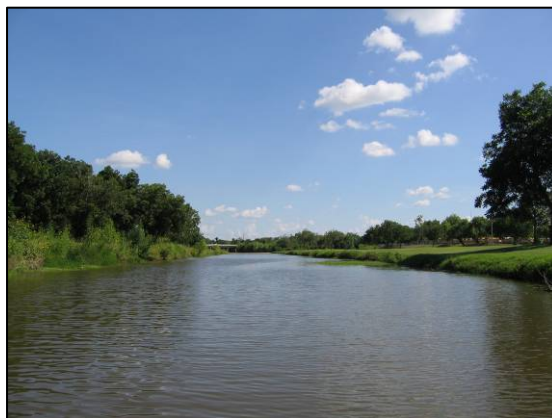
**Photogroup 5-8**

Atascosa River Site AR3\_03 depicting typical banks along the right and left sides of the river. [\[Return to Text\]](#)

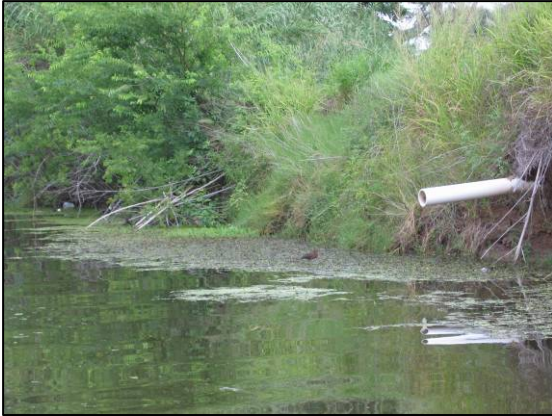
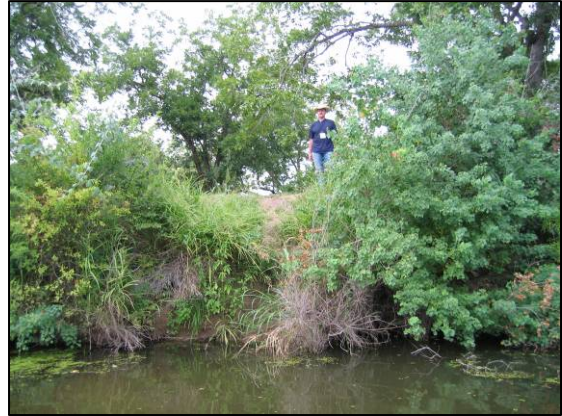
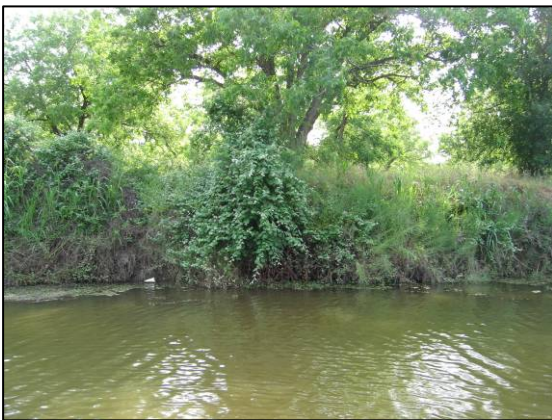
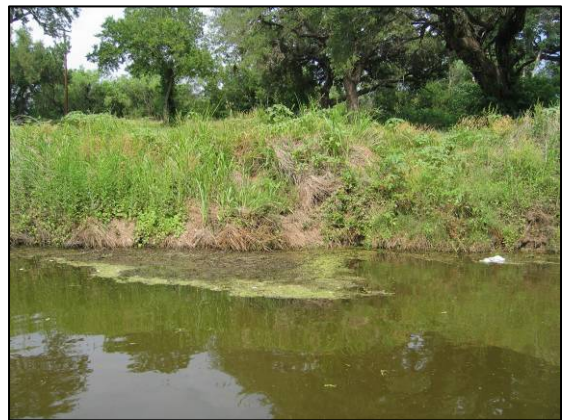
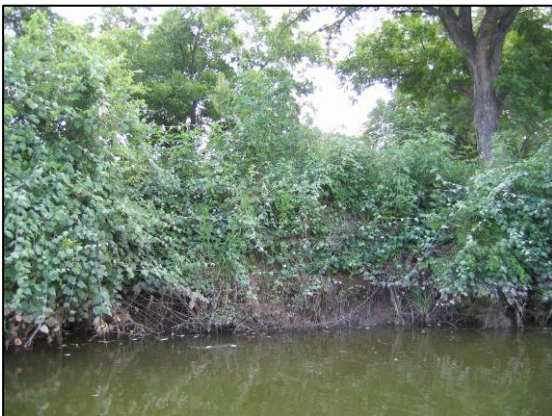
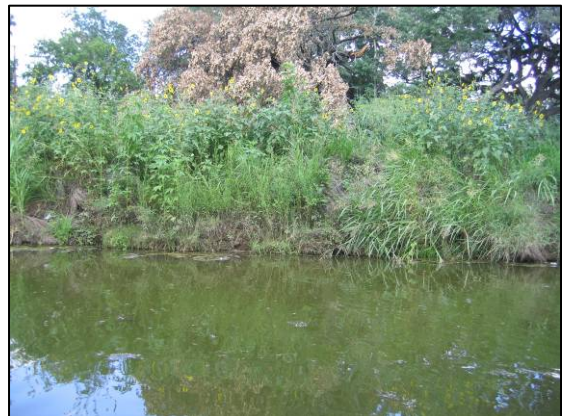
**Photogroup 5-10** Atascosa River Site AR3\_04 depicting the access and general appearance. (Individual in upper right photo was local resident sitting near river.) [\[Return to Text\]](#)

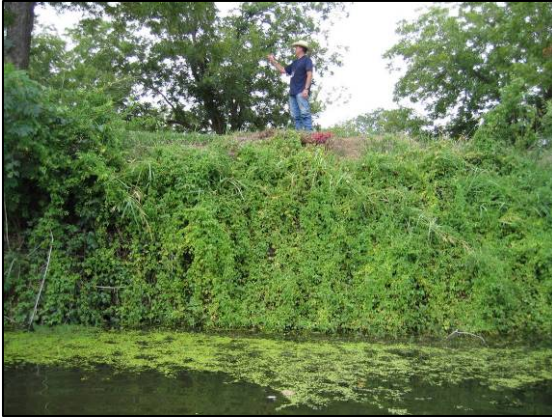
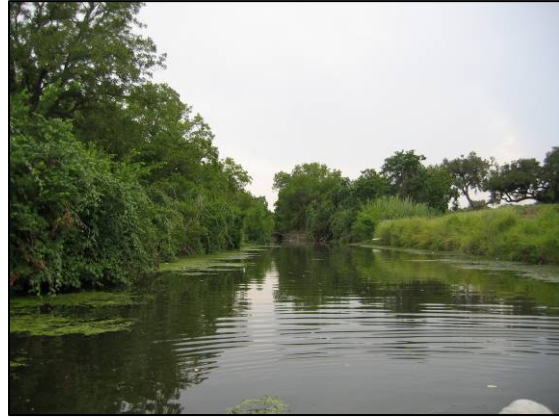
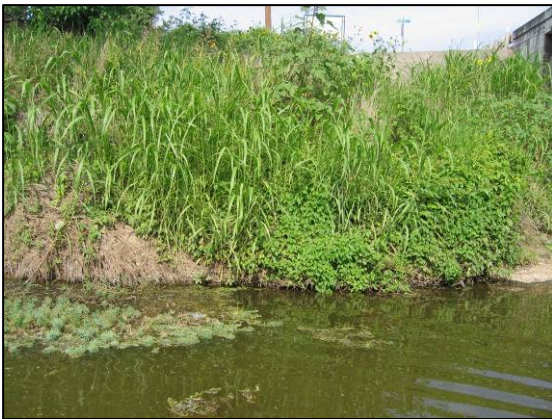
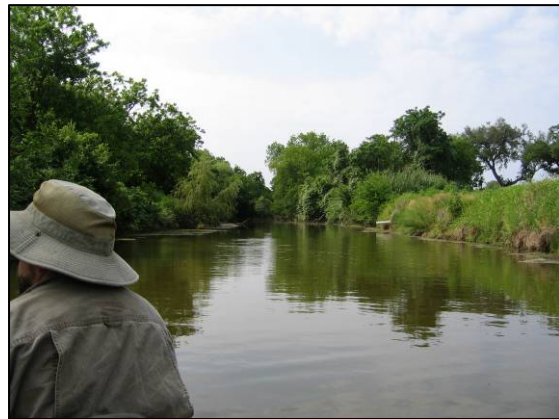
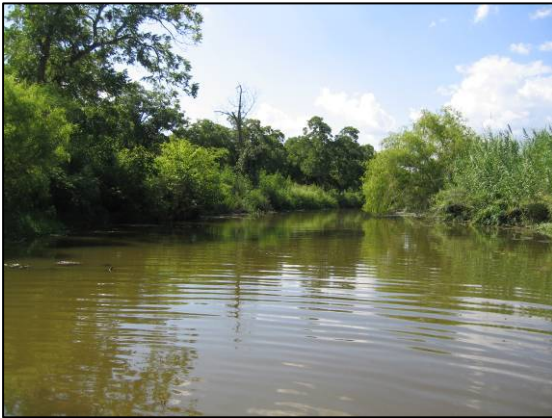
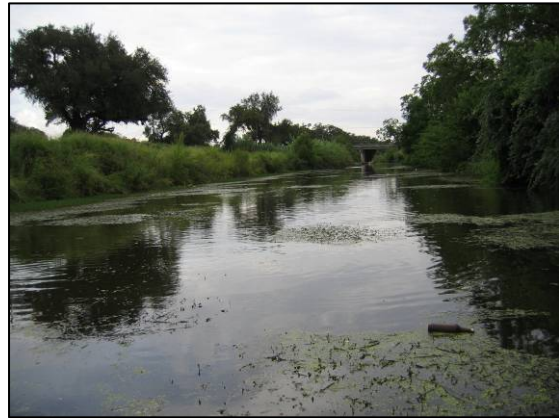
**Photogroup 5-11** Atascosa River Site AR3\_04 depicting typical banks along the right and left sides of the river. (Individual in upper right photo is field staff.) [\[Return to Text\]](#)

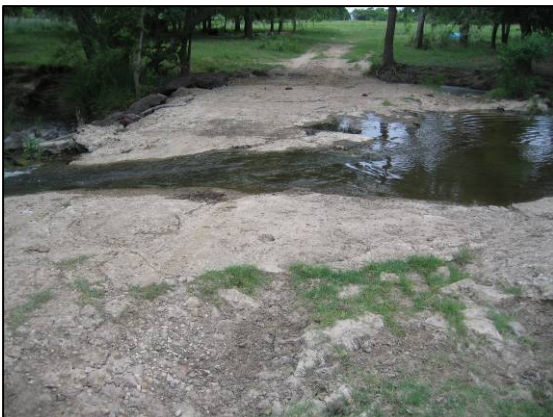
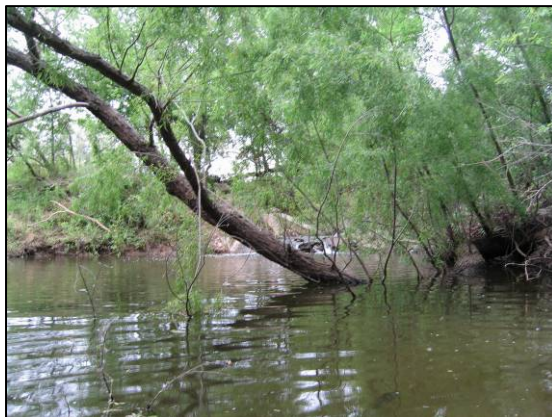
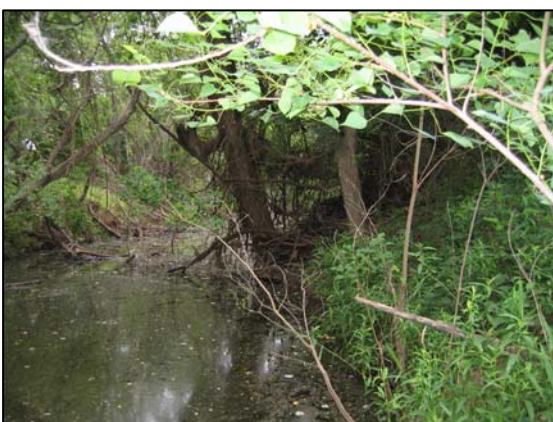
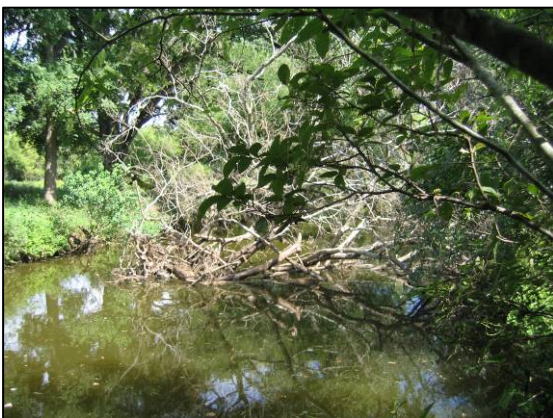
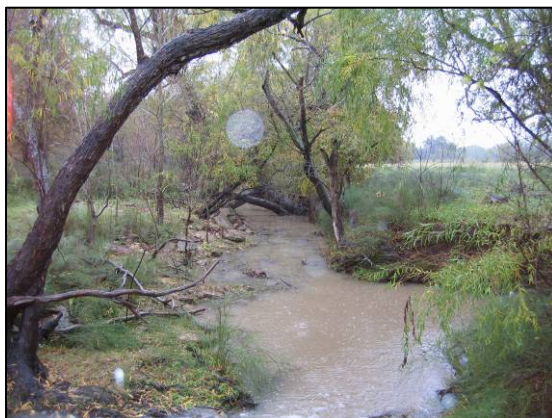
**Photogroup 5-12** Atascosa River Site AR3\_04 depicting dense vegetation on water surface and water color. (All individuals pictured are field staff.)  
[\[Return to Text\]](#)

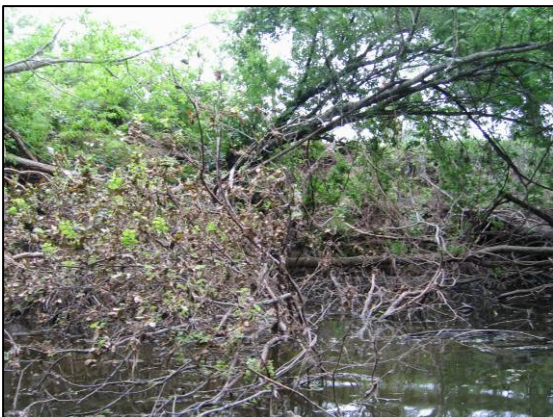
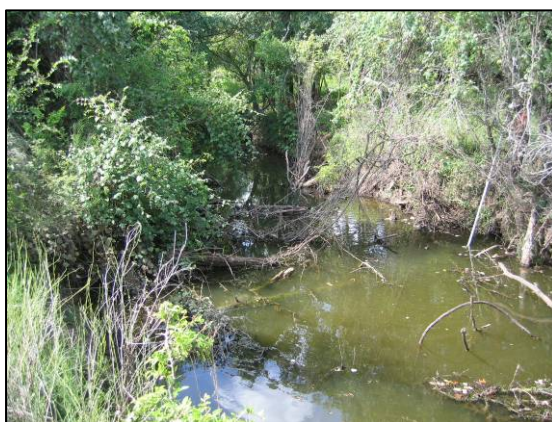
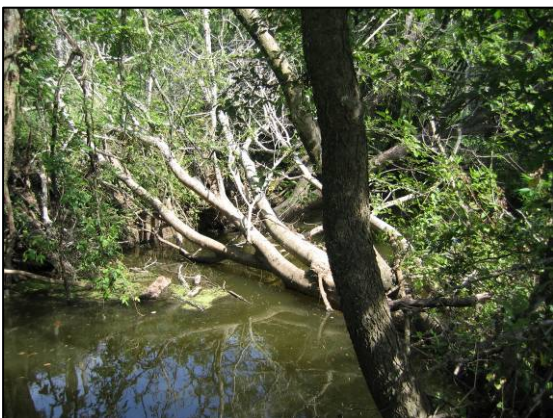
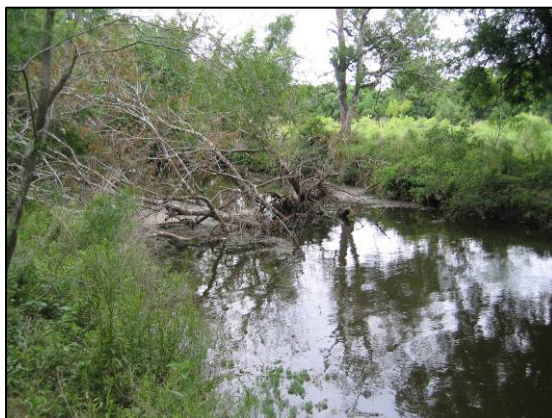
**Photogroup 5-13** Atascosa River Site AR3\_05 depicting access and general appearance of river. [[Return to Text](#)]

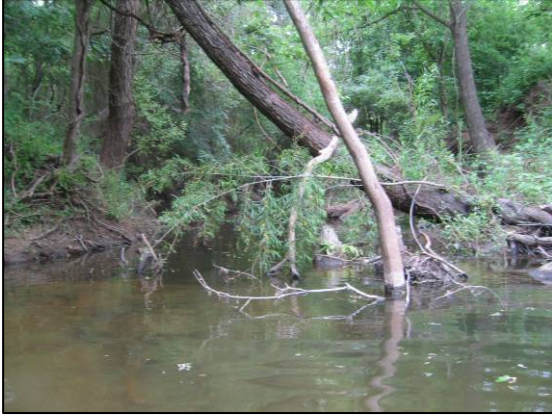
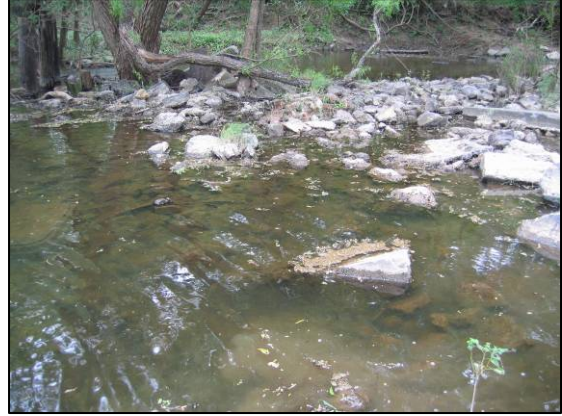
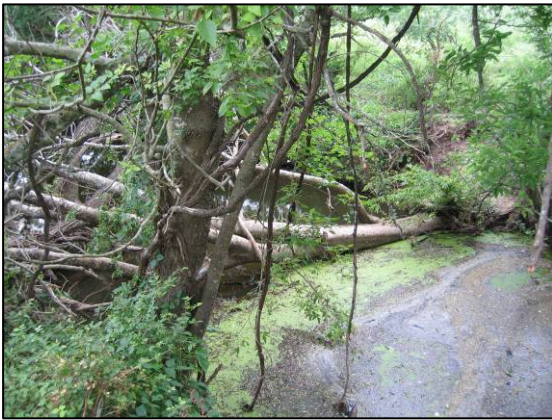
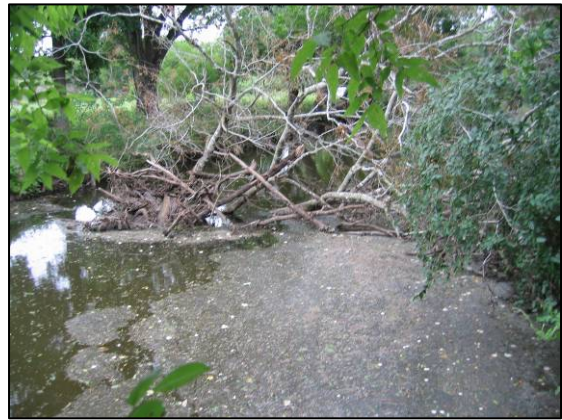
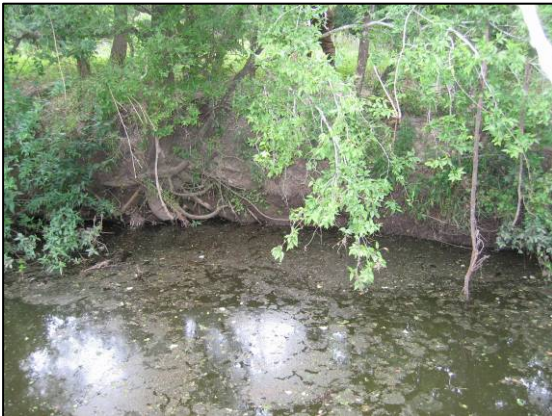
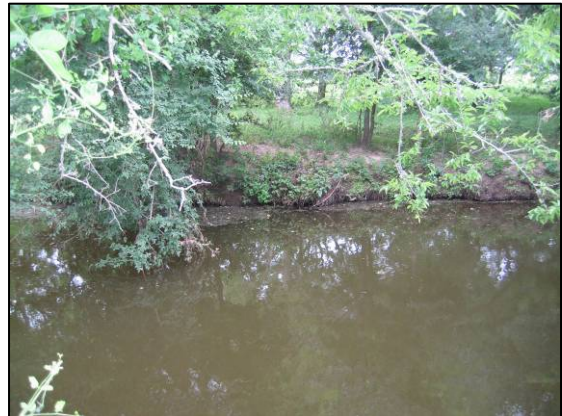
**Photogroup 5-14** Atascosa River Site AR3\_05 depicting obstructions encountered along river. [\[Return to Text\]](#)
