# Atascosa River Recreational Use-Attainability Analyses

Report to TMDL Program  
Texas Commission on Environmental Quality  
Project and Work Order Number  
582-6-70859-26

Tim Jones  
Jeff Stroebel  
Larry Hauck  
Texas Institute for Applied Environmental Research  
Tarleton State University  
Stephenville, Texas

December 2010

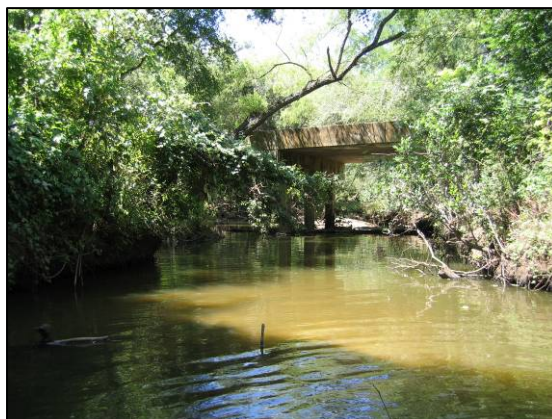
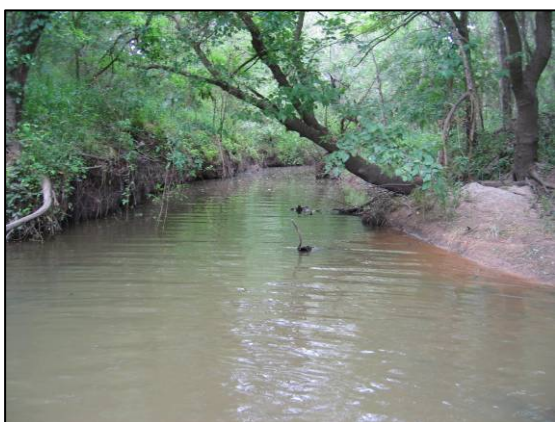
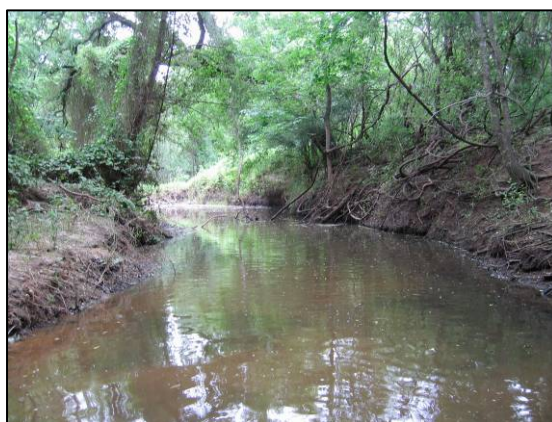
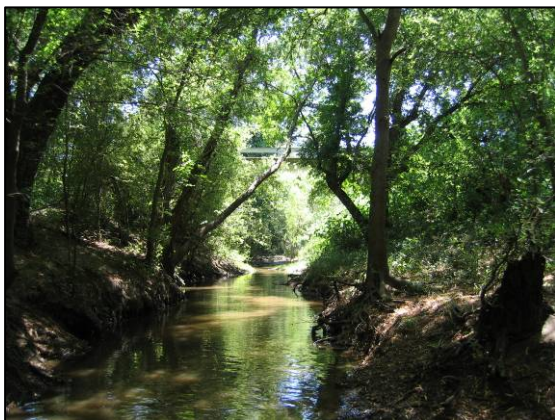
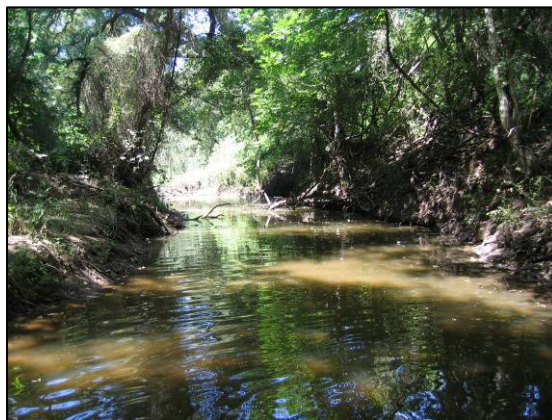
**Photogroup 5-15** Atascosa River Site AR3\_05 depicting water color and clarity of the surface. [\[Return to Text\]](#)

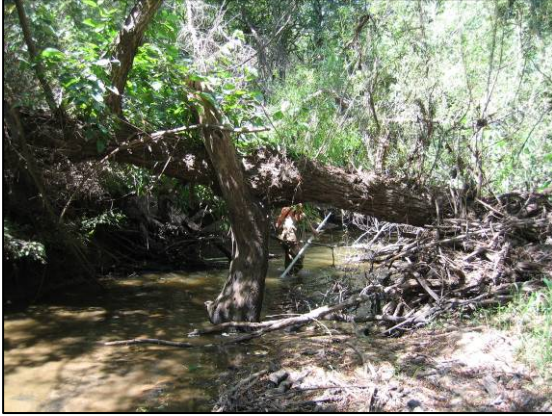
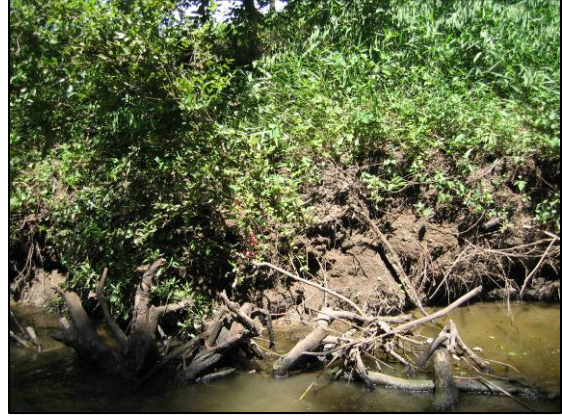
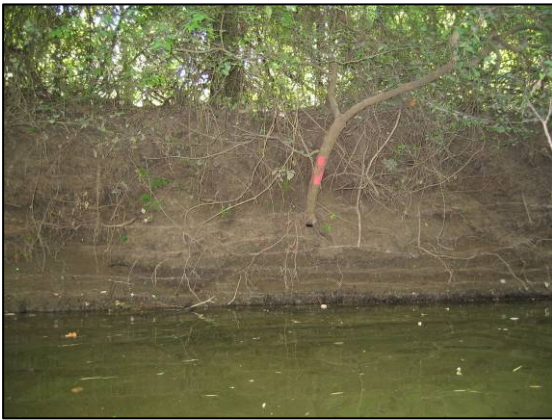
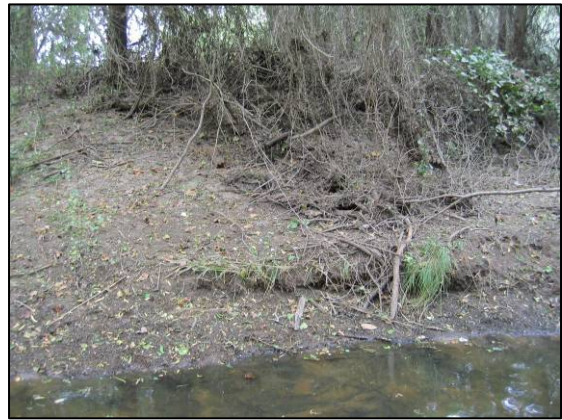
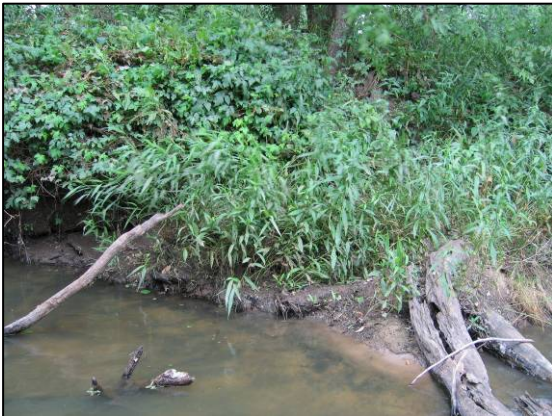
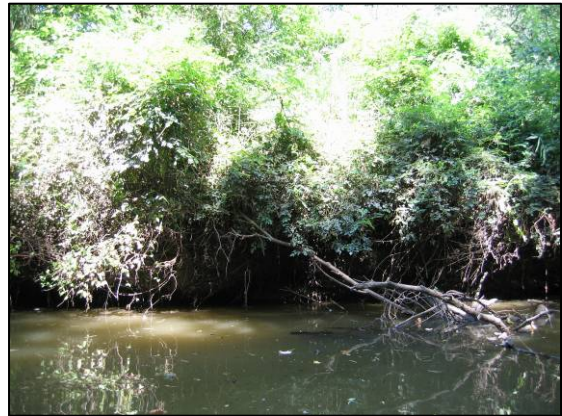
**Photogroup 5-16** Atascosa River Site AR3\_06 depicting the general appearance of the river. [\[Return to Text\]](#)

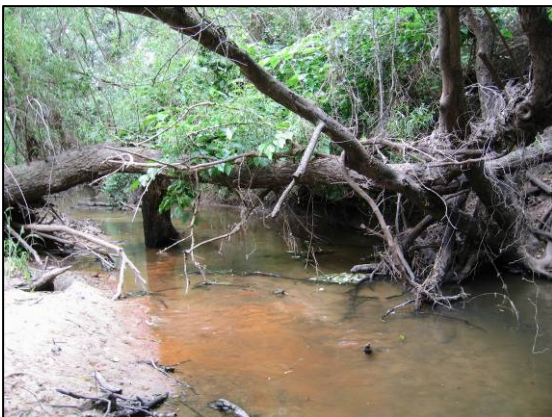
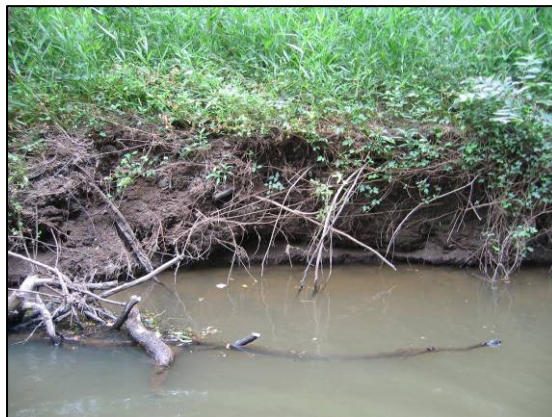
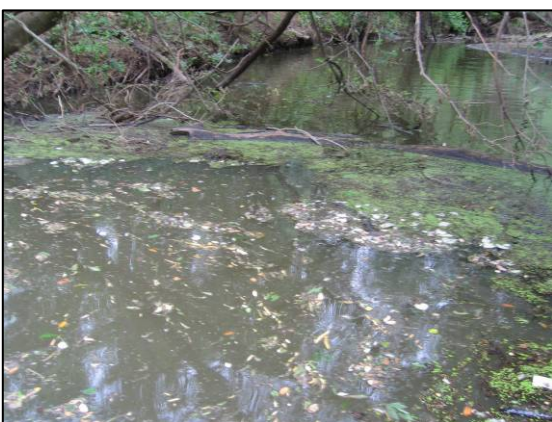
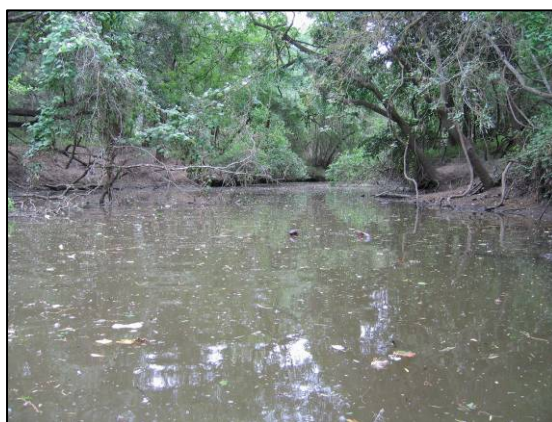
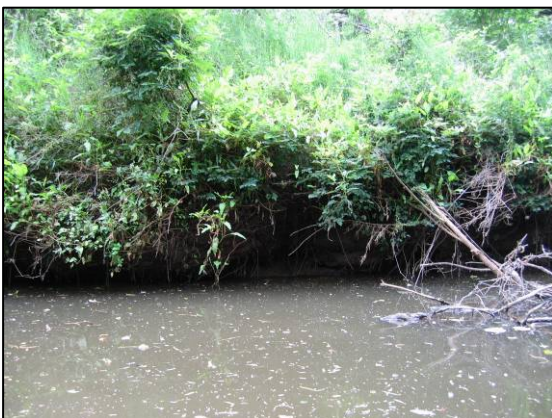
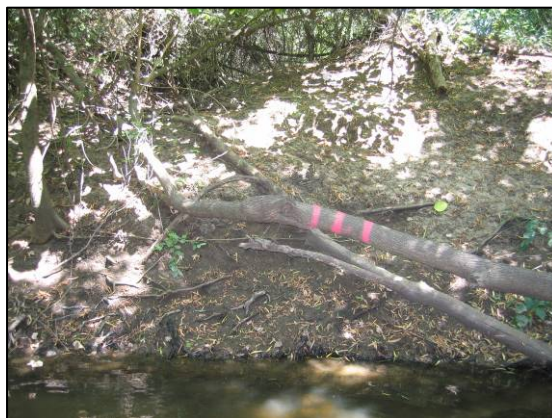
**Photogroup 5-17** Atascosa River Site AR3\_06 depicting the obstruction and some of the immediate riparian zone in the reach. (Individual in upper left photo is field staff.) [[Return to Text](#)]

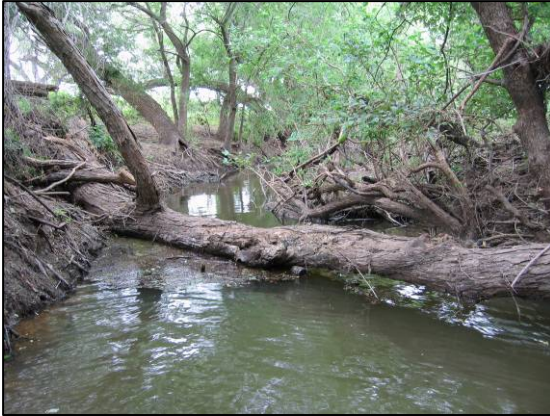
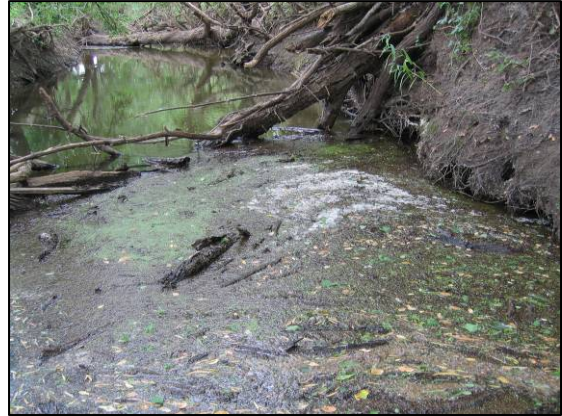
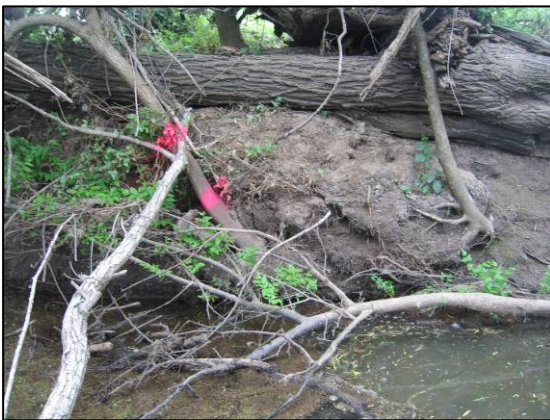
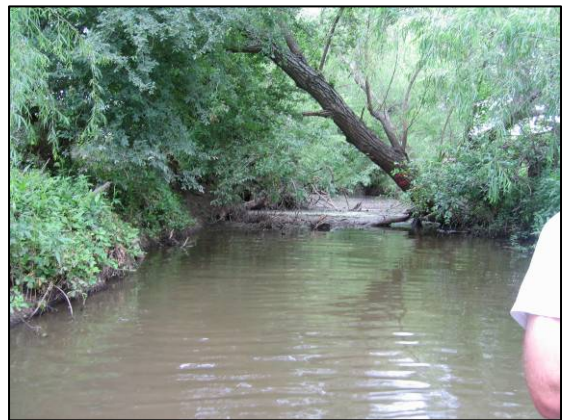
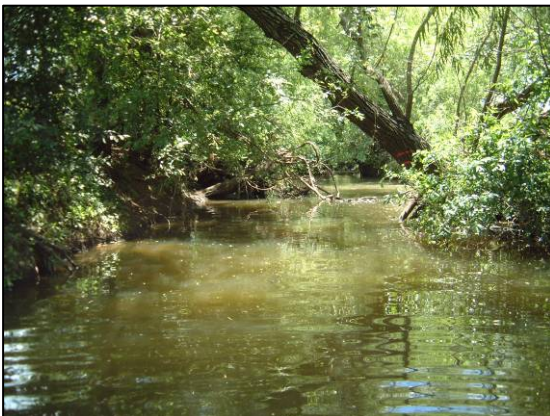
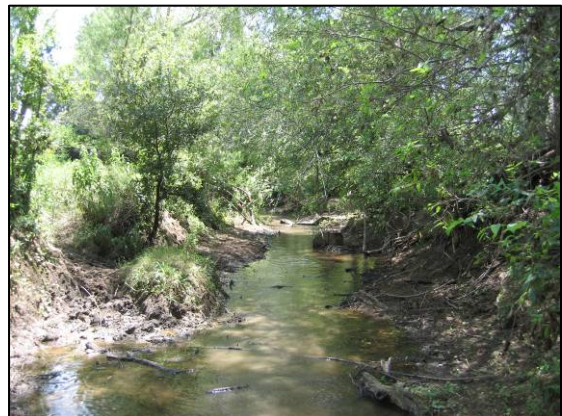
**Photogroup 5-21**

Atascosa River Site AR3\_07 depicting stream color and surface clarity. (Arm in center right photo belongs to field staff.) [[Return to Text](#)]

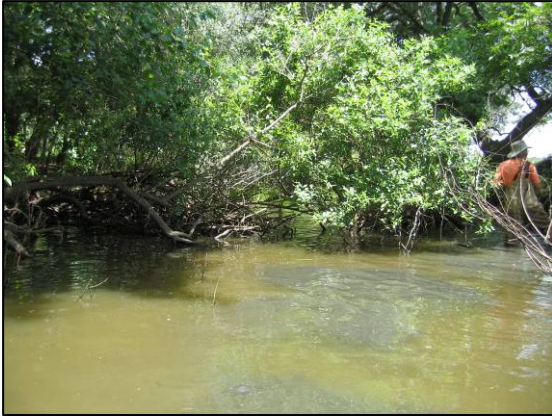
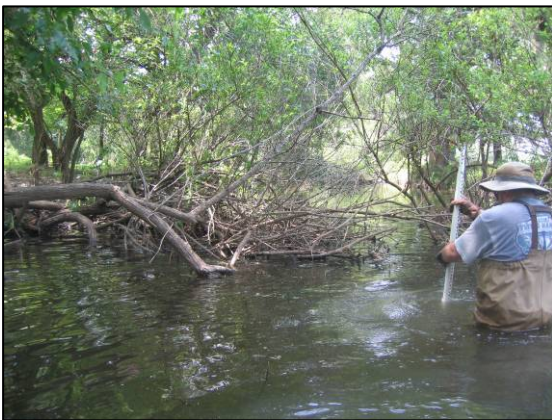
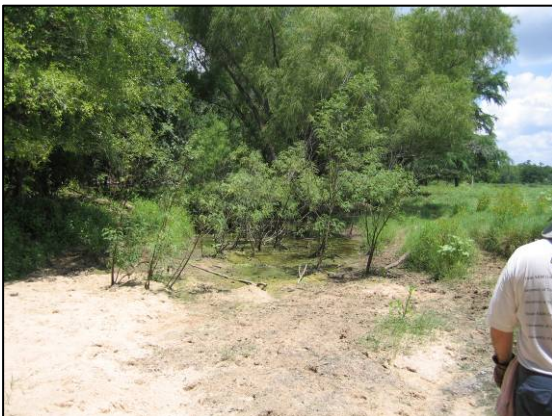
**Photogroup 5-29**

Atascosa River Site AR3\_10 depicting some of the wading, obstructions encountered, and portions of the dry streambed observed in June 2010. (All individuals pictured are field staff.)

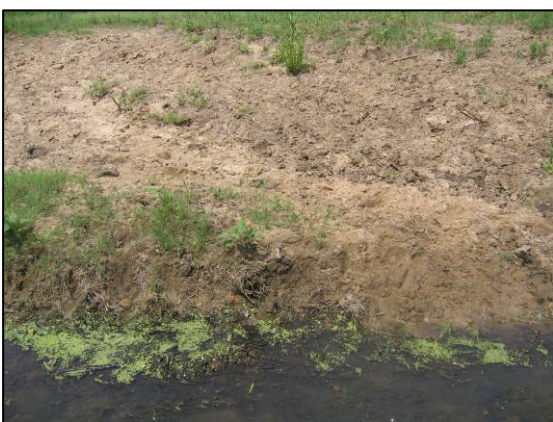
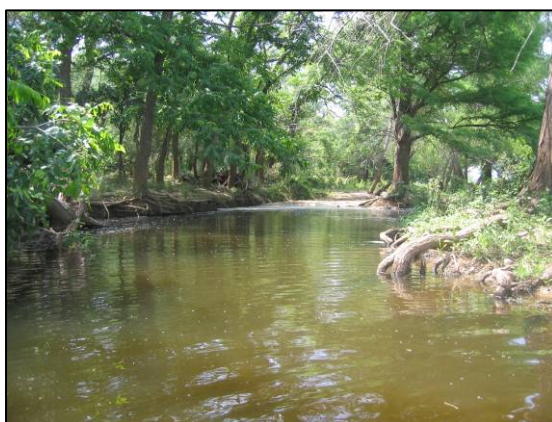
**Photogroup 5-30** Atascosa River Site AR3\_10 depicting the water color and surface clarity. [[Return to Text](#)]

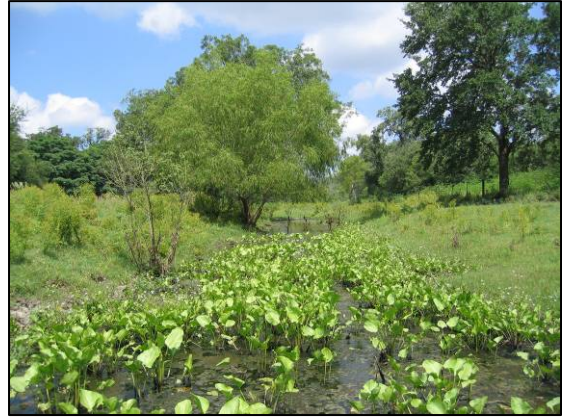
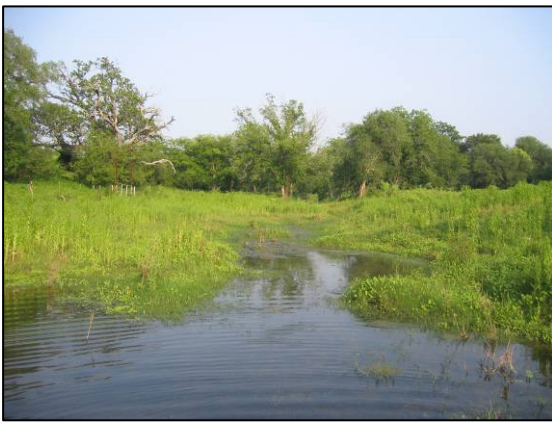
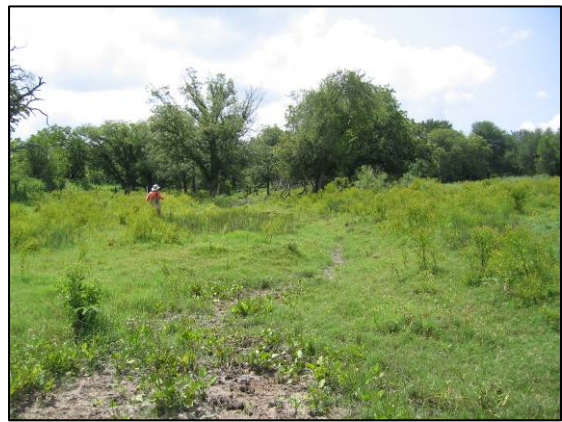
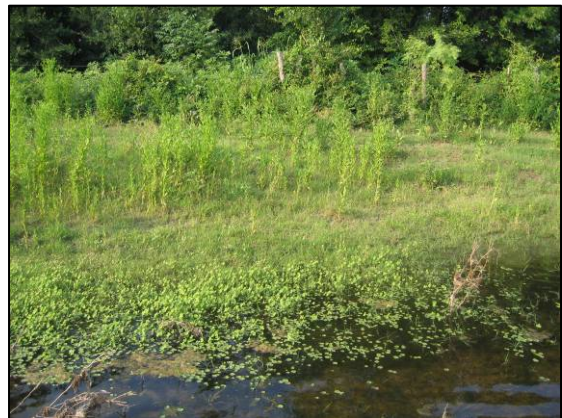
**Photogroup 5-32** Atascosa River Site AR3\_11 with photograph pairs contrasting stream conditions for the May and June 2010 surveys. (Individual in center right photo is field staff.) [\[Return to Text\]](#)

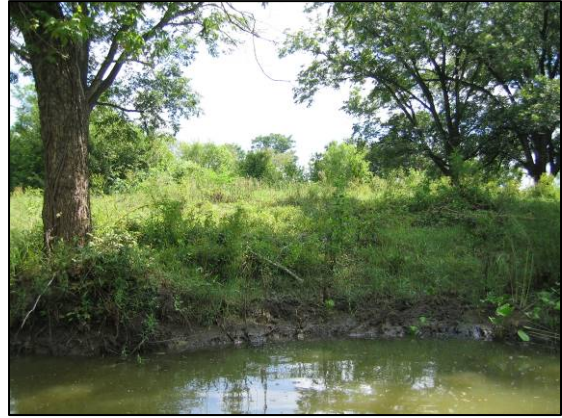
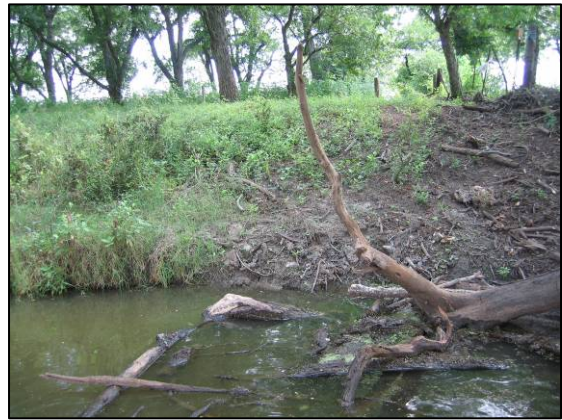
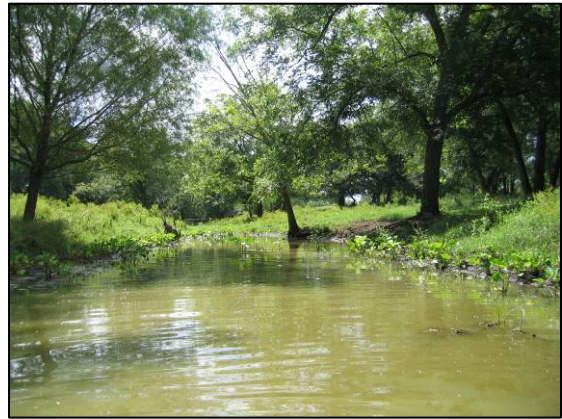
**Photogroup 5-33**

Atascosa River Site AR3\_11 with photograph pairs contrasting the water color and surface clarity from May to June surveys. [[Return to Text](#)]

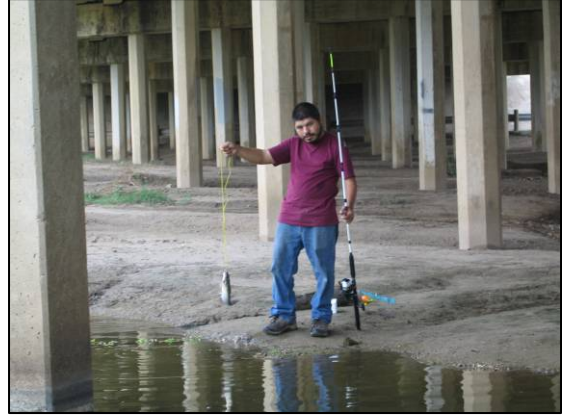
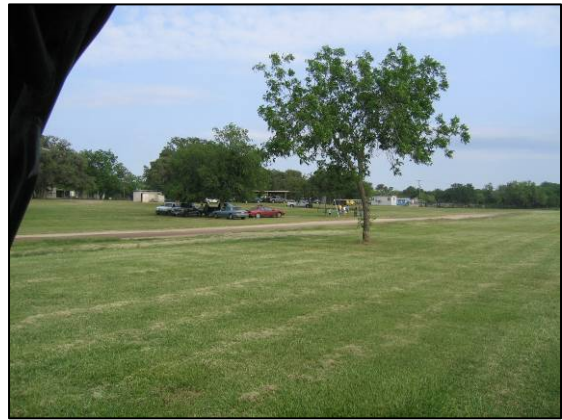
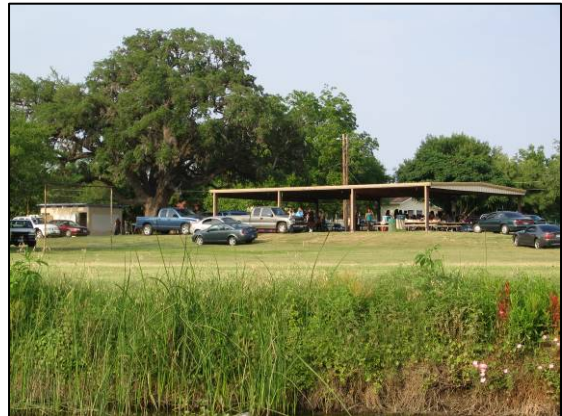
**Photogroup 5-34** Atascosa River Site AR3\_03 illustrating some of the activities observed at the site. (Individuals pictured are local residents in park) (Lower left photo – field staff performing interview.) [[Return to Text](#)]

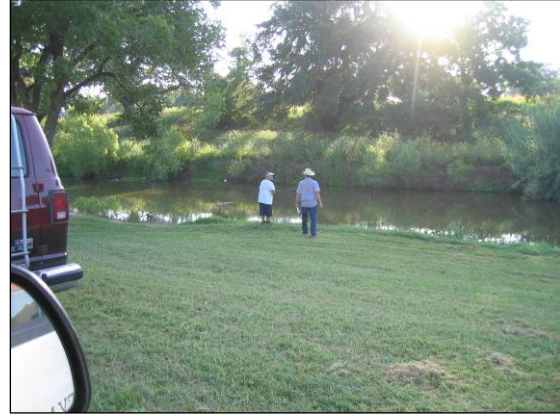
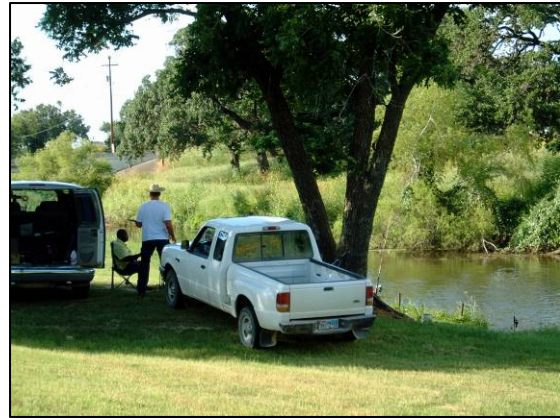
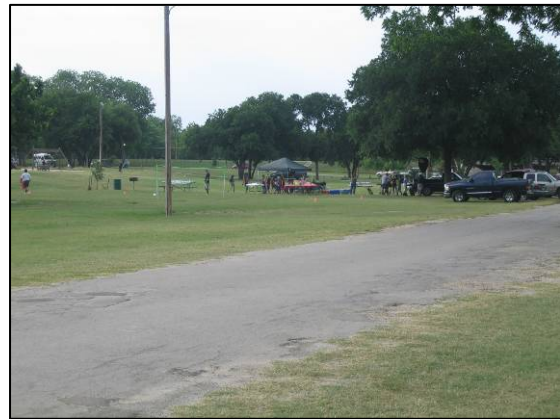
**Photogroup 5-35**

Atascosa River Site AR3\_03 illustrating some of the activities observed at the site. (Field staff performing interviews and local citizens utilizing park.) [\[Return to Text\]](#)

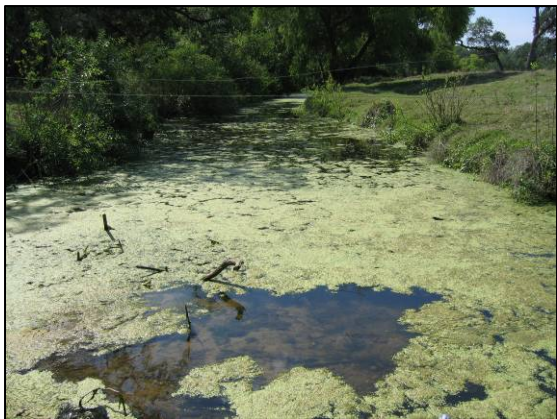
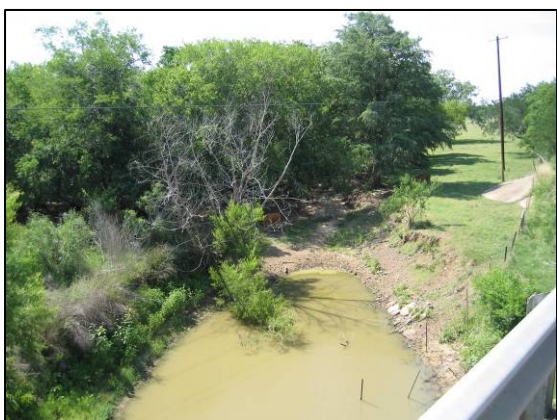
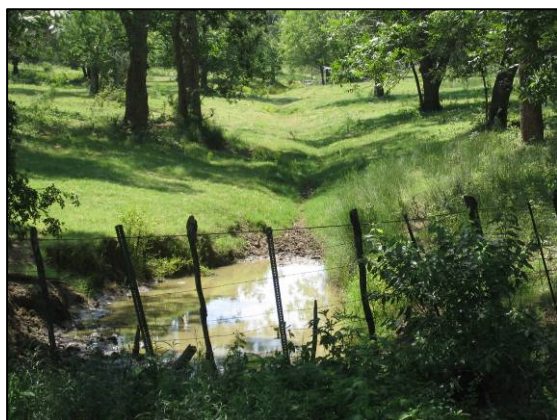
**Photogroup 5-37**

Atascosa River AU 2107\_03 depicting documented conditions observed on August 6, 2009. Upper: Site AR3\_08 - left upstream, right downstream. Middle: Site AR310 – left upstream, right downstream. Bottom: AR3\_11 - left upstream, right downstream. [[Return to Text](#)]

Flows were low at sites above Site AR3\_09 in May, and in June Sites AR3\_10 and AR3\_11 were not flowing at all. The remaining nine sites from AR3\_01 through AR3\_09 were still flowing as all these sites are downstream of either the Poteet WWTF discharge or the Pleasanton WWTF discharge. TIAER did not have a prior history at most of the sites above FM 476 other than scouting efforts that occurred at various times prior to this study. As mentioned above, prior visits (bacteria monitoring during 2006 – 2007) to the Atascosa River at FM 476 revealed times at which the stream was dry or not flowing. The river at SH 16 was observed several times in travels from Poteet to Jourdanton under a variety of flow regimes ranging from flooding to dry, except for the large pool below the dam. At Granato Road some level of flow was generally observed as flow as water exits large pool on the upstream side of the road. [Photogroup 5-37](#) illustrates some flow conditions observed on August 6, 2009.

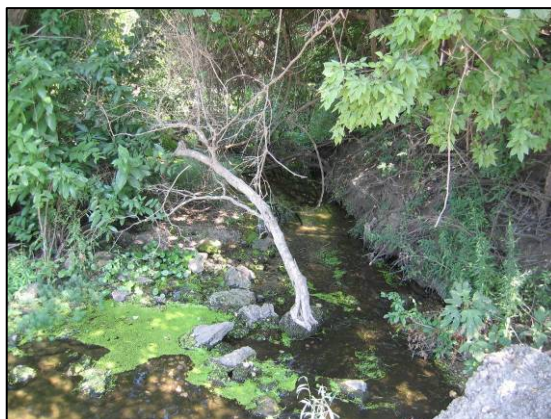
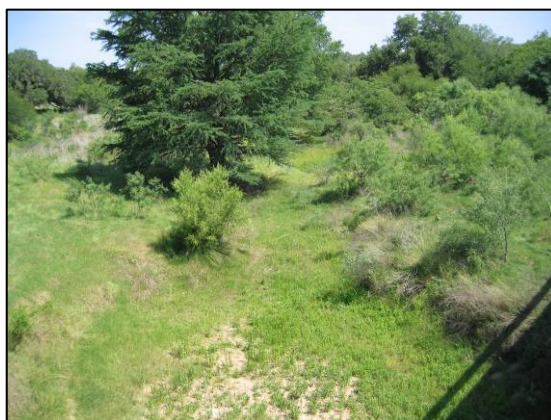
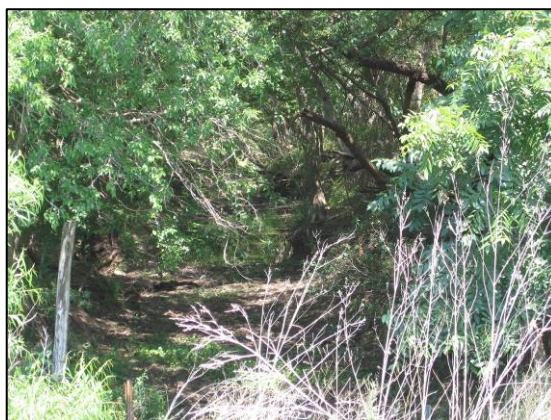
**Photogroup 5-36** Atascosa River Site AR3\_04 illustrating some of the activities and locals observed at the site. [[Return to Text](#)]

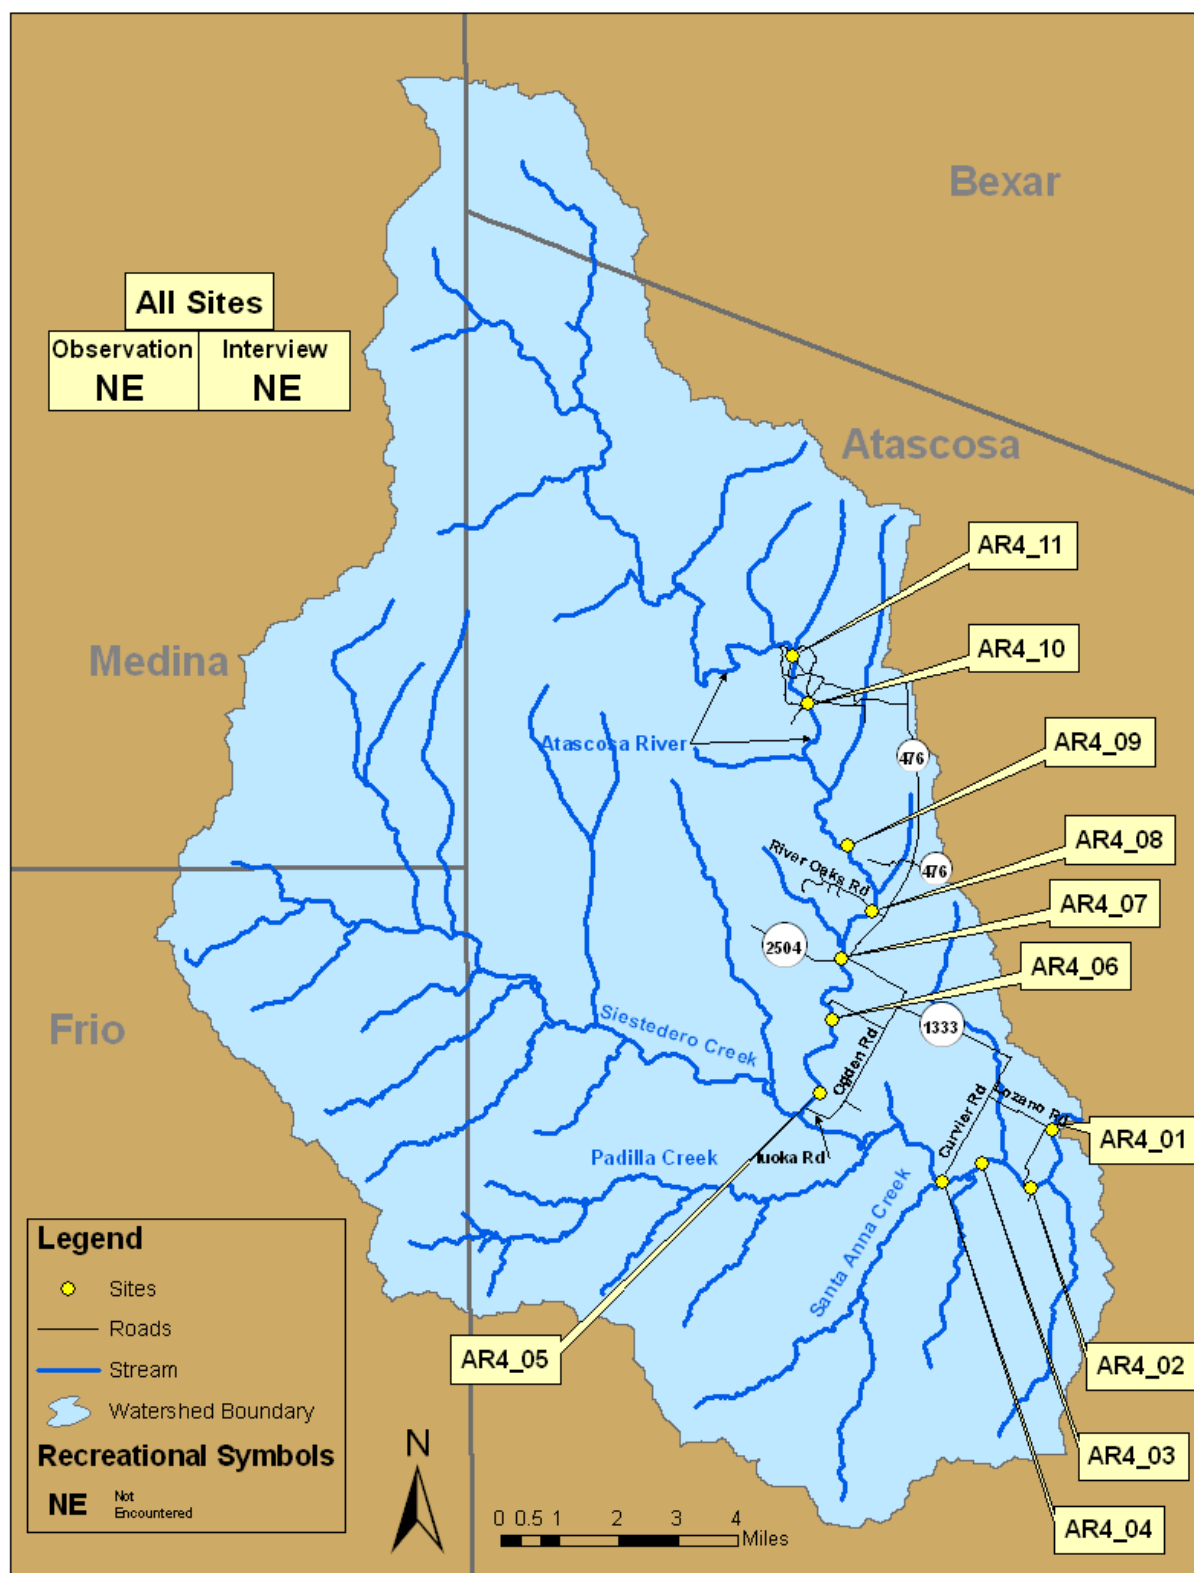
**Figure 6-2** Summary of observed and interviewed human activities in AU2107\_04

As observed in other assessment units of the Atascosa River, AU2107\_04 runs primarily through privately owned properties of substantial acreages. Public access is limited to the right-of-way at six road crossings, five of which were used for the survey. Fences, locked gates and distance from the road to the stream at 4 of the 11 sites surveyed limit access to the river in AU 2107\_04. No aquatic recreational activities were observed by TIAER field staff during the surveys. Similarly, none of the landowners interviewed shared any information to indicate that any form of contact recreation occurred on their property or within AU 2107\_04. One individual recollected that about 100 years ago her mother or other relatives would swim and play in the river but in her 76 years on the property that had not happened. A summary of the observed and interviewed activities, or lack thereof, is provided in Figure 6-2.

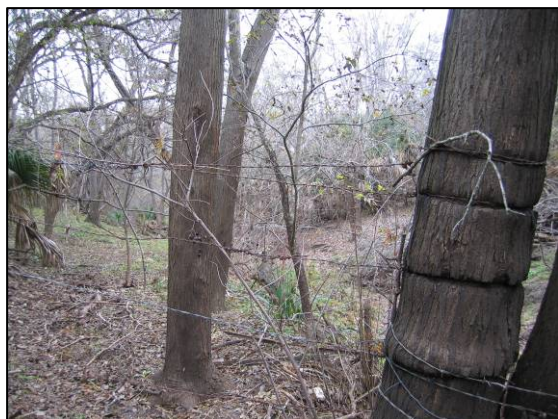
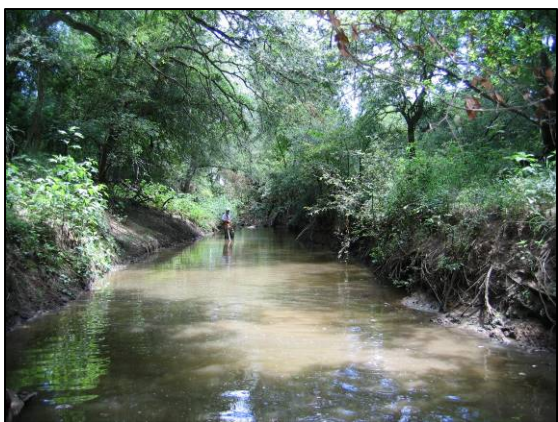
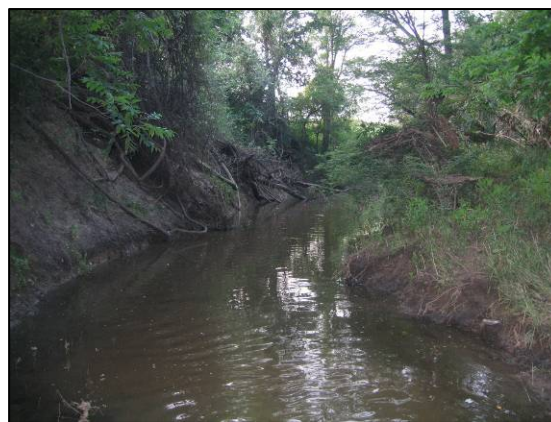
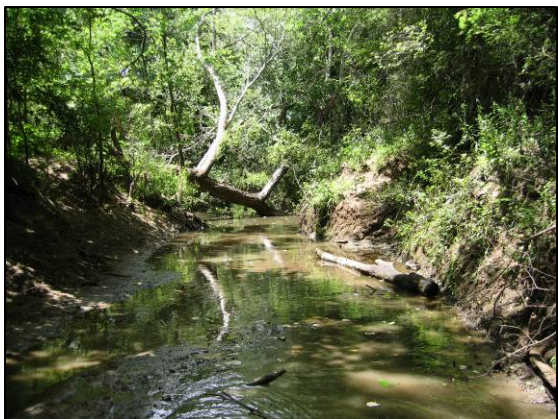
**Photogroup 6-1**

Atascosa River Site AR4\_01 depicting access to and the general appearance of the river. [\[Return to Text\]](#)

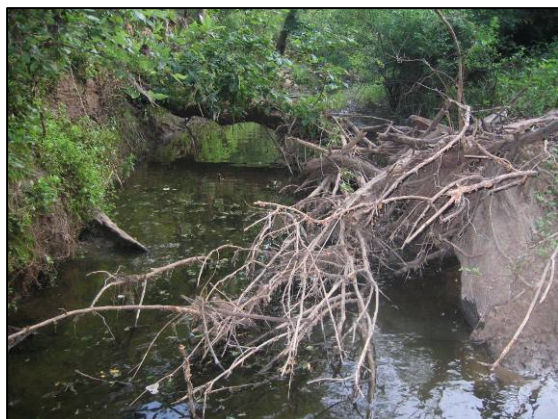
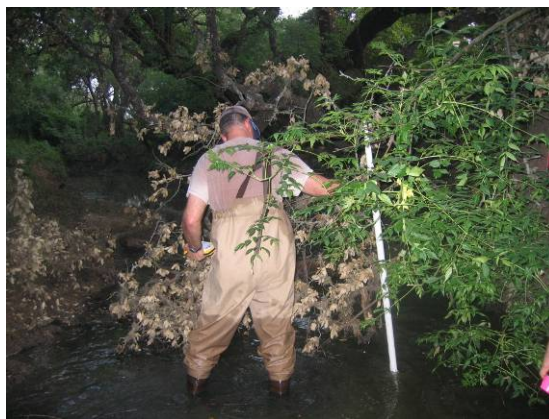
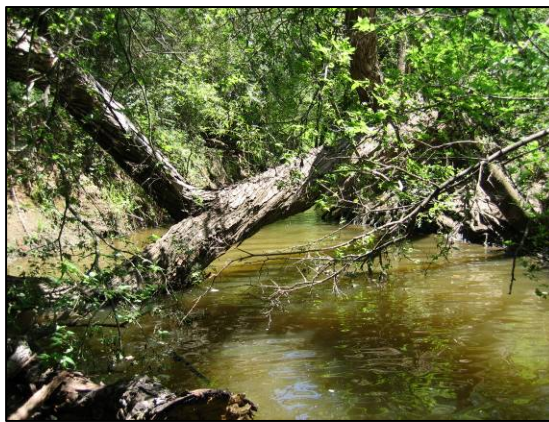
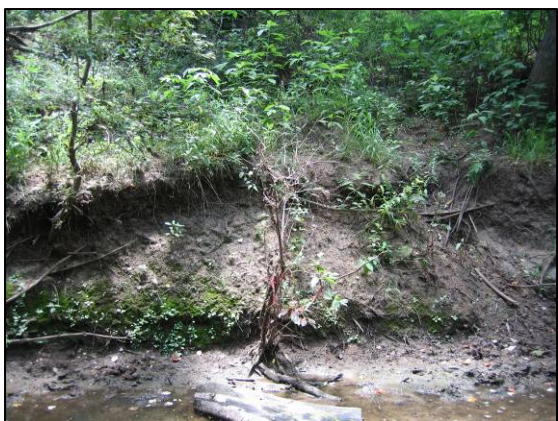
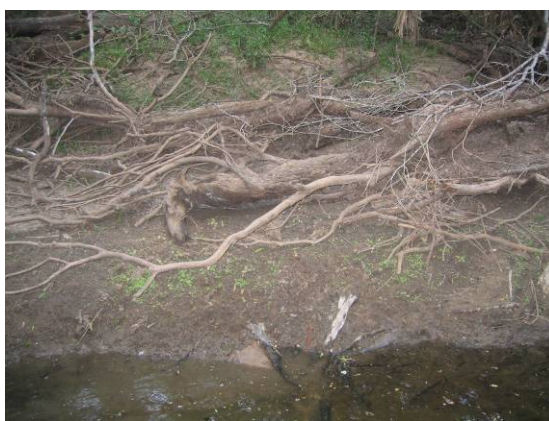
**Photogroup 6-2**

Atascosa River Site AR4\_01 depicting obstructions and bank access. (Individual in upper right photo is field staff). [\[Return to Text\]](#)

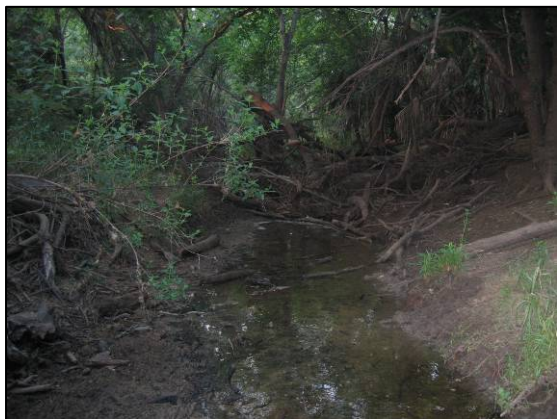
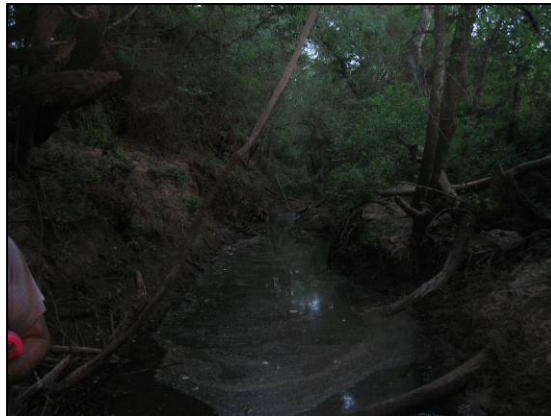
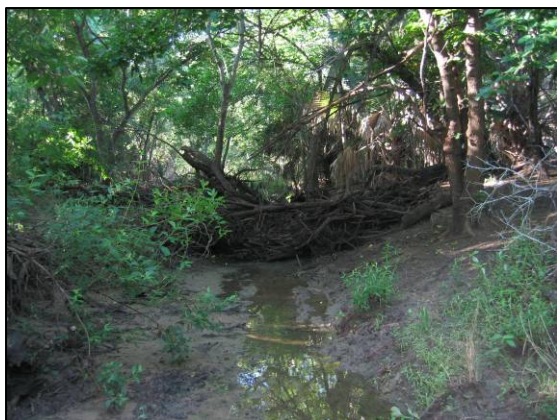
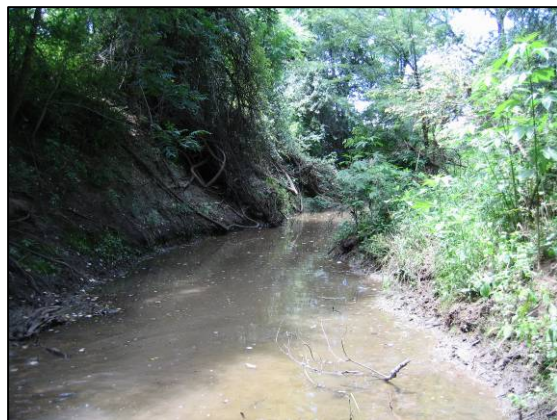
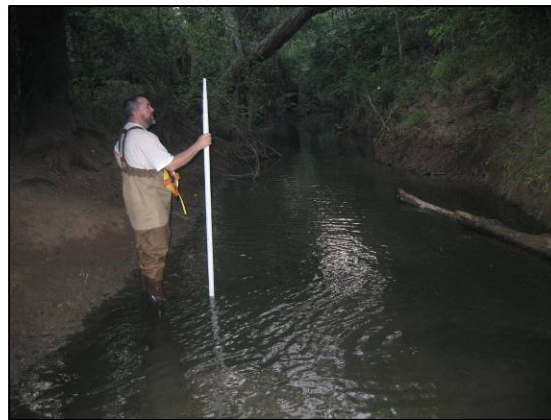
**Photogroup 6-3**

Atascosa River Site AR4\_01 showing water color and clarity of the surface. (Individual in lower right photo is field staff.) [\[Return to Text\]](#)

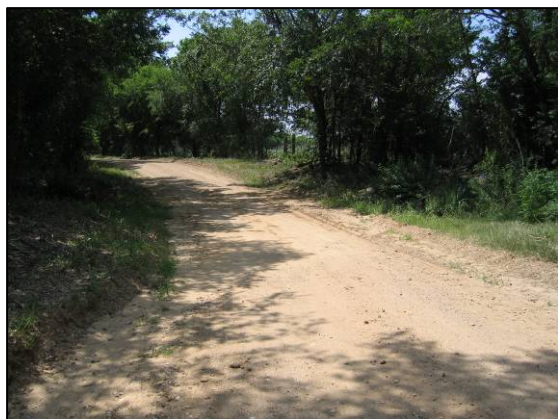
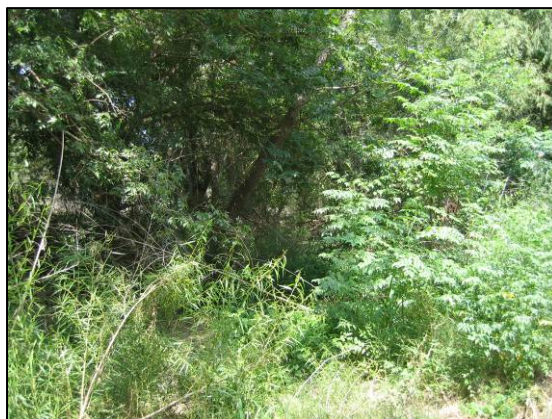
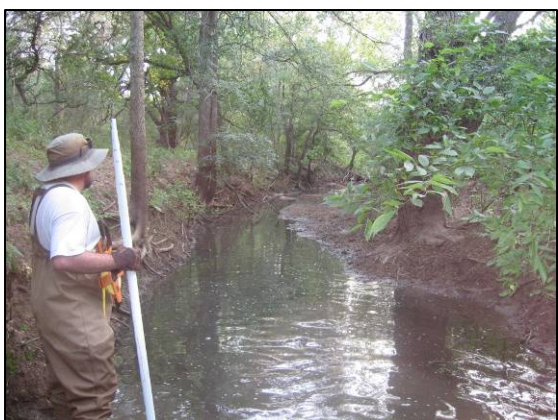
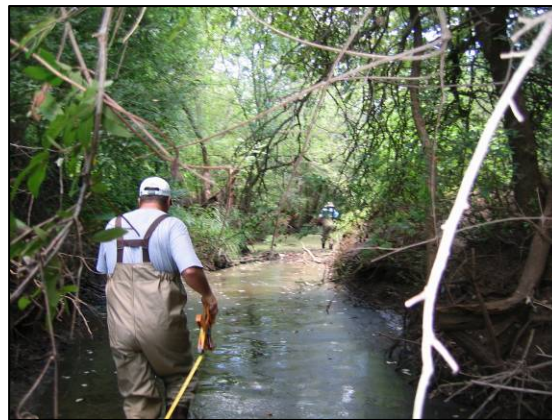
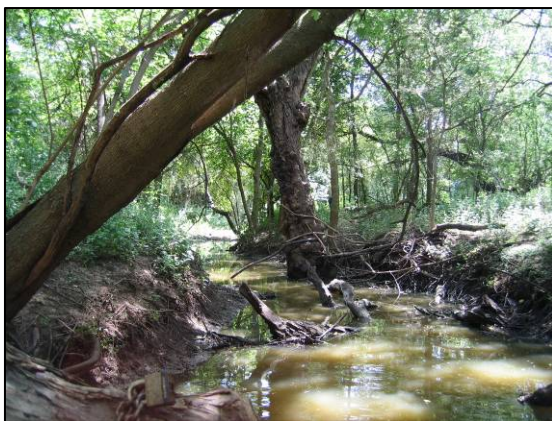
**Photogroup 6-4**

Atascosa River Site AR4\_02 depicting the road access and general appearance of the river. (All individuals pictured are field staff.) [\[Return to Text\]](#)

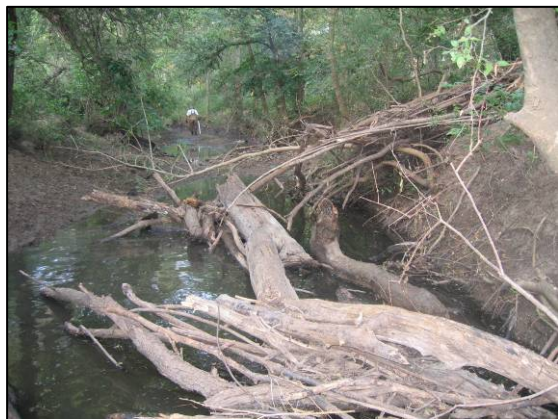
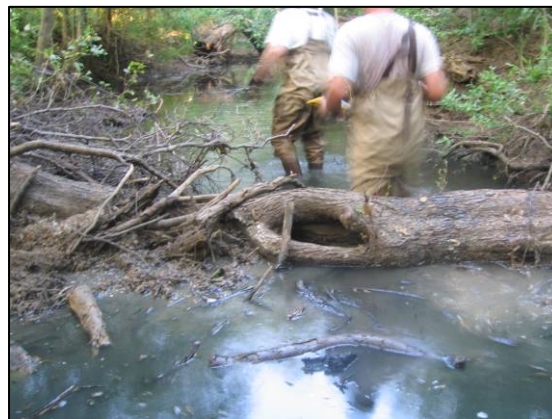
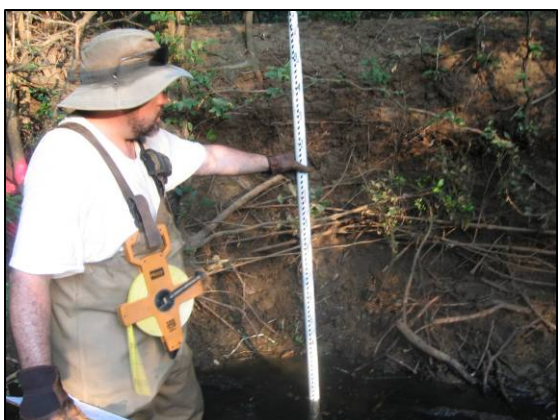
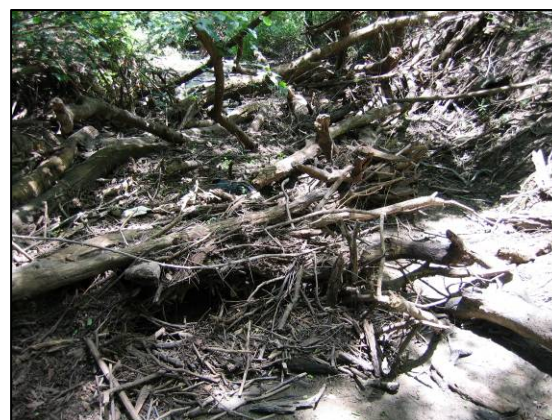
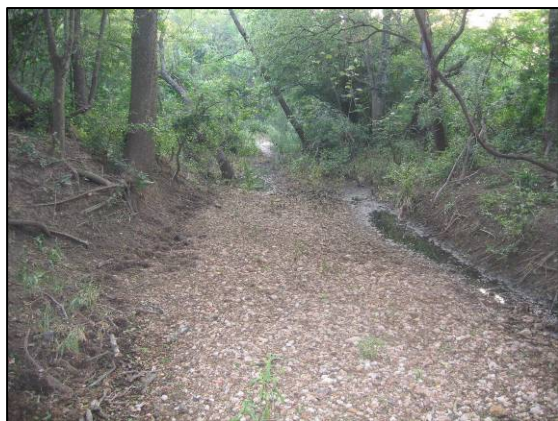
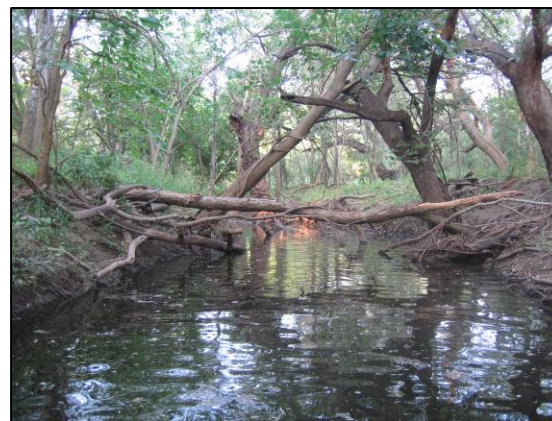
**Photogroup 6-5**

Atascosa River Site AR4\_02 depicts obstructions, bank access and dry bed with no flow. (All individuals pictured are field staff.) [\[Return to Text\]](#)

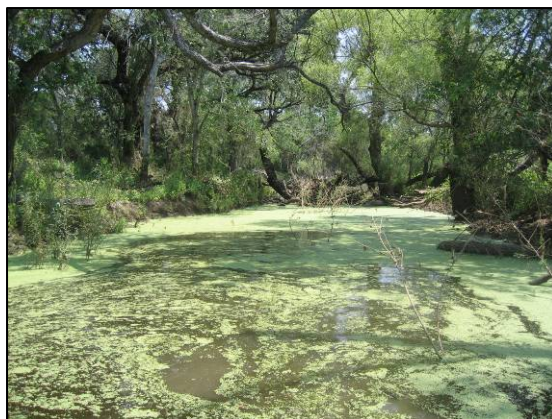
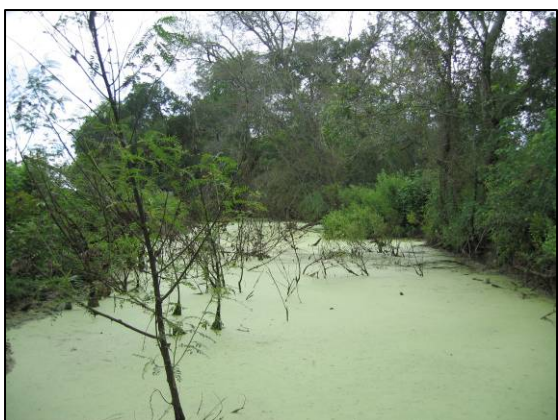
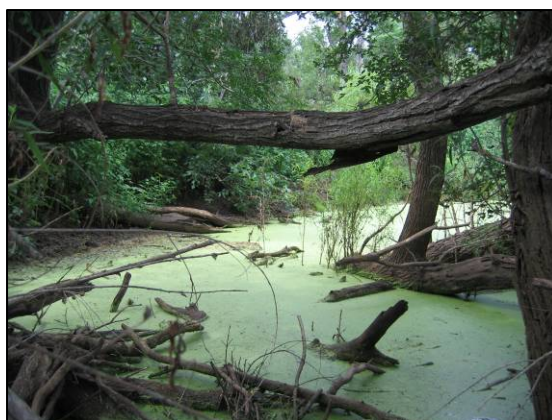
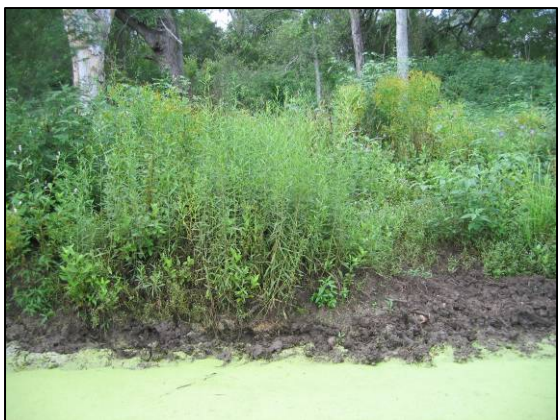
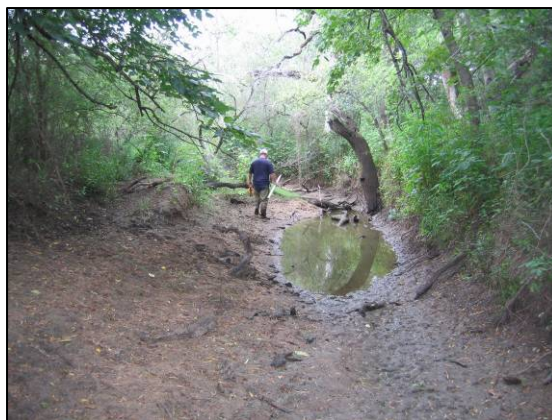
**Photogroup 6-6**

Atascosa River Site AR4\_02 depicting water color, aquatic vegetation and surface film. (Individual in center right photo is field staff.) [\[Return to Text\]](#)

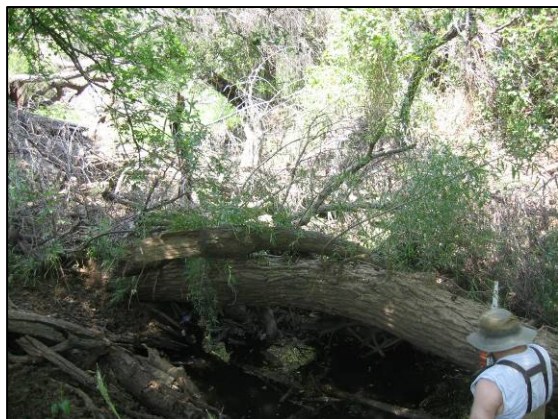
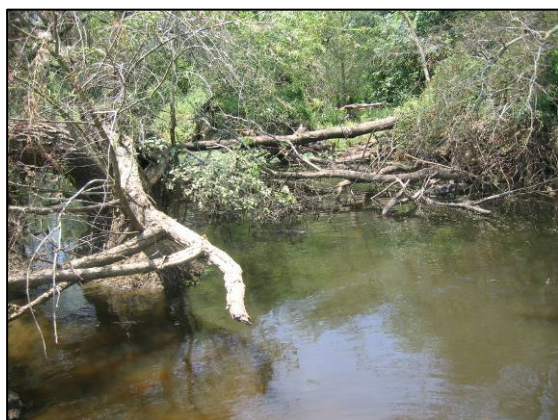
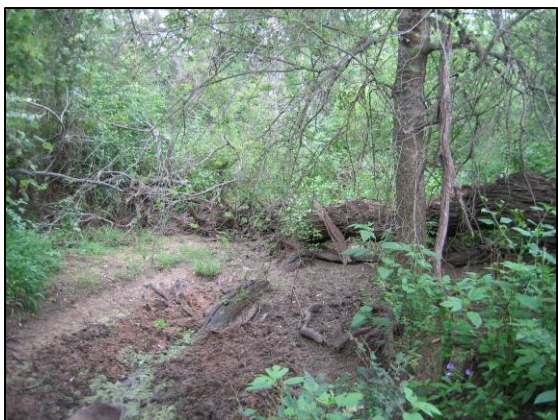
**Photogroup 6-8**

Atascosa River Site AR4\_03 showing some of the many obstructions encountered and no flow, dried conditions. (Individual in upper left photo is field staff.) [Return to Text](#)

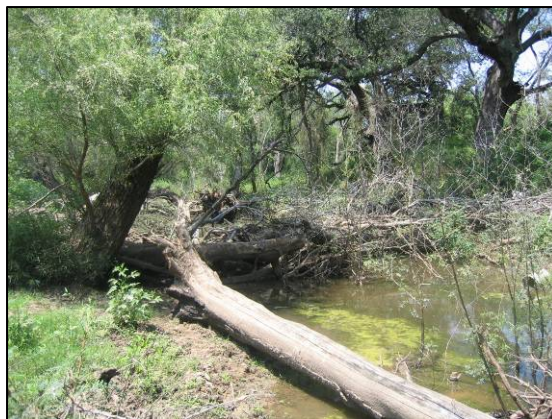
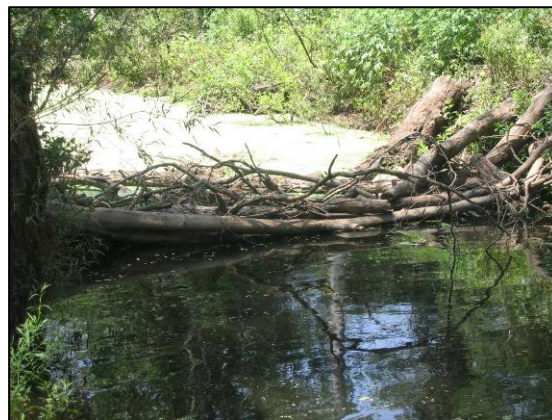
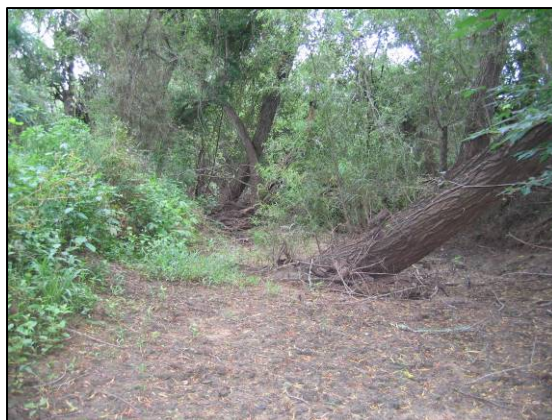
**Photogroup 6-7**

Atascosa River Site AR4\_03 depicting the general appearance of the river. (Individual in lower right photo is field staff.) [\[Return to Text\]](#)
