# Atascosa River Recreational Use-Attainability Analyses

Report to TMDL Program  
Texas Commission on Environmental Quality  
Project and Work Order Number  
582-6-70859-26

Tim Jones  
Jeff Stroebel  
Larry Hauck  
Texas Institute for Applied Environmental Research  
Tarleton State University  
Stephenville, Texas

December 2010

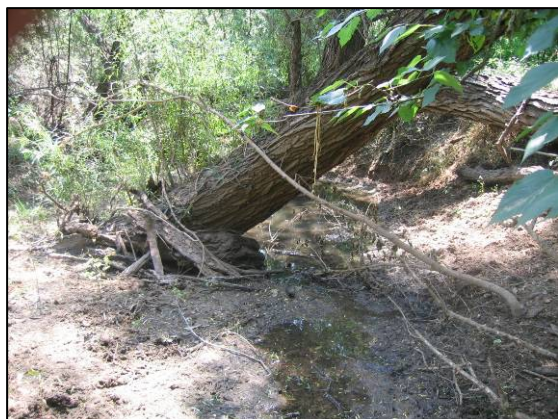
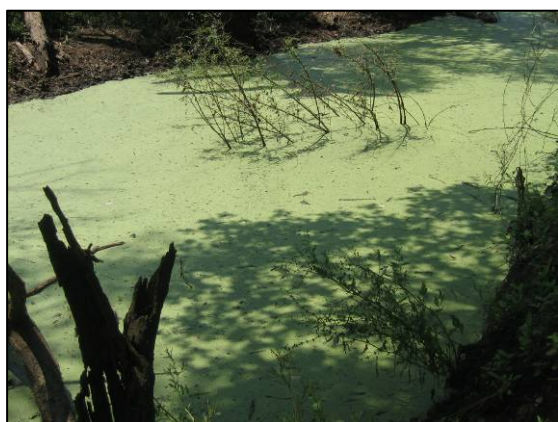
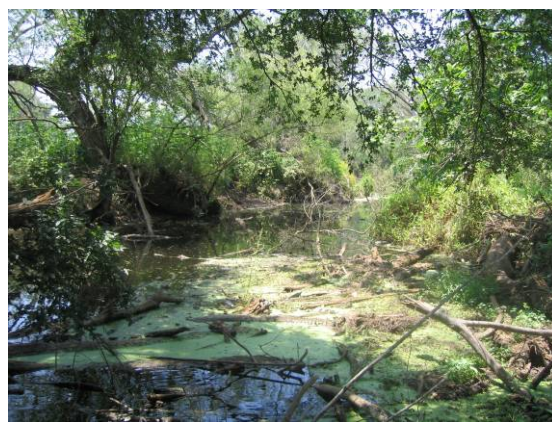
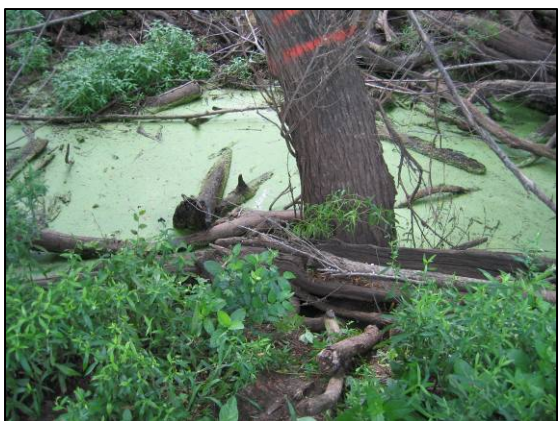
**Photogroup 6-9**

Atascosa River Site AR4\_03 showing water color and dense rafts of duckweed. [[Return to Text](#)]

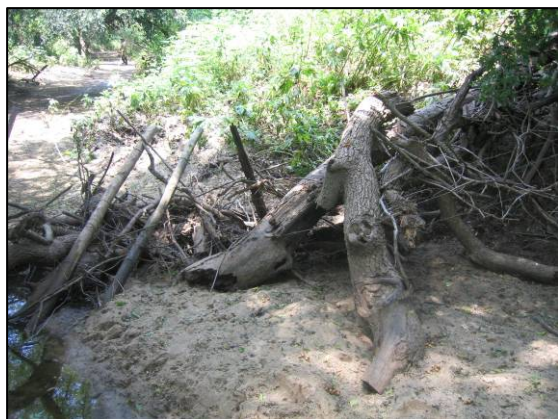
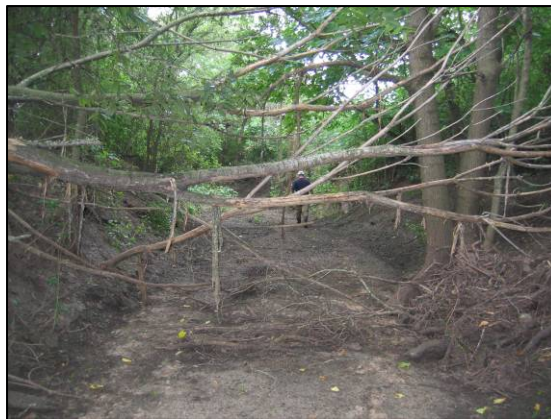
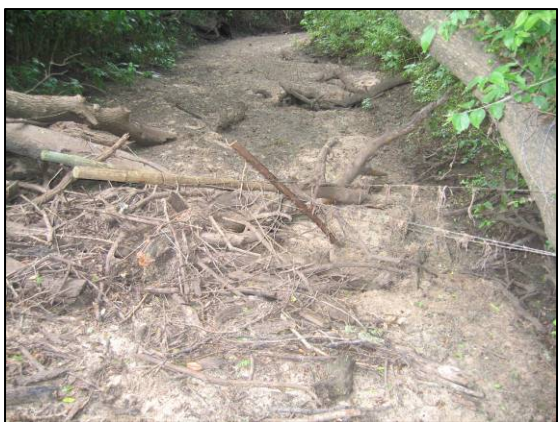
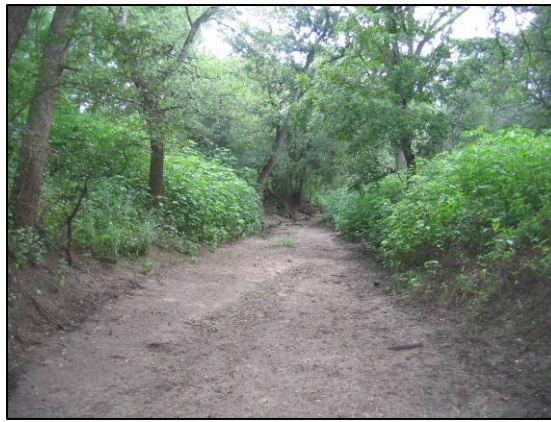
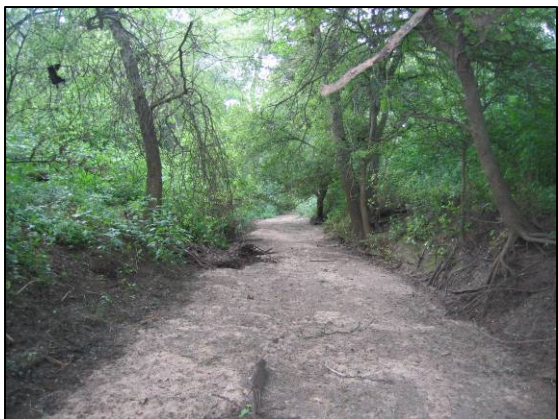
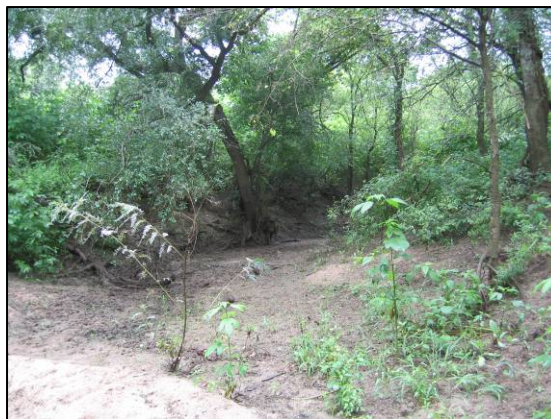
**Photogroup 6-10** Atascosa River Site AR4\_04 depicting the general appearance of the river, including dried streambeds. (Individual in upper right photo is field staff.) [\[Return to Text\]](#)

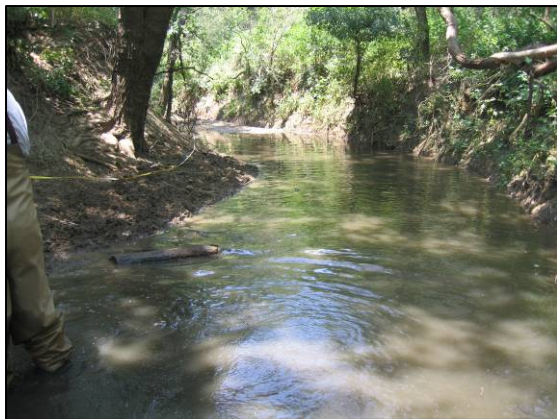
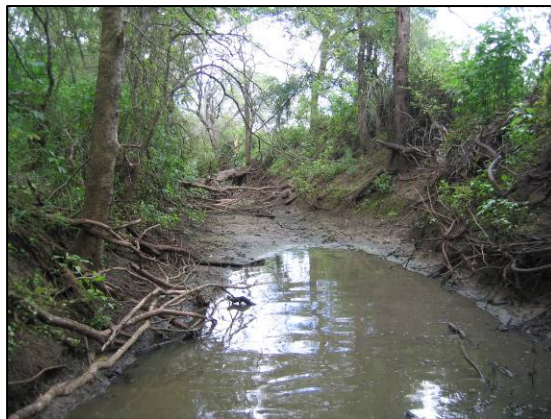
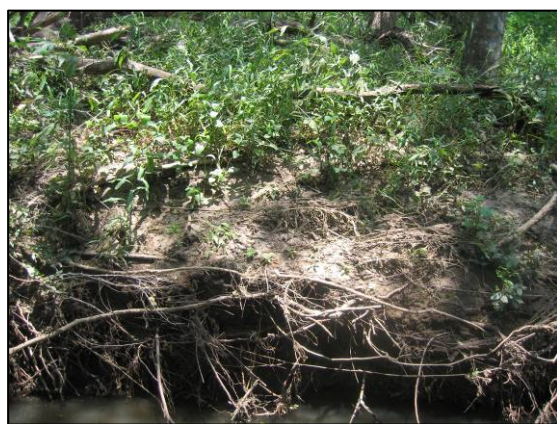
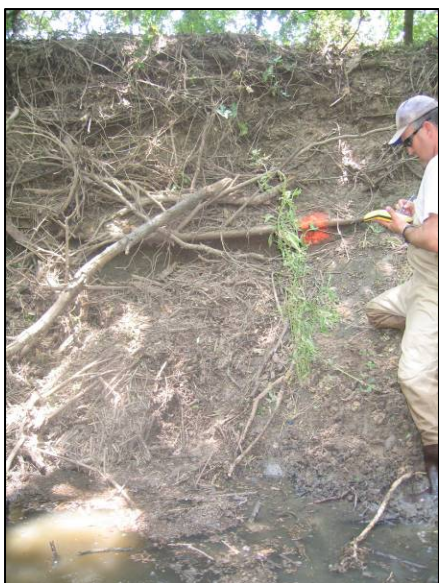
**Photogroup 6-11** Atascosa River Site AR4\_04 depicts obstructions encountered and dry streambed. [[Return to Text](#)]

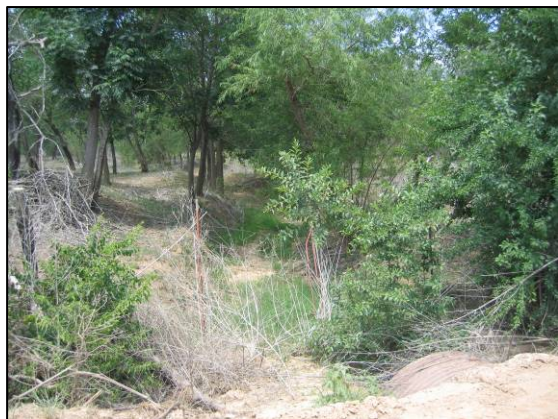
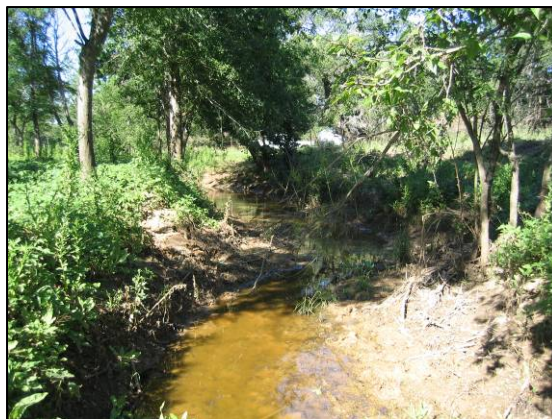
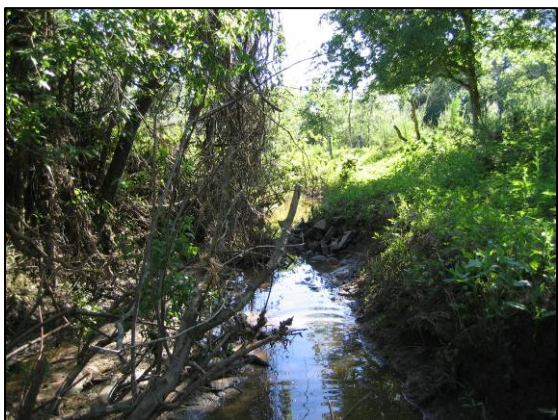
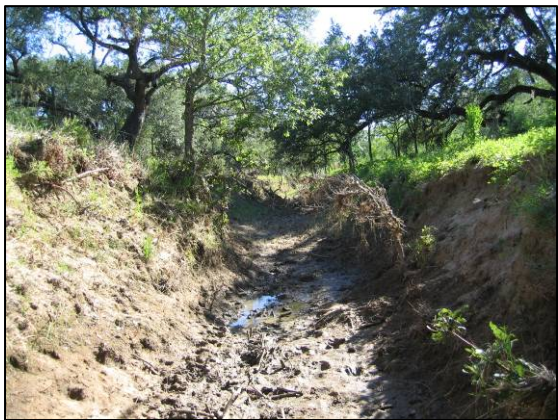
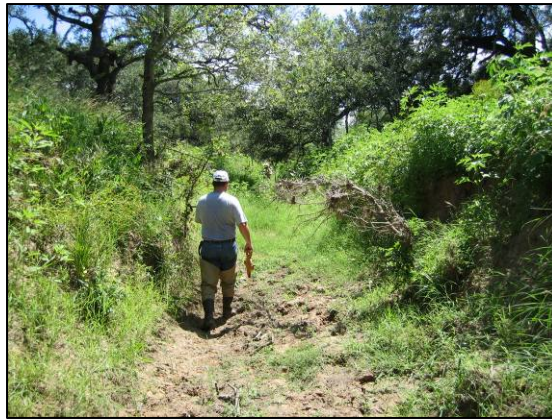
**Photogroup 6-12** Atascosa River Site AR4\_04 showing water color and surface appearance. (Individual in lower left photo is field staff.) [\[Return to Text\]](#)

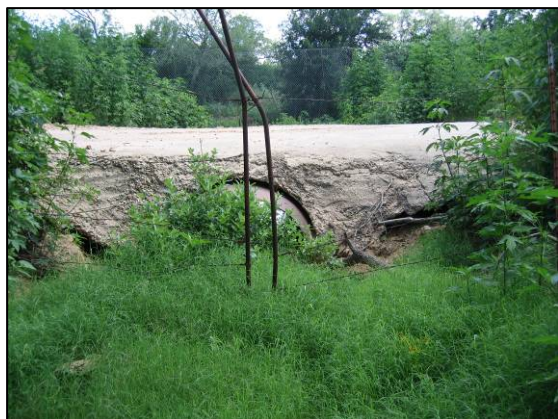
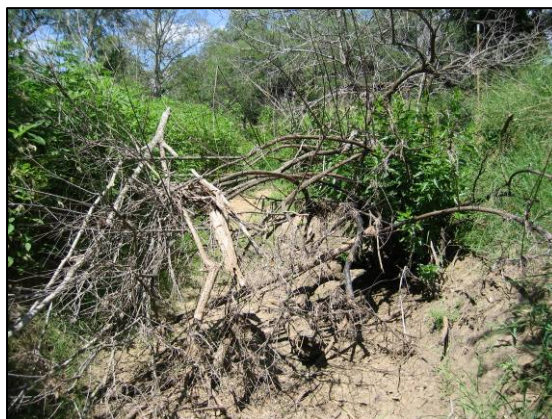
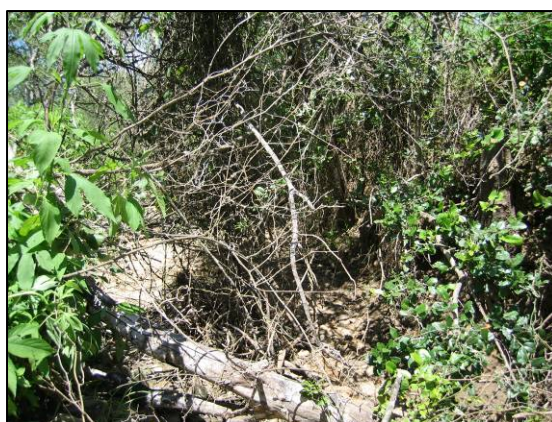
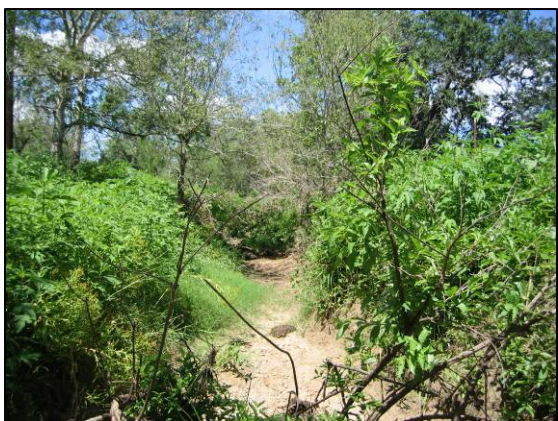
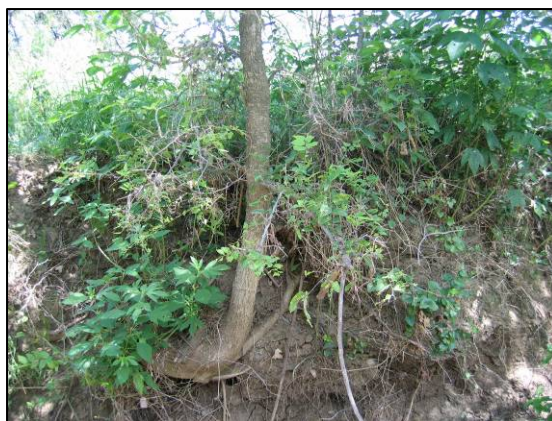
**Photogroup 6-13**

Atascosa River Site AR4\_05 depicting fence at property boundary on Iuka Road (upper left) and general appearance of site. (All individuals pictured are field staff.) [\[Return to Text\]](#)

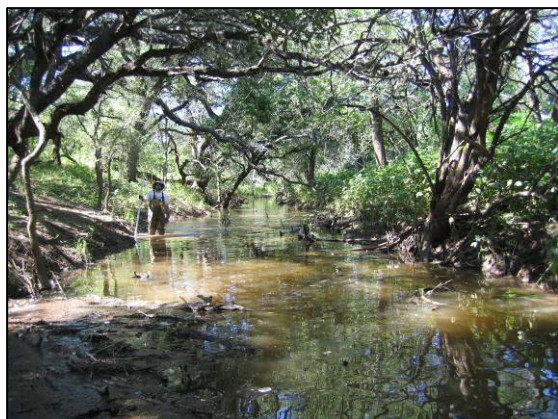
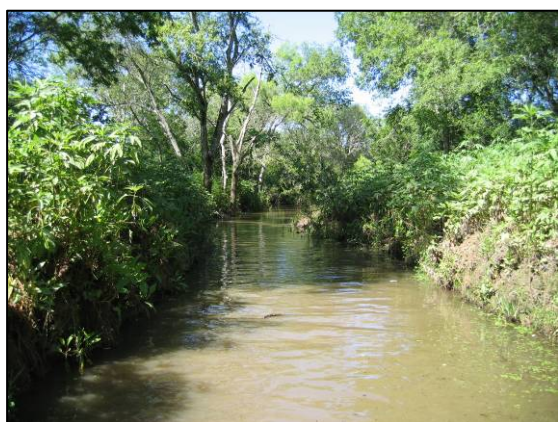
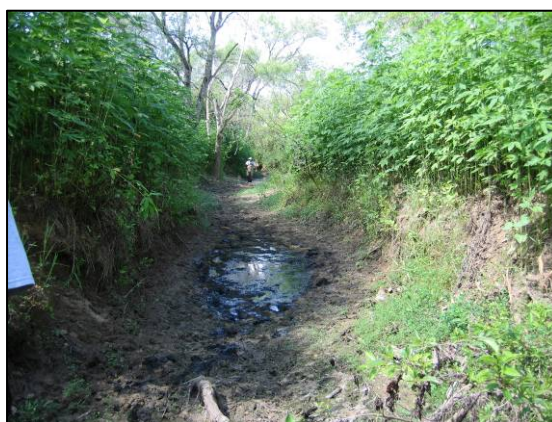
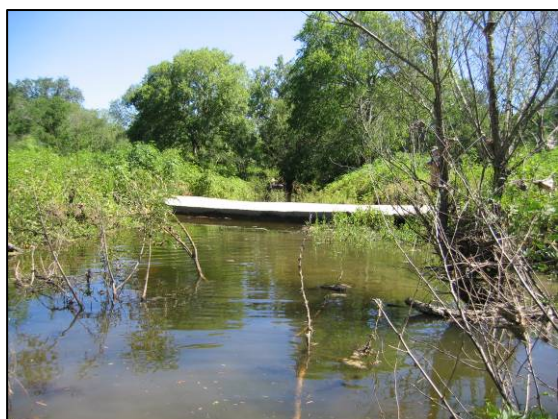
**Photogroup 6-15**

Atascosa River Site AR4\_05 depicts the general appearance and conditions through pairs of contrasting photographs from May to June 2010. (All individuals pictured are field staff.) [Return to Text](#)

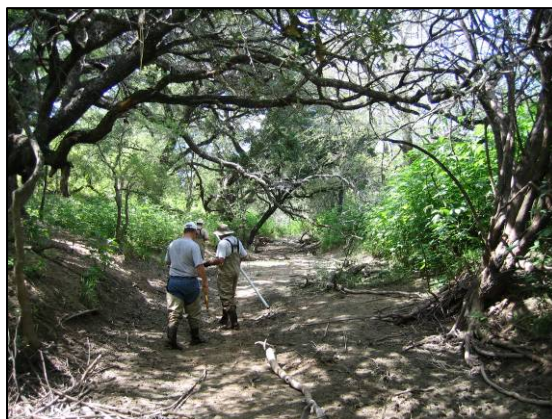
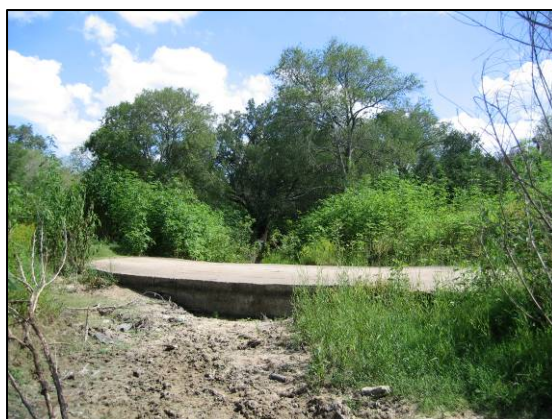
**Photogroup 6-14** Atascosa River Site AR4\_05 depicting obstructions, the dry creek bottom and tall banks. [[Return to Text](#)]

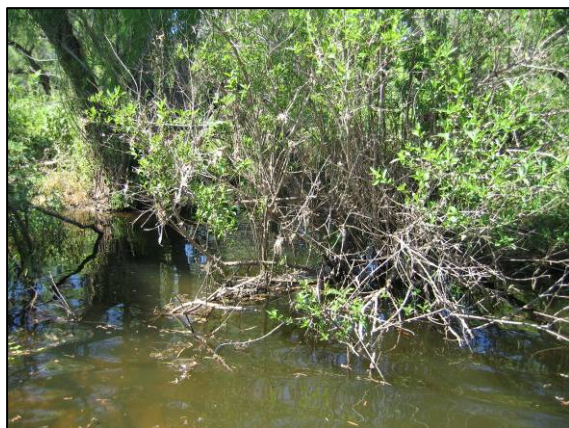
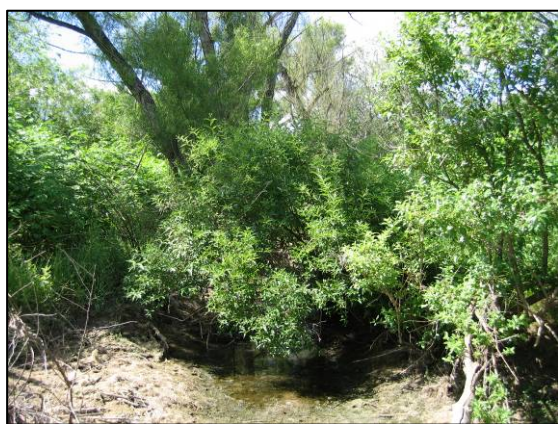
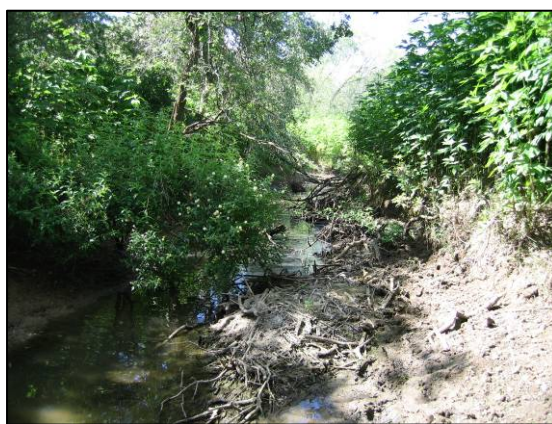
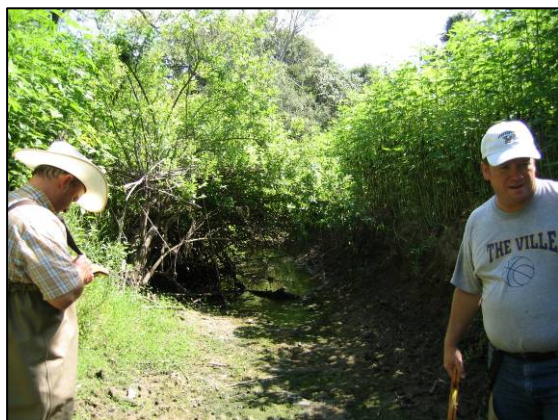
**Photogroup 6-16** Atascosa River Site AR4\_06 depicting obstructions and bank access at site. (All individuals pictured are field staff.) [\[Return to Text\]](#)

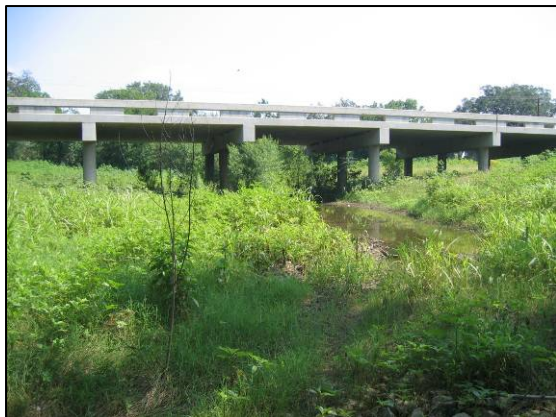
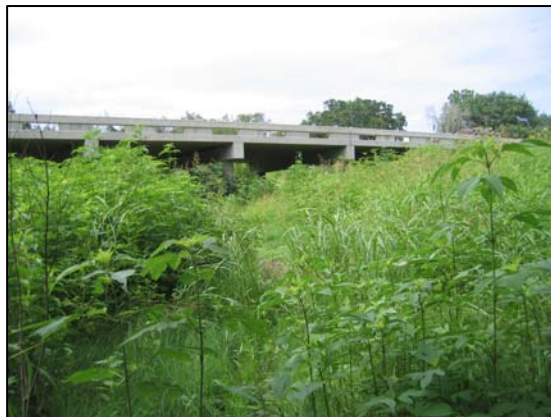
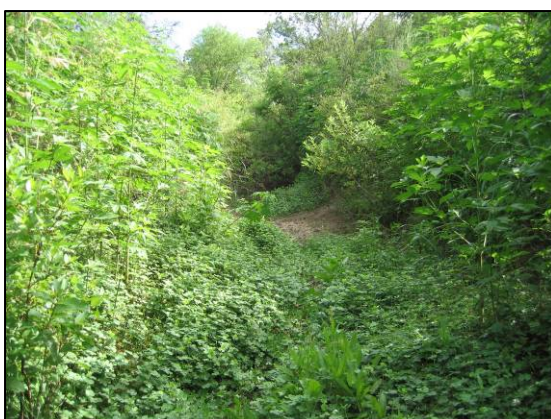
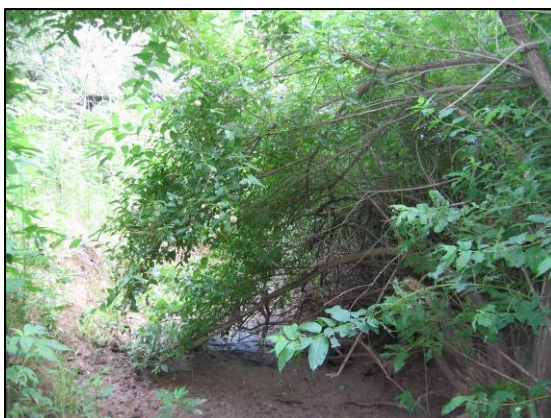
**Photogroup 6-17** Atascosa River Site AR4\_06 depicting the water color and surface clarity.  
[\[Return to Text\]](#)

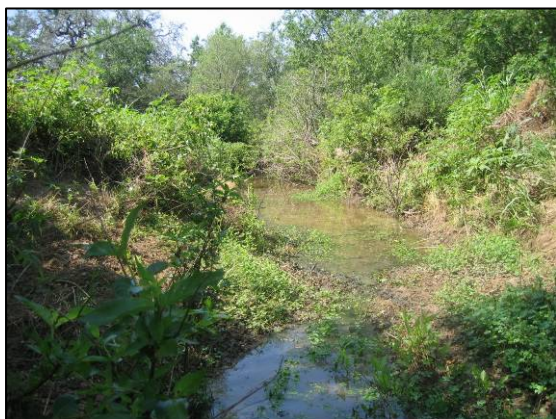
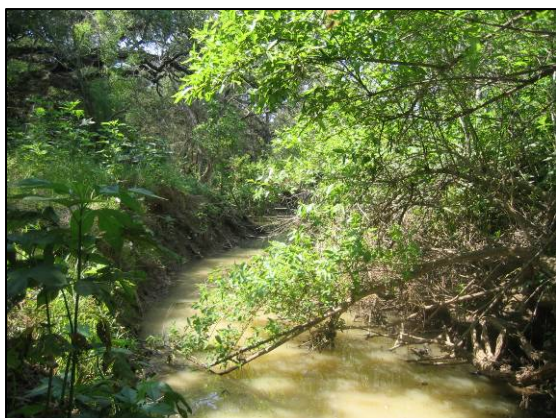
**Photogroup 6-18**

Atascosa River Site AR4\_07 depicts the general appearance and conditions through contrasting sets of photographs from May to June 2010. [[Return to Text](#)]

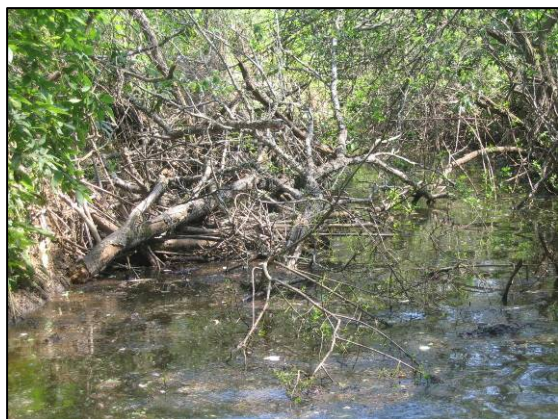
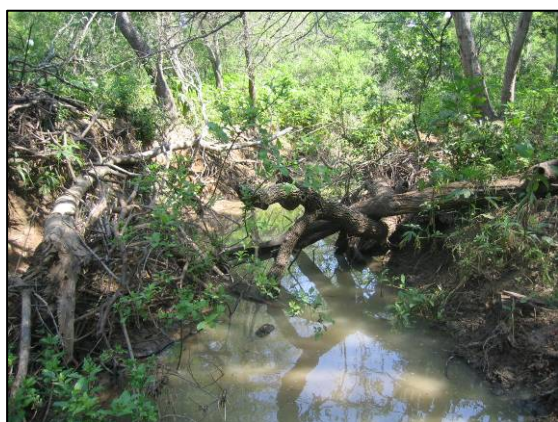
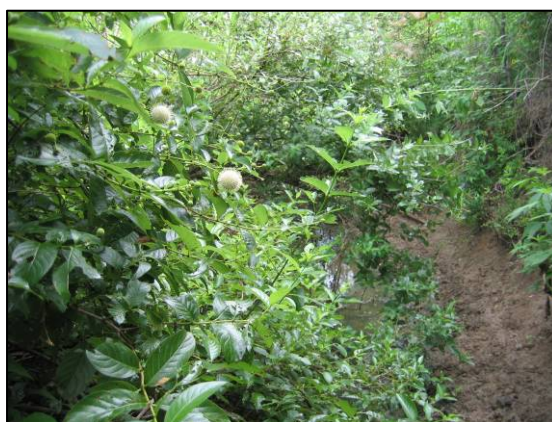
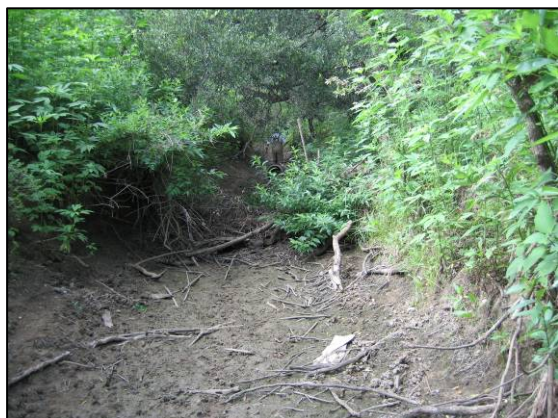
**Photogroup 6-19** Atascosa River Site AR4\_07 depicting the numerous obstructions encountered in both May and June. [[Return to Text](#)]

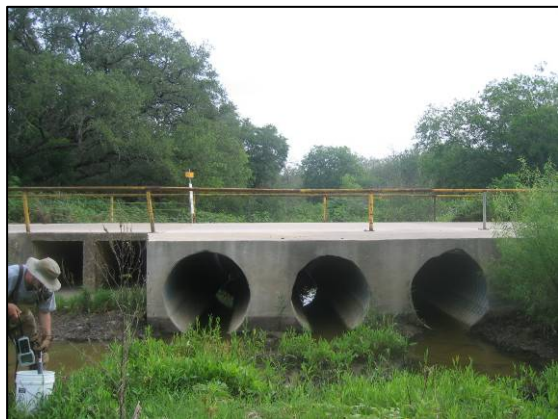
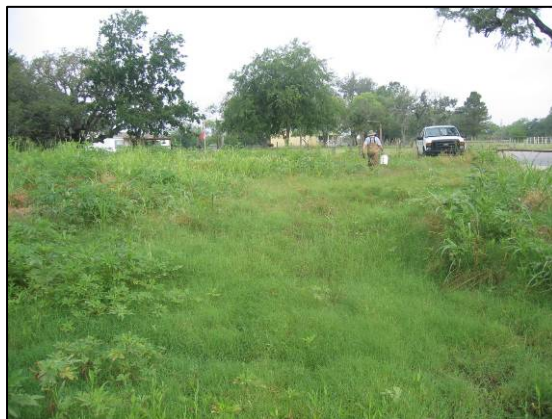
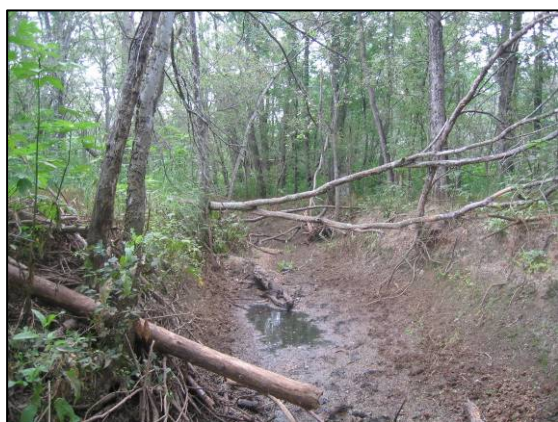
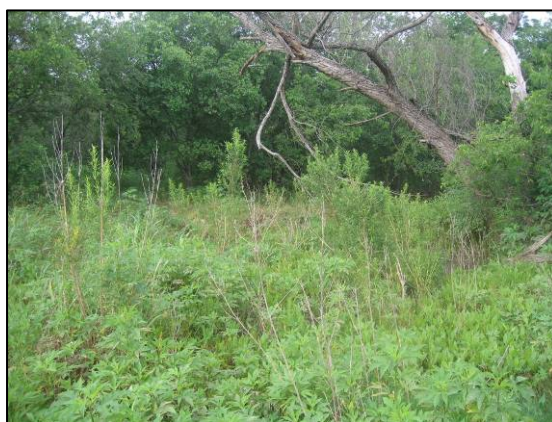
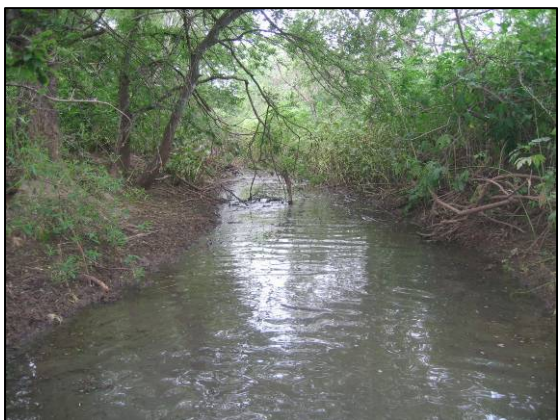
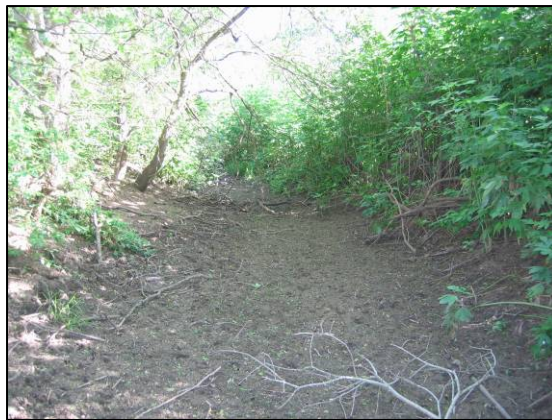
**Photogroup 6-20** Atascosa River Site AR4\_07 showing water color, surface debris and dry streambed. [[Return to Text](#)]

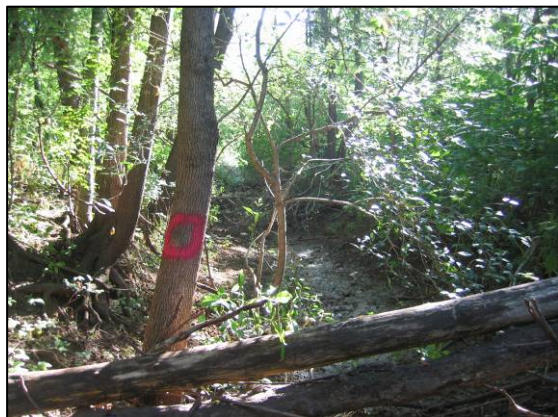
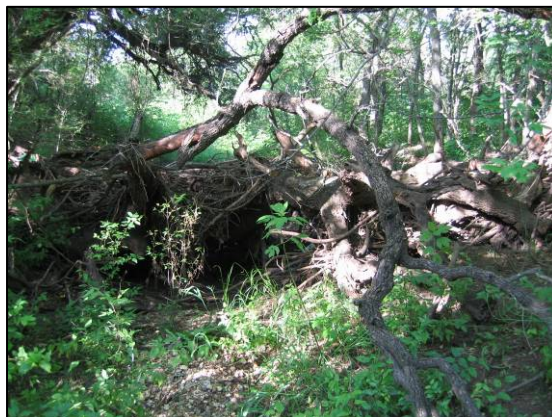
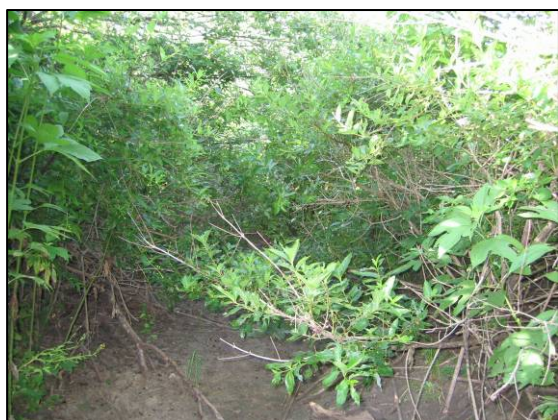
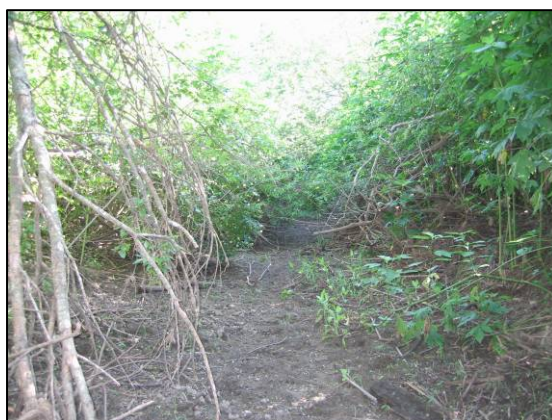
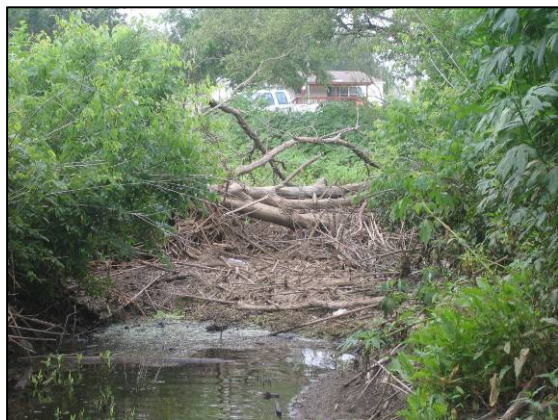
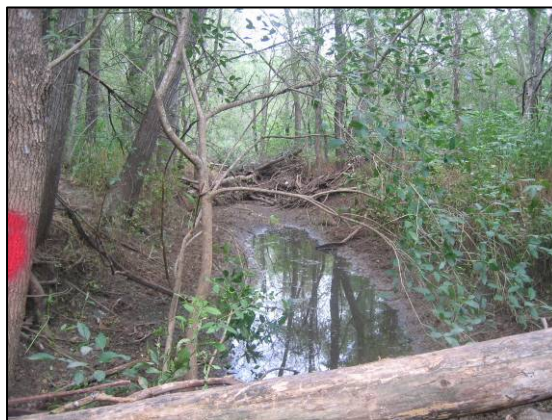
**Photogroup 6-21**

Atascosa River Site AR4\_08 depicting the access and general appearance of the river. (All individuals pictured are field staff.) [[Return to Text](#)]

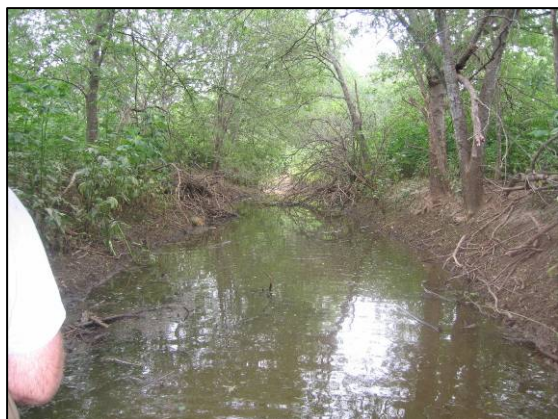
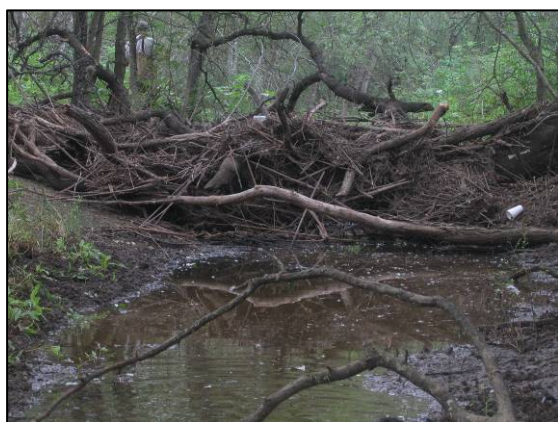
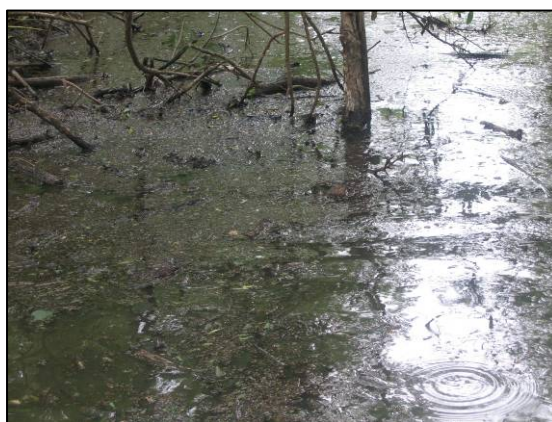
**Photogroup 6-23** Atascosa River Site AR4\_08 showing the water color and debris observed on the water surface. (Arm in center left photo is field staff.)  
[\[Return to Text\]](#)

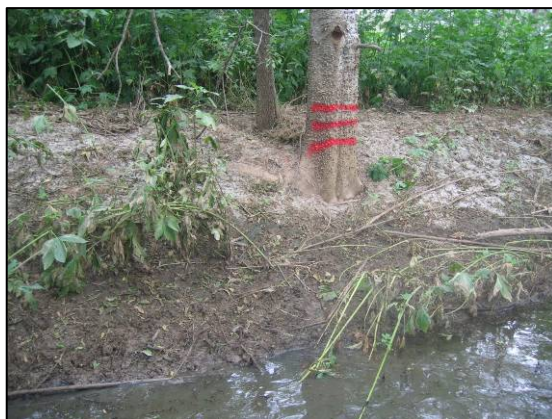
**Photogroup 6-22**

Atascosa River Site AR4\_08 depicting the numerous obstructions encountered. [[Return to Text](#)]

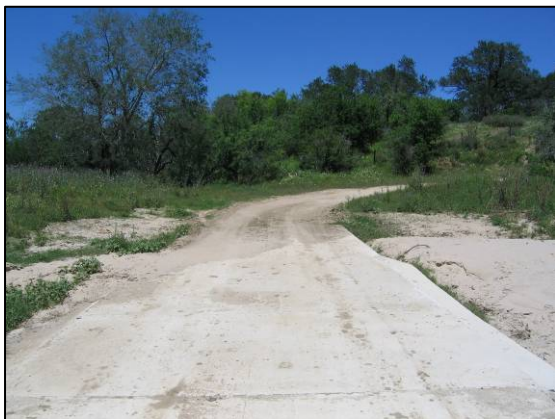
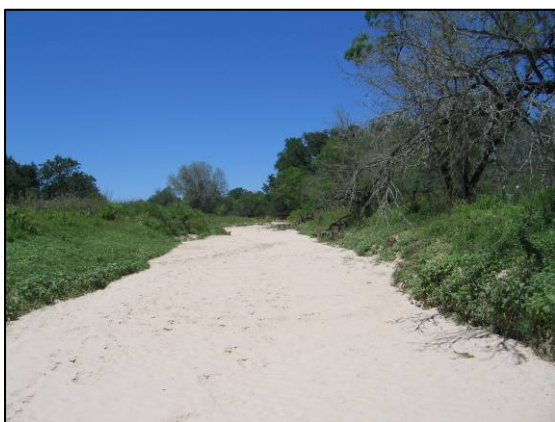
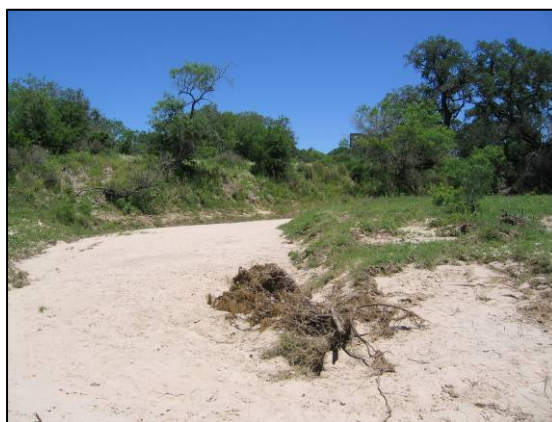
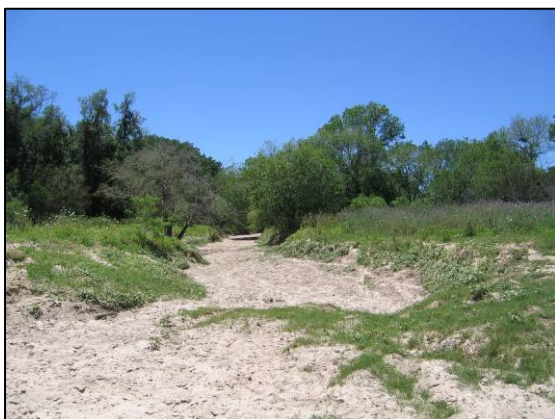
**Photogroup 6-24** Atascosa River Site AR4\_09 depicting access to and general appearance of the streambed in both May and June 2010. [[Return to Text](#)]

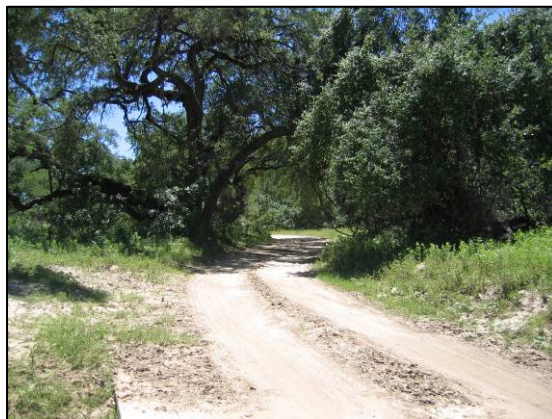
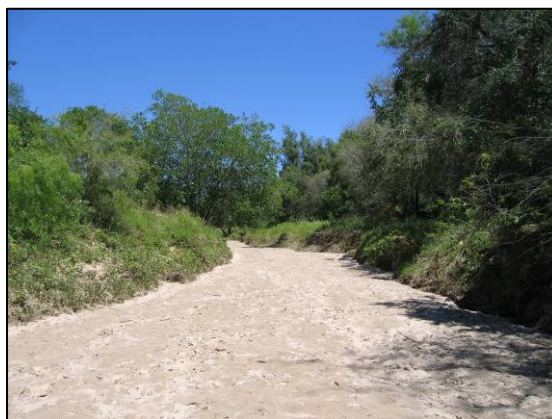
The surveyed reach at Site AR4\_09 was dry during both surveys for the entire 300-m reach. The substrate was very loose sand which made walking extremely difficult, though no obstacles were encountered.

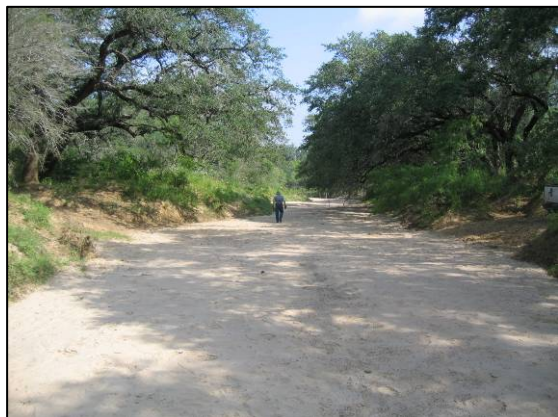
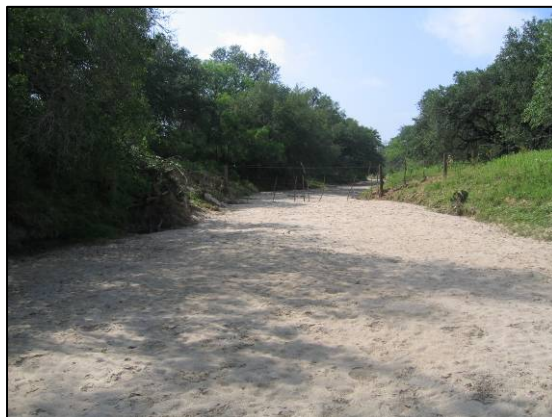
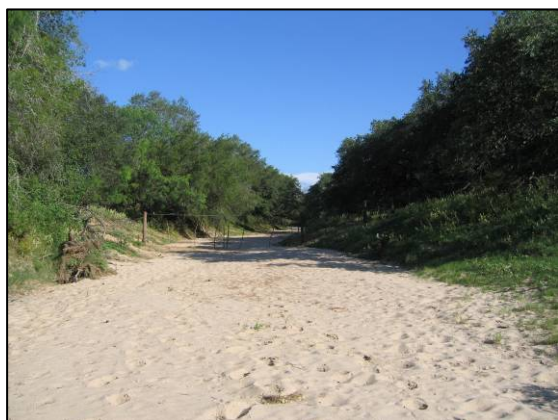
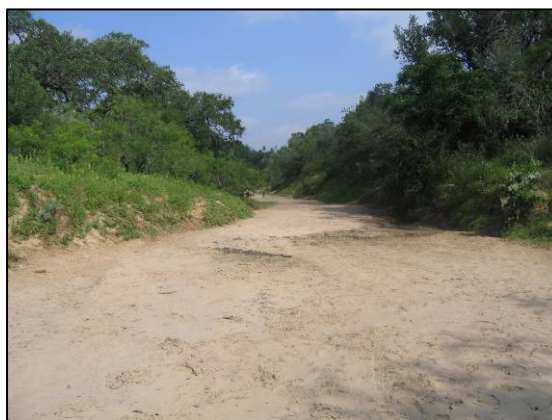
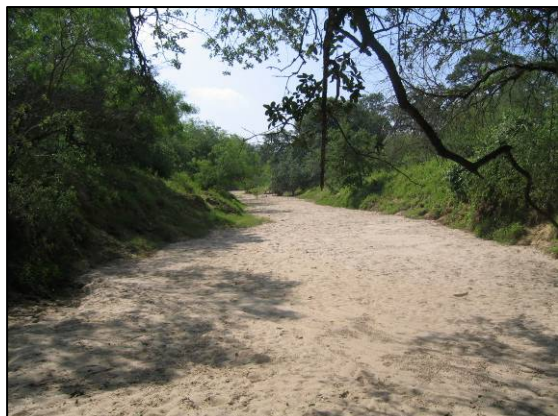
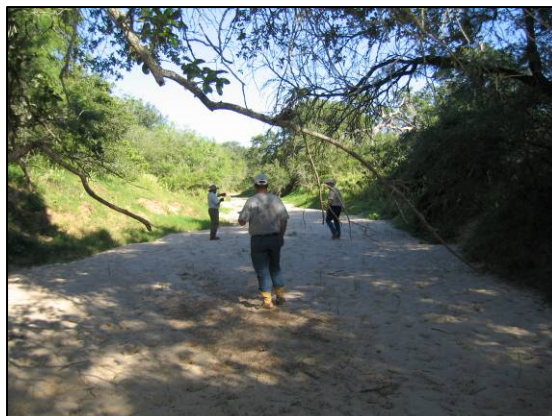
**Photogroup 6-25**

Atascosa River Site AR4\_10 depicting access and general appearance of the streambed in both May and June 2010. (All individuals pictured are field staff.) [\[Return to Text\]](#)

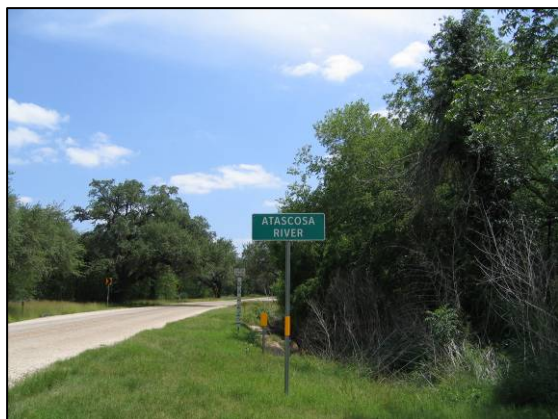
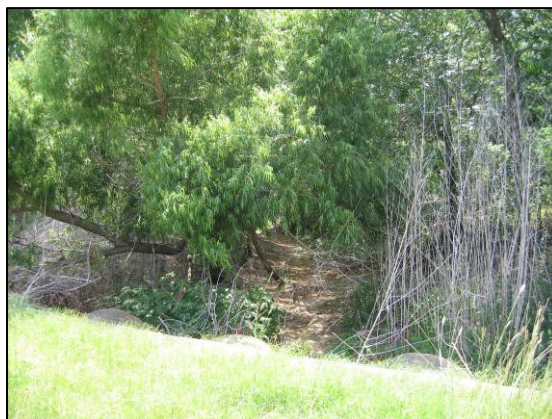
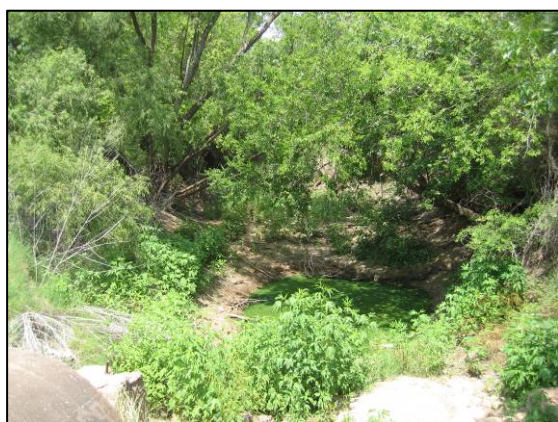
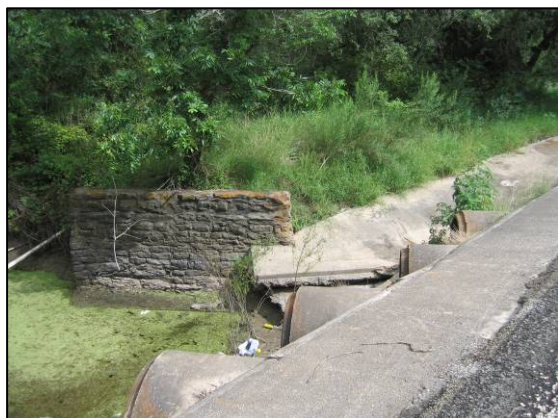
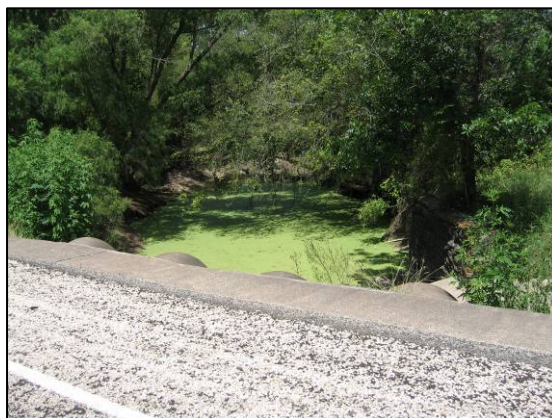
**Photogroup 6-27** Atascosa River depicting observations at FM1333. [[Return to Text](#)]

In addition to the sites described above, one road crossing at which permission could not be obtained was visited during the watershed surveys to observe whether or not contact recreation activities or evidence of activities could be observed. The additional road crossing visited was the Atascosa River at FM 1333 west of Poteet. TIAER staff passed this location several times on scouting trips, site visits and intentionally on weekends to try to ascertain if this site afforded recreation to the public. At no time were individuals encountered at the crossing, and no evidence of any type of recreation, either primary or secondary, was recorded. [Photogroup 6-27](#) depicts typical observations at FM 1333.
