# **Nueces River Authority**

## **2025 Watershed Characterization Report**

**Basin 22**

**Basin 24**

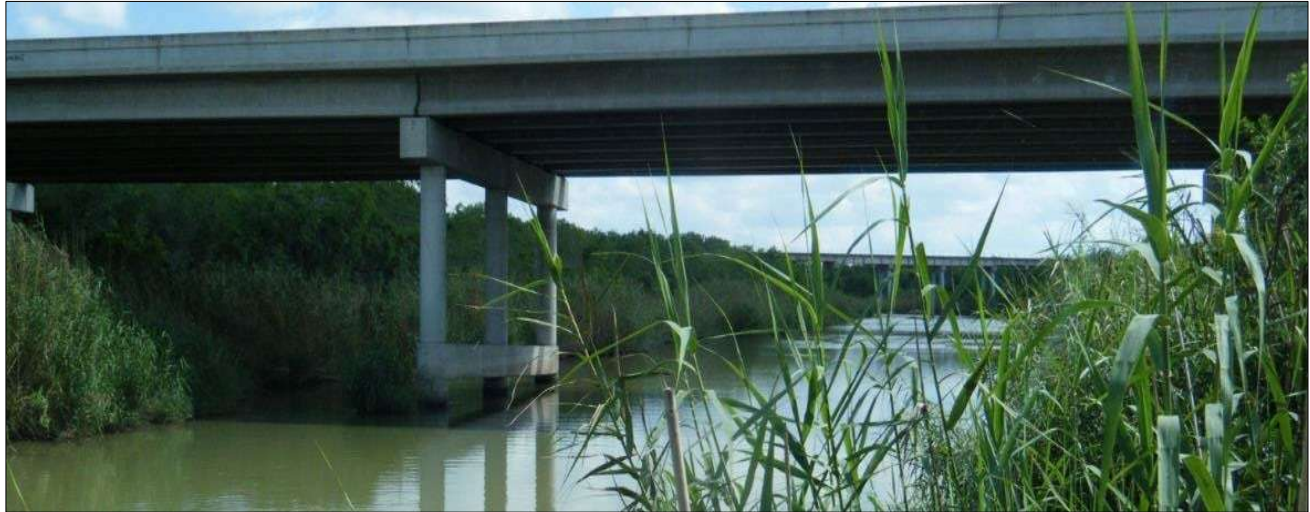
Figure 3: Arroyo Colorado at Cemetery Road

**Segment Description:** Segment 2202 flows 63 miles from FM 2062 in Hidalgo County to 110 yards downstream of Cemetery Road south of the Port of Harlingen. The segment is divided into four AUs and the watershed is 252,633 acres. There are numerous cities along US 83 just north of the Arroyo Colorado, with farming activities in between. The Arroyo Colorado is the primary conveyance of wastewater and agricultural runoff for this area. Segment 2202 consists of four active stations: **13074** AU\_01, **13079** AU\_02, **13081** AU\_03, **13084** AU\_04.

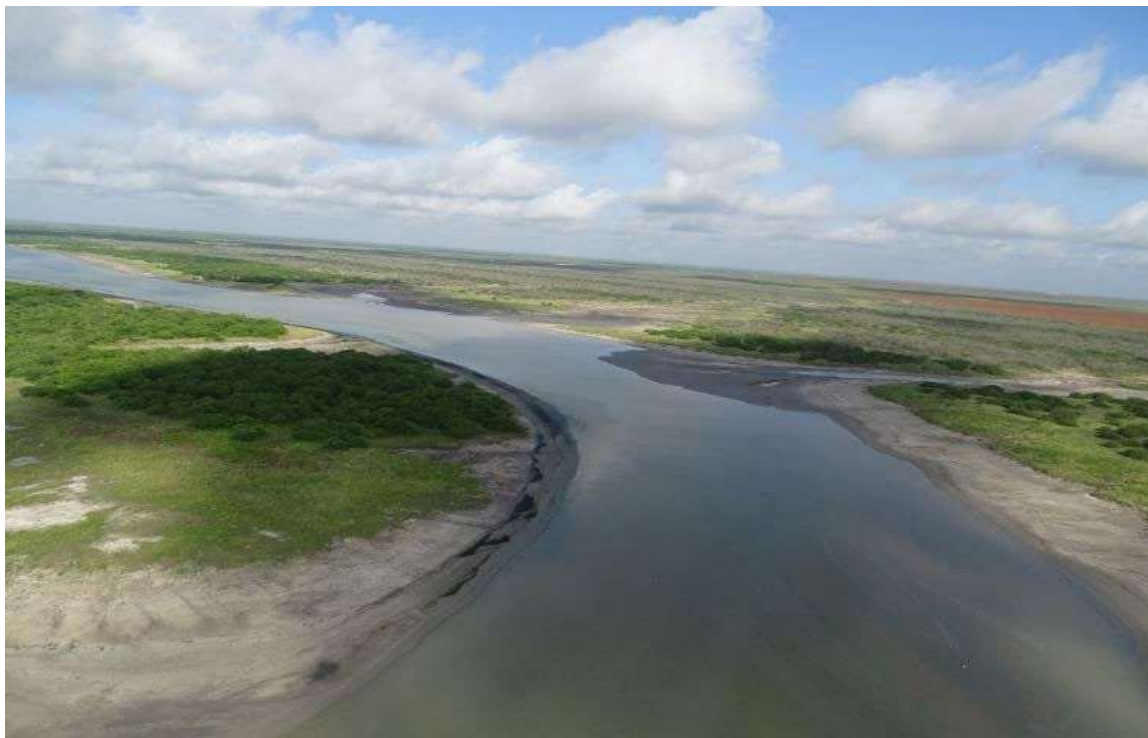
Figure 6: Petronila Creek Above Tidal

**Site Description-** Segment 2204 flows 44 miles from the confluence of Agua Dulce and Banquete Creeks in Nueces County to a point 0.6 miles upstream of a private road crossing near Laureles Ranch in Kleberg County. The segment is part of the Baffin Bay watershed which is 1,867,755 acres. It is divided into two AUs and the segment is primarily farmland interspersed with numerous small communities and cities. It flows through the City of Driscoll (pop. 631) at US 77. There are nine WWTPs that discharge to this segment and a stormwater discharge permit for a hazardous waste landfill. Segment 2204 has three active stations: **13094** AU\_01, **13096** AU\_02, **20806** AU\_02. These stations are often used as illegal dumping sites. Possible recommendations for special studies include the specific lethal dose of D.O. to cause fish kills.

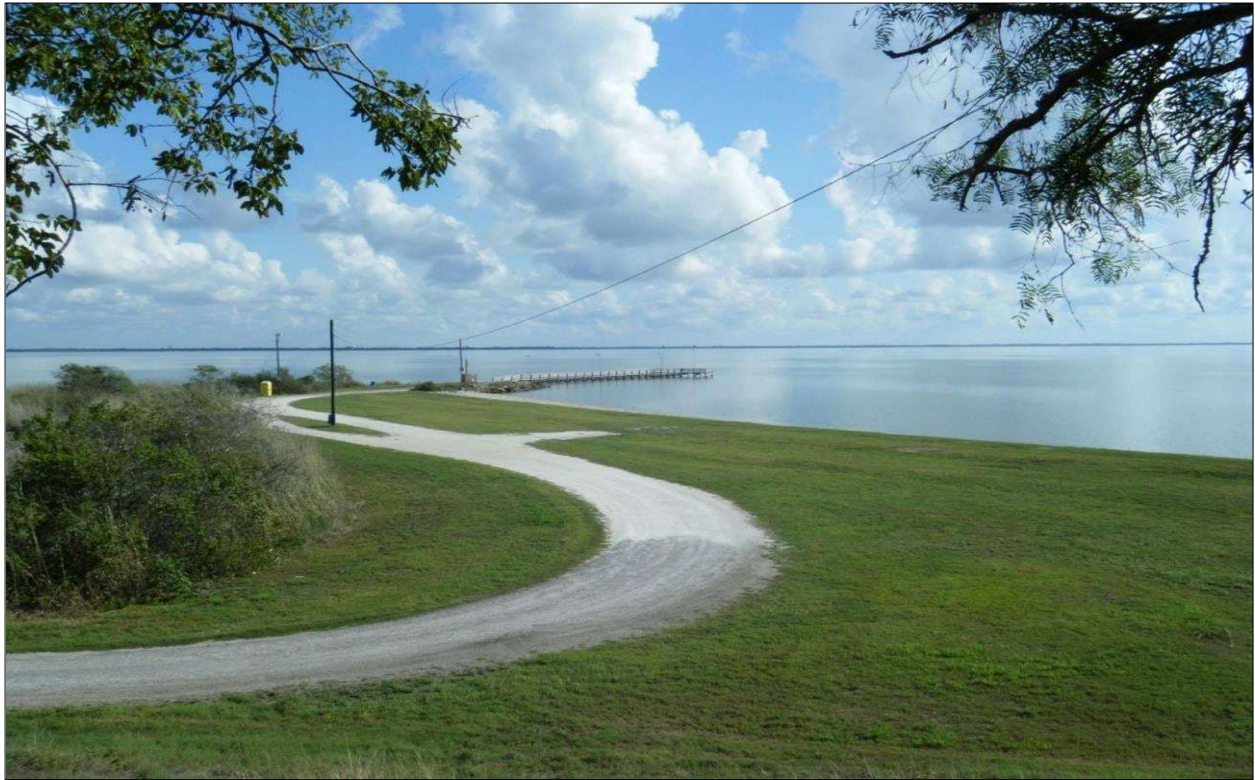
Figure 9: San Antonio Bay

**Segment Description** - This segment is primarily in Refugio and Calhoun Counties and includes Guadalupe Bay. The official boundary for the San Antonio – Nueces Coastal Basin includes all of Hynes Bay and only a portion of San Antonio Bay. Its watershed is 69,939 acres. The area around the bay is dominated by farms and ranch lands. The small town of Austwell (pop. 133) is on the bay and is the only community in the area. Segment 2462 has one station numbered **13397**.

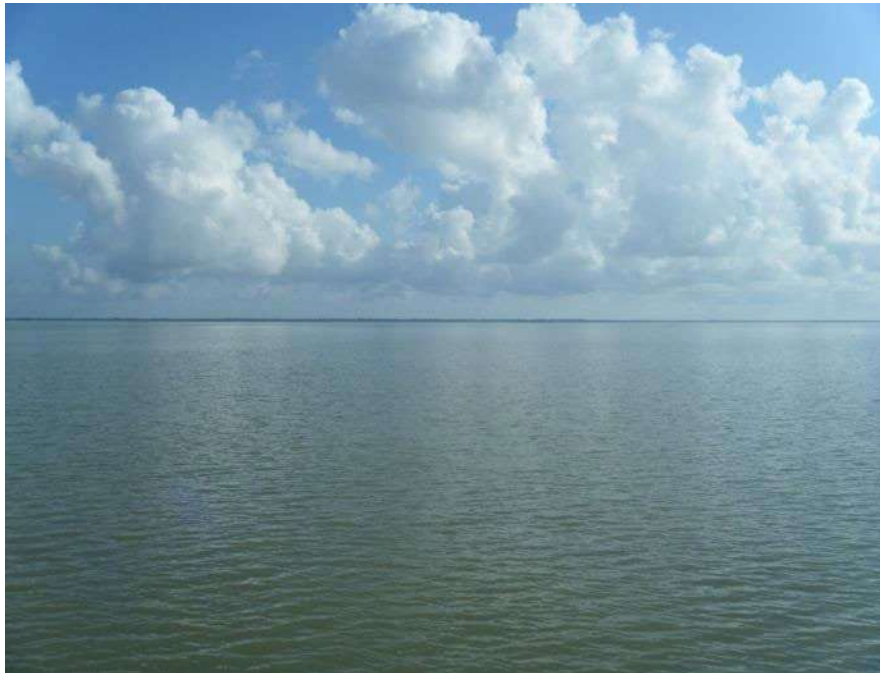
Figure 11: Mesquite Bay

**Segment Description** - Mesquite Bay is in the northernmost bay in the monitoring jurisdiction located in Aransas County. Its watershed is 37,323 acres. The bay is surrounded by natural areas. The Aransas Wildlife Refuge is to the southeast. Segment 2463 has one station numbered 13400

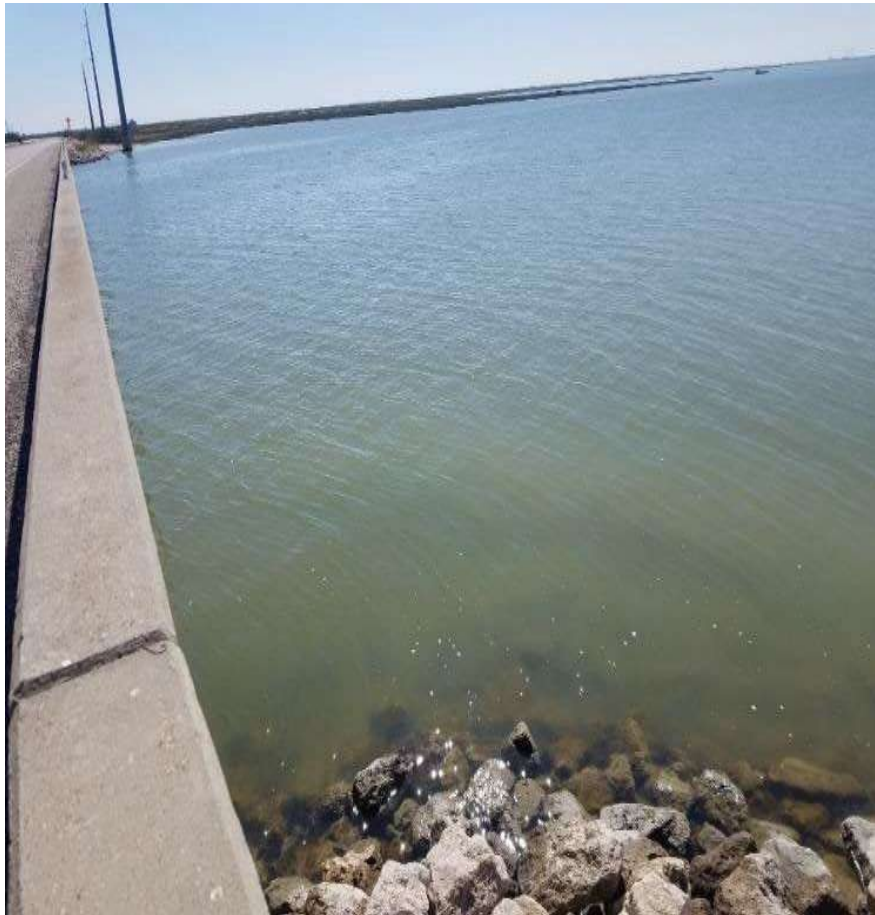
Figure 15: Mission Bay

Segment Description- These bays are in Refugio and Aransas counties. Its watershed is 249,235 acres. Segment 2472 is composed of three bays and three AUs. The south and west bay have multiple developments and small communities. The north and west sides are mostly farm and ranch lands. Segment 2472 has three stations: **14783** AU\_01, **17724** AU\_02, **13405** AU\_03.

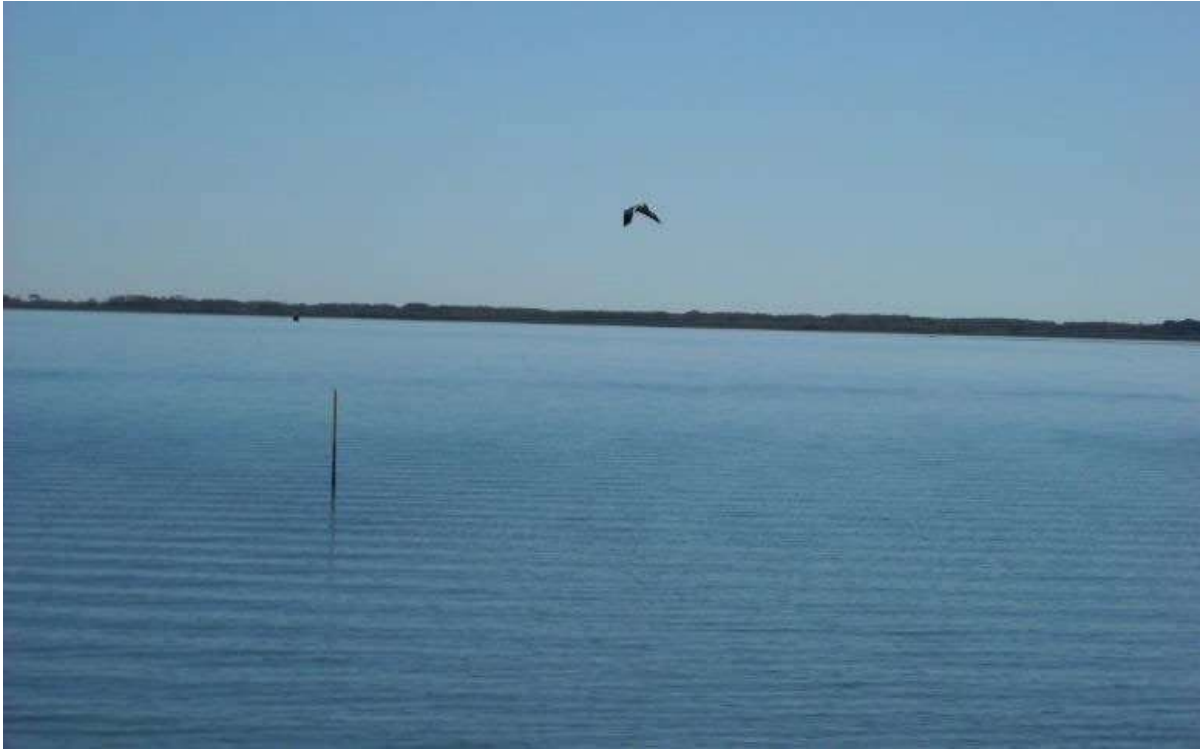
Figure 17: St. Charles Bay

Segment Description - Segment 2473 is in Aransas County and consists of one AU. Its watershed is 162,401 acres. The bay is nearly surrounded by the Aransas Wildlife Refuge. The small community of Lamara, home to the “Big Oak”, is located on the southwest side adjacent to Aransas Bay. Segment 2473 has one station numbered **17692**.

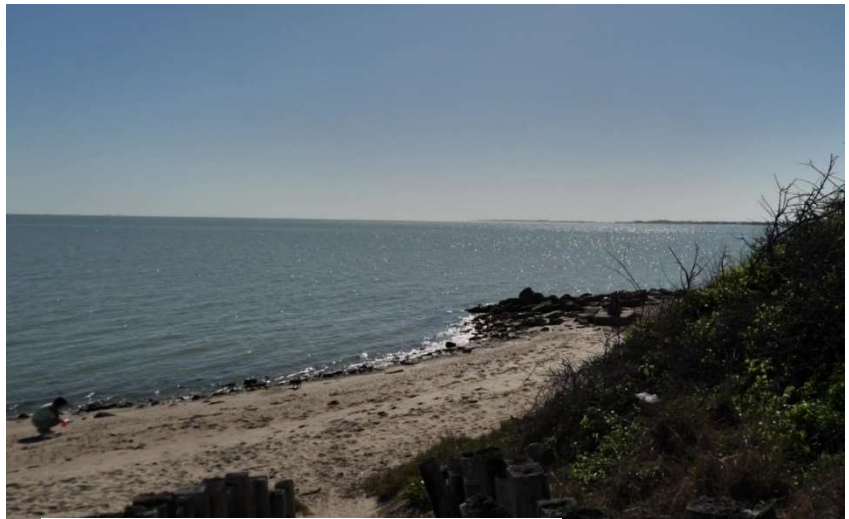
Figure 19: Corpus Christi Bay

Segment Description: Corpus Christi Bay is in Nueces County and is split between the San Antonio-Nueces and the Nueces-Rio Grande Coastal Basins. The bay is divided into four AUs and the watershed is 147,878 acres. The bay is nearly surrounded by cities and industries. The City of Corpus Christi borders the south side of the bay and encompasses a large portion of Mustang Island. Along the northern shore are the cities of Portland, Ingleside, and Ingleside-By-The-Bay. There are several industries located along La Quinta Channel, along with the closed Naval Station Ingleside. Segment 2481 has three stations: **13409 AU\_01**, **13411 AU\_02**, **14355 AU\_03**.

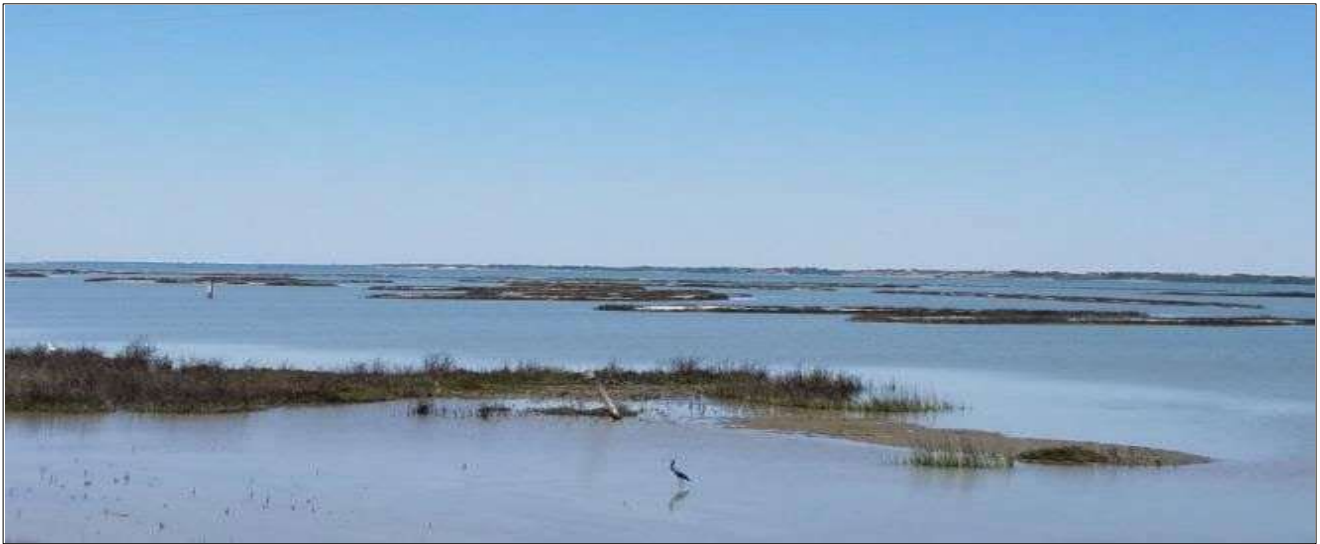
Figure 20: Nueces Bay

**Segment Description:** Nueces Bay is a shallow, secondary bay in Nueces County. Nueces Bay provides the boundary between the San Antonio – Nueces and Nueces – Rio Grande Coastal Basins and consists of a single AU. Its watershed is 92,834 acres. The bay is bordered on the south by the City of Corpus Christi where there are many industries associated with the ship channel. A large portion of the Nueces Delta has been bought and designated as a preserve. The area north of the bay is primarily farm and ranch lands. Segment 2482 has one station numbered **13422**.

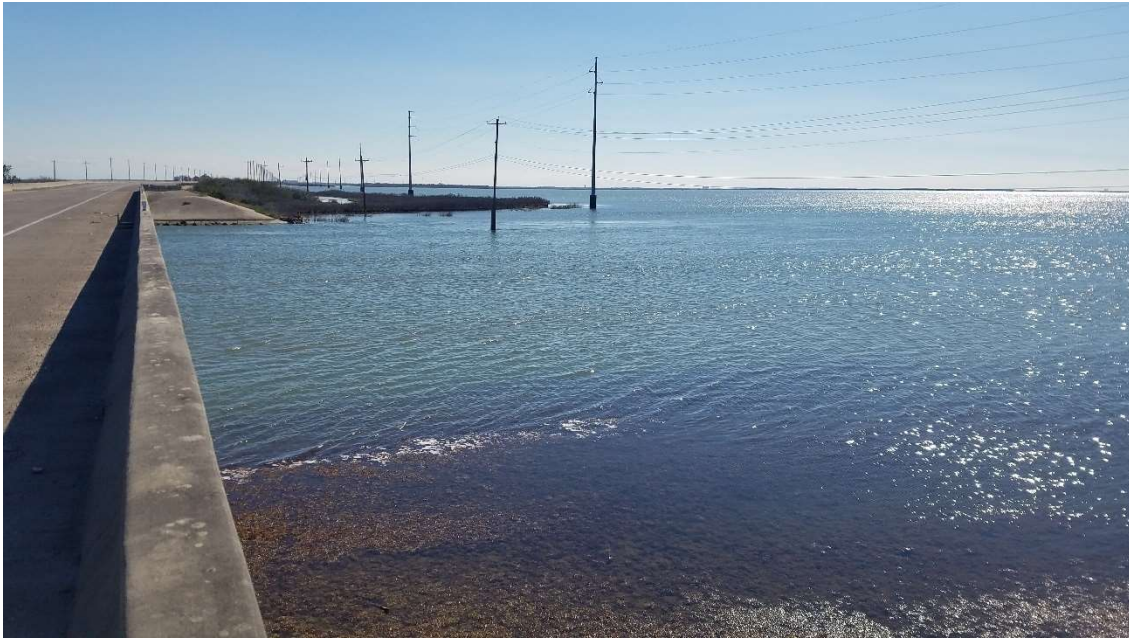
Figure 22: Redfish Bay

**Segment Description** - Redfish Bay is in Nueces County and its watershed is 45,936 acres. There is very little undeveloped land on the western shore of the bay. The main cities are Ingleside (pop. 10,165) and Aransas Pass (pop. 8,088), with numerous small communities all the way to Rockport (10,841). Port Aransas (pop. 4,123) encompasses most of the eastern shoreline. Segment 2483 has one station numbered **13426**.

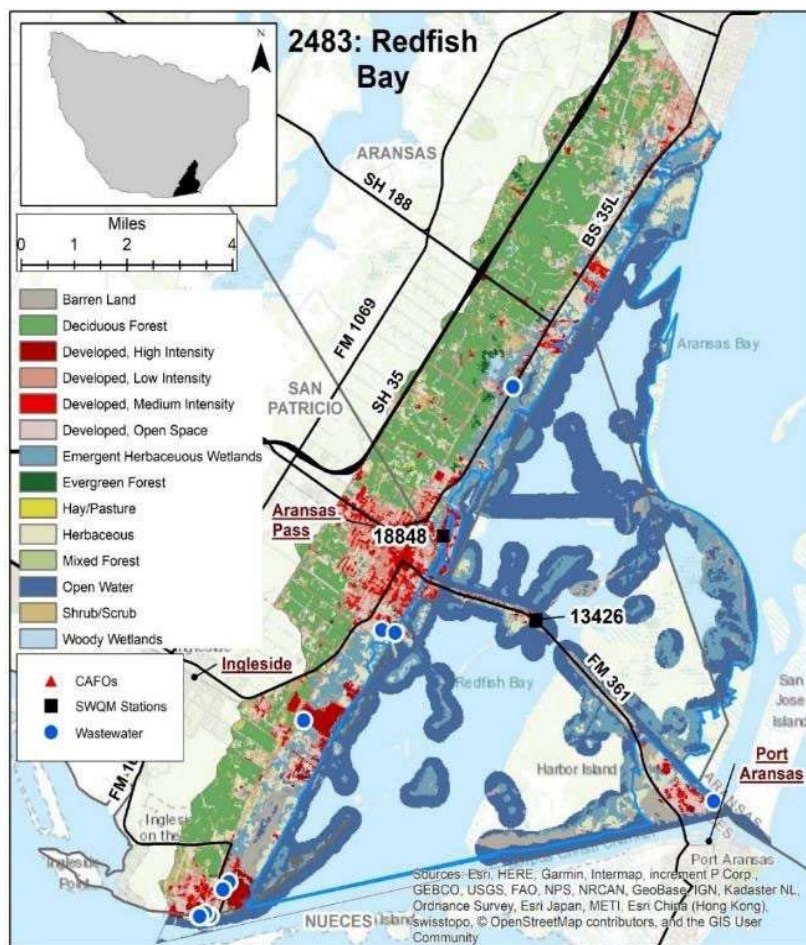
Figure 23: Map of Redfish Bay

Redfish Bay is primarily influenced by Nueces Bay and the Nueces River, which contribute freshwater inflows.

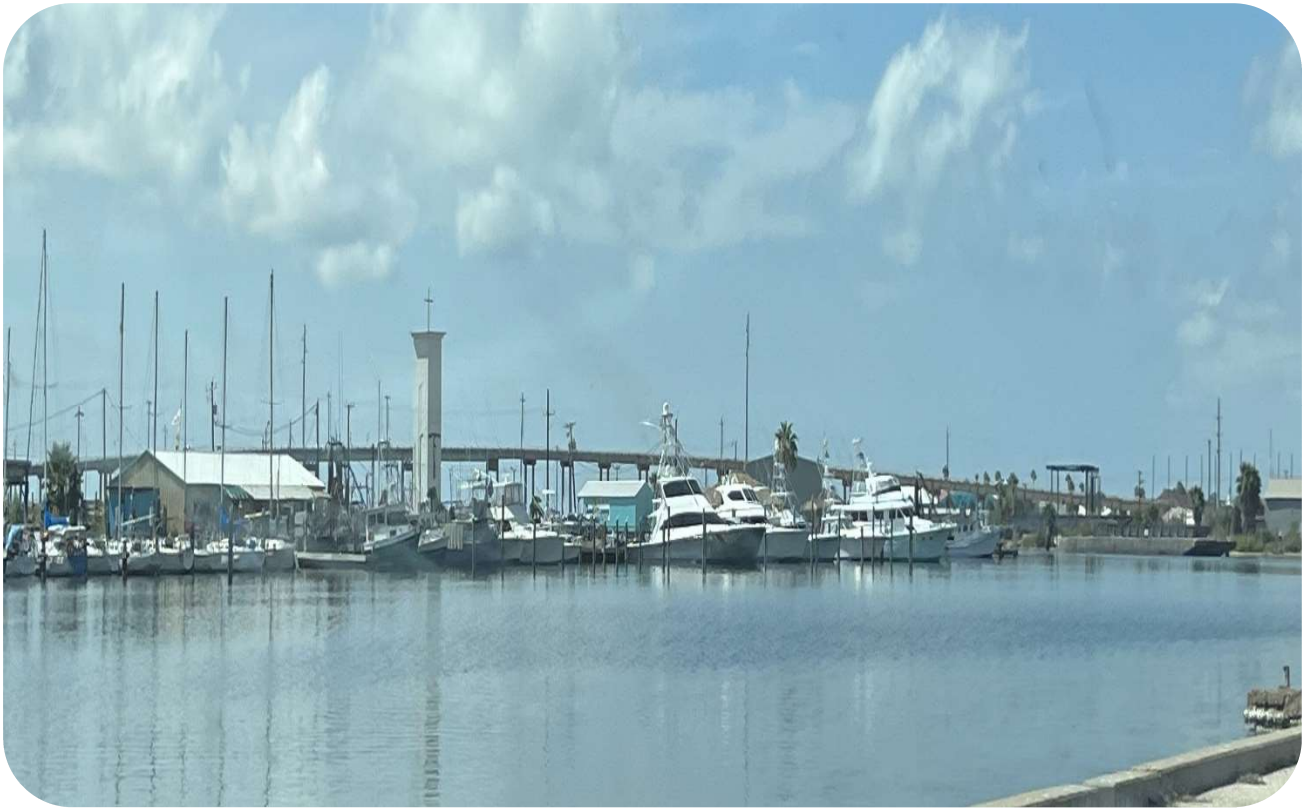
Figure 24: Conn Brown Harbor

**Segment Description** - The harbor is within the City of Aransas Pass. The northeast end is in Aransas County and the southwest end is in San Patricio County. Conn Brown Harbor was a commercial harbor used primarily by shrimpers, for many years, ending in the mid-2000s. The harbor is now used mainly by recreational fishermen and boaters. Segment 2483A consists of one station numbered **18848**.

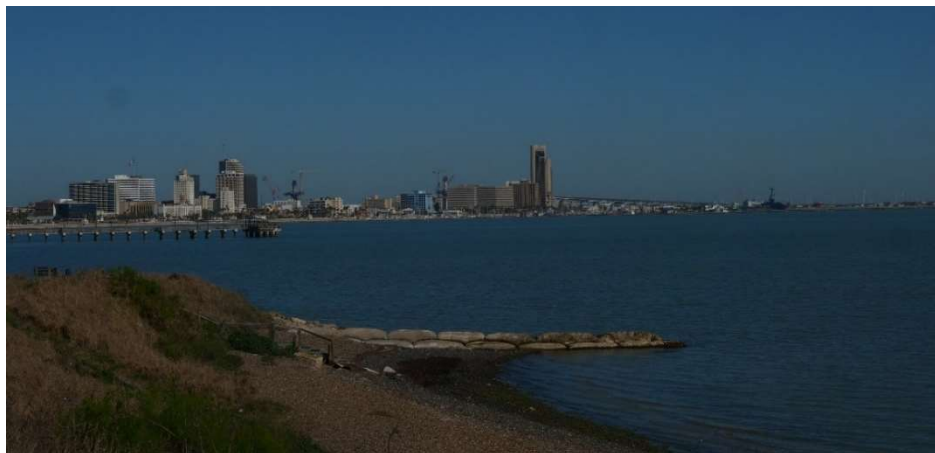
Figure 25: Corpus Christi Inner Harbor

Segment Description - The Corpus Christi Inner Harbor (CCIH) is in the City of Corpus Christi (pop. 326,554) in Nueces County. Its watershed is 13,360 acres and it comprises of one segment. CCIH is home to the Port of Corpus Christi, the second deepest port in the State of Texas. Many refineries and other industries are located all along the harbor. There are also numerous permitted wastewater outfalls, many of which are stormwater. Segment 2484 consists of two stations: **13432** and **13439**.

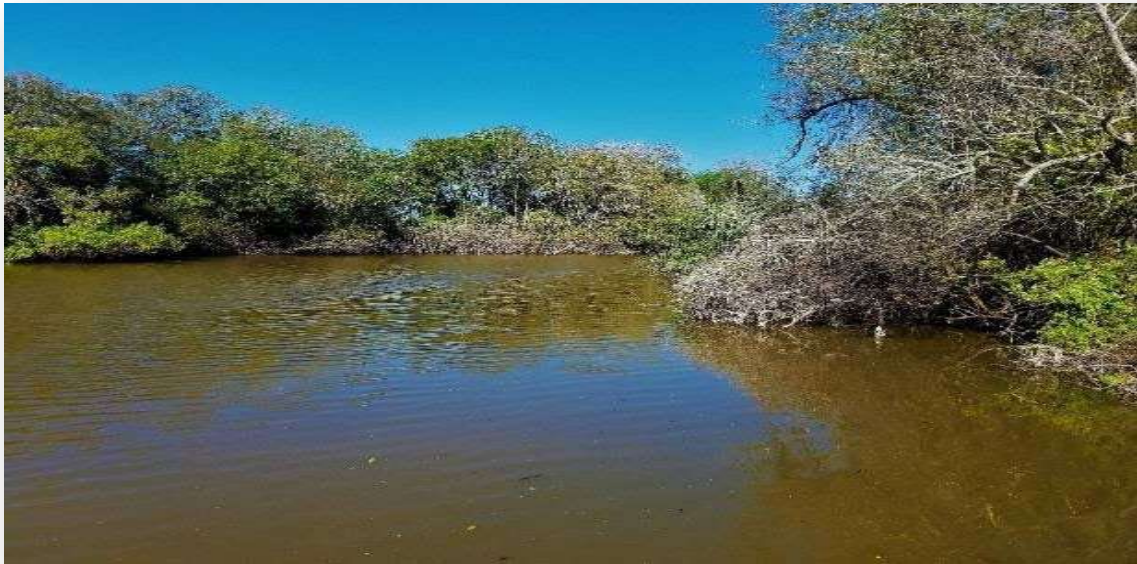
Figure 26: Oso Bay

**Segment Description** - Oso Bay is in the City of Corpus Christi (pop. 326,554) in Nueces County. The bay is divided into three AUs and its watershed is 29,661 acres. The northwest portion of the bay between Ward Island and Ennis Joslin Road in AU\_03 is known as the Blind Oso. Oso Bay receives much of the storm water runoff from the City of Corpus Christi as well as the cooling water from the Barney Davis Power Plant. The housing developments around the bay range from large, multi-acre tracts to neighborhoods with many houses per acre, to apartment complexes. Segment 2485 consists of two stations: **13440** AU\_02, **13442** AU\_03.

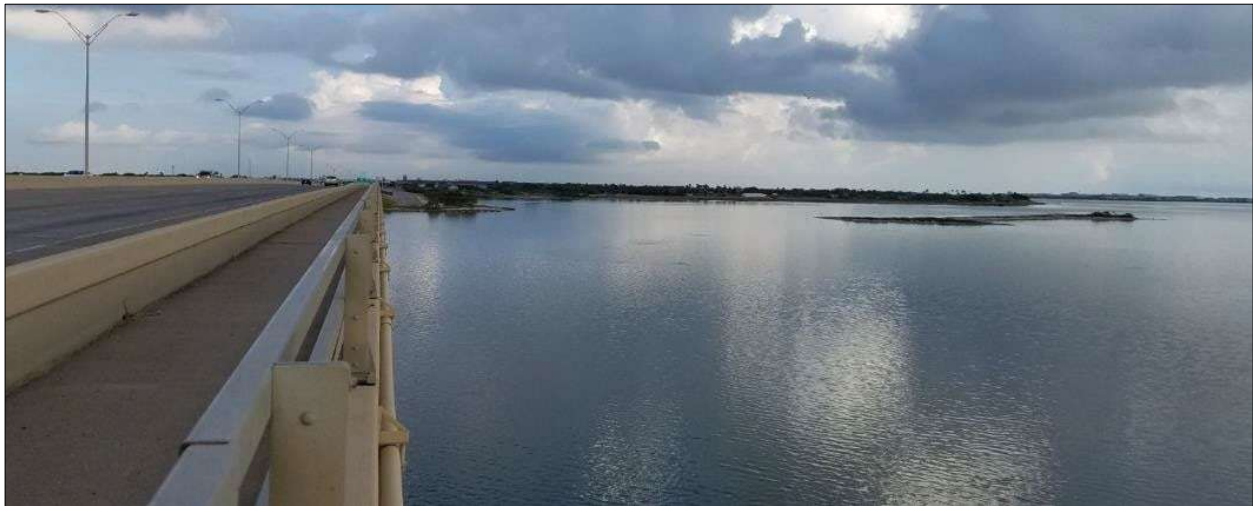
Figure 28: Oso Creek at SH286

**Segment Description** - Oso Creek flows 29.5 miles from a point 3 miles upstream of SH 44 west of Corpus Christi (pop. 326,554) to the confluence with Oso Bay in Nueces County. Its watershed is 118,380 acres. The southeastern end of the creek flows through highly developed areas of Corpus Christi. The northwestern end is primarily rural, but development is rapidly encroaching. Segment 2485A consists of two stations: **13028** and **13029**.

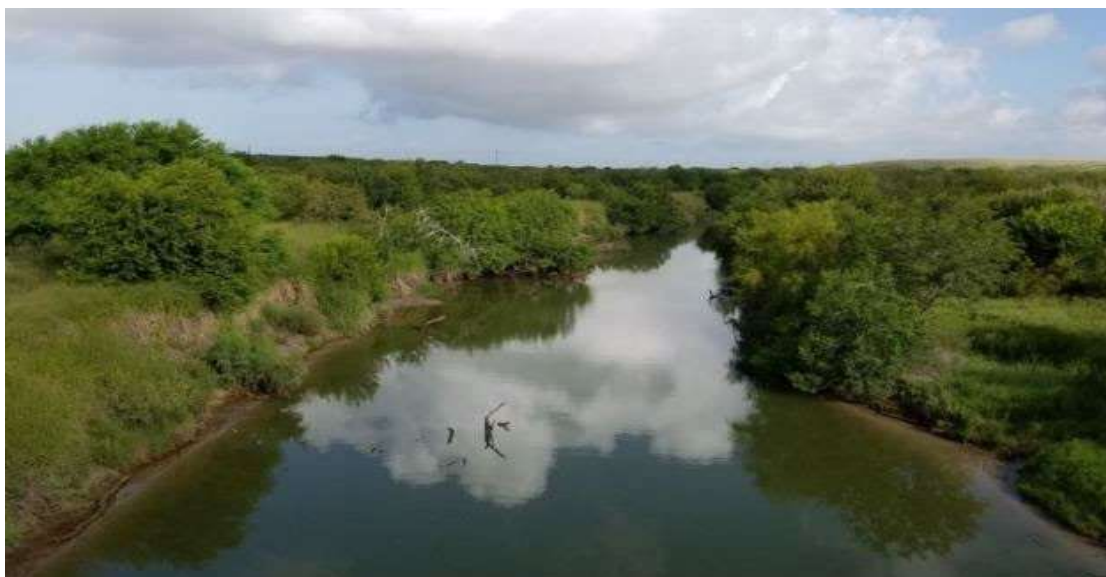
Figure 30: Unnamed Tributary of Oso Creek

**Segment Description** - The unclassified water body is from a point 3.2 miles west of SH 286 to the confluence with Oso Creek. This tributary is a primarily rural area, but development is rapidly encroaching.

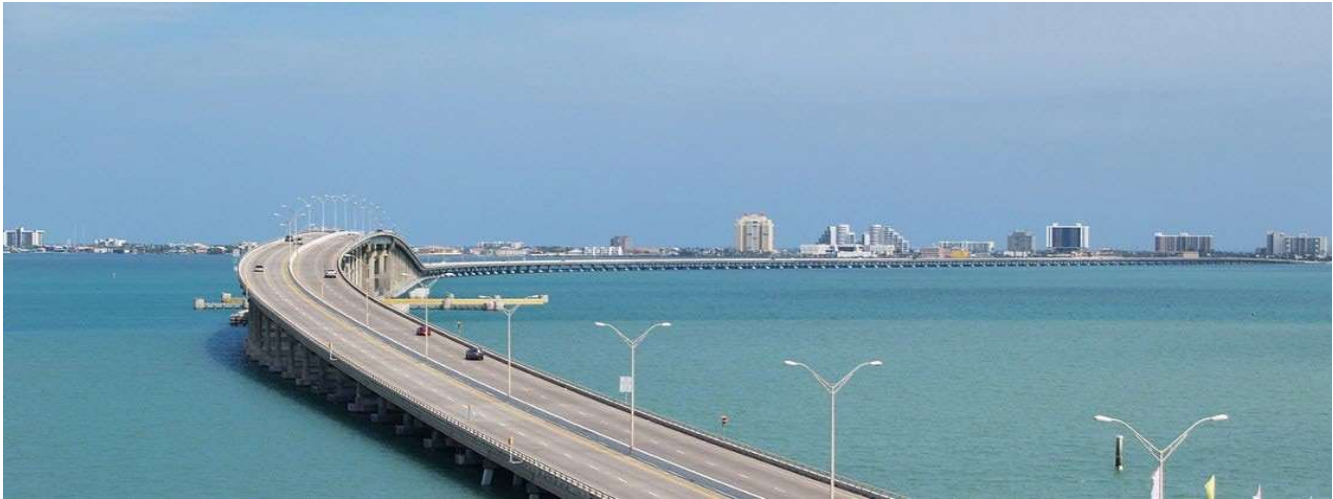
Figure 32: Laguna Madre

**Segment Description** - The Laguna Madre runs along the Texas coast from Corpus Christi Bay in Nueces County to the Brownsville Ship Channel in Cameron County. It is divided into three AUs and its watershed is 4,222,224 acres. The only development is in the very northern and very southern ends: Corpus Christi and Port Isabel, respectively. Padre Island National Seashore encompasses most of the barrier island to the east. The land to the west is predominantly large ranches such as the King Ranch. There are numerous WWTPs permitted to discharge to the Laguna Madre via the North Floodway, some of which are as far west as McAllen. Segment 2491 consists of six stations: **13445 AU\_01**, **13446 AU\_03**, **13447 AU\_02**, **13448 AU\_01**, **13449 AU\_01**, **14870 AU\_03**.

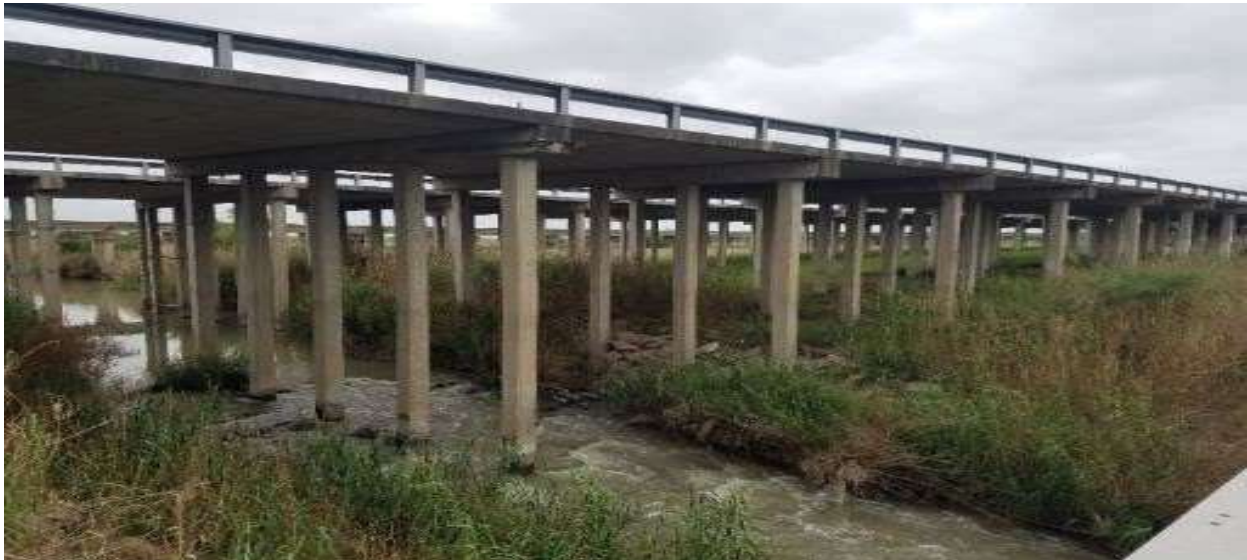
Figure 34: North Floodway Station 20930

**Segment Description** – Located in the Lower Rio Grande Valley (LRGV), the North Floodway is used to drain WWTP effluent, return flows from irrigation, and diverted flood waters flows from the Arroyo Colorado. It runs 2.5 kilometers south of the intersection of US 77 and FM 2629 in Sebastian.

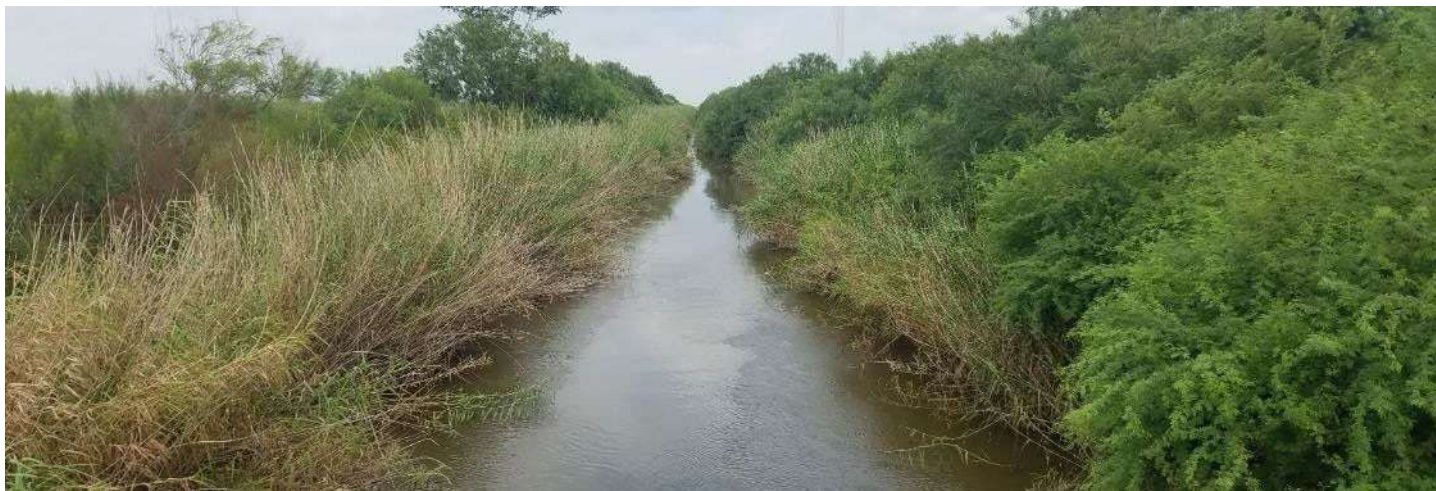
Figure 35: Raymondville Drain at CR 445

**Segment Description** – Raymondville Drain flowing into the Laguna Madre. Segment 2491C consists of one active station numbered 22004 AU\_01.

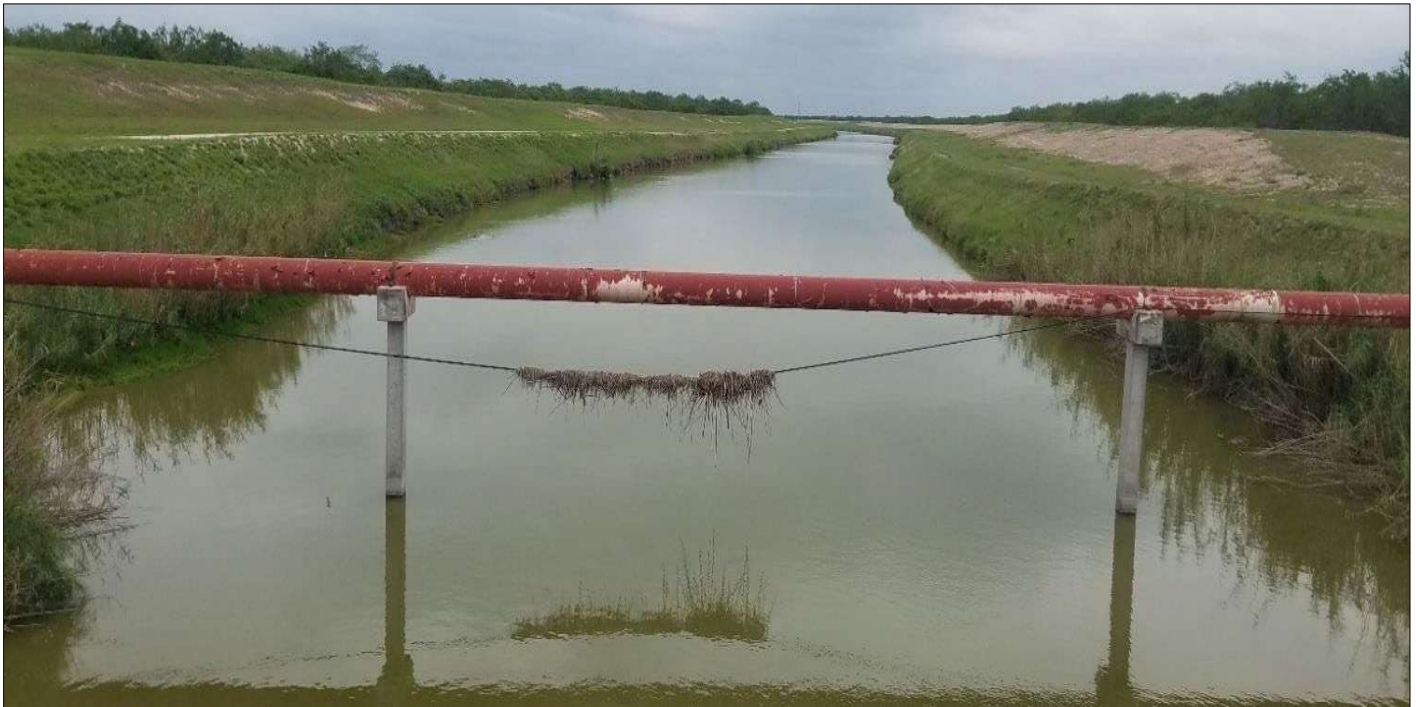
Figure 37: Hidalgo Main Drain

Hidalgo Main Floodwater Channel flowing into Laguna Madre. Segment 2491C\_03 consists of one station numbered **22003** AU\_01.

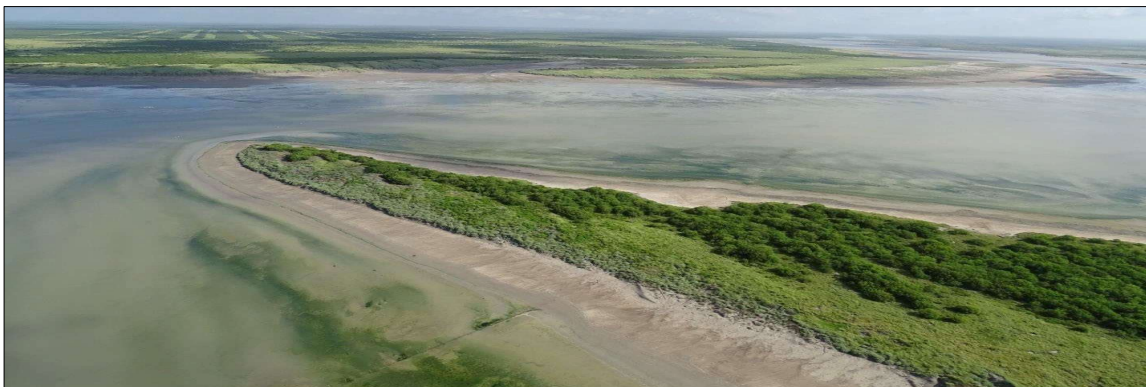
Figure 38: Alazan Bay

**Segment Description** - Baffin Bay is a hypersaline secondary bay located in Kleberg and Kenedy counties. Alazan Bay is a tertiary bay located in the northeastern arm of Baffin Bay in Kleberg County, Cayo del Grullo is the northwestern arm in Kleberg County, and Laguna Salado is the western arm in Kleberg and Kenedy Counties. Its watershed is 1,376,310 acres. The City of Kingsville (pop. 25,487) is the only large city in the watershed. Most of the bay is surrounded by large ranches such as the King Ranch. There are only a few public access points. Segment 2492 consists of two stations: **13450 AU\_01** and **13452 AU\_01**.

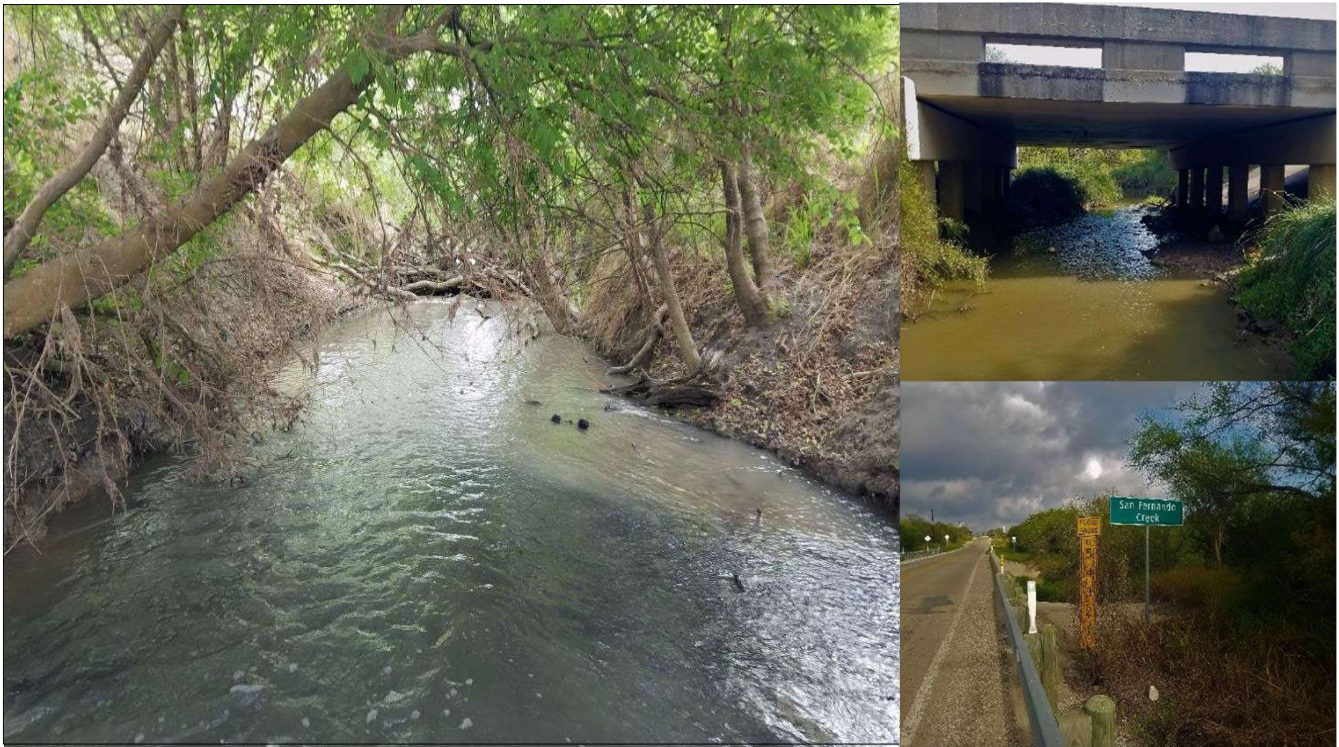
Figure 40: San Fernando Creek at US 77

**Segment Description** - San Fernando Creek flows 45.6 miles from a point just east of the Nueces and Jim Wells County lines to the confluence of the Cayo del Grullo arm of Baffin Bay in Kleberg County. Its watershed is 288,572 acres. While primarily rural, the creek flows through the City of Alice (pop. 18,887) and the City of Kingsville (pop. 25,487). There are a number WWTPs that discharge into the creek providing consistent flow. The watershed also has several small communities on septic systems. Segment 2492A consists of one station numbered **13033**.

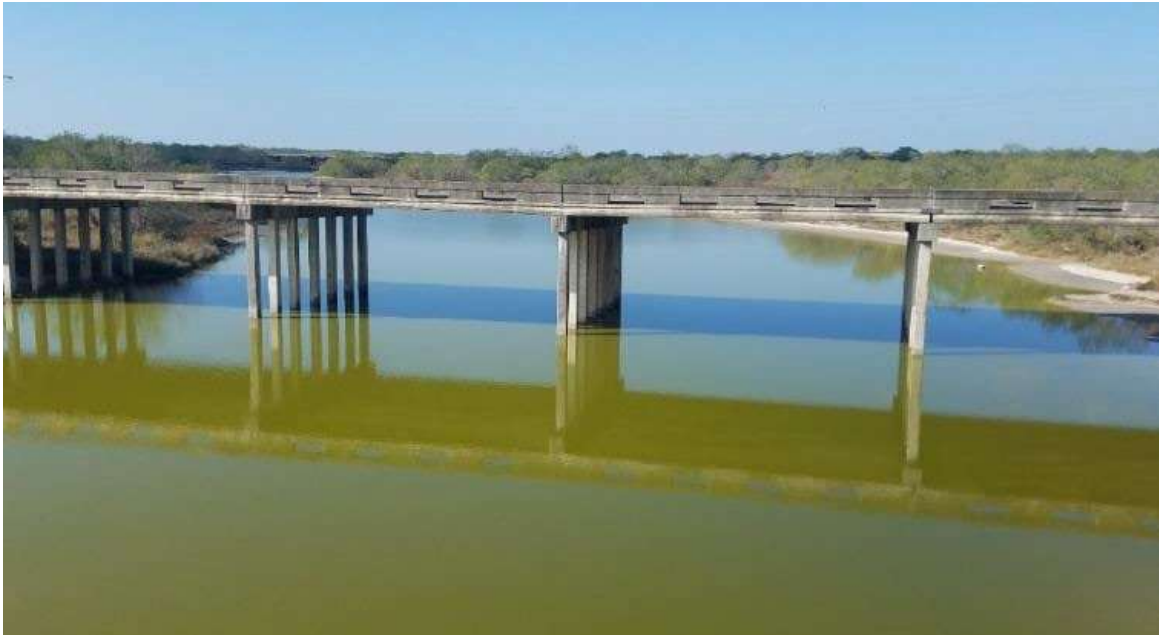
Figure 42: Los Olmos Creek at US 77

**Segment Description** – The tidal portion of Los Olmos Creek starts from the confluence with Laguna Salada upstream 10.9 km (6.8 mi) southwest of Riviera. Segment 2492B consists of one station numbered **13034** AU\_01.

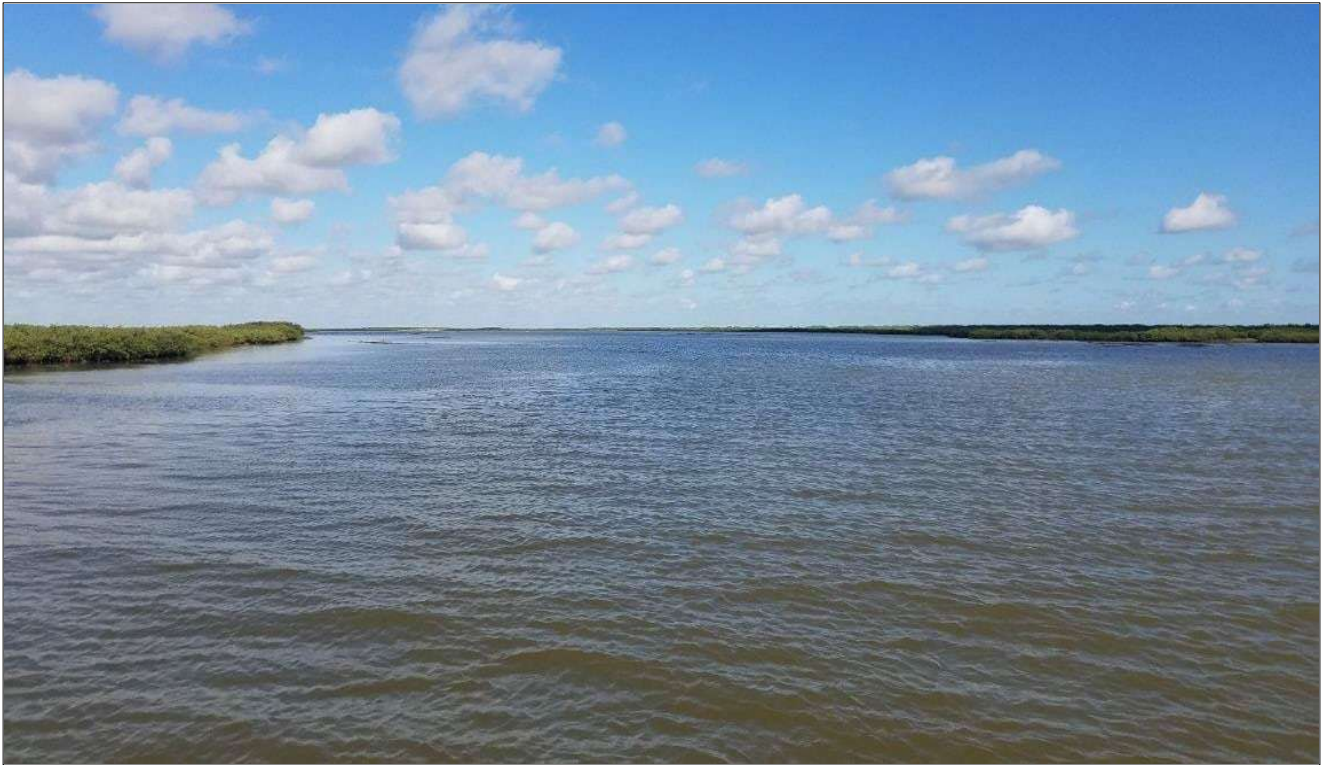
Figure 47: San Martin Lake Tidal

**Segment Description** – San Martin Lake starts from the confluence with the Brownsville Ship Channel. upstream to the confluence with drainage ditches flowing into San Martin Lakes. Segment 2494C consists of one station numbered **22170 AU\_01**.

In **Segment 2494C: 22170 (AU\_01)** for Chlorophyll-a it failed to meet the screening level of 11.6 mg/L: the average exceedance was 24.83 mg/L. Total phosphorus failed to meet the screening level of 0.21 mg/L: the average exceedance was 0.49 mg/L. The bacteria impairment is currently classified as 5r, a WPP is under development or accepted by EPA for this parameter.
