Nueces River Authority
Steering Committee and Stakeholder Update #4
(4th Quarter of FY 2016-17)
June - August 2016

Routine Clean Rivers Program (CRP) Monitoring

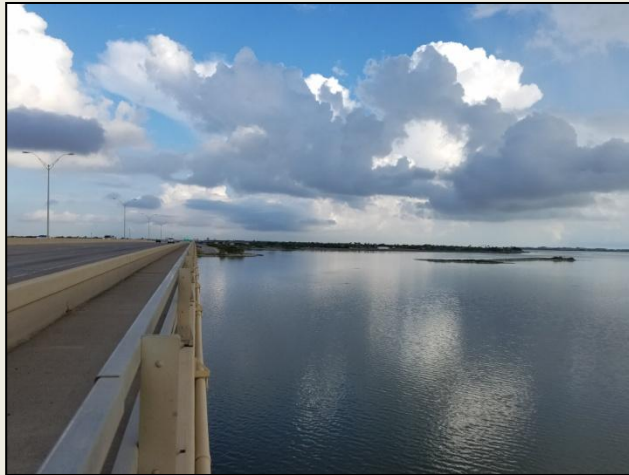
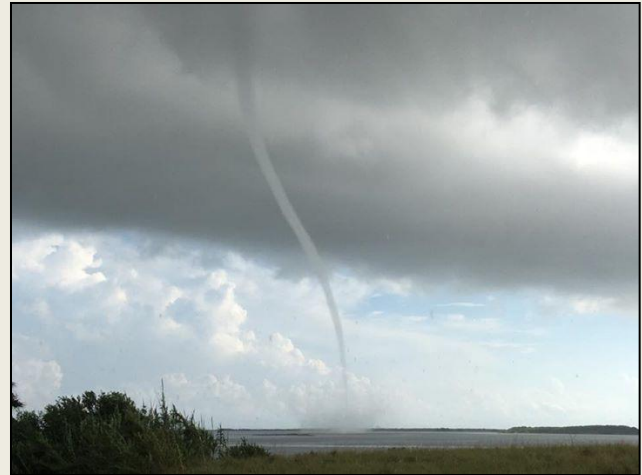
The Nueces River Authority (NRA) conducted routine quarterly water quality monitoring at 9 coastal stations and 37 river stations. No 24 hour dissolved oxygen monitoring was conducted due to flooding at the stations. Monitoring on Oso Bay (station ID 13440) preceded a spectacular water spout by approximately ten minutes. The image (below, right) was courtesy of the Corpus Christi Police Department Blotter.

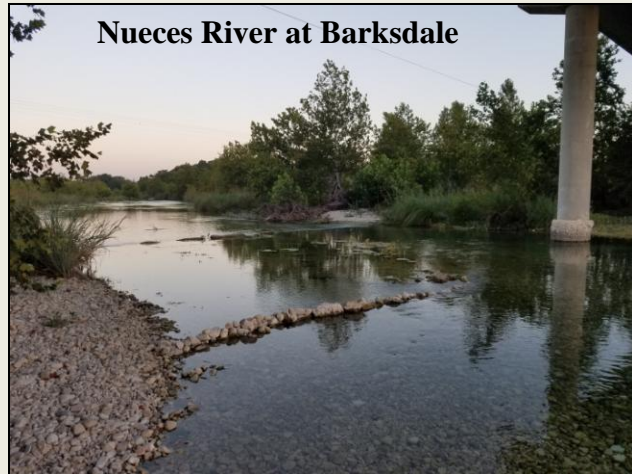
NRA resumed quarterly sampling on the Nueces River at Barksdale in the Upper Basin (Station ID 13005). Station 13005 was discontinued in fiscal year 2015 in favor of a historical site downstream at the 19-mile Crossing (Station ID 17604). Both sites are being monitored now. Specific conductance was 425 μ mhos in Barksdale and 436 μ mhos at the 19-mile crossing. Bacteria concentrations were 4cfu/100mL and 51 cfu/100mL respectively; the standard there is 126 cfu/mL.

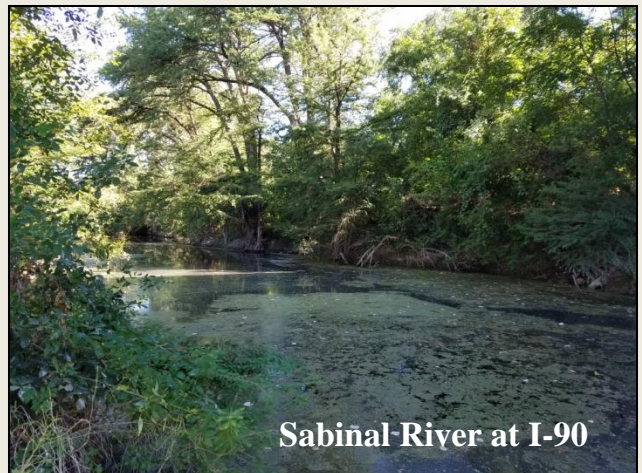
Water appearance on the Sabinal River (Station ID 12993) below the bridge at I-90 was less than inviting due to an abundance of floating algae. Dissolved oxygen values were a little low (3.5mg/L, 42.0% saturation). A man walking his dog nearby mentioned that the alga had been “pretty bad recently”. Floating algae was not observed on a subsequent trip out in late August. Bacteria concentrations were a little high though (308 cfu/100mL); the standard there is 126 cfu/100mL.

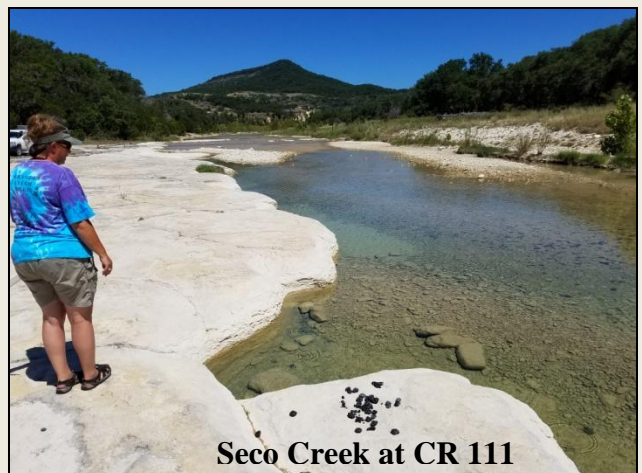
NRA field staff also picked up a sampling station on Seco Creek at County Road 111 (Station ID 13013). The clear water creek station, located down a long caliche road, is just downstream of the USGS stream gauge (Station 08201500). Water temperature was on the warm side compared with other hill country spring fed creeks (31.5 °C/88.7°F). Specific conductance was 402 μ mhos. The bacteria concentration was 99 cfu/mL; the standard there in 126cfu/mL.

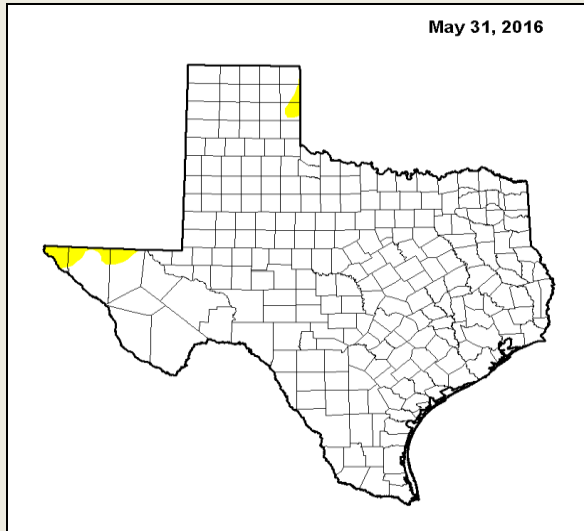
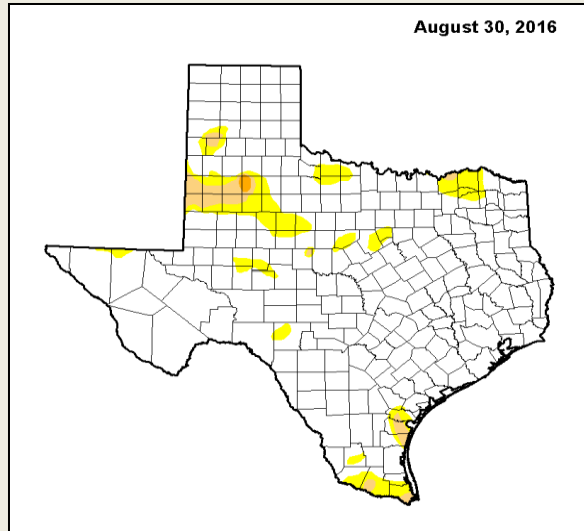
Much of the Nueces River Basin and adjoining basins were rapidly returning to drought conditions in the fourth quarter (June – August 2016) during the first half of the quarter, however, the rains did come. The drought index (The US Drought Monitor for Texas) shows the location of drought conditions in Texas compared with the beginning of the quarter.

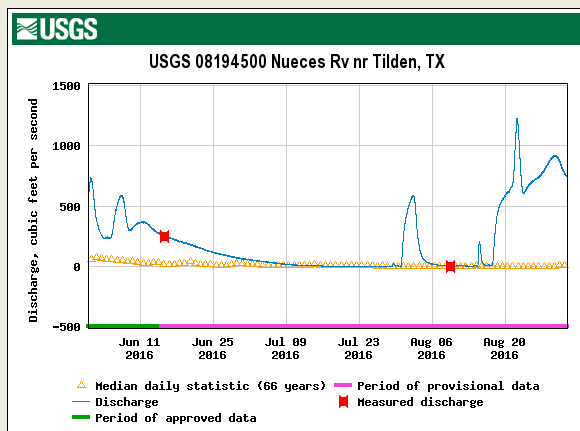
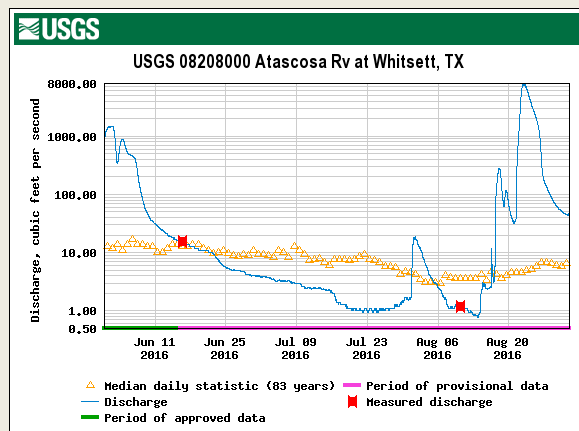
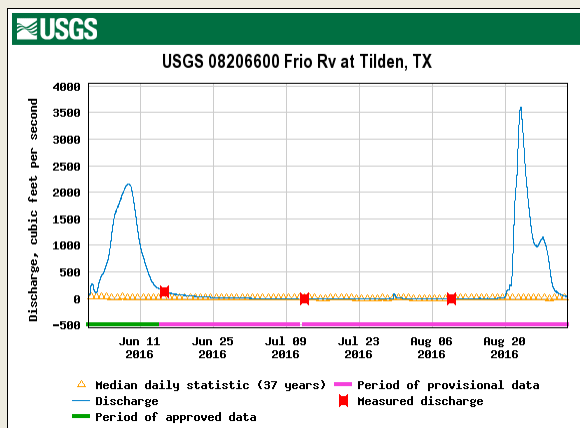
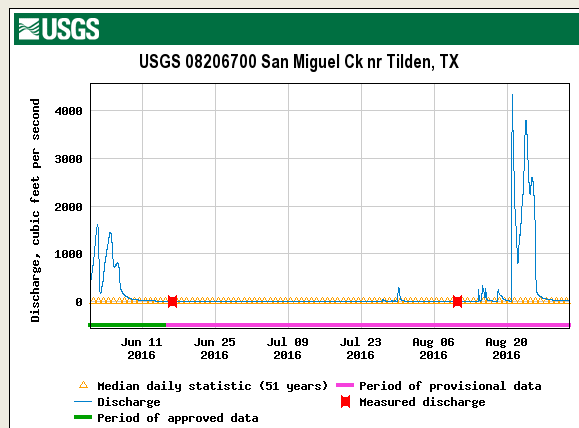
A significant precipitation event in the Nueces River Watershed occurred in August sending river levels rising. The Atascosa River, which flows into Lake Corpus Christi, recorded the greatest flow rates (around 8,000 cfs).

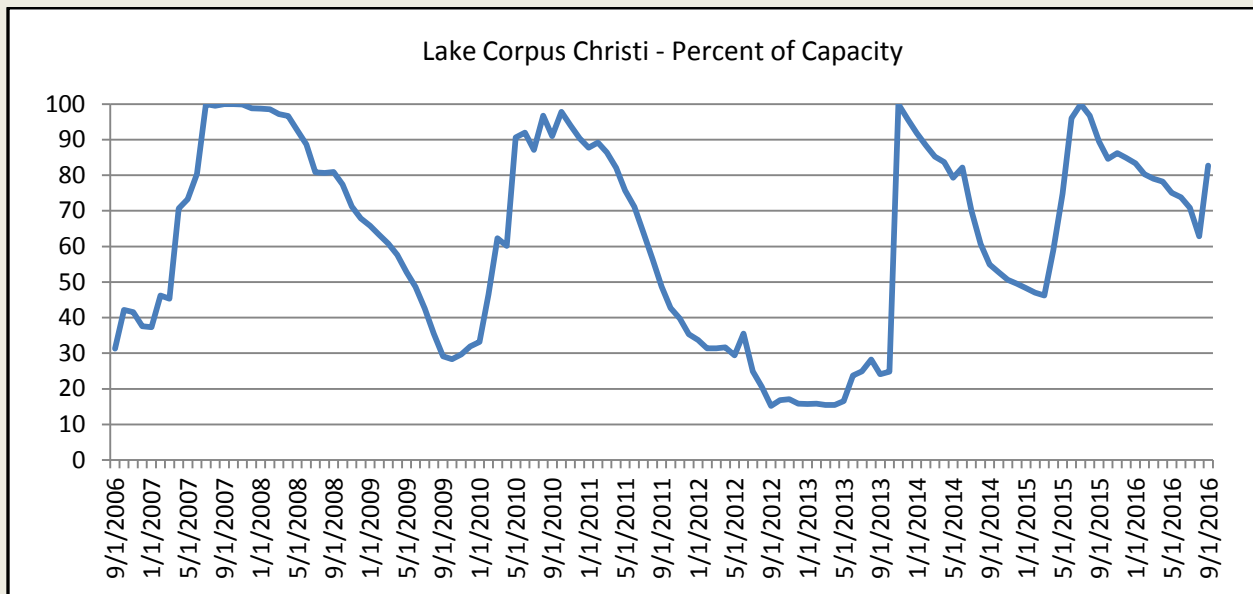
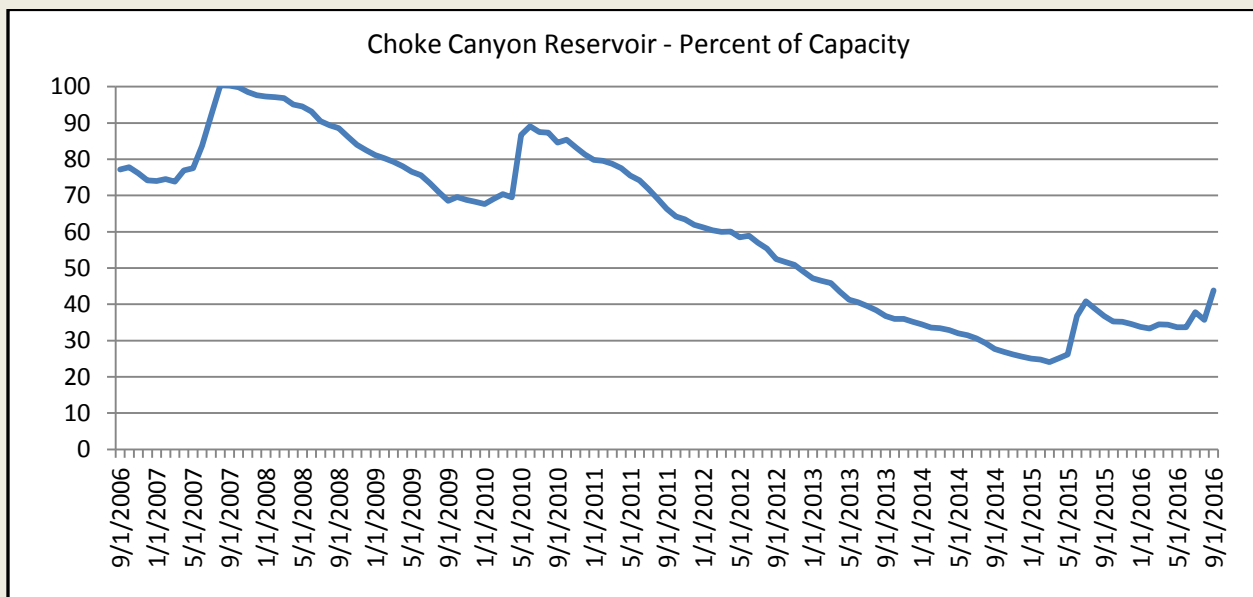
Lake levels responded to the August rain event with an increase in storage of approximately 10% from 44.6% to 54.2% of combined capacity (Choke Canyon + Lake Corpus Christi). Total inflows to the Reservoir System were 114,371 acre-feet in August. For the Daily Reservoir System and Pass-Thru Status Report, please visit the website <https://www.nueces-ra.org/CP/CITY/passthru/index.php>.

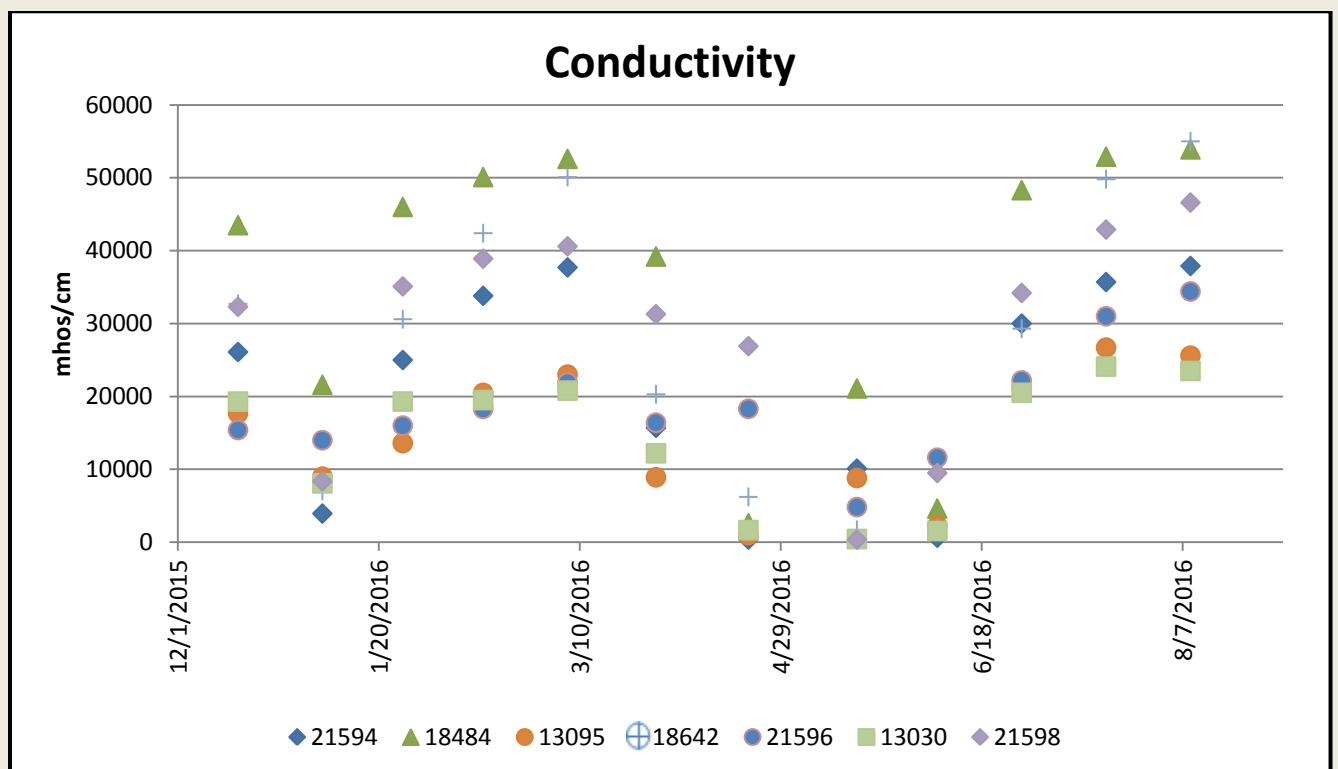
Phase 2 of the Petronila Creek Tributary Study, which analyzes chloride, sulfate, and TDS at seven sites, was completed in August 2016. Specific Conductance trends over the course of the yearlong study are summarized in the chart below.

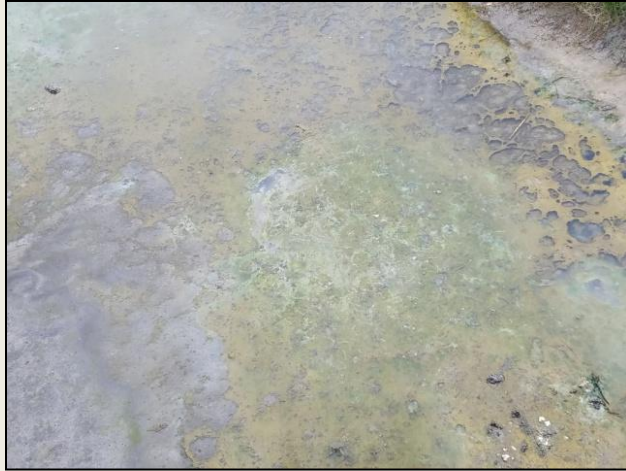
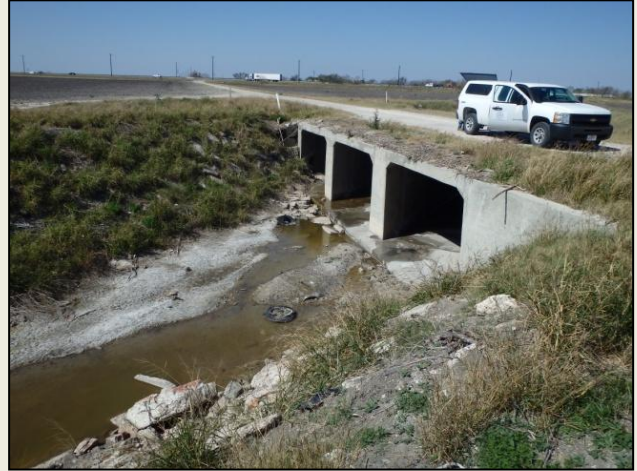
Station 21594 is a tributary to Petronila Creek located just east of US77 and north of Driscoll on County Road 233. The site is bordered by farmland. Water depth is approximately 0.2m during low flow conditions and has a muddy bottom. Colorful algal mats have been observed just upstream of the crossing on numerous occasions. Riparian vegetation is restricted to small herbaceous plants and grasses along the straightened and channelized drainage.

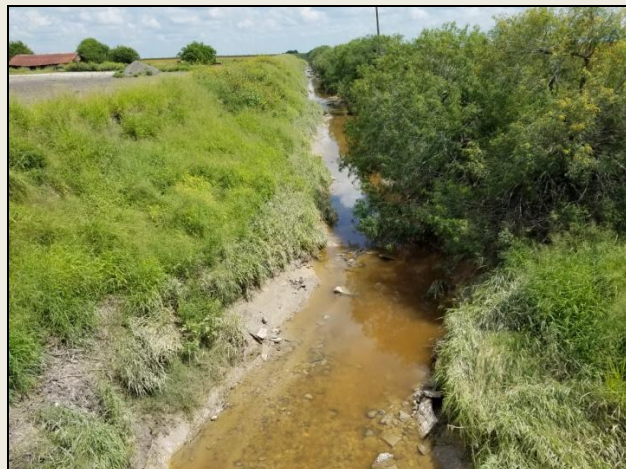
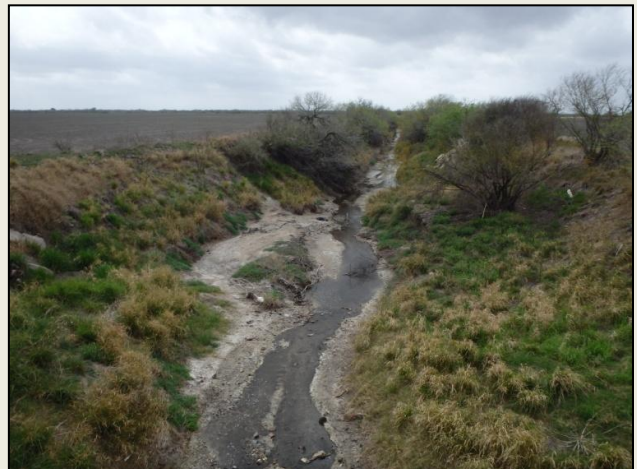
Station 18484 is a tributary to Petronila Creek located just east of US77 and north of Driscoll on County Road 24. The site is approximately 2 miles down an unpaved road which is bordered by farmland and a farmhouse. Water depth is approximately 0.1m during low flow conditions and has a muddy/gravel bottom. Water color at this site during low flow conditions is orange/brown but with low turbidity. Riparian vegetation is limited to the area adjacent to the drainage and includes grasses along with mesquite and huisache.

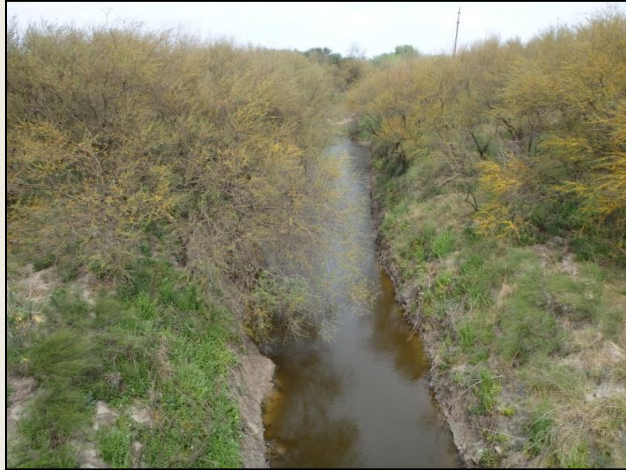
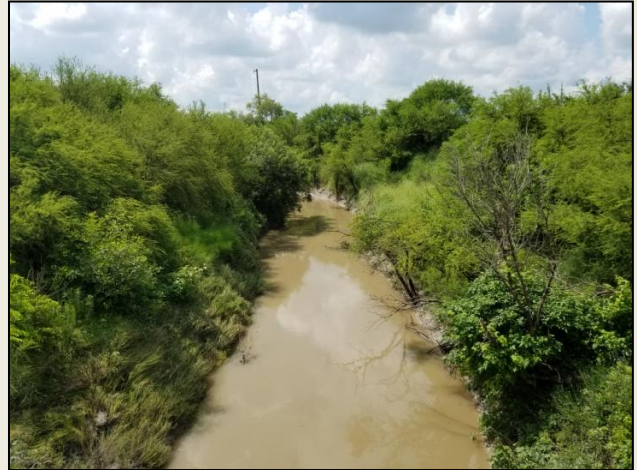
Station 13095 is located at the bridge crossing at Petronila Creek on County Road 232. The creek is narrow and winding in this area and subject to flooding. Water depth at this site is approximately 0.3m during low flow conditions with a firm but muddy bottom. The riparian vegetation consists mainly of tall grasses and huisache trees. This location is also used for illegal dumping.

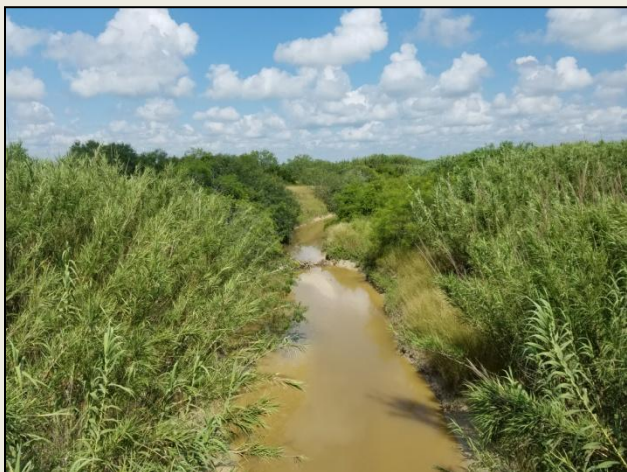
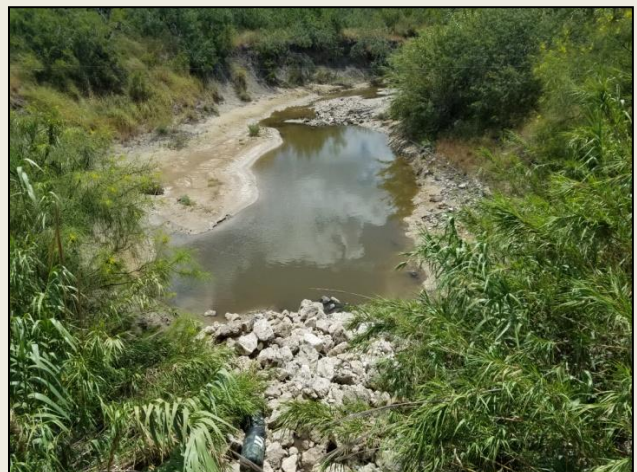
Station 18642 is a tributary to Petronila Creek located at a bridge crossing off FM 892 just south of the crossing of Petronila Creek on the same road. The site is recognizable due to a large stand of river cane on the upstream side of the bridge crossing; downstream, a scoured out pool exists. Water depth under the bridge is approximately 0.2m and rocky (medium to large limestone rocks). This site is commonly used as a dumping ground for carcasses and household items.

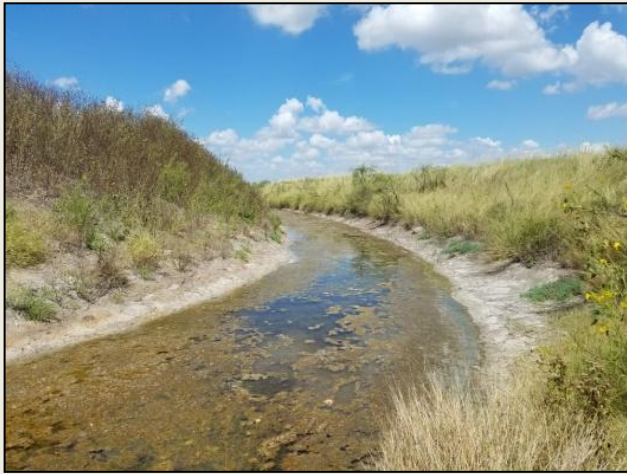
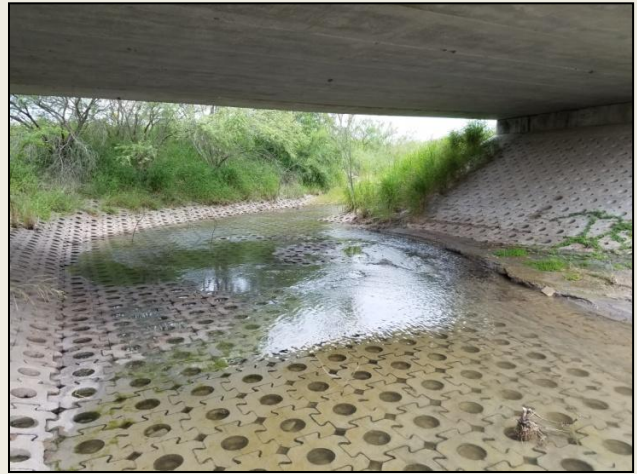
Station 21596 is a tributary to Petronila Creek located at a bridge crossing off FM 892 just south of Station 18642. There is a small pool located just downstream of the bridge. The stream channel under the bridge is lined with brick that has some erosion on the downstream portion. Upstream, shoal grass (*Halodule wrightii*) and surface floating algae proliferates during low flow conditions. Riparian vegetation consists of grasses, mesquite, retama, huisache and herbaceous plants.

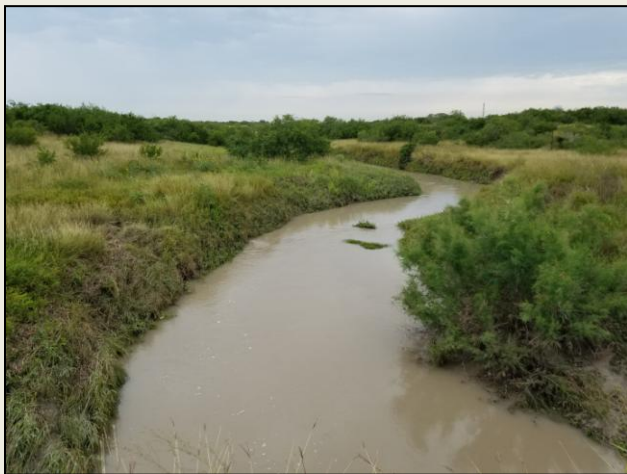
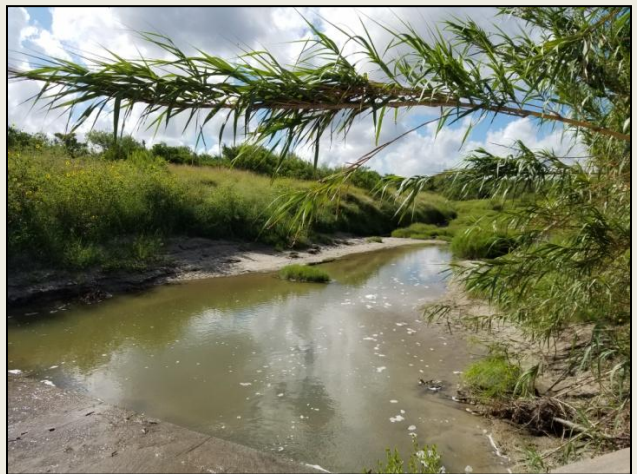
Station 13030 is a tributary to Petronila Creek located on FM 70 just east of the crossing at Petronila Creek. This site is a fairly dangerous site to conduct bridge sampling so field staff sample from the base of the bridge. Bottom sediments are fine silts. Water depth is approximately 0.3m just downstream from the base of the bridge. Riparian vegetations include river cane, retama, and grasses.

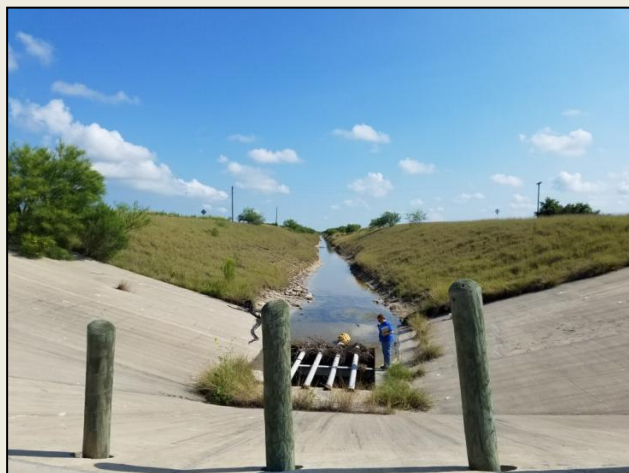
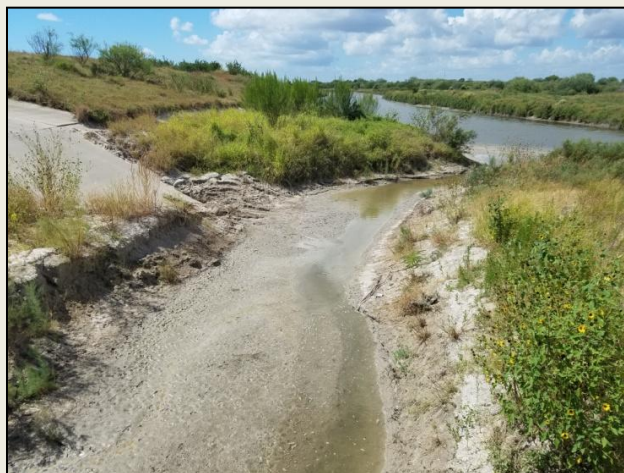
Station 21598 is a tributary to Petronila Creek located on FM 70. NRA staff travel approximately 1 mile from FM 70 on a dirt road that is owned and maintained by the City of Corpus Christi. Monitoring takes place just upstream from a concrete-lined ditch relief culvert. The confluence of the tributary and Petronila Creek is approximately 30m downstream of the culvert. Water depth is approximately 0.1m during low flow conditions. NRA field staff has documented shoal grass (*Halodule wrightii*) in the streambed just upstream from the grate (bottom left photo). Riparian vegetation consists of grasses, herbaceous vegetation and salt cedar (downstream of the culvert).

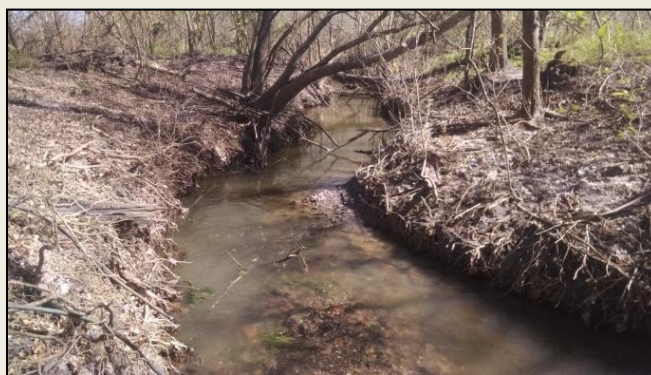
Since 2002, Oso Creek (Segment 2485A), which flows 28 miles to the confluence of Oso Bay in Nueces County has been identified as being impaired for having bacteria concentrations that exceed state water quality standards. Since 2003, the TCEQ and the TSSWCB have conducted studies of bacteria sources and quantities in the Oso Creek

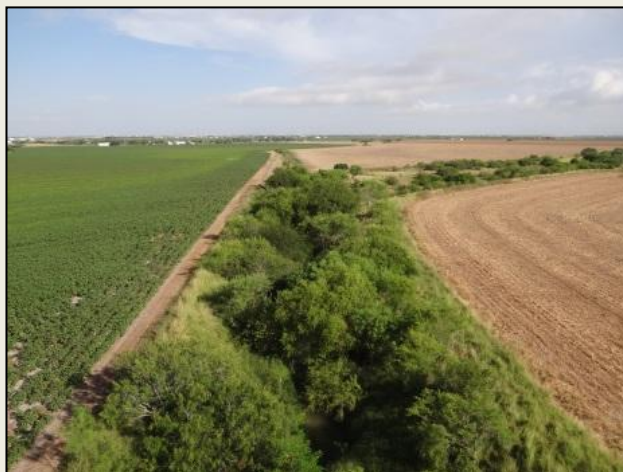
Riparian conditions along Oso Creek (2485A), West Oso Creek (2485D) and two unnamed tributaries were observed by helicopter on July 19th, 2016. The aerial survey identified the present state of the riparian corridor, potential sites to conduct ground level evaluations and identify areas where riparian areas could possibly be expanded. NRA will partner with the Coastal Bend Regional Stream Team to monitor up to three, ground level, visual assessment sites on a regular basis.

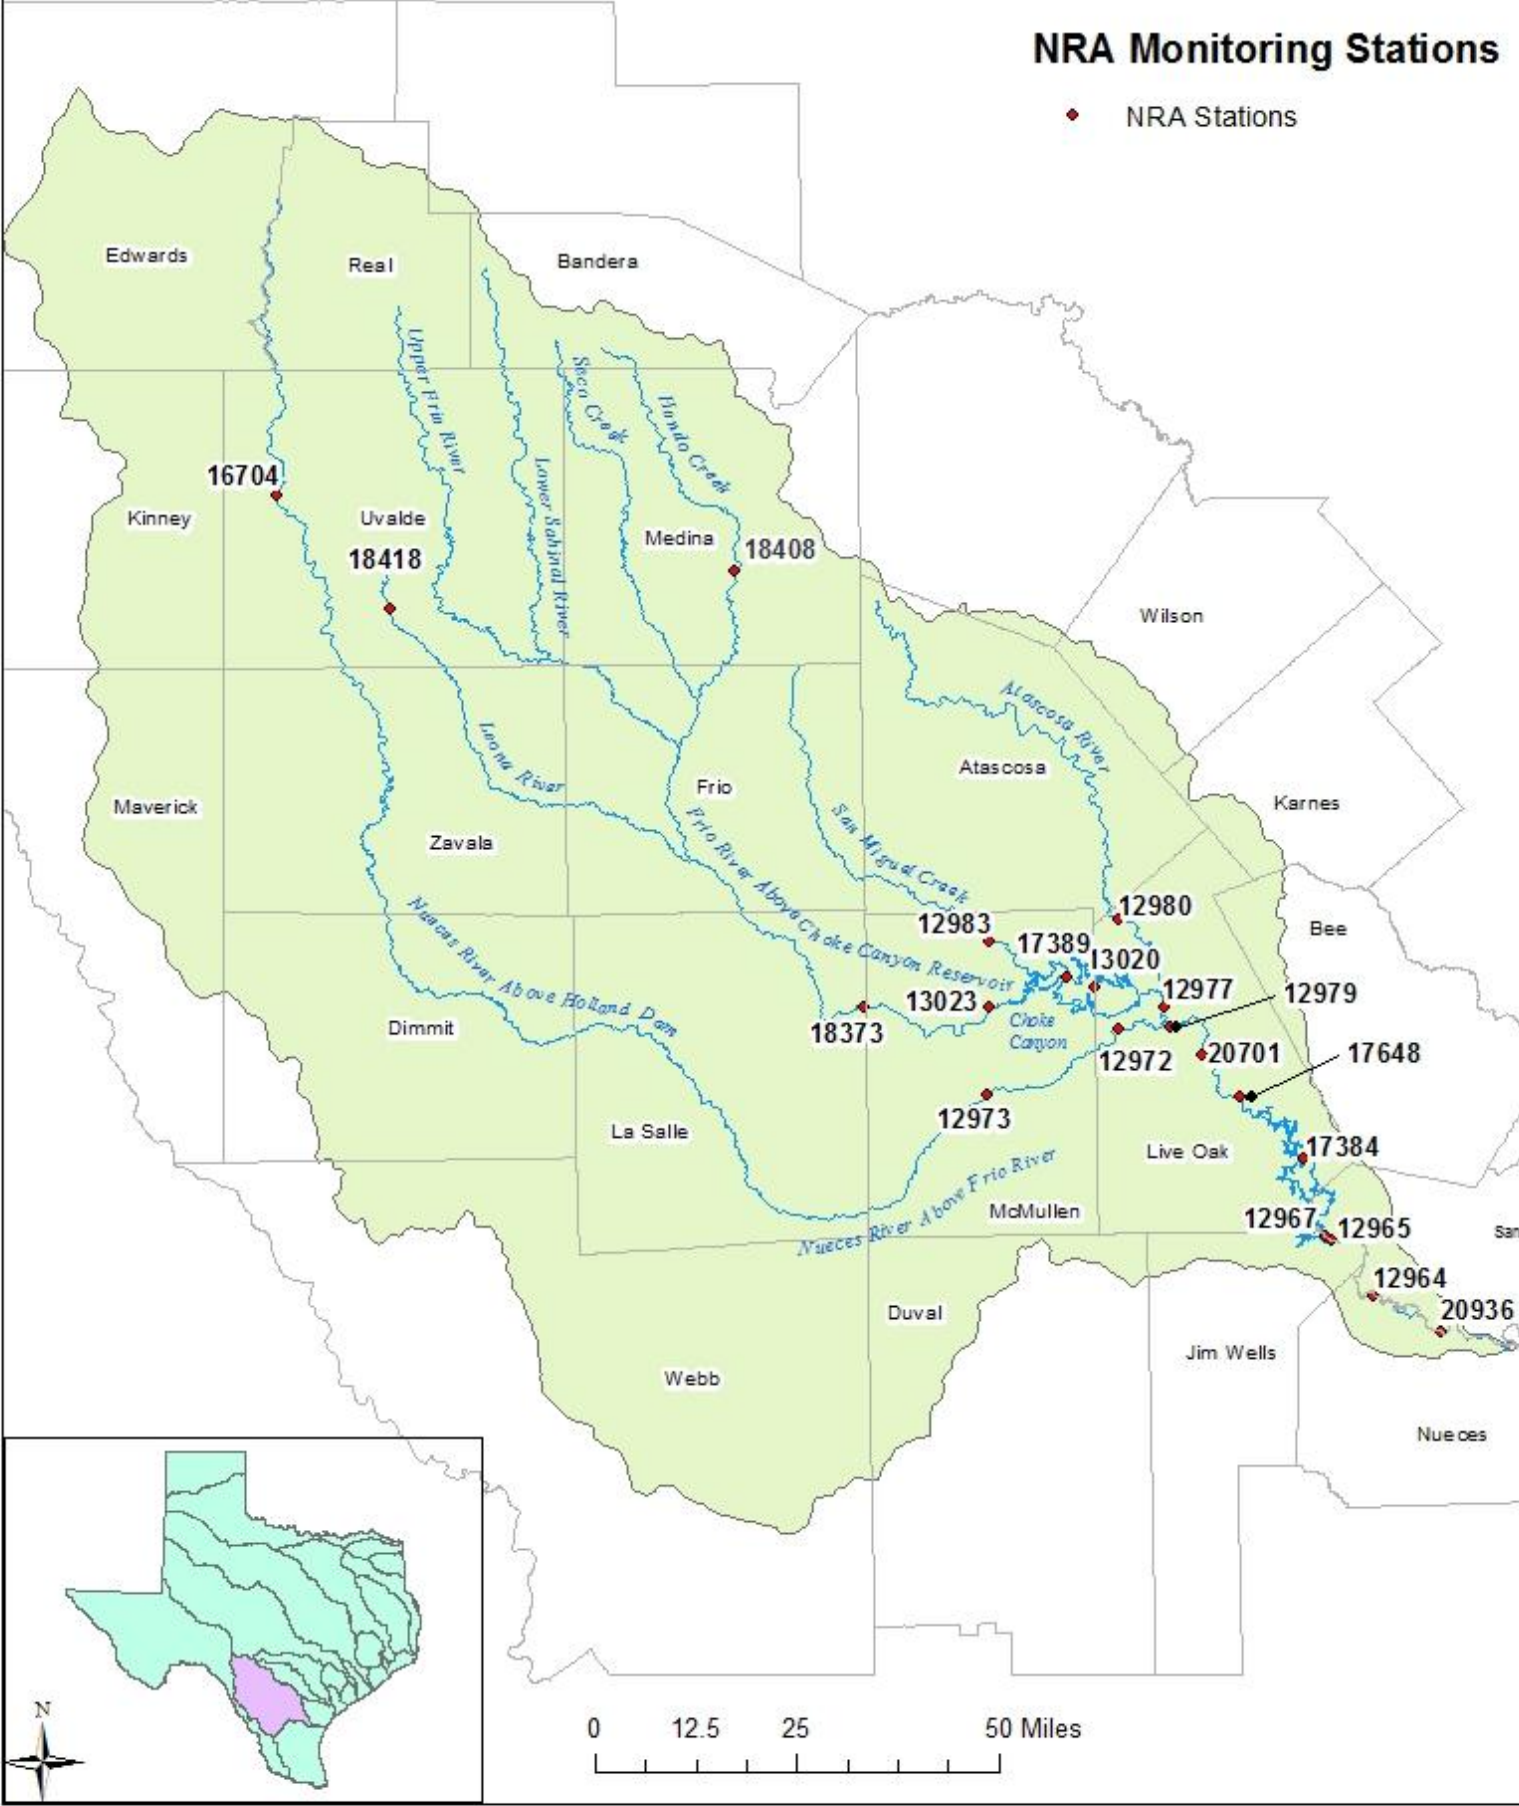
NRA Monitoring Stations

◆ NRA Stations

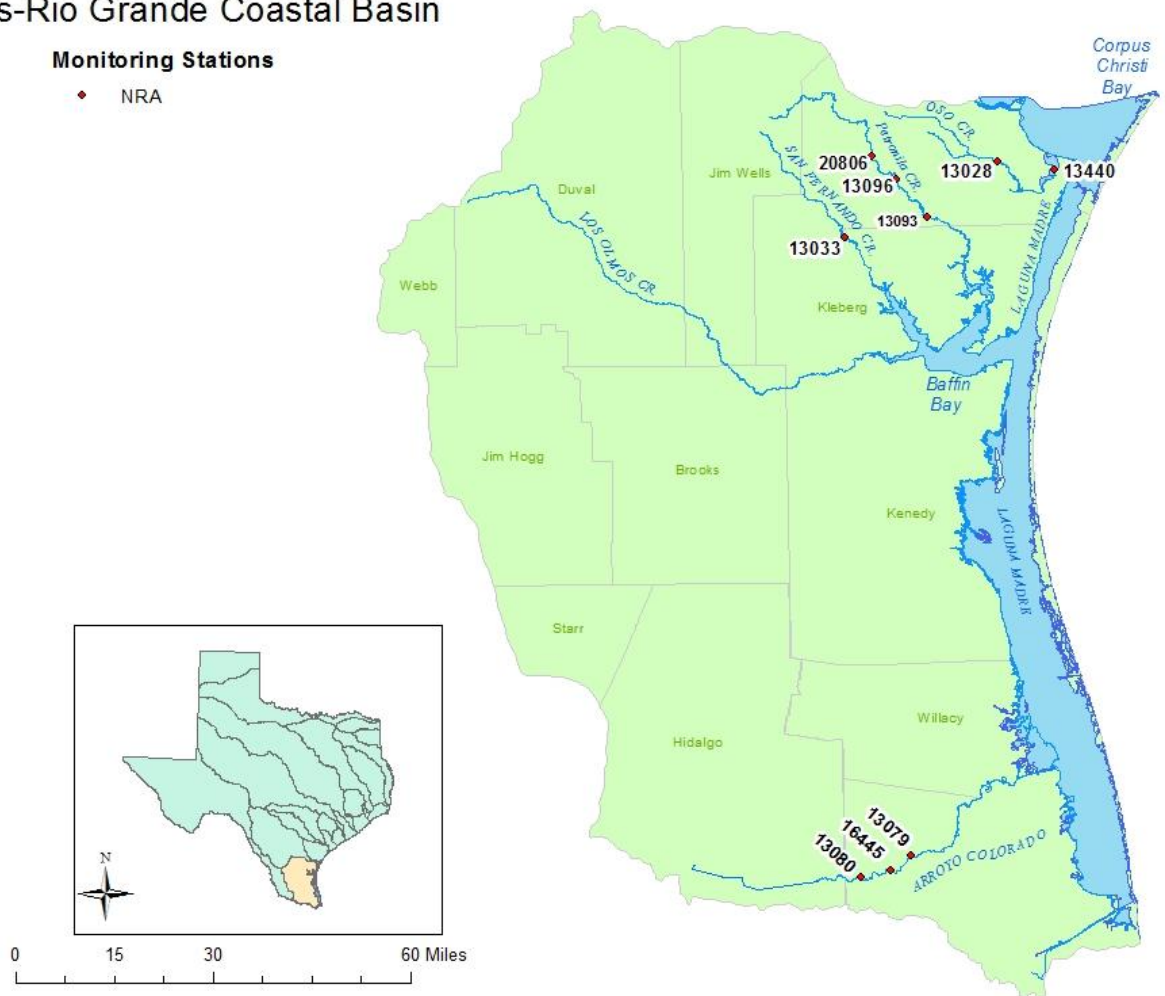
Monitoring Stations

◆ NRA
