# *Clean Rivers Program Quarterly Newsletter*

**Quarter #1, September - November 2021**

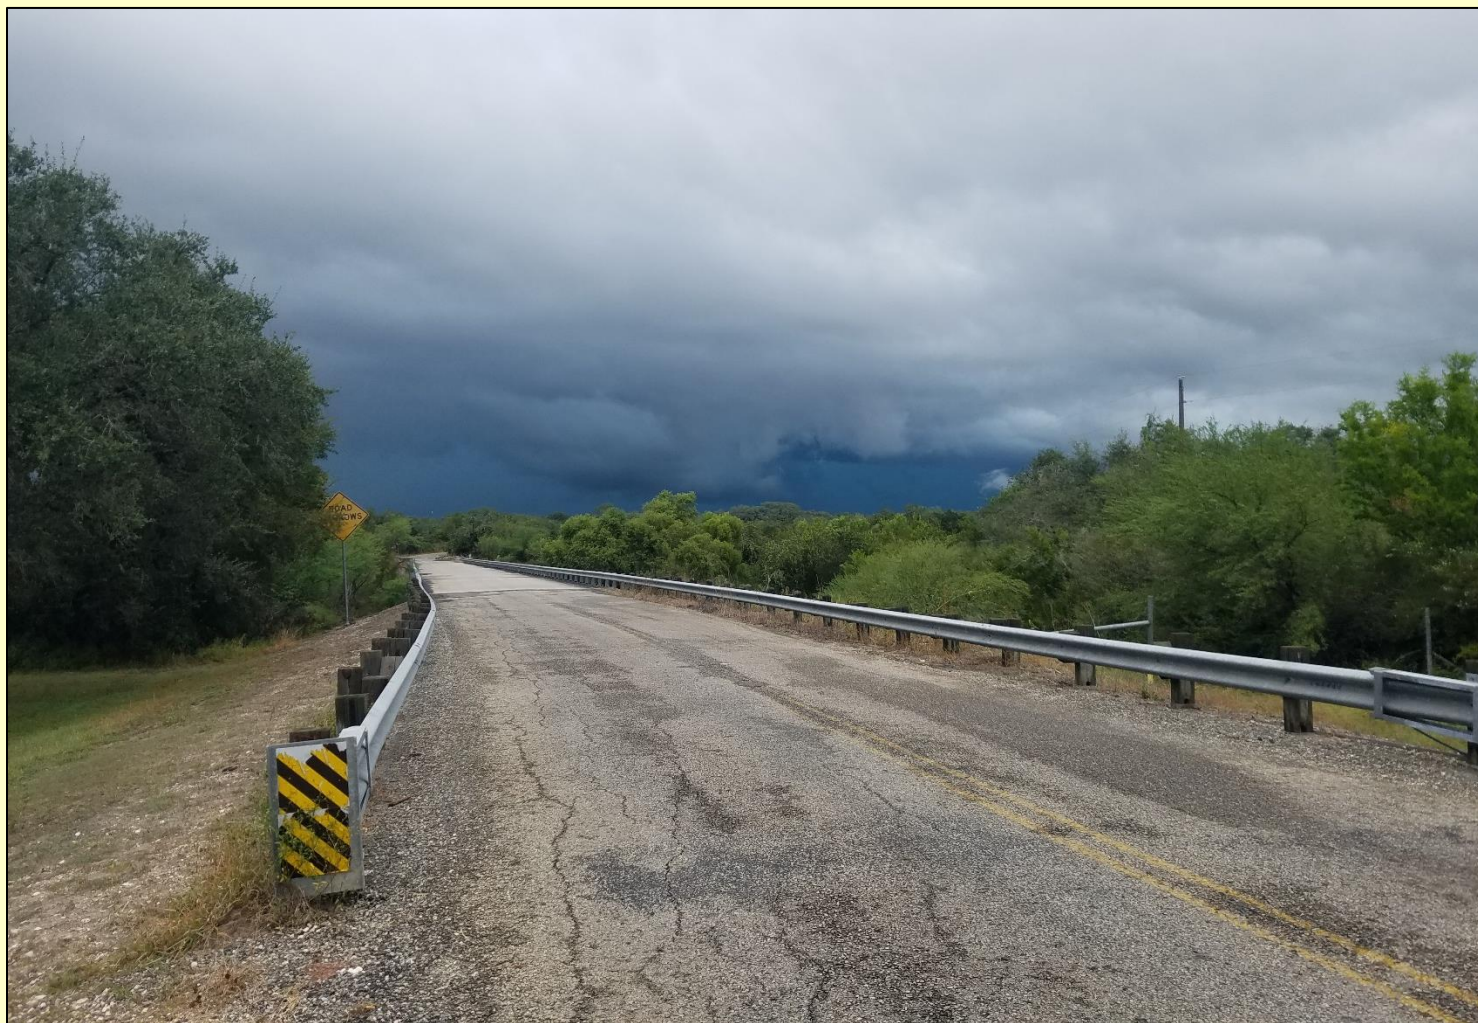
Station 12952 – Aransas Creek east of Skidmore

Water quality monitoring on the Mission and Aransas rivers occurred on September 29<sup>th</sup>. Chiltipin Creek was monitored on September 29<sup>th</sup>. Elevated bacteria concentrations were encountered on all locations. Heavy rains during the sampling event likely attributed to elevated bacteria concentrations due to non-point source runoff.

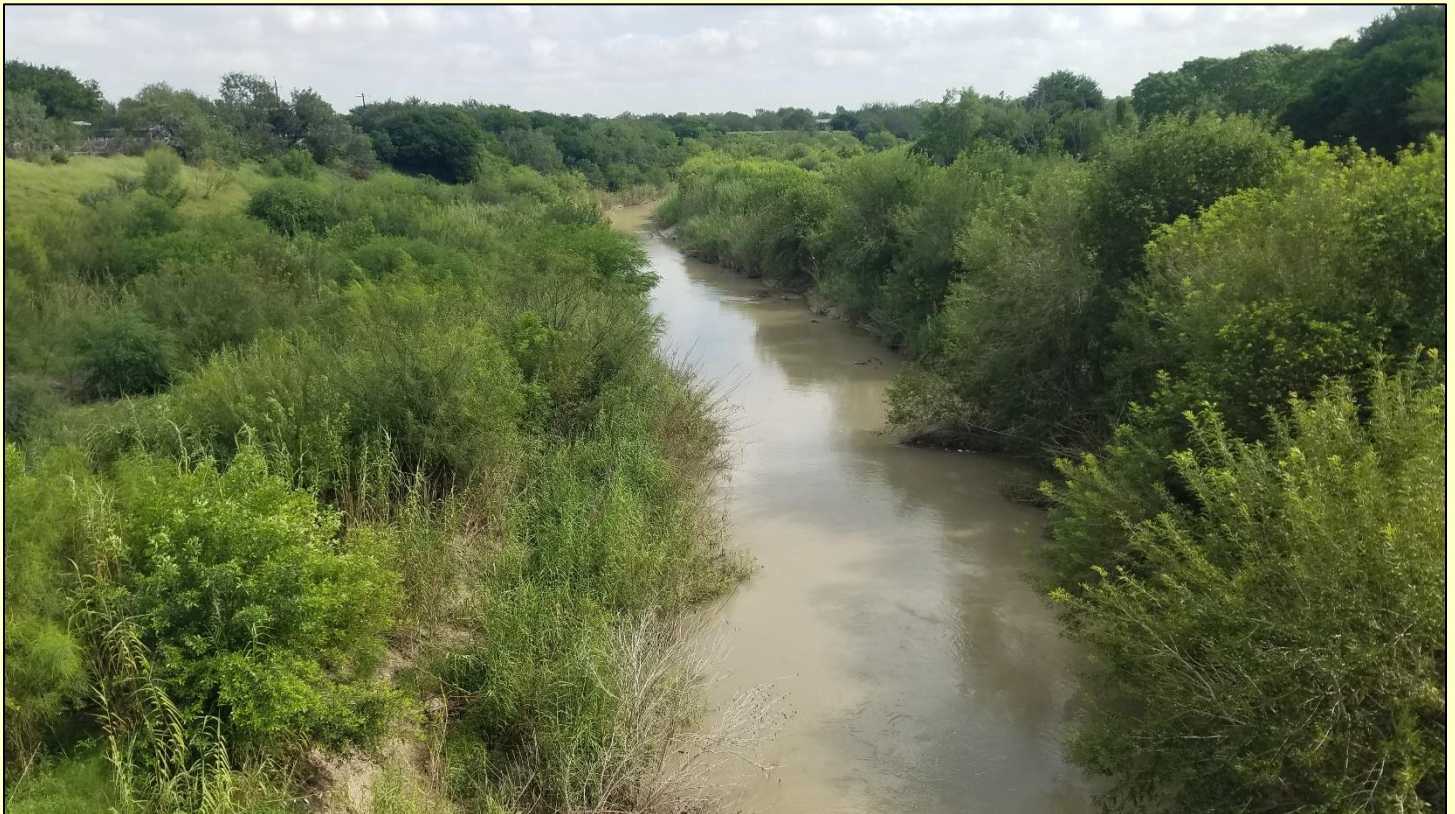
Station 13079 - Arroyo Colorado at US 77 in Harlingen

Station 13079 is located on the above tidal portion of the Arroyo Colorado (Segment 2202) at the US-77 Bridge in Harlingen. Water quality at Station 13079 was monitored on October 26<sup>th</sup>. Bacteria levels (204 MPN) were above the standard (126 MPN) during the site visit. Nitrate concentrations were highly elevated (6.75 mg/L) compared with the screening level of 1.95 mg/L. Total phosphorus was 0.23 mg/L, below the screening limit of 0.69 mg/L. Chlorophyll-*a* concentrations (12.4 µg/L) were just under the screening level of 14.1 µg/L. Bacteria concentrations were highly elevated at 2,000 CFU/100 mL (*E. coli* standard of 126 CFU/100mL) following an approximate 1.5 inches of rain 3 days prior to the site visit (*E. coli* standard of 126 CFU/100mL). Flow was 140 CFS according to the USGS stream gage.

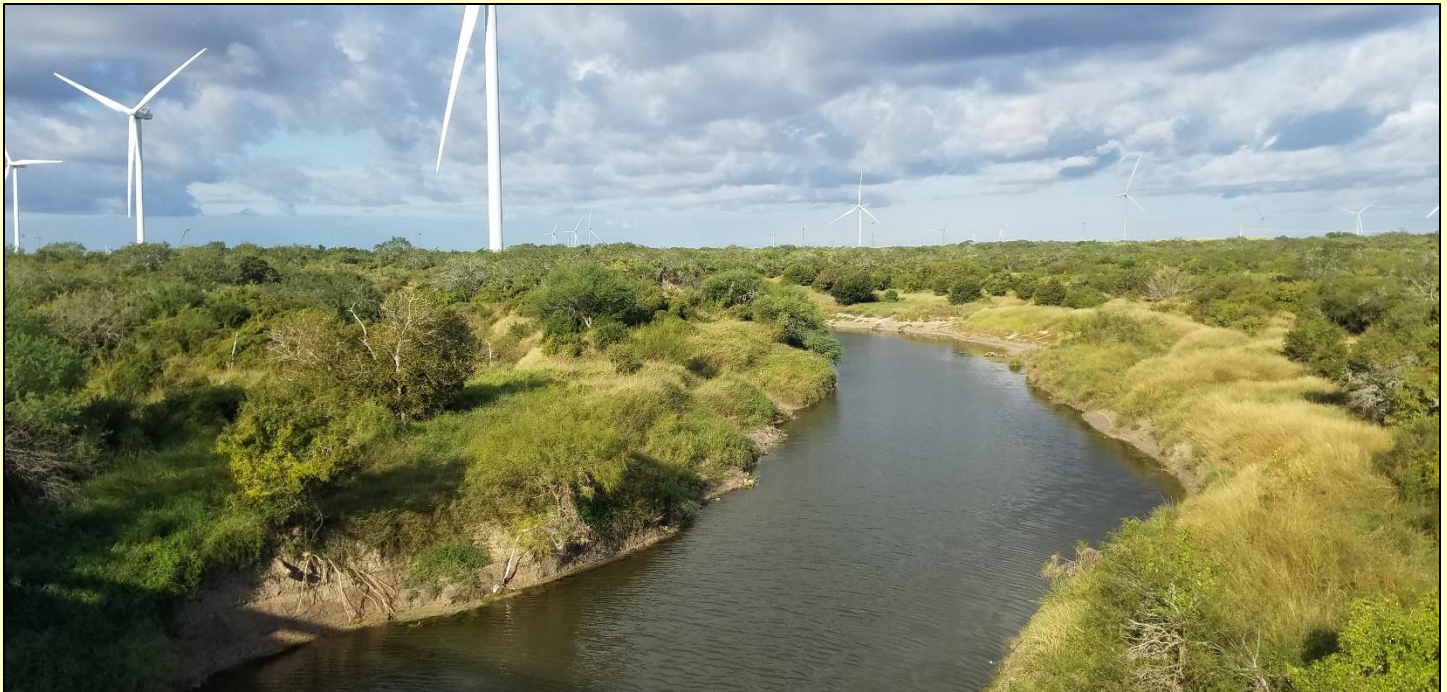
Station 13093 – Petronila Creek at FM 70

Petronila Creek is a tributary to Baffin Bay. Since FY 2013-2014, the TCEQ has contracted with NRA to conduct monthly water quality monitoring to identify chloride, sulfate, and TDS contributions from tributaries of Petronila Creek, including drainage ditches. For FY 2022, NRA is conducting monthly monitoring at 13 sites, the same location as the past 4 years. Four sites are located on the main stem of Petronila Creek (13096, 13095, 13094, and 13093 – data is in bold on the graph). Monitoring for September through November is summarized below. (Disclaimer – Data has not been validated or input into the SWQMIS Database.)

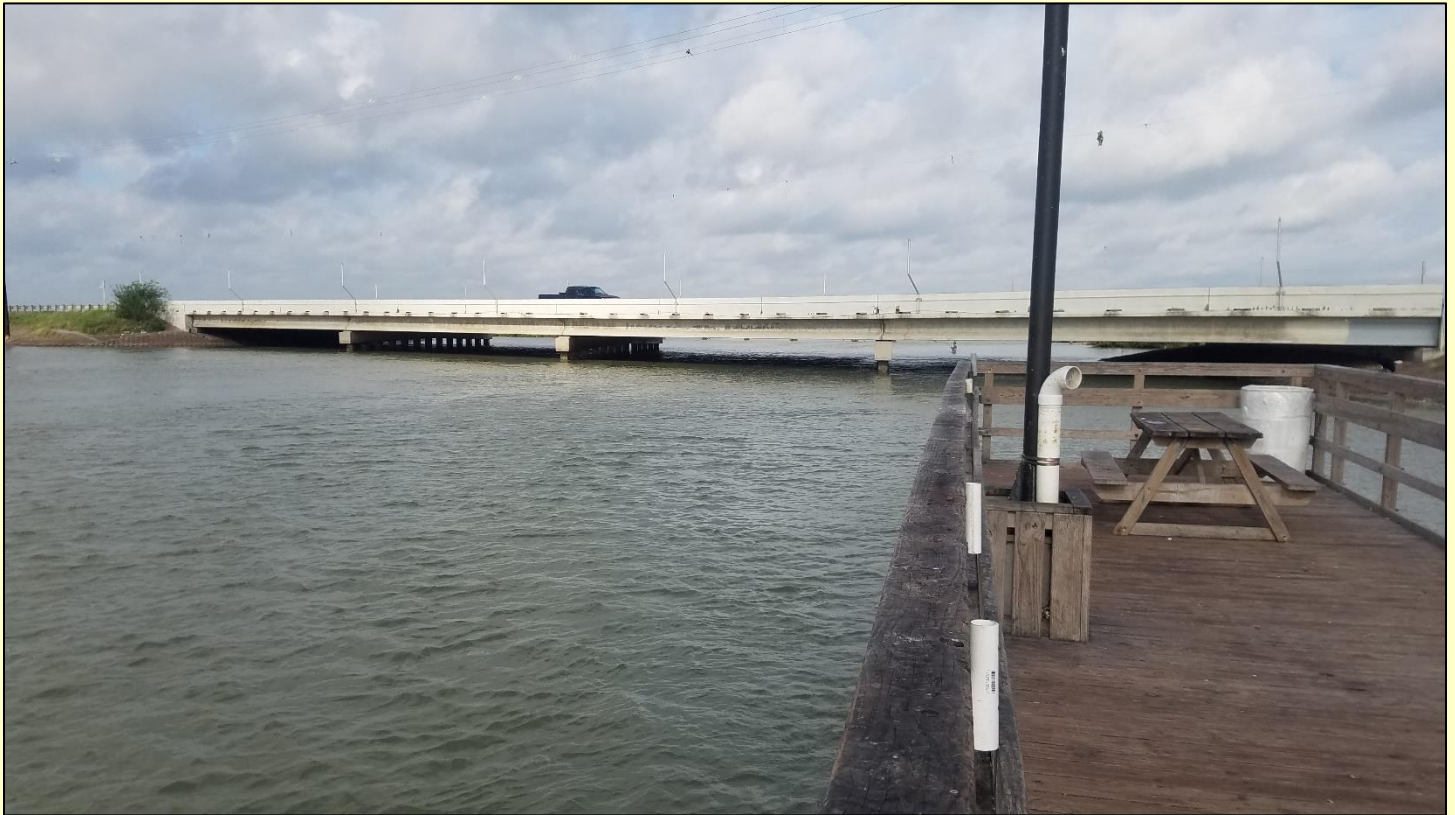
Station 22170 - San Martin Lake System

San Martin Lake system is located off the Brownsville Ship Channel in the Lower Rio Grande Valley. NRA field staff rented a boat from UTRGV to travel up the shallow waterway on October 26<sup>th</sup>. Nutrient parameters were very low, well below the screening levels with nitrate being below the detection limit of 0.025 mg/L. Total phosphorus was 0.23 mg/L, below the screening limit of 0.69 mg/L. Chlorophyll-*a* concentrations were slightly elevated at 19.5 µg/L. Bacteria concentrations were highly elevated at 2,000 CFU/100 mL following an approximate 1.5-inch rain 3 days prior to the site visit. If you would learn more about water quality projects in the Lower Laguna Madre/Brownsville Ship Channel (LLMBSC), visit the Cameron County website: <http://www.co.cameron.tx.us/llmbsc/>

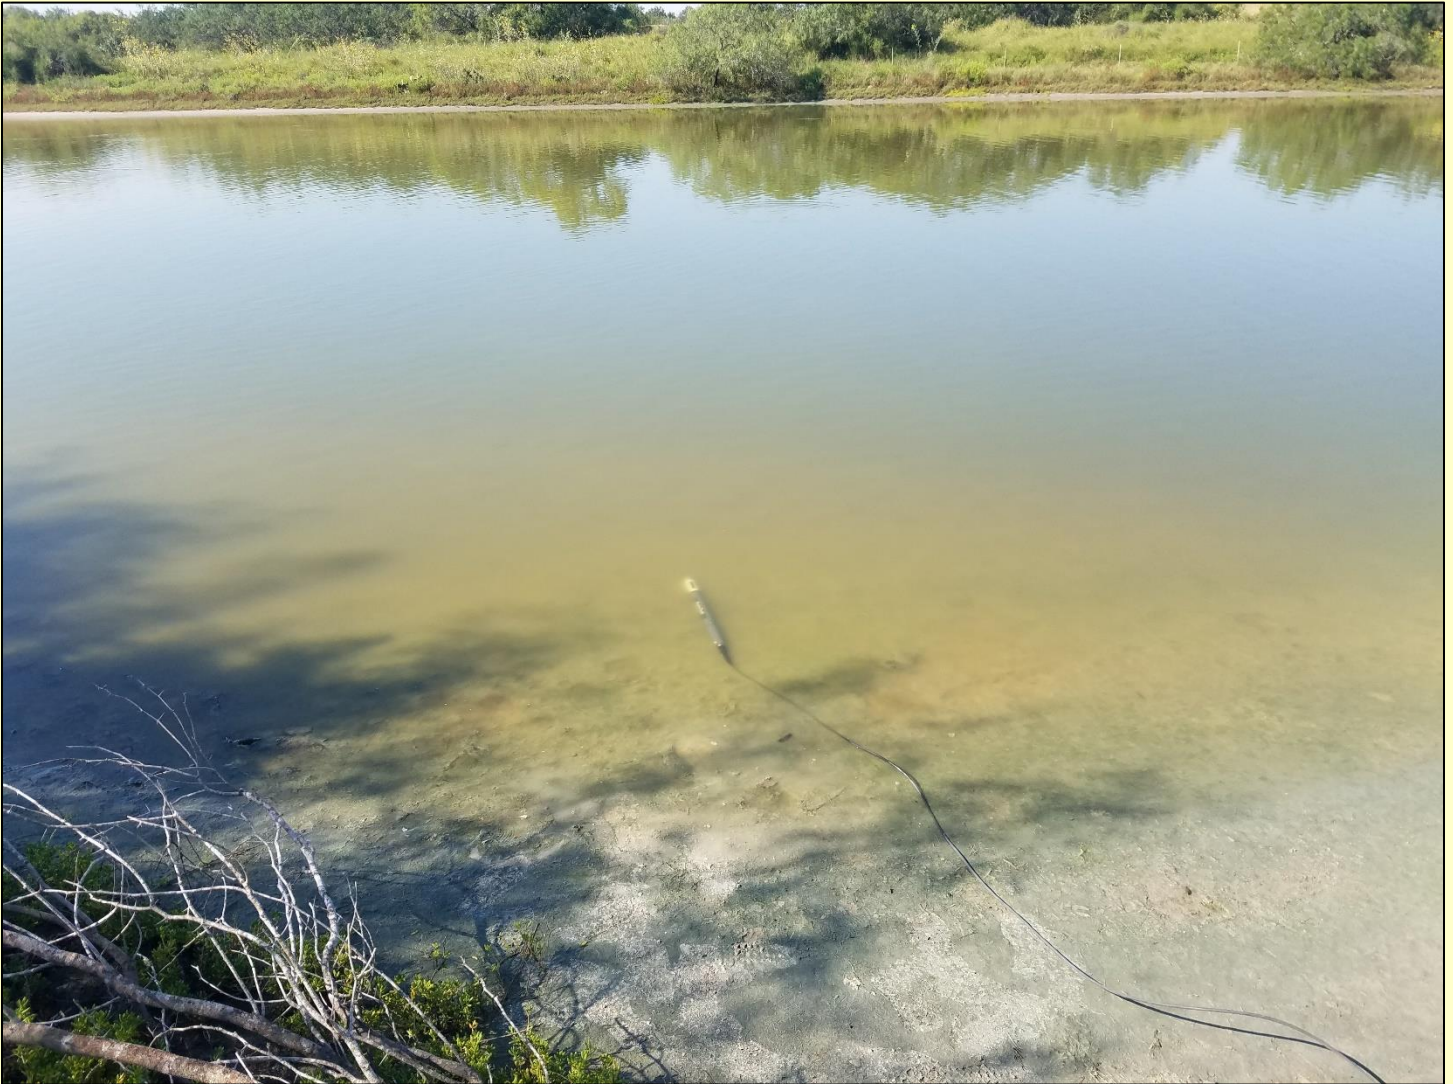
Station 13034 – Los Olmos Creek Tidal at US 77 south of Riviera

Los Olmos Creek runs 71 miles from southern Duval County to its confluence with Laguna Salada, an inlet of Baffin Bay. The creek was a new site (Station ID 13034) for FY2019, located at the bridge crossing at US 77 south of Riviera. NRA field staff visited the site on October 6<sup>th</sup>, 4 days after the area received approximately 8 inches of rain. Salinity values dropped to the 32 PSU range (seawater is around 35 PSU) after the flow event. Bacteria concentrations were very high on the site visit ( $>2,400$  MPN), same as the last 4 quarters. Nutrient concentrations were extremely elevated with nitrate (36.5 mg/L) values well above the screening level of 1.10 mg/L for nitrate. Chlorophyll-*a* concentrations were relatively low at 6.6  $\mu\text{g/L}$  compared to the screening level of 21.0  $\mu\text{g/L}$ . Total phosphorus levels (0.31 mg/L) were within the screening level of 0.66 mg/L.

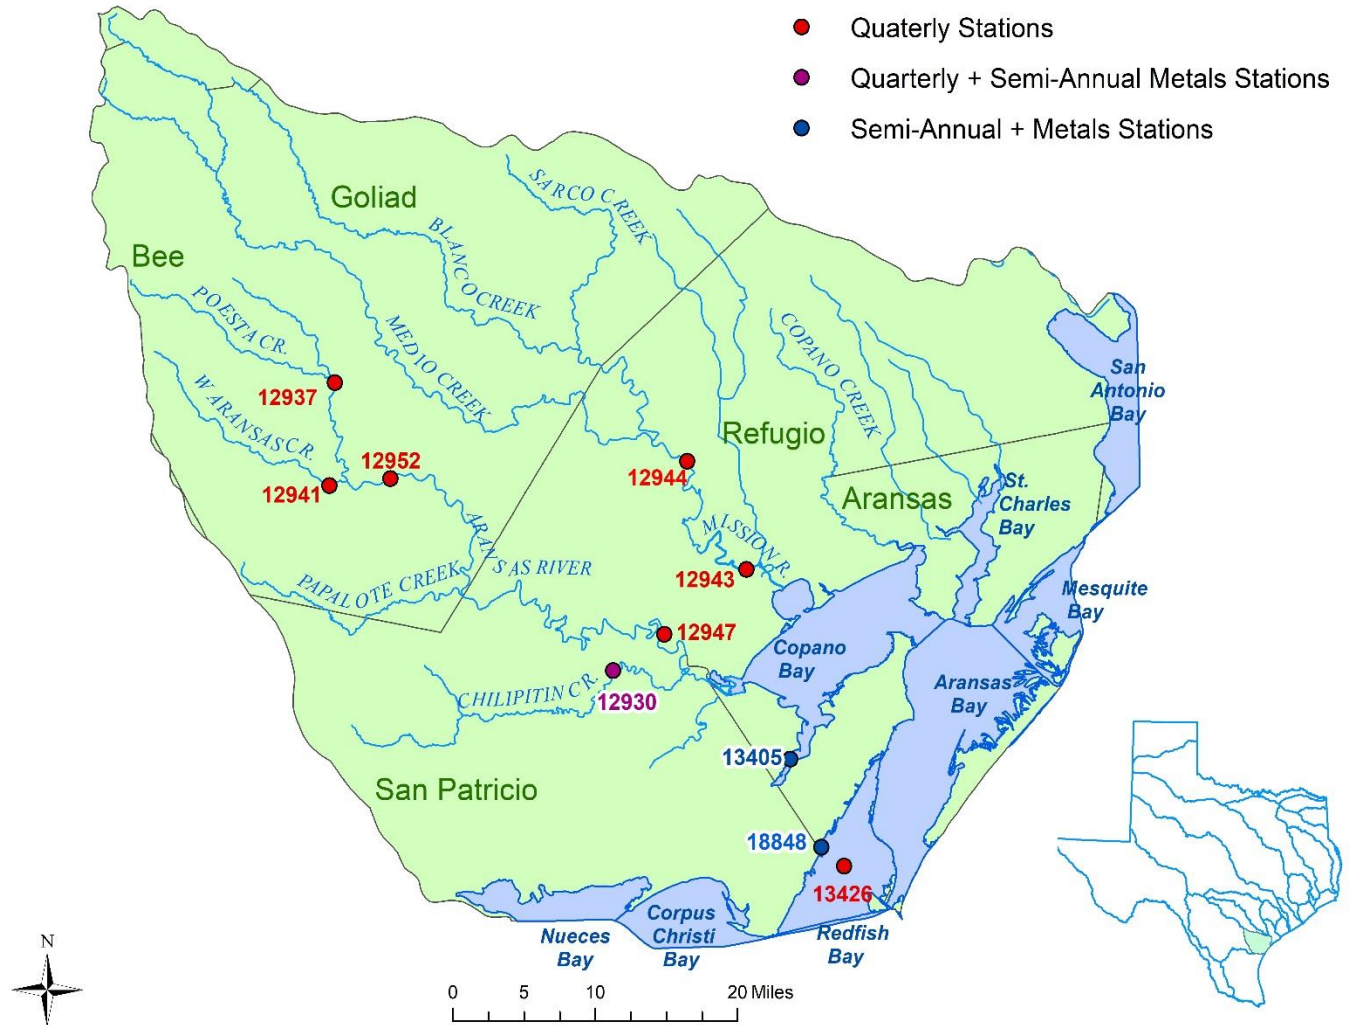
# Nueces River Basin

## NRA Monitoring Stations

- Quarterly Stations
- Quarterly + Metal Stations
- BCRAGD Stations
- ★ 24 Hour DO
