# Riparian Evaluation Report: Tributaries of Baffin Bay

August 30, 2019

**Water Body:** Baffin Bay 2492 Tributaries

**Contract No:** CBBEP 1907

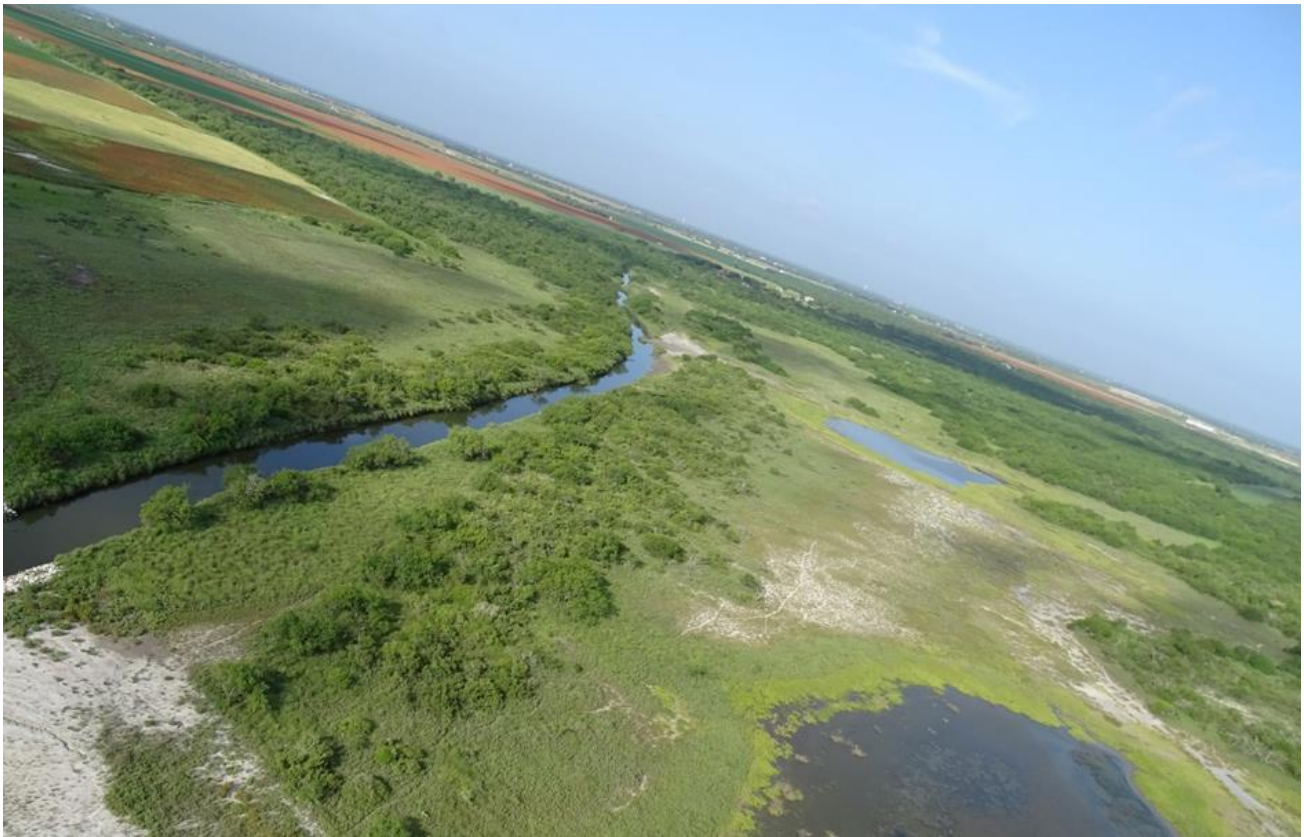
**Figure 6** Image shows wide functional marsh-like riparian area flanking San Fernando Creek near its mouth at Cayo del Grullo. Farming activities are set back from the creek, and the wide floodplain is well vegetated.

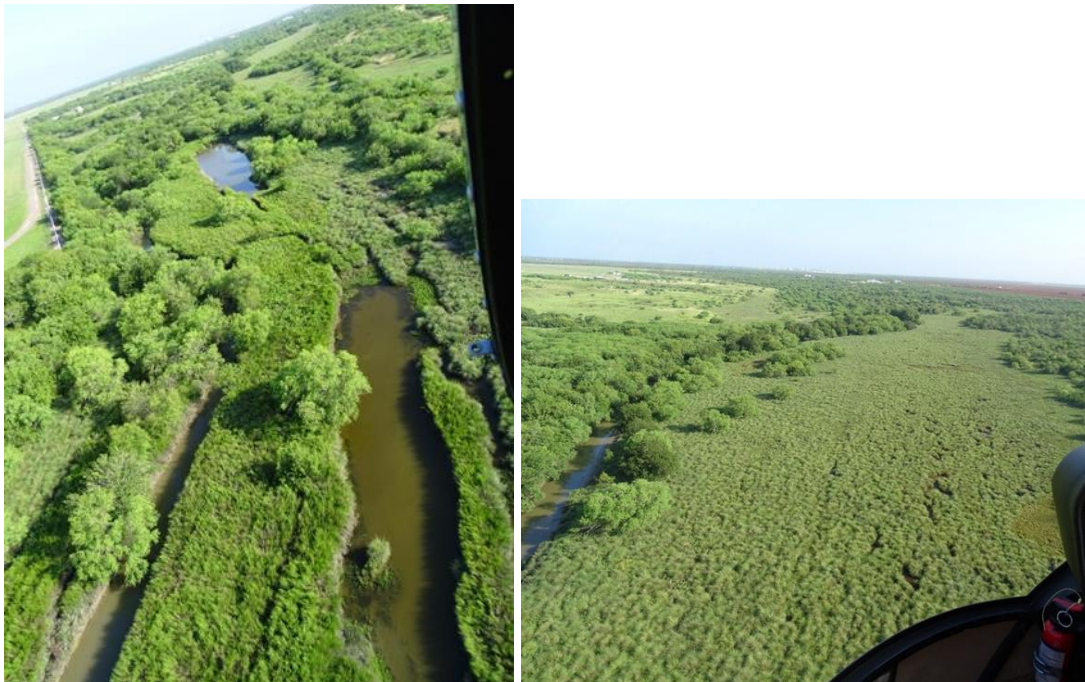
**Figure 7** These images show highly functional riparian areas along San Fernando Creek around the Naval Air Station. Image on the left shows braided channels with banks vegetated in Spiny aster. Image on the right shows a riparian area (river right) more than 1,000 feet wide covered in Cordgrass with pockets of standing water. Retama and Mesquite ring the channels with occasional Willow and Ash trees present.

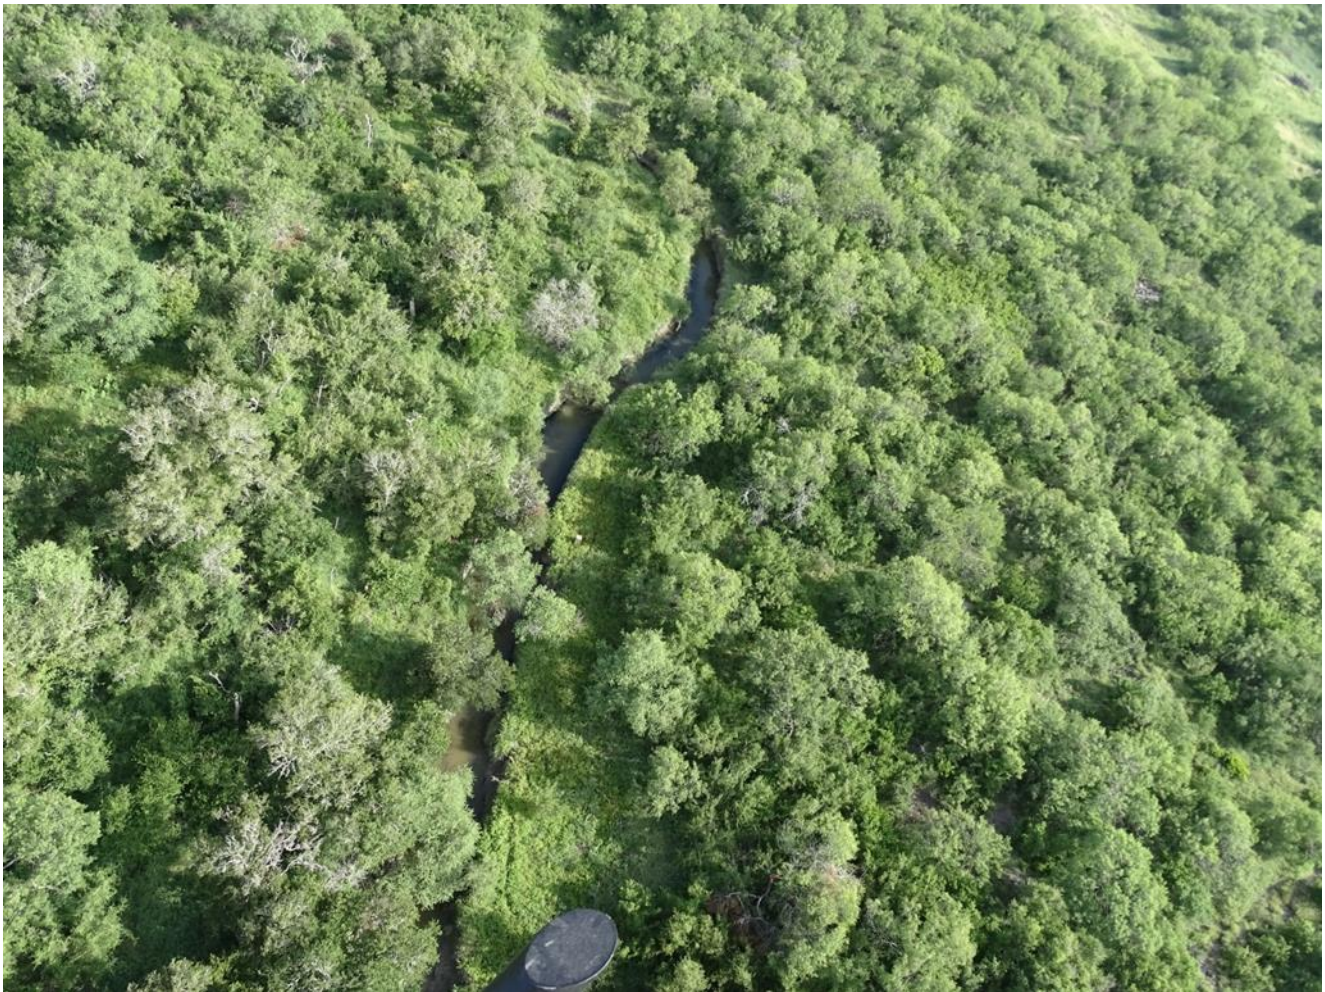
**Figure 8** Near the top of the reach the creek narrows and becomes a heavily wooded meandering stream, retaining a highly functional condition.

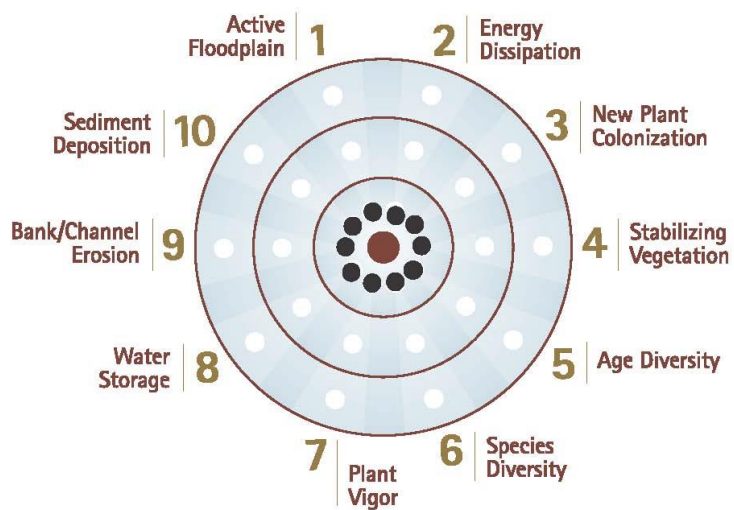
**Figure 9** Bull's-Eye evaluation target for the lower reach of San Fernando Creek.

3. **New plant colonization.** New plants were observed colonizing fresh sediments throughout.
4. **Stabilizing vegetation.** Banks are covered with stabilizing vegetation. (Spiny aster SR8, Marshhay/Gulf cordgrass SR9, Retama SR6)

5. **Age diversity and reproduction of riparian vegetation.** All age groups were observed.
6. **Species diversity of riparian vegetation.** More than five species of native riparian plants were observed.

7. **Plant vigor.** Riparian plants appear healthy and vigorous with no signs of heavy grazing, mowing, trampling or browsing.
8. **Water storage.** Several OBL and FACW plant species were observed both at the water's edge and on the floodplain. (Spiny aster FACW, Marshhay/Gulf cordgrass FACW/OBL, Buttercup FACW, Sea-oxeye daisy FACW, Saltgrass FACW, Shoregrass OBL, Retama FACW, Dwarf palmetto FACW)

9. **Bank and channel erosion.** Erosion and deposition appear balanced and channel size and shape appear of size and depth to manage sediment.
10. **Sediment deposition.** Normal and balanced sediment deposition were observed within this reach.

Work with landowners to reward the current stewardship; protect and document the highly functional riparian condition along the lower reach of San Fernando Creek. Without creating new hindrances, find ways to utilize this reach to demonstrate capability for riparian recovery and its influence on water quality.

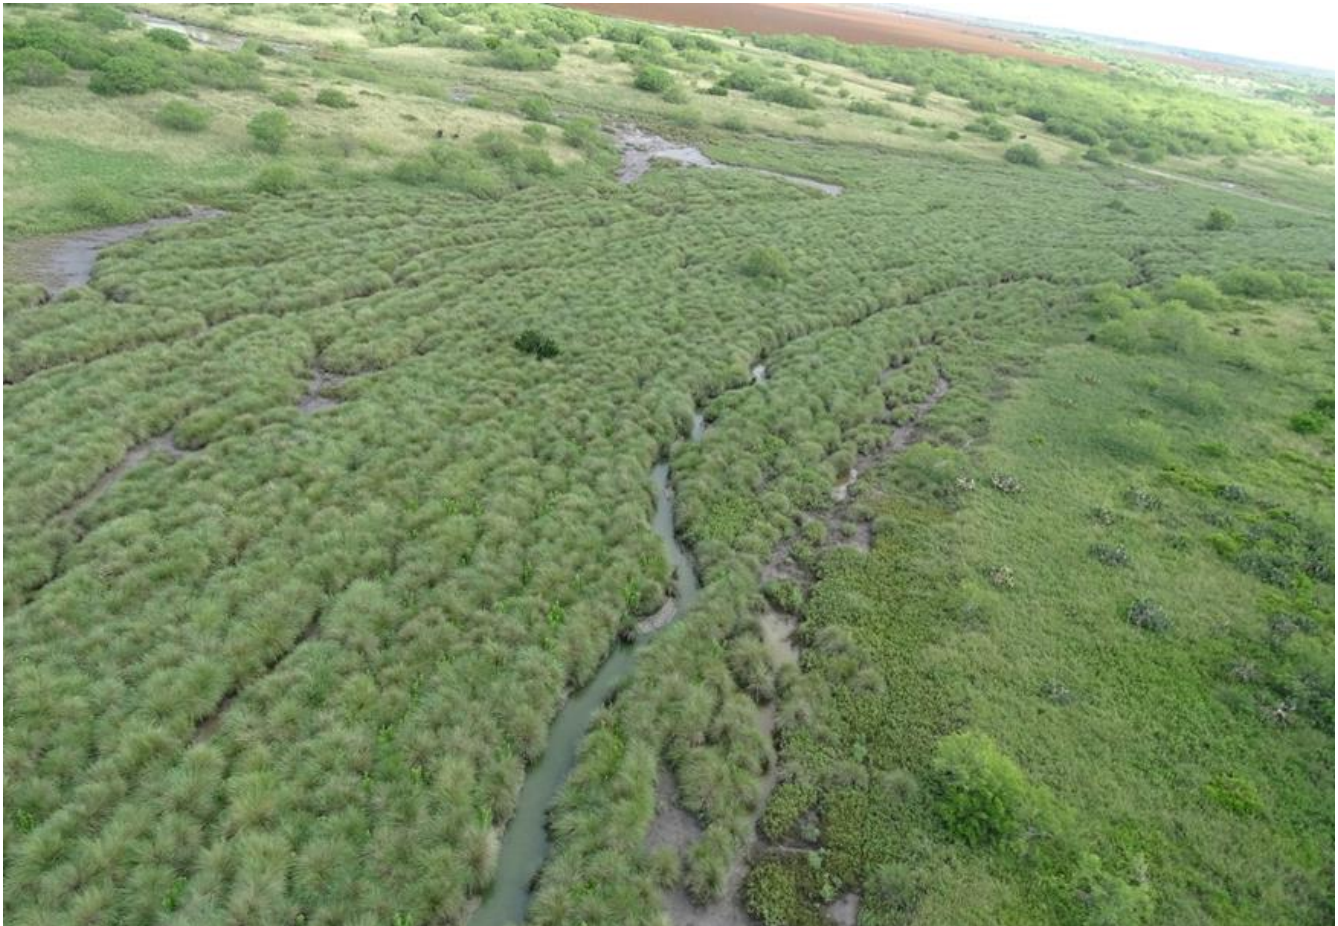
**Figure 11** Carreta Creek's channel is braided and laced with Cordgrass. The overall width of channel and riparian area is estimated at about 1,000 feet in this area.

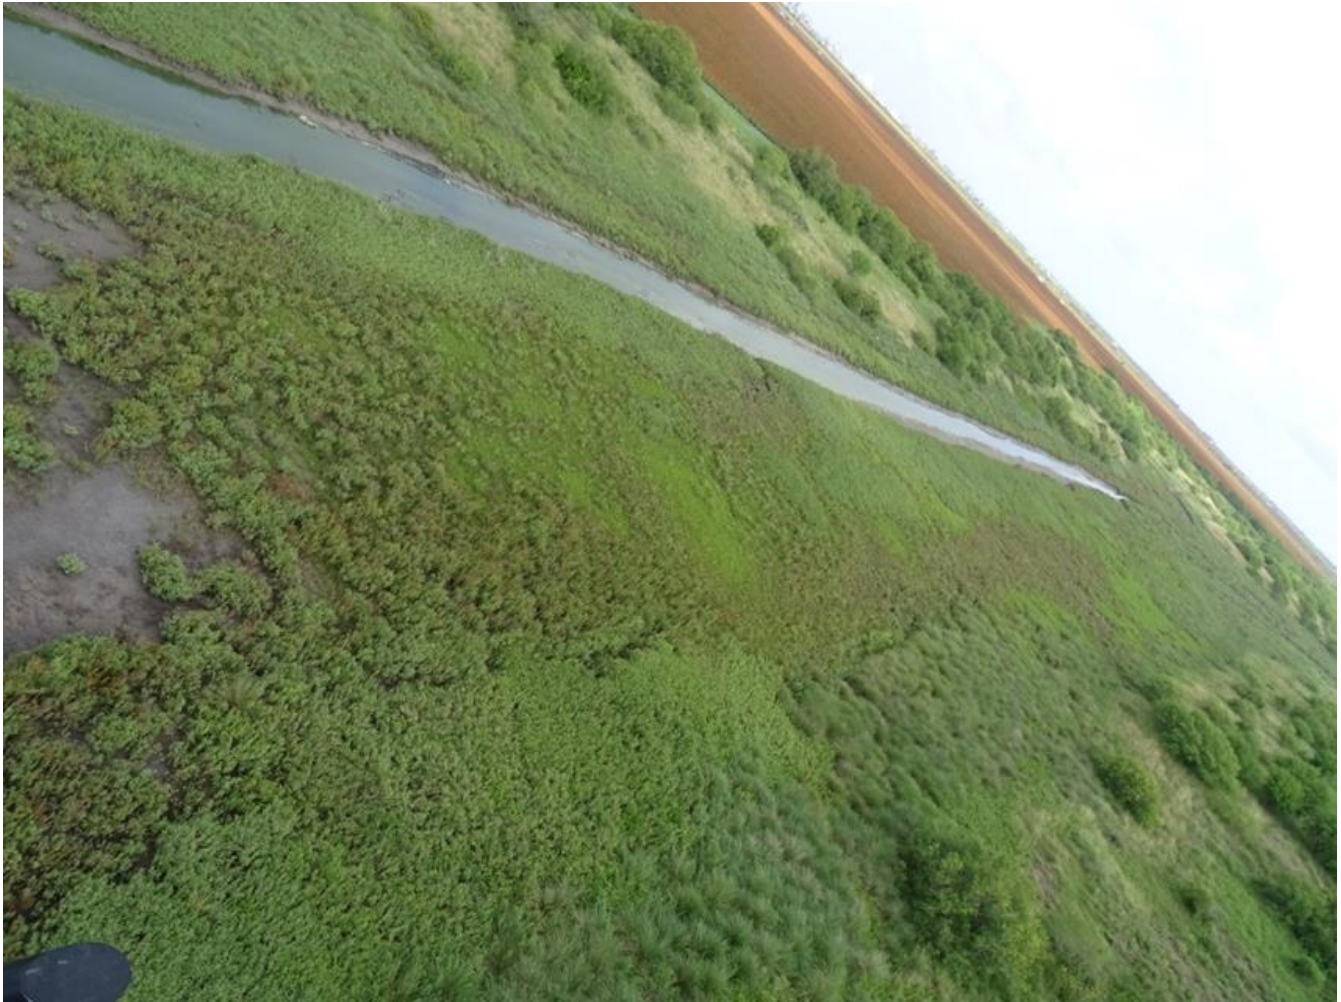
**Figure 12** Further upstream the creek's channel becomes straight and single thread, but the riparian area remains wide and well vegetated.

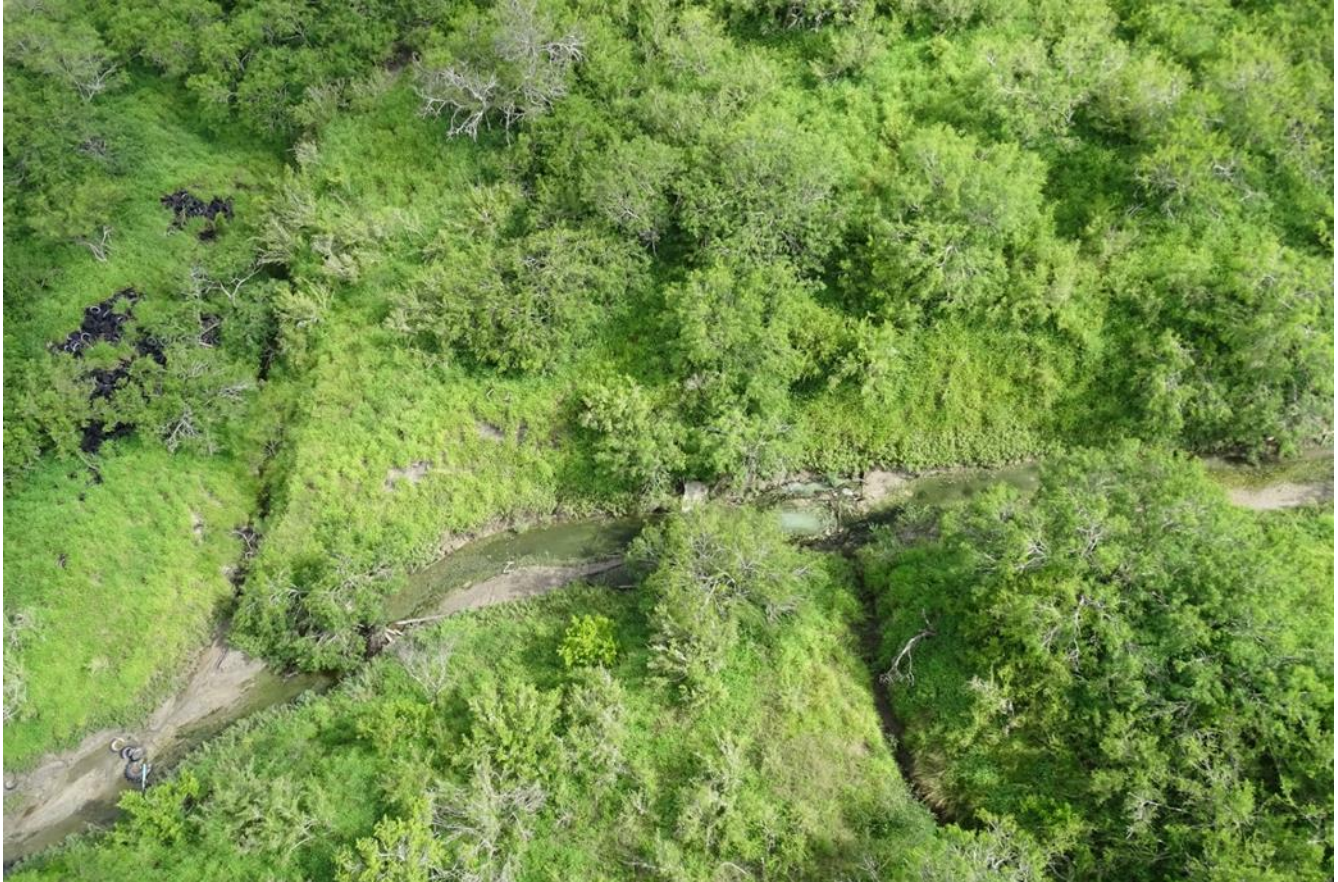
**Figure 17** Pictured here are one of several large tire and debris dumps located on the creek. Banks are vegetated here, but not with riparian plants that can provide functional attributes.

- 1) Work with landowners and engage community leaders to address the dumping and learn about riparian function.
- 2) Encourage a cessation or setback of mowing in the riparian area where acceptable for accommodating drainage.

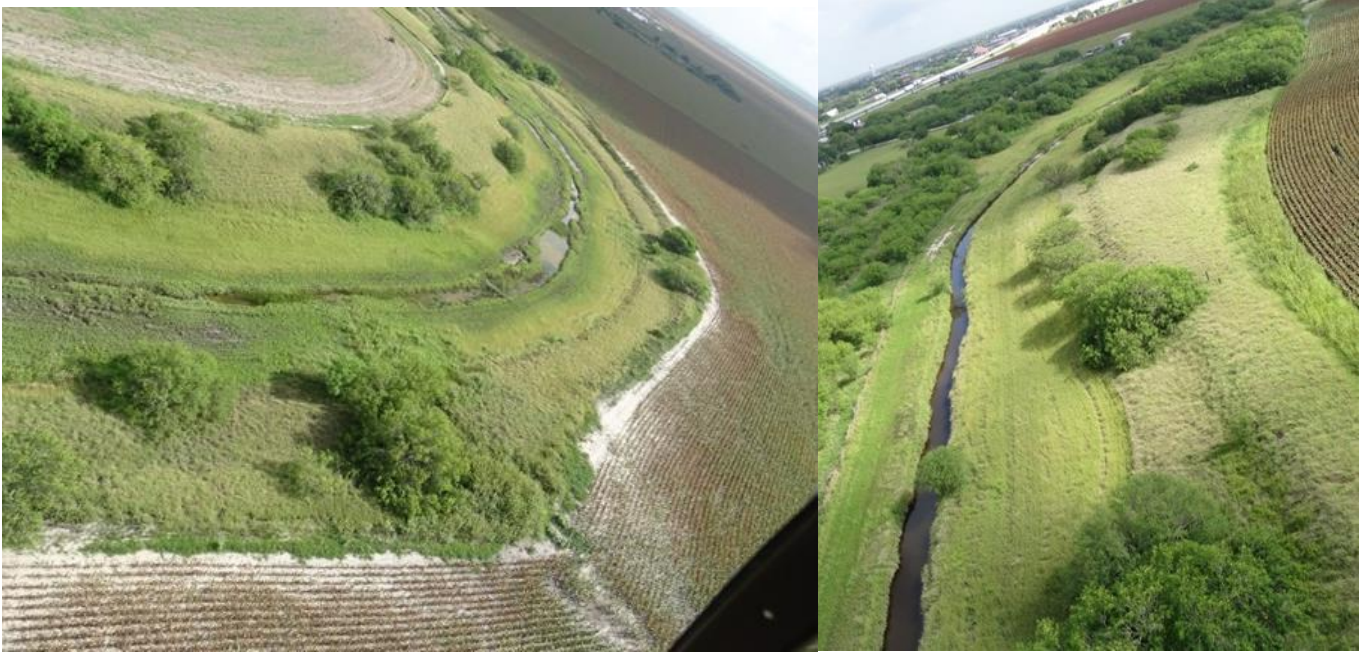
**Figure 18** Farming too close, channelizing and mowing riparian areas to enhance field drainage serves to hinder riparian function along a creek. Pictured here, the creek is well vegetated primarily with non-riparian grasses. One exception in the image on the left are the obligate plants growing within the channel that appear to be trapping some fresh sediment and creating tiny meanders to process it.

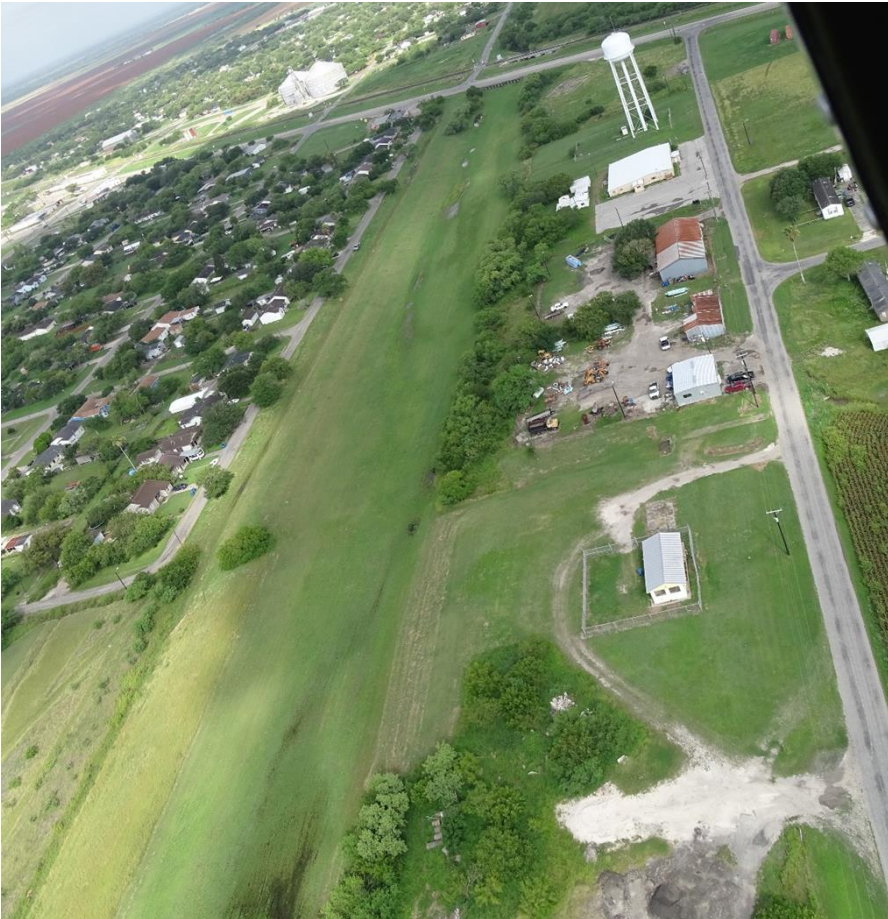
**Figure 19** As the creek runs through Bishop it become a wide, grassy drain way primarily vegetated with non-riparian grasses that are mowed to enhance drainage.

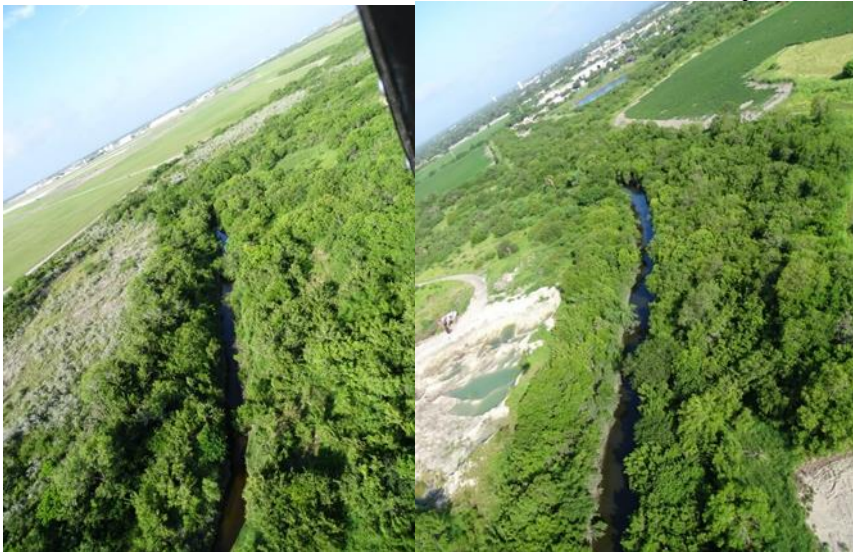
**Figure 22** Tranquitas Creek below U.S. 77 is a highly functional wooded creek. Farming and mining activities are mostly set back from the banks and do not appear to be hindering riparian function.

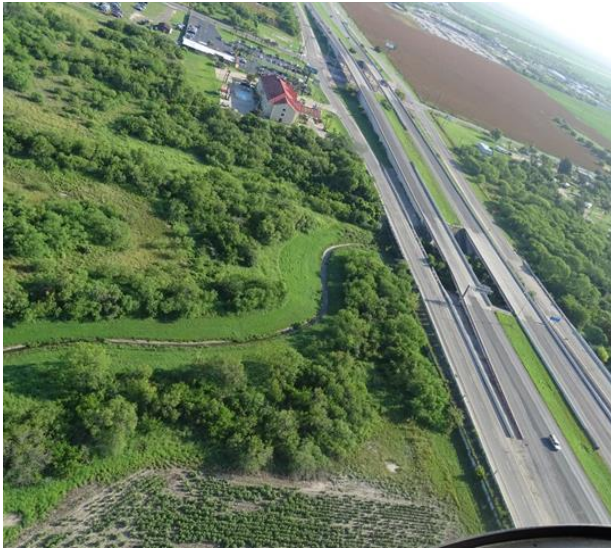
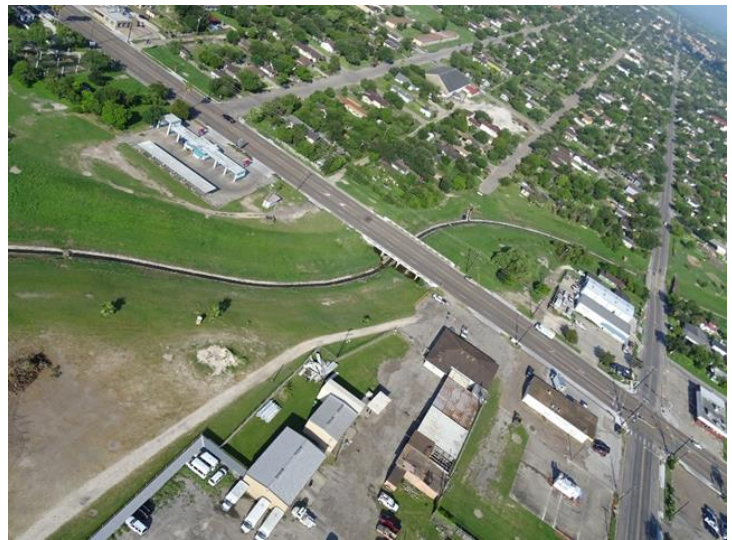
**Figure 23** As the creek enters Kingsville, passing under U.S. 77, it becomes a manicured and manipulated floodway with hardened cement bed.

- 1) Engage Kingsville community leaders and stakeholders to recognize the potential value of a healthy functional (wooded) stream running through their town. A functional stream can also preform floodway/drainage services while offering recreation and aesthetic value to residents and visitors.
- 2) Work with landowners to reward the current stewardship; protect and document the highly functional riparian condition along Tranquitas Creek below U.S. Hwy 77. Without creating new hindrances, find ways to utilize the high functioning portion of the creek to inform stakeholders of the potential for recovery of a wooded stream amenity within Kingsville.

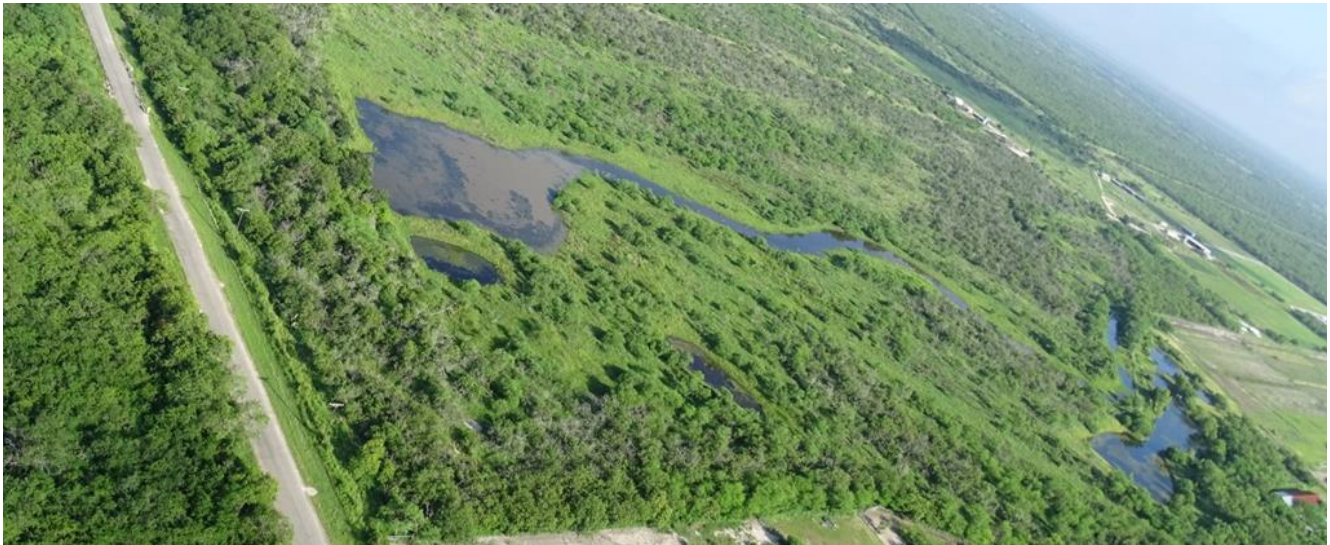
**Figure 24** As the creek leaves Kingsville it once again becomes highly functional ending at Tranquitas Lake above FM 1355.

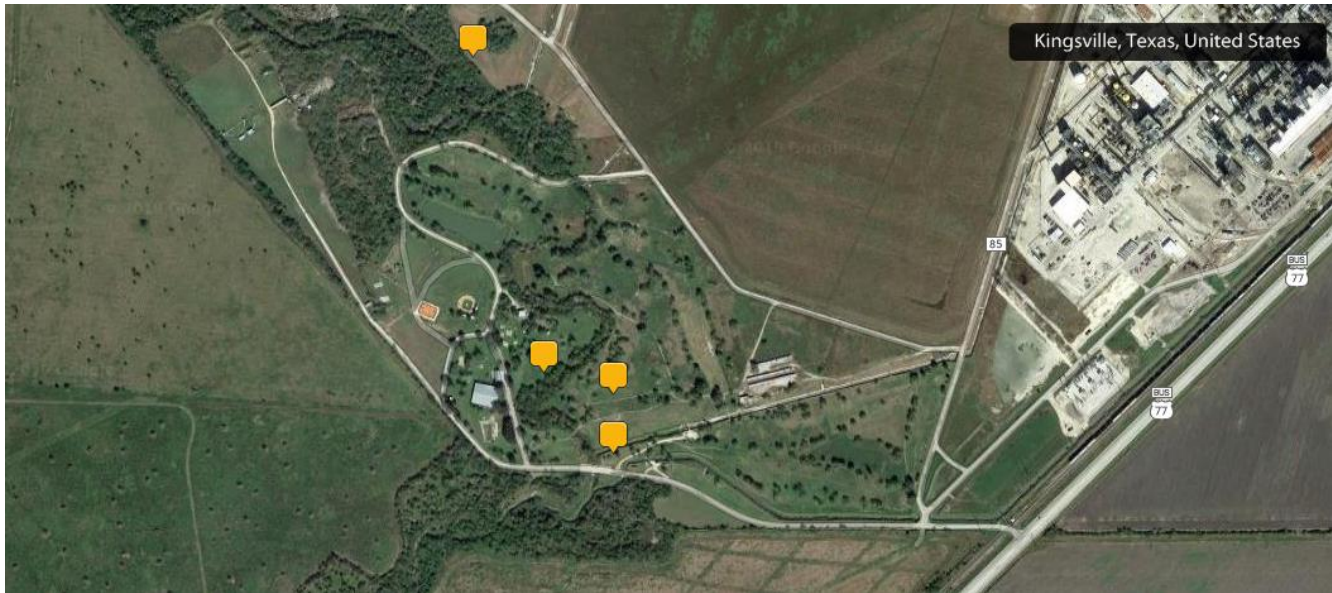
**Figure 28** GoogleEarth™ image of the park/plant area along Upper Reach of San Fernando Creek where the creek banks are manicured and channel/floodplain appear altered.

Work with landowners to address the identified hindrances within the park/plant area which could include setting mowing/manicuring away from the creek bank to allow riparian plant recovery.

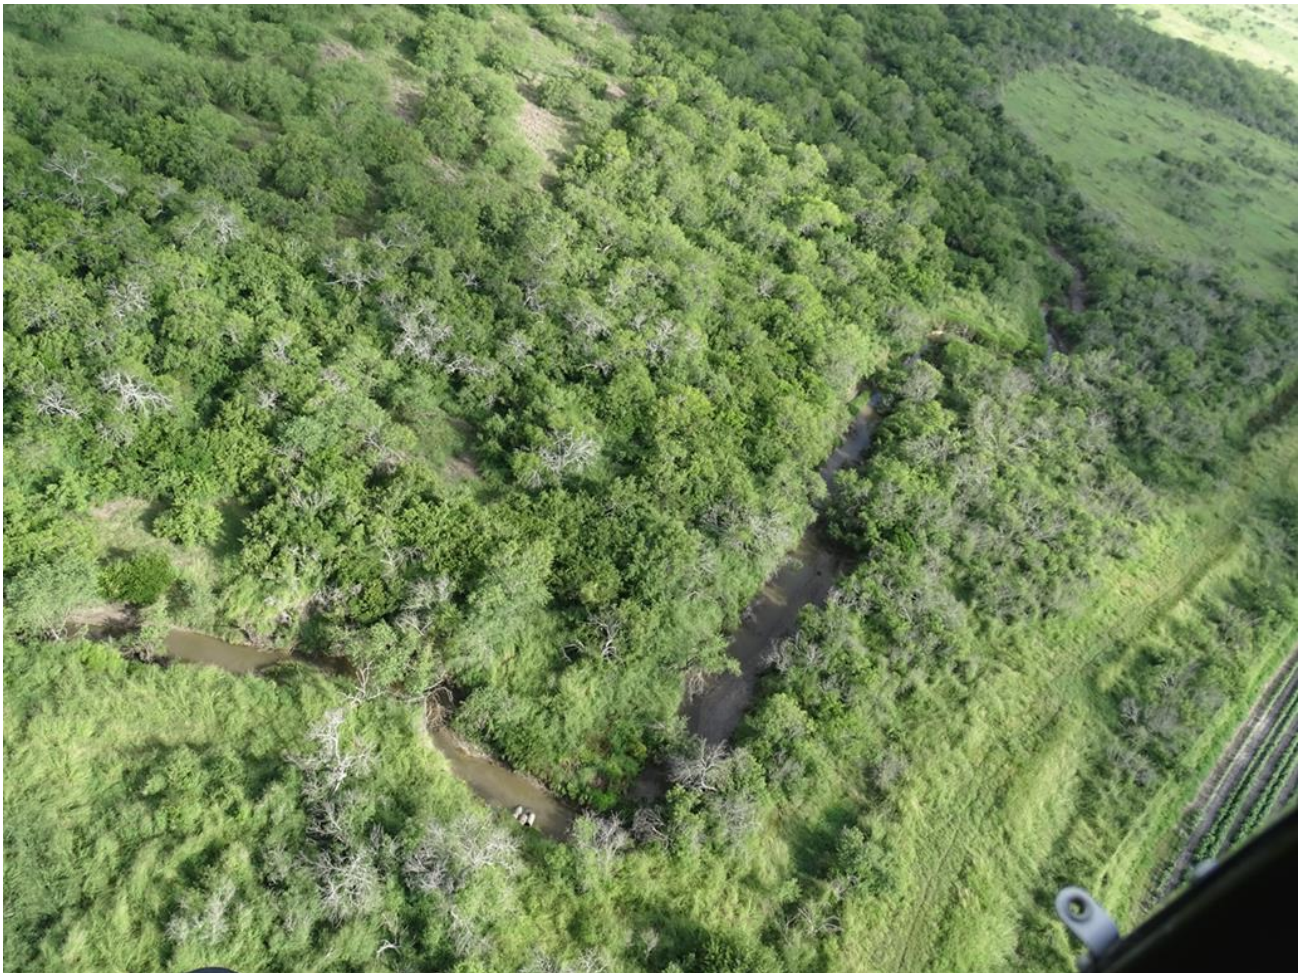
**Figure 30** Heavily wooded meandering channel of the upper reach of San Fernando Creek.

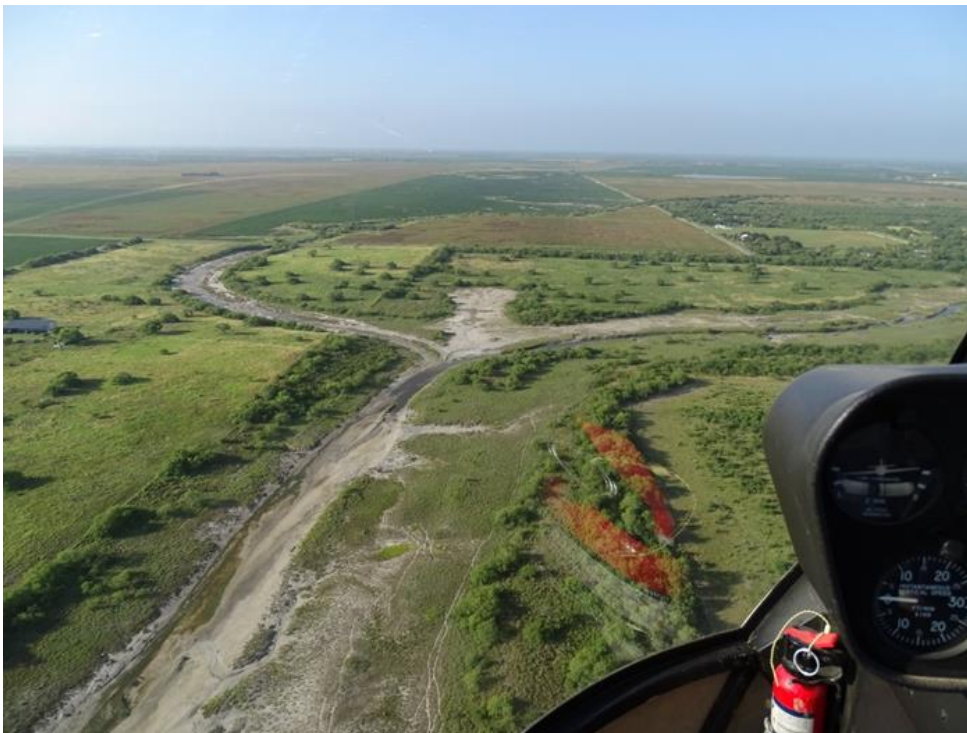
**Figure 36** Confluence of Janboncillos (right) and the tributary (left).

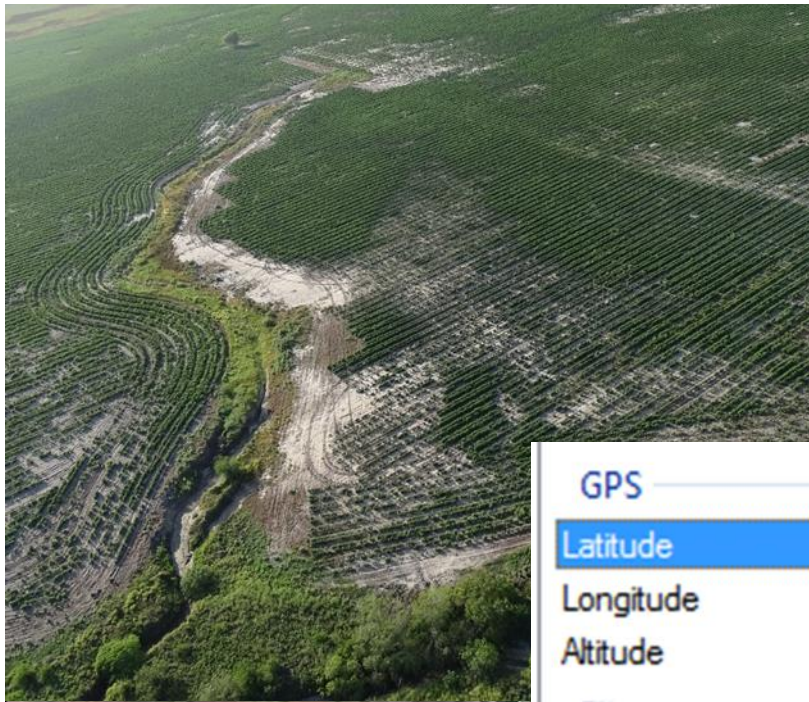
**Figure 37** This image shows a poorly designed crossing on Jaboncillos Creek. It appears that the creek has down cut around the crossing and left its conduits high and dry. Piles of cement debris can be seen dumped along the channel around the crossing in an apparent attempt to dissipate stream energy. Stream crossings should always be located on a straight section of channel to avoid excessive stream energy being directed at the crossing.

- 1) Work with landowners to address identified hindrances.
- 2) Remove, repair or replace the poorly designed crossing.

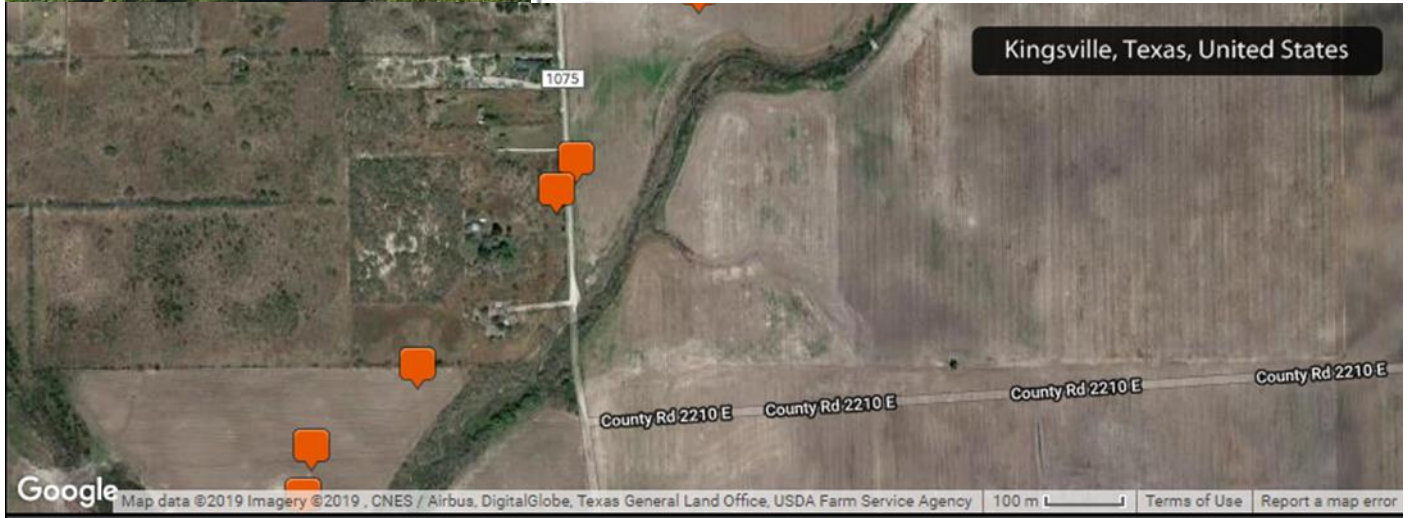
**Figure 38** Looking east at the confluence of a small drain way and Jaboncillos Creek tributary. This image illustrates the hindrance of farming to close to a drain way and the opportunity for enhanced function with a setback of disturbance. This image is an aerial photo point choice.

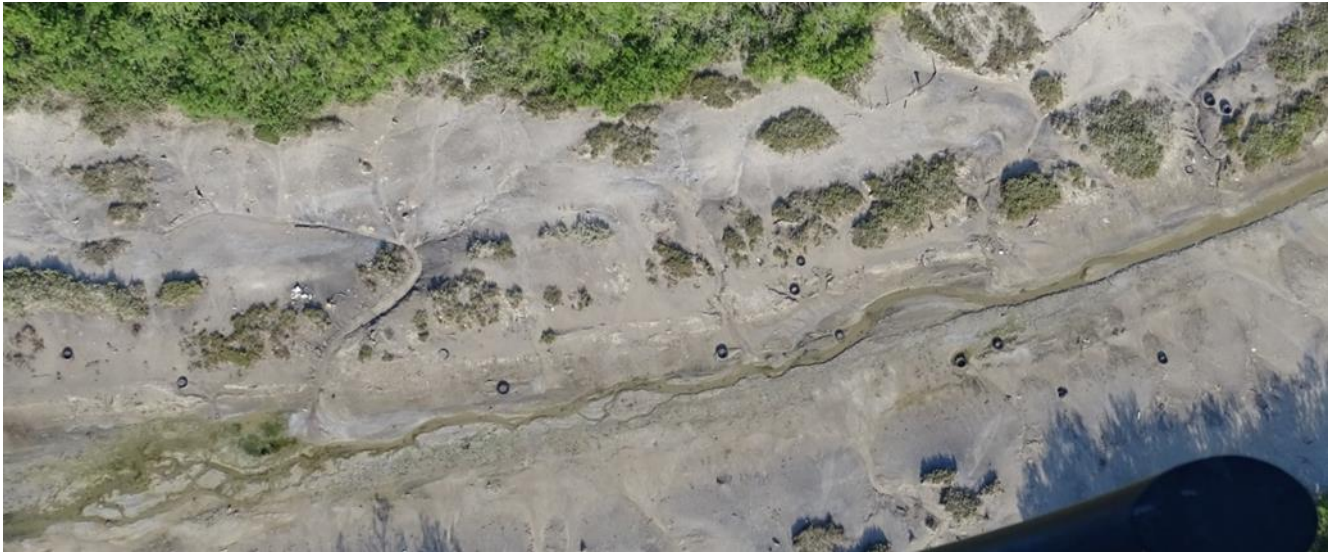
**Figure 39** Image shows discarded tires dotting the channel of Jaboncillos creek. Tires can be seen in large numbers, floating, strewn and in dump piles along many Baffin Bay tributaries.

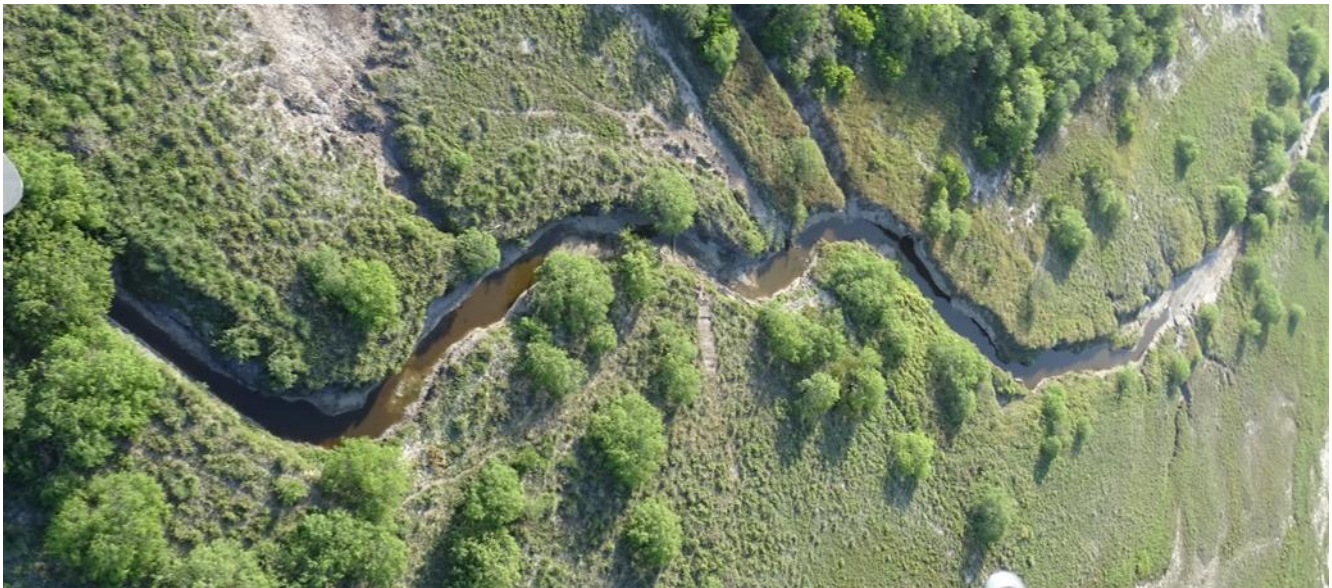
**Figure 40** Image shows channel slightly incised and grazing concentrations in the creek area that appears to be hindering vegetation recovery.

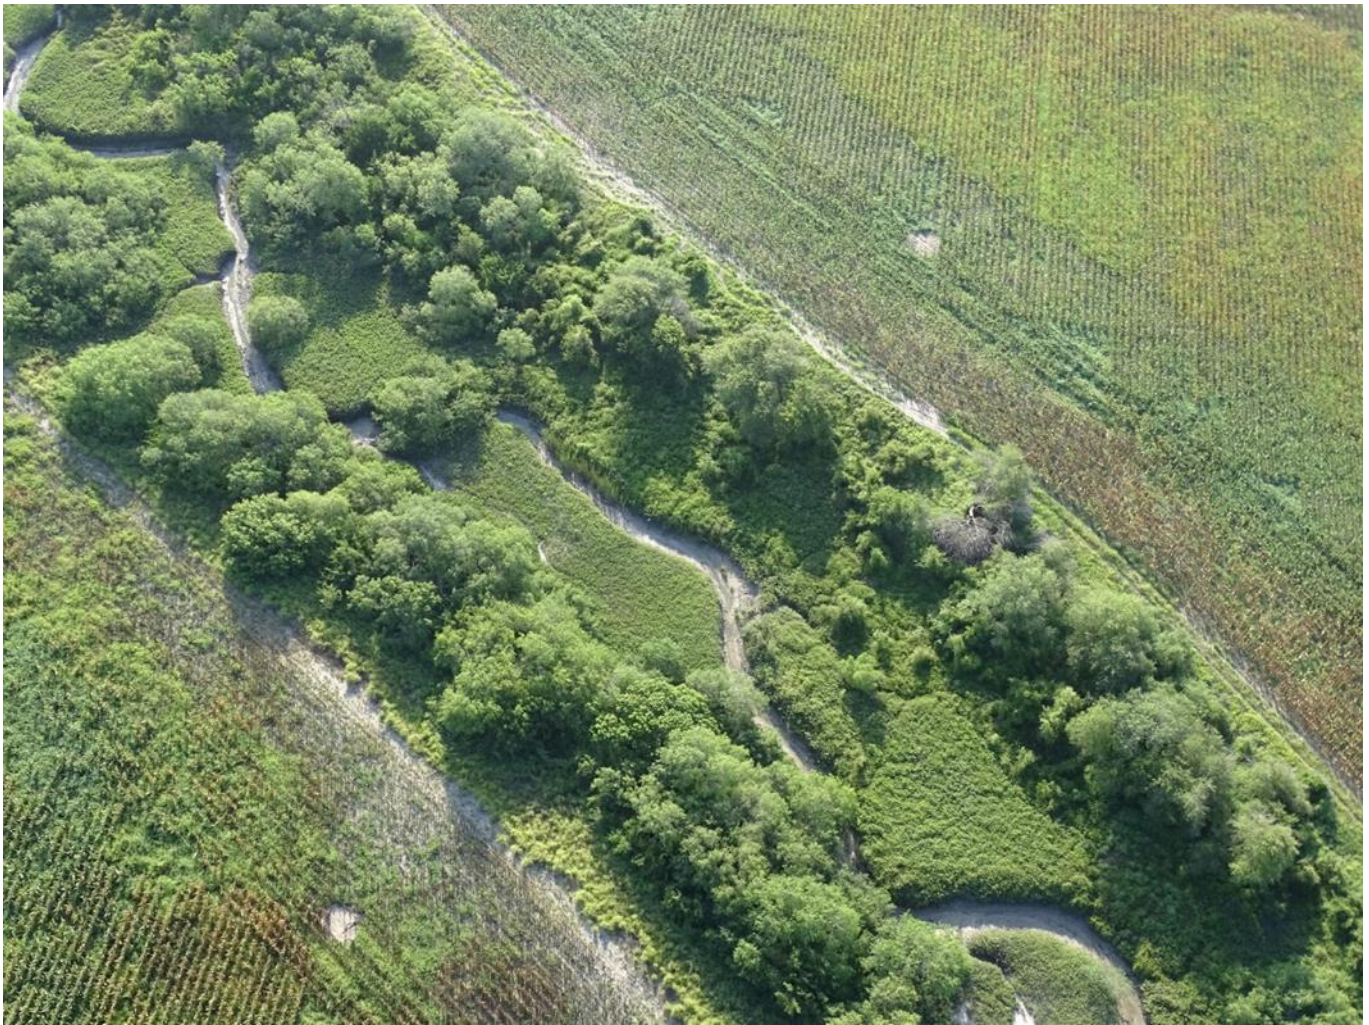
**Figure 41** Image shows an exceptionally well-buffered segment of the tributary.

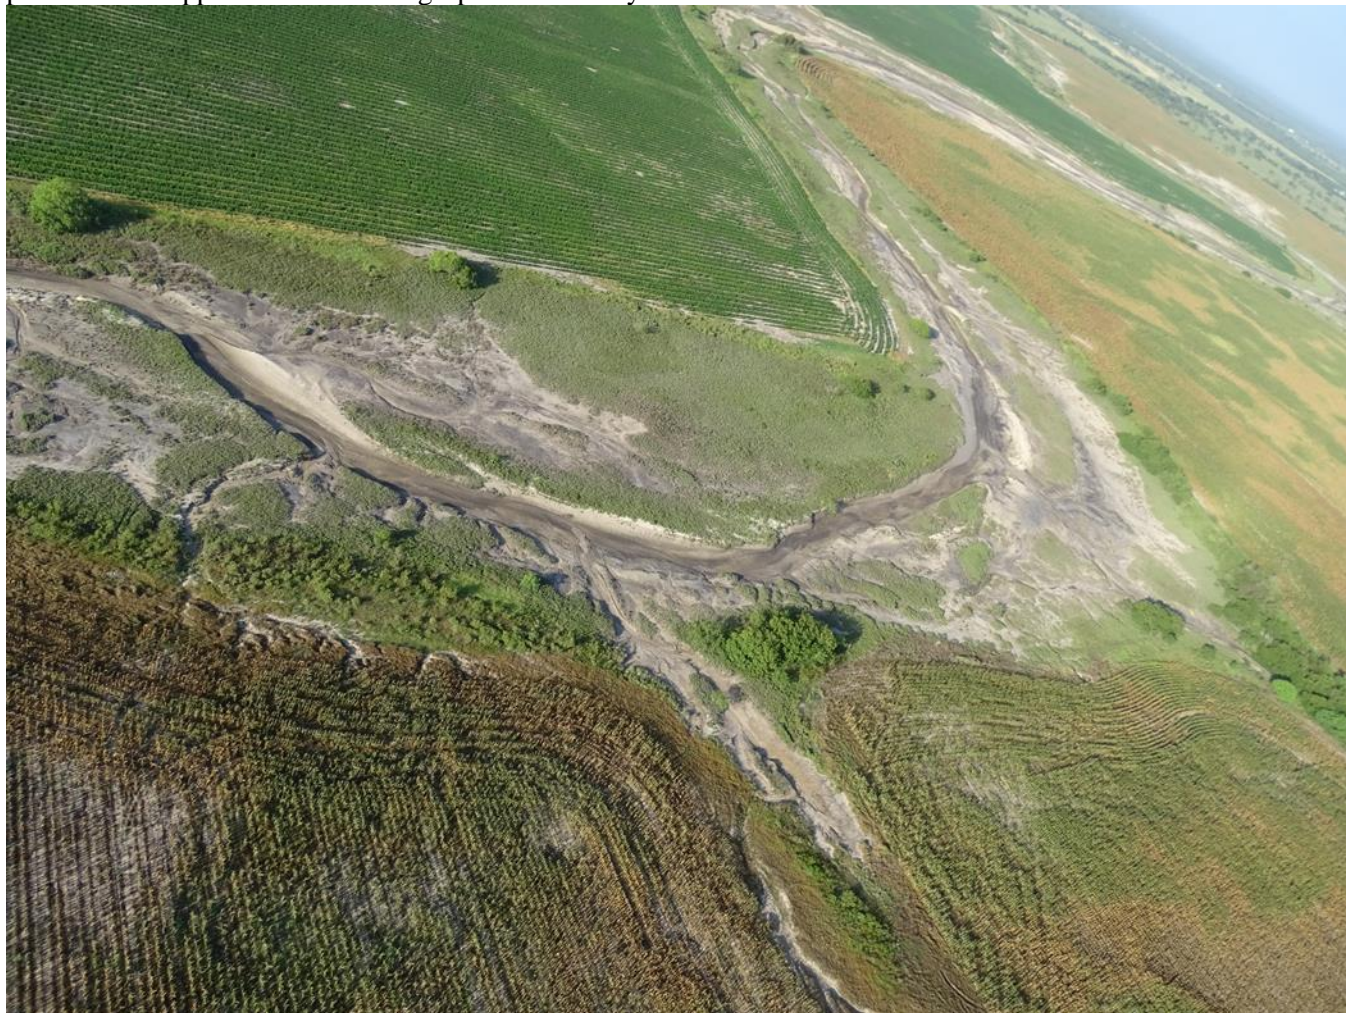
**Figure 44** Image illustrates the riparian condition along most of Radicha Creek and its tributaries.

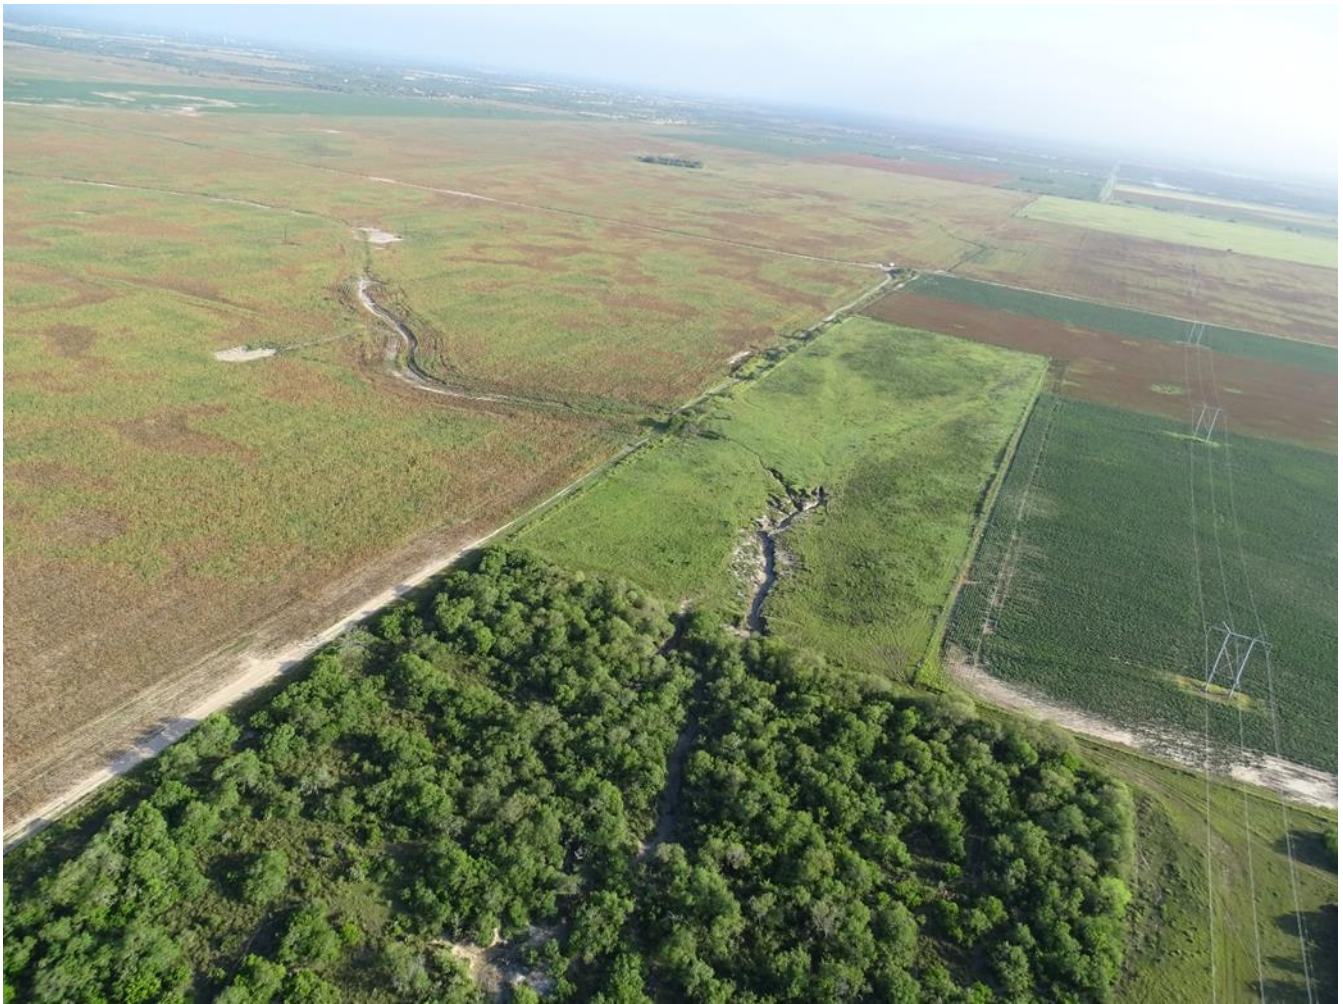
**Figure 45** Image illustrates the riparian condition along most of Radicha Creek and its tributaries in contrast with the heavily wooded tract in the foreground.
