# Riparian Evaluation Report: Tributaries of Baffin Bay

August 30, 2019

**Water Body:** Baffin Bay 2492 Tributaries

**Contract No:** CBBEP 1907

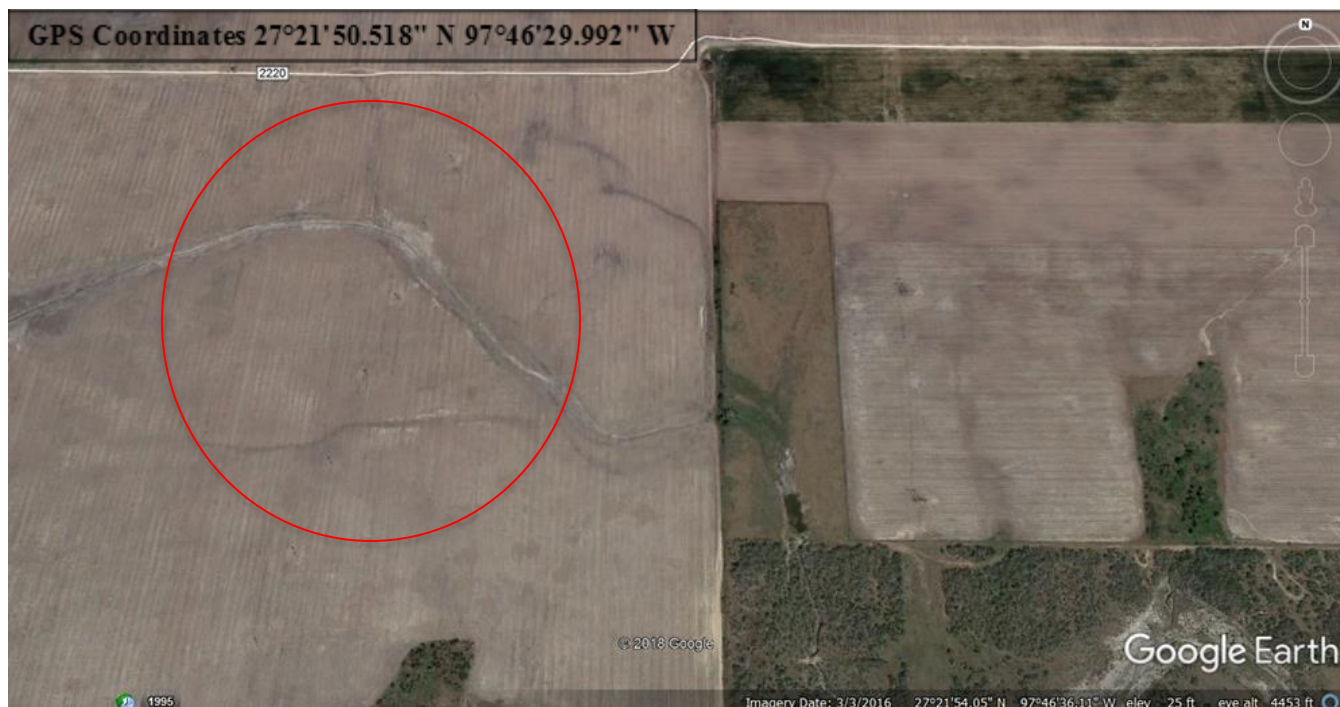
**Figure 47** The location of the image is shown on the Google Earth tm map and is an aerial photo point choice at the GPS Coordinates of 27°21'50.518" N 97°46'29.992" W.

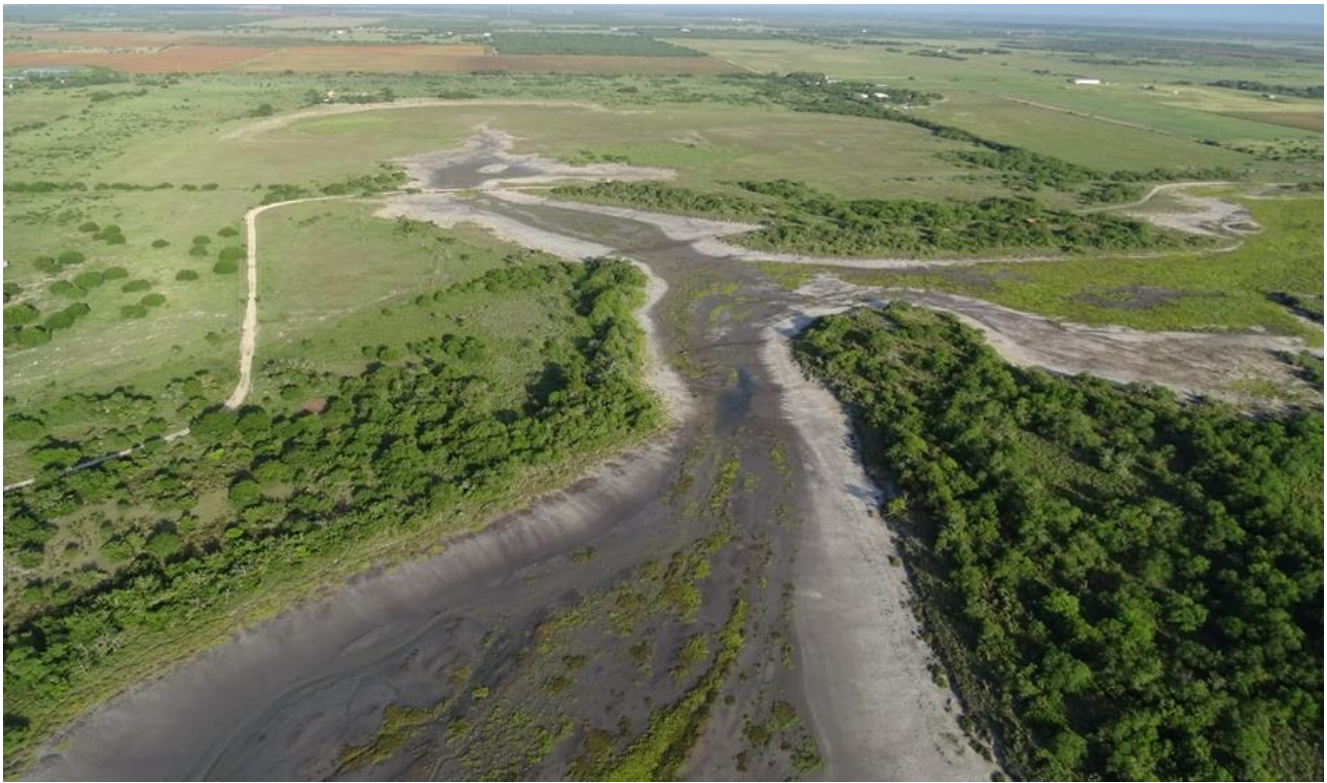
**Figure 50** Looking upstream from the mouth of Vattman Creek. The creek veers to the right in this image.

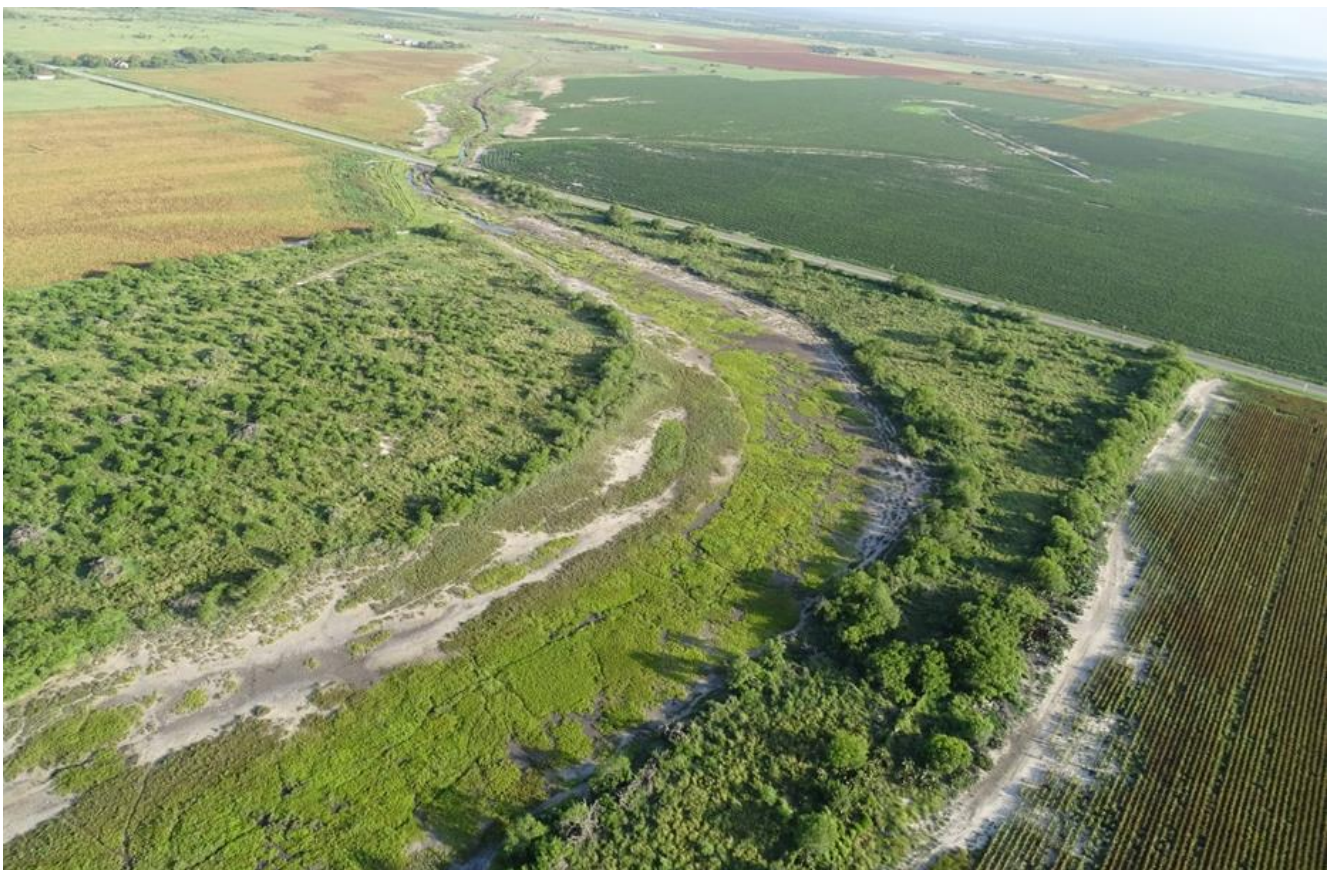
**Figure 51** Looking upstream at the FM 628 crossing of Vattman Creek, the riparian areas is functional and well vegetated below and immediately above this location.

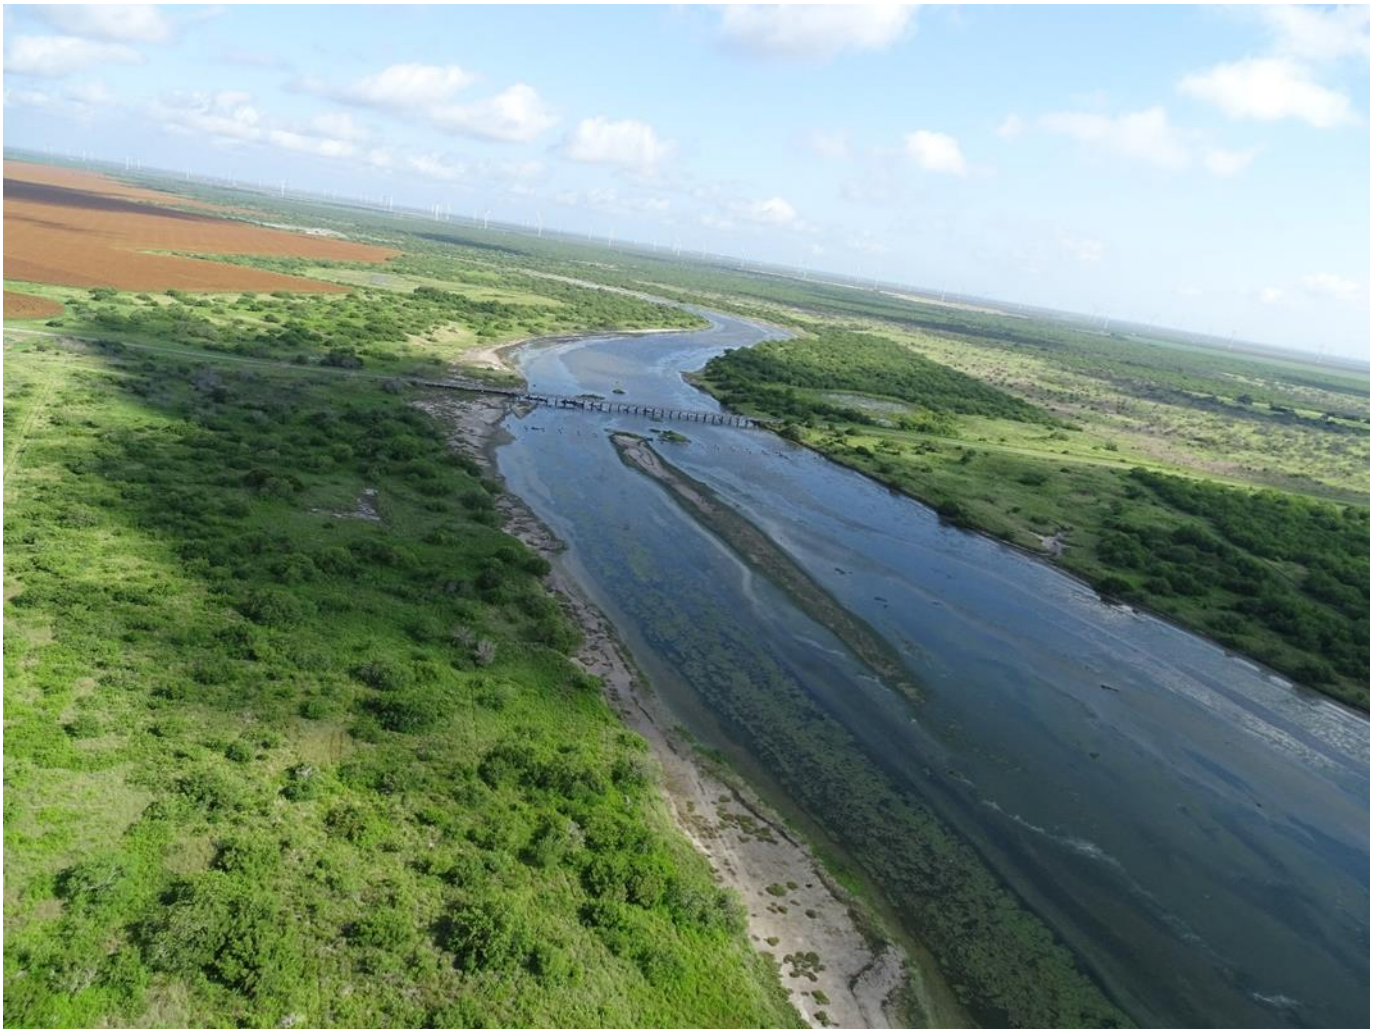
**Figure 56** Image shows wide functional riparian area flanking Petronila Creek at the Laureles Ranch Road bridge. Farming activities are set back from the creek, and the wide floodplain is well vegetated.

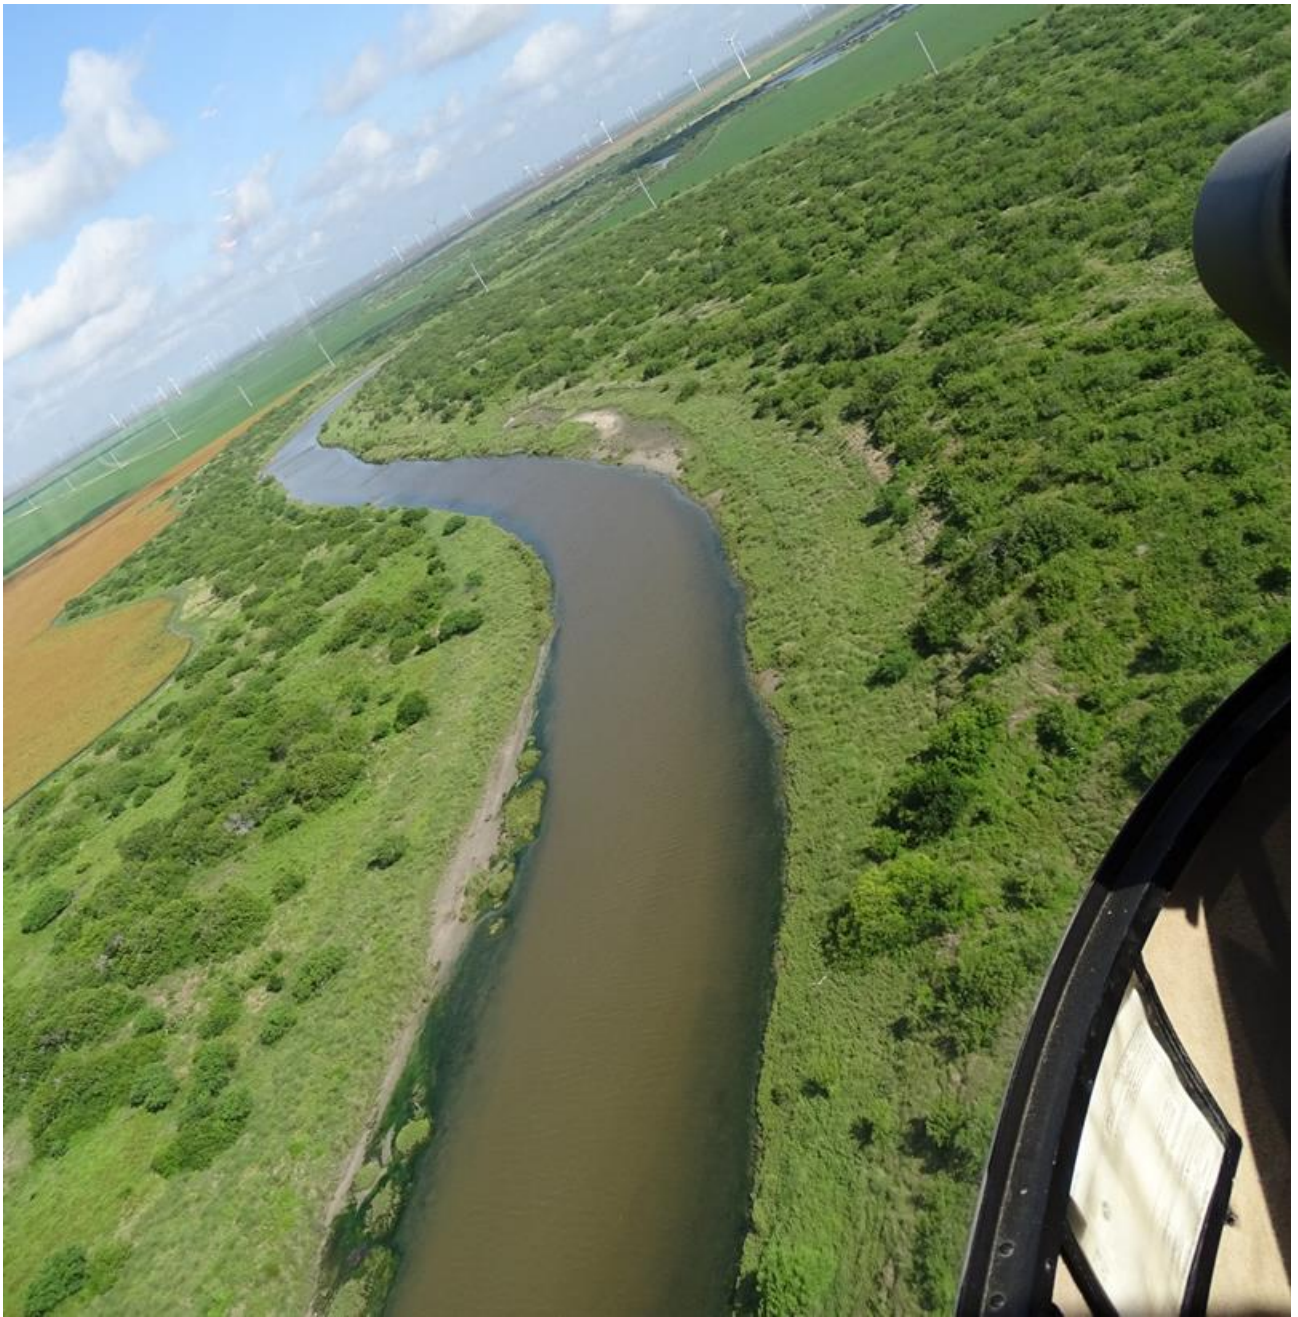
**Figure 57** Images show highly functional riparian areas along the Lower/Chapman Ranch Reach of Petronila Creek near the top of the reach. Banks are well vegetated in what appears to be Cordgrass with Retama and Mesquite. A fringe of algae is visible along the channel edge. At this point, the riparian area is narrower than the downstream areas of the reach.

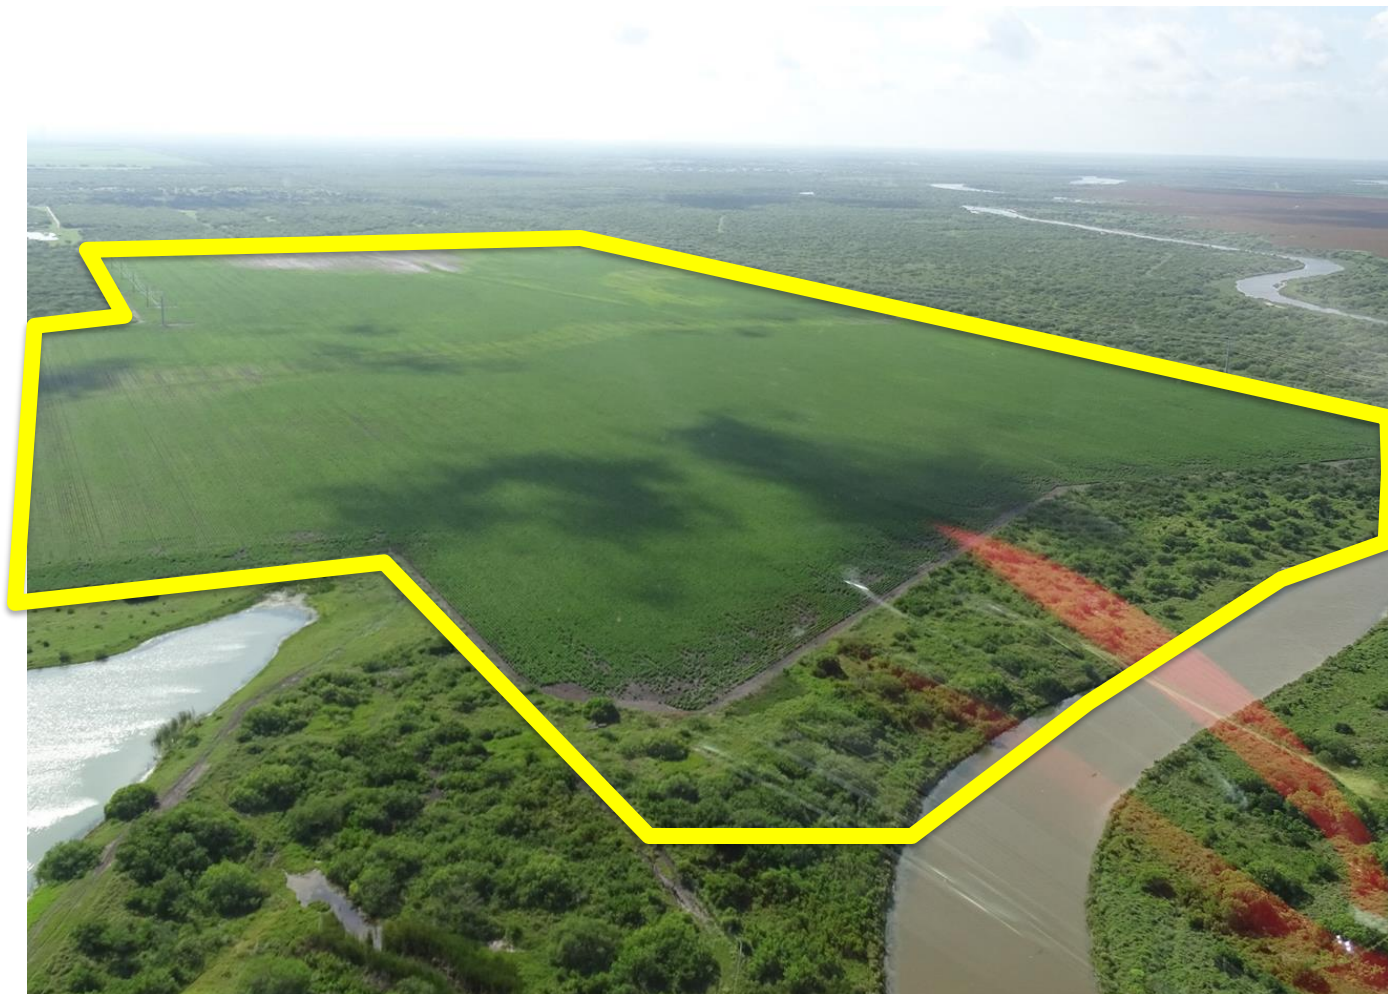
**Figure 58** Pictured here is part of a 200+/- acre farm where an installed wetland is being contemplated to improve water quality in Petronila Creek before it reaches the bay.

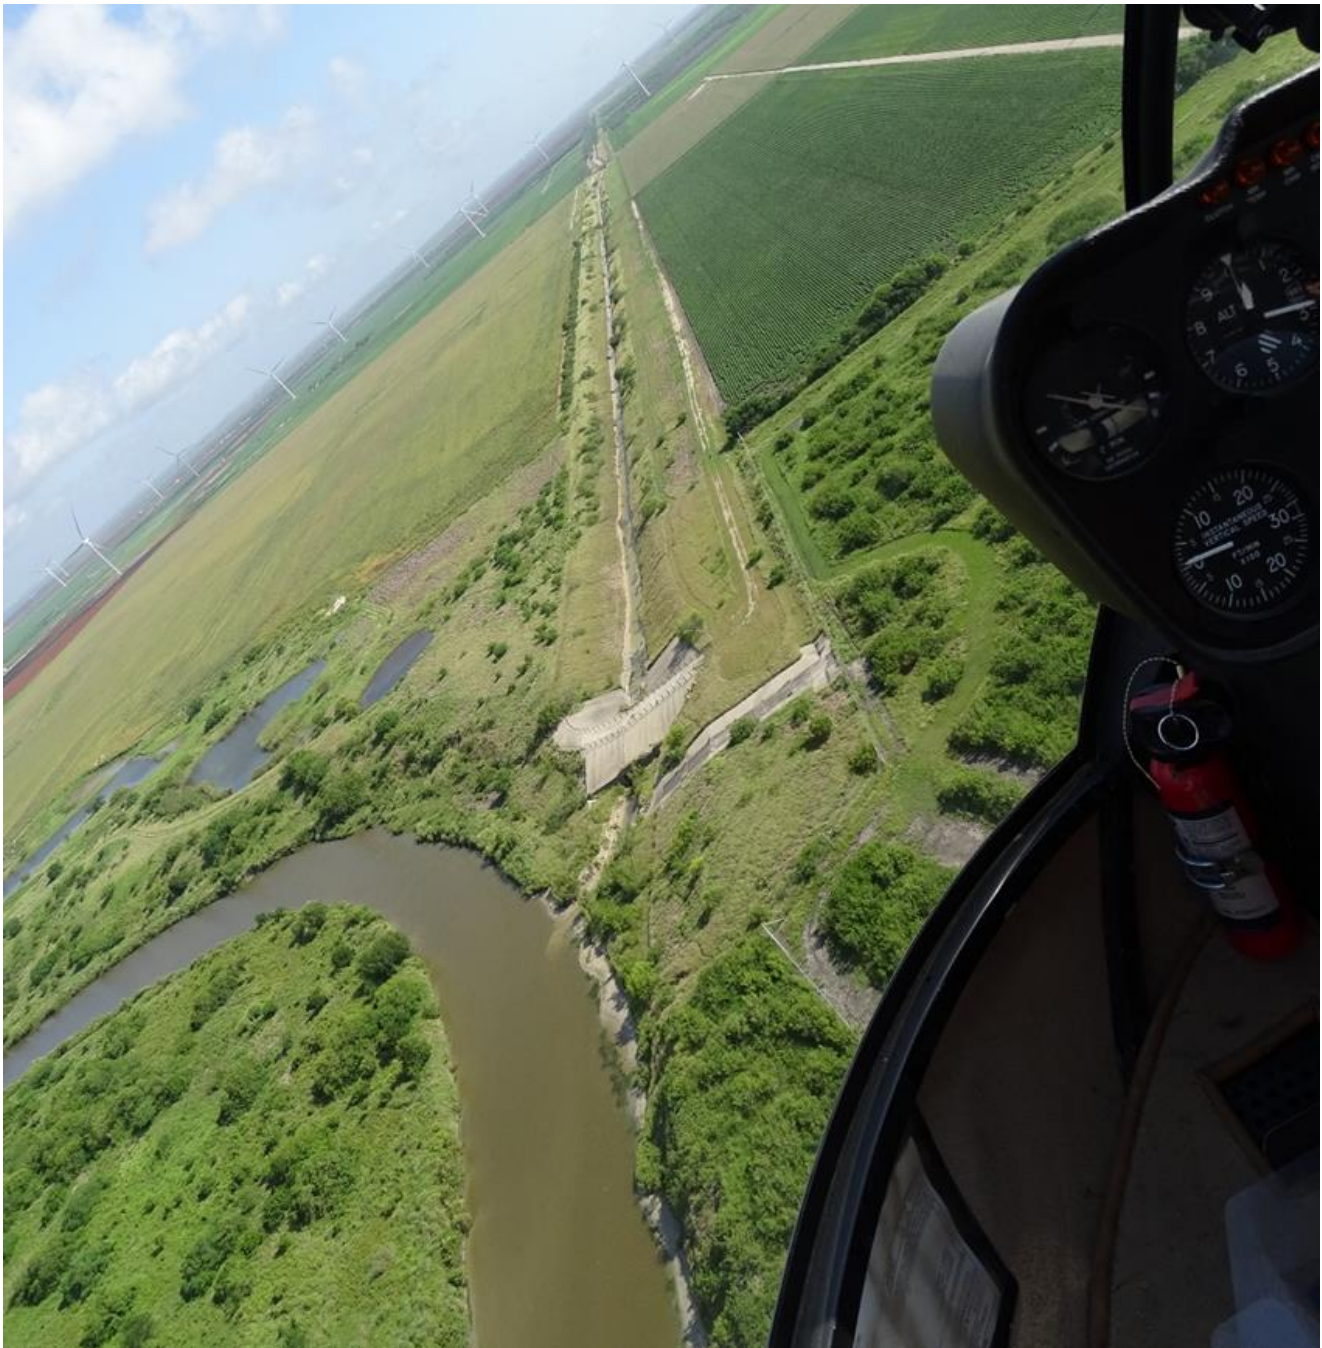
**Figure 59** Near the top of the reach, the creek and its riparian area narrow and become meandering. This image shows the confluence of the Landfill Ditch stormwater drain to Petronila Creek.

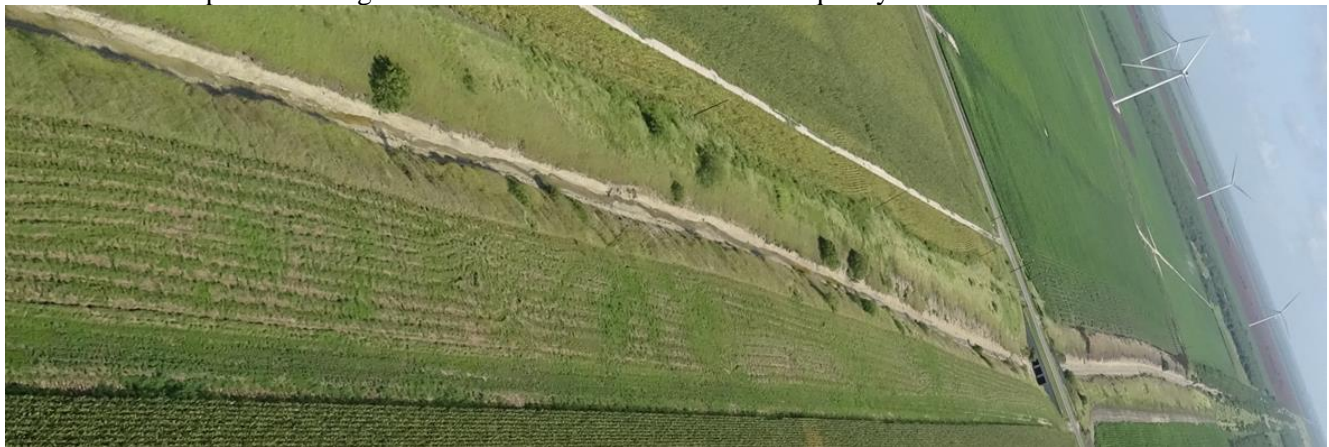
**Figure 62** This image shows the Landfill Ditch stormwater drain to the Lower Reach of Petronilla Creek incised and its banks either bare or kept mowed. There appears to be a setback, perhaps an easement that restricts row crops to within 80-150 feet of the channel edge.

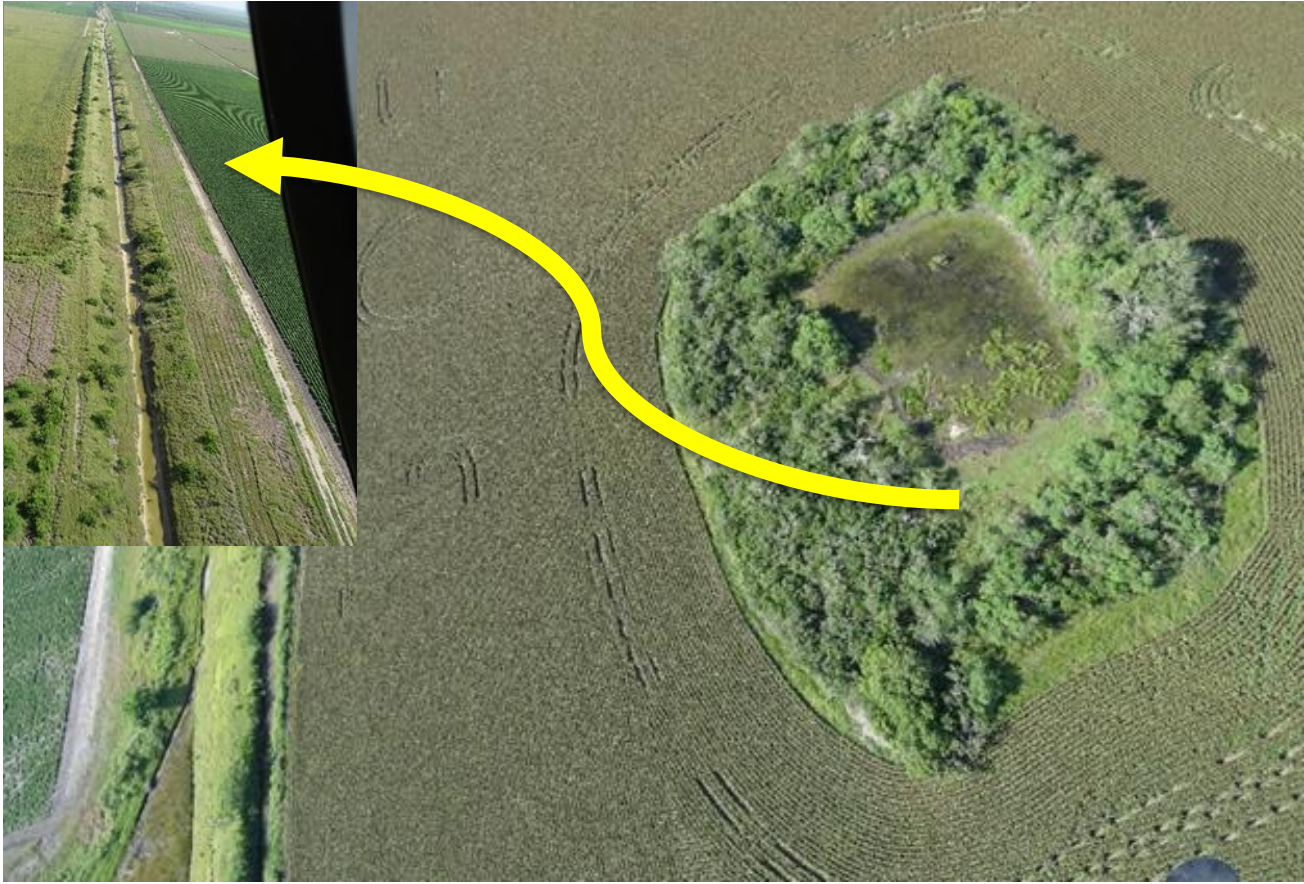
**Figure 63** The Landfill Ditch stormwater drain to the Lower Reach of Petronila Creek is overly straight for a natural drain. In this image we identified a water hole that may be a remnant of the old meandering channel of a natural drain before channelization. This feature could be included in a re-meander project to enhance riparian function for the benefit of water quality.

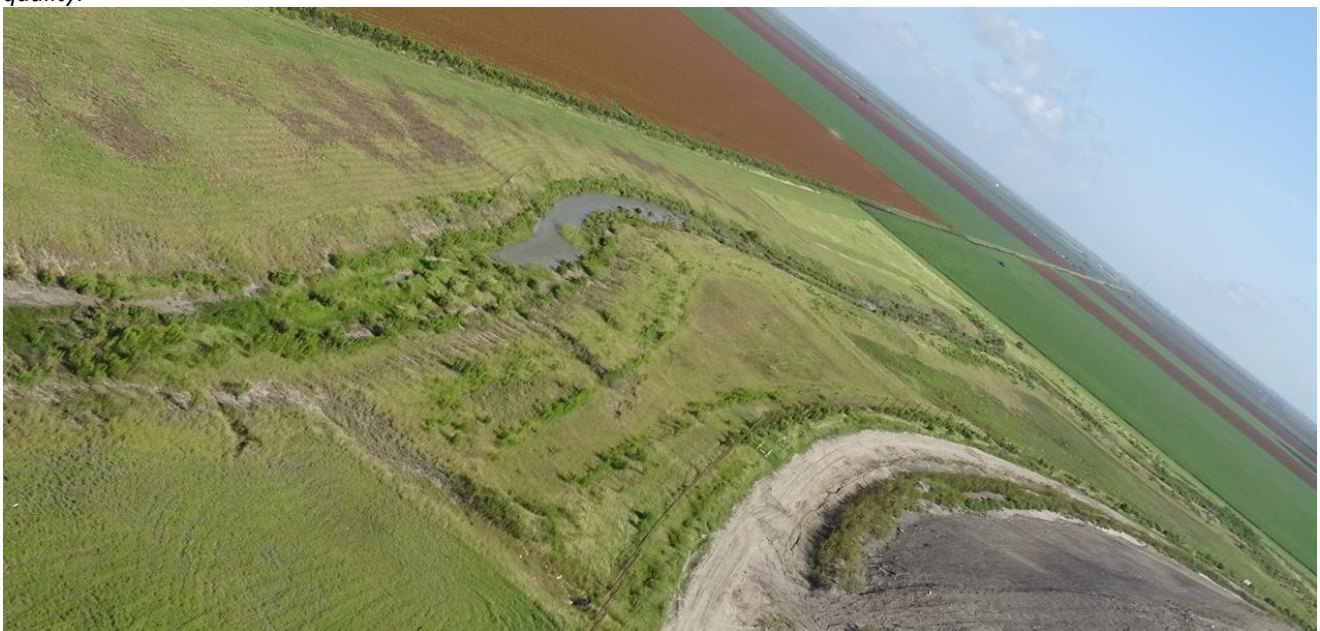
**Figure 64** Near the landfill the drain becomes more functional, vegetated with obligates and slightly meandering.

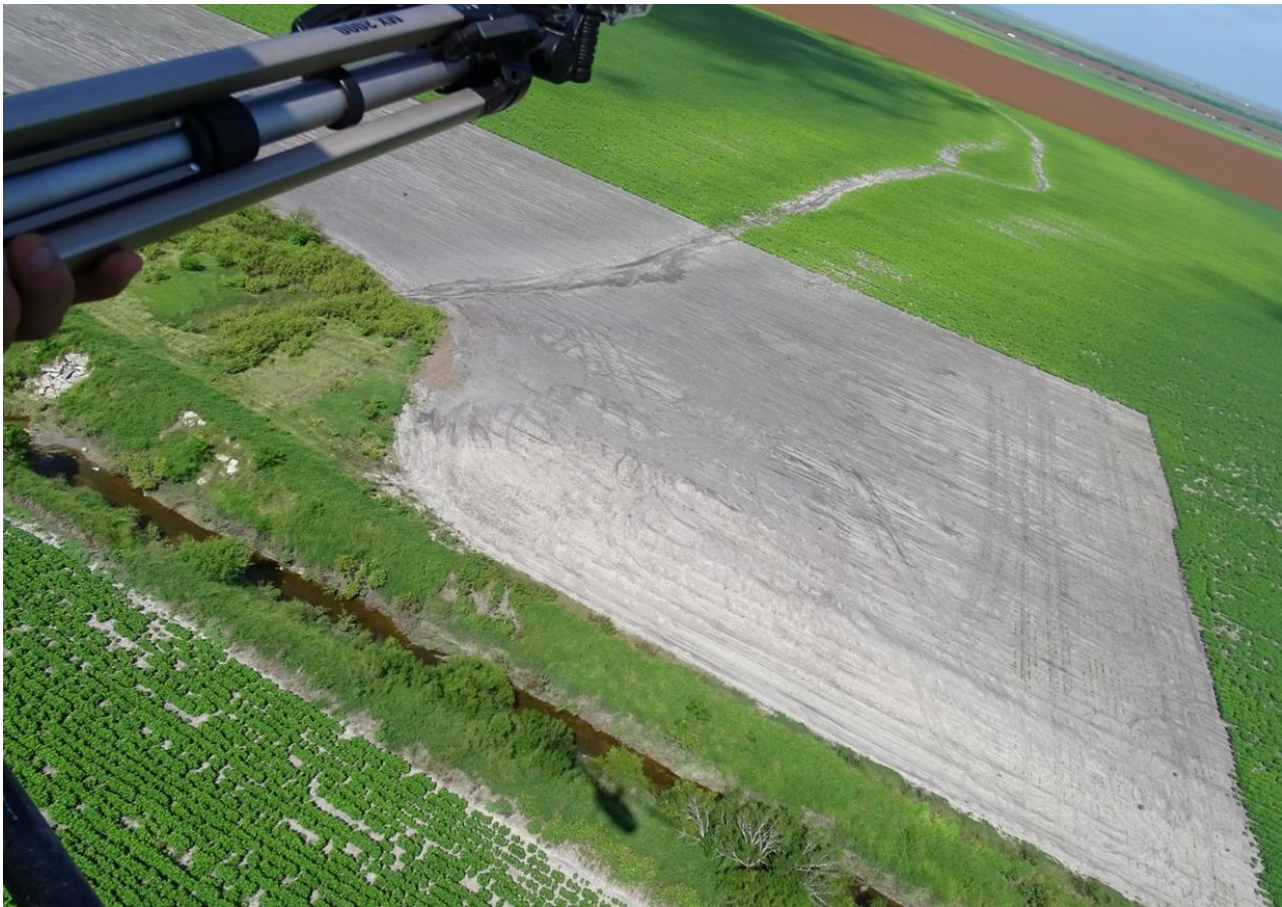
**Figure 69** This image shows gullies forming where runoff drains from adjacent farmland into the ditch. Allowing the drain to develop energy dissipating vegetation could slow the runoff and help slow the gully formation.

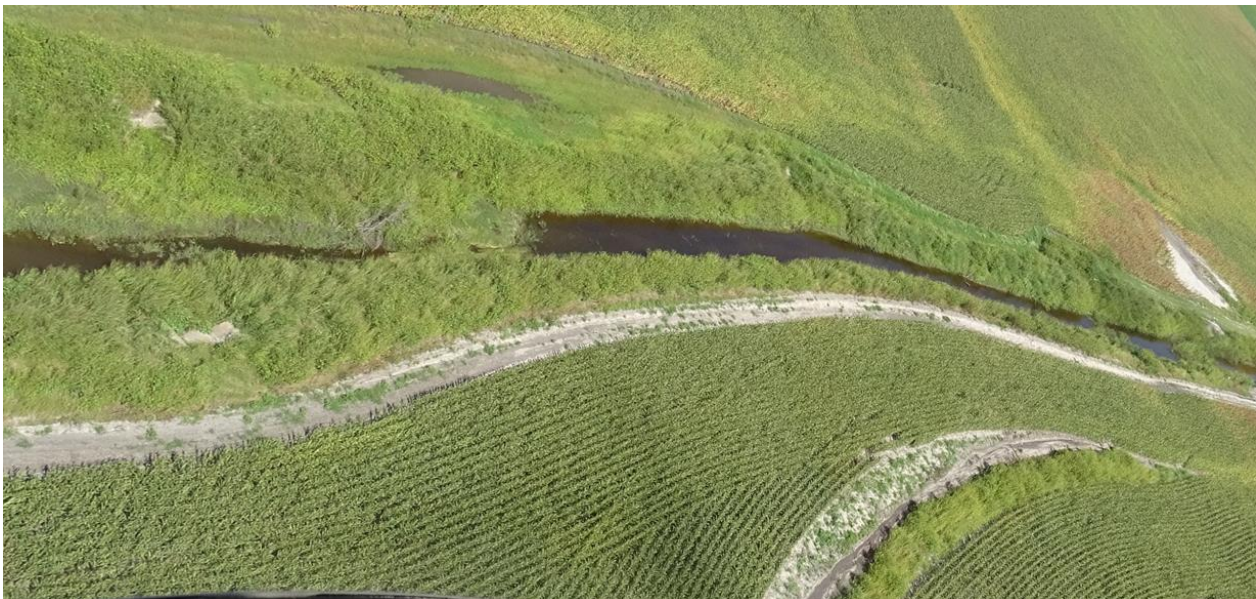
**Figure 70** In this image the banks of Lost Creek Ditch appear well vegetated, but only a portion of the vegetation is believed to be native riparian plants, like Spiny aster. Herbaceous buffers for creeks draining farmland were often planted in Guinea grass, a strong colonizer of disturbed soils. It is a non-native, weak-rooted, ground-covering plant that does not advance riparian function.

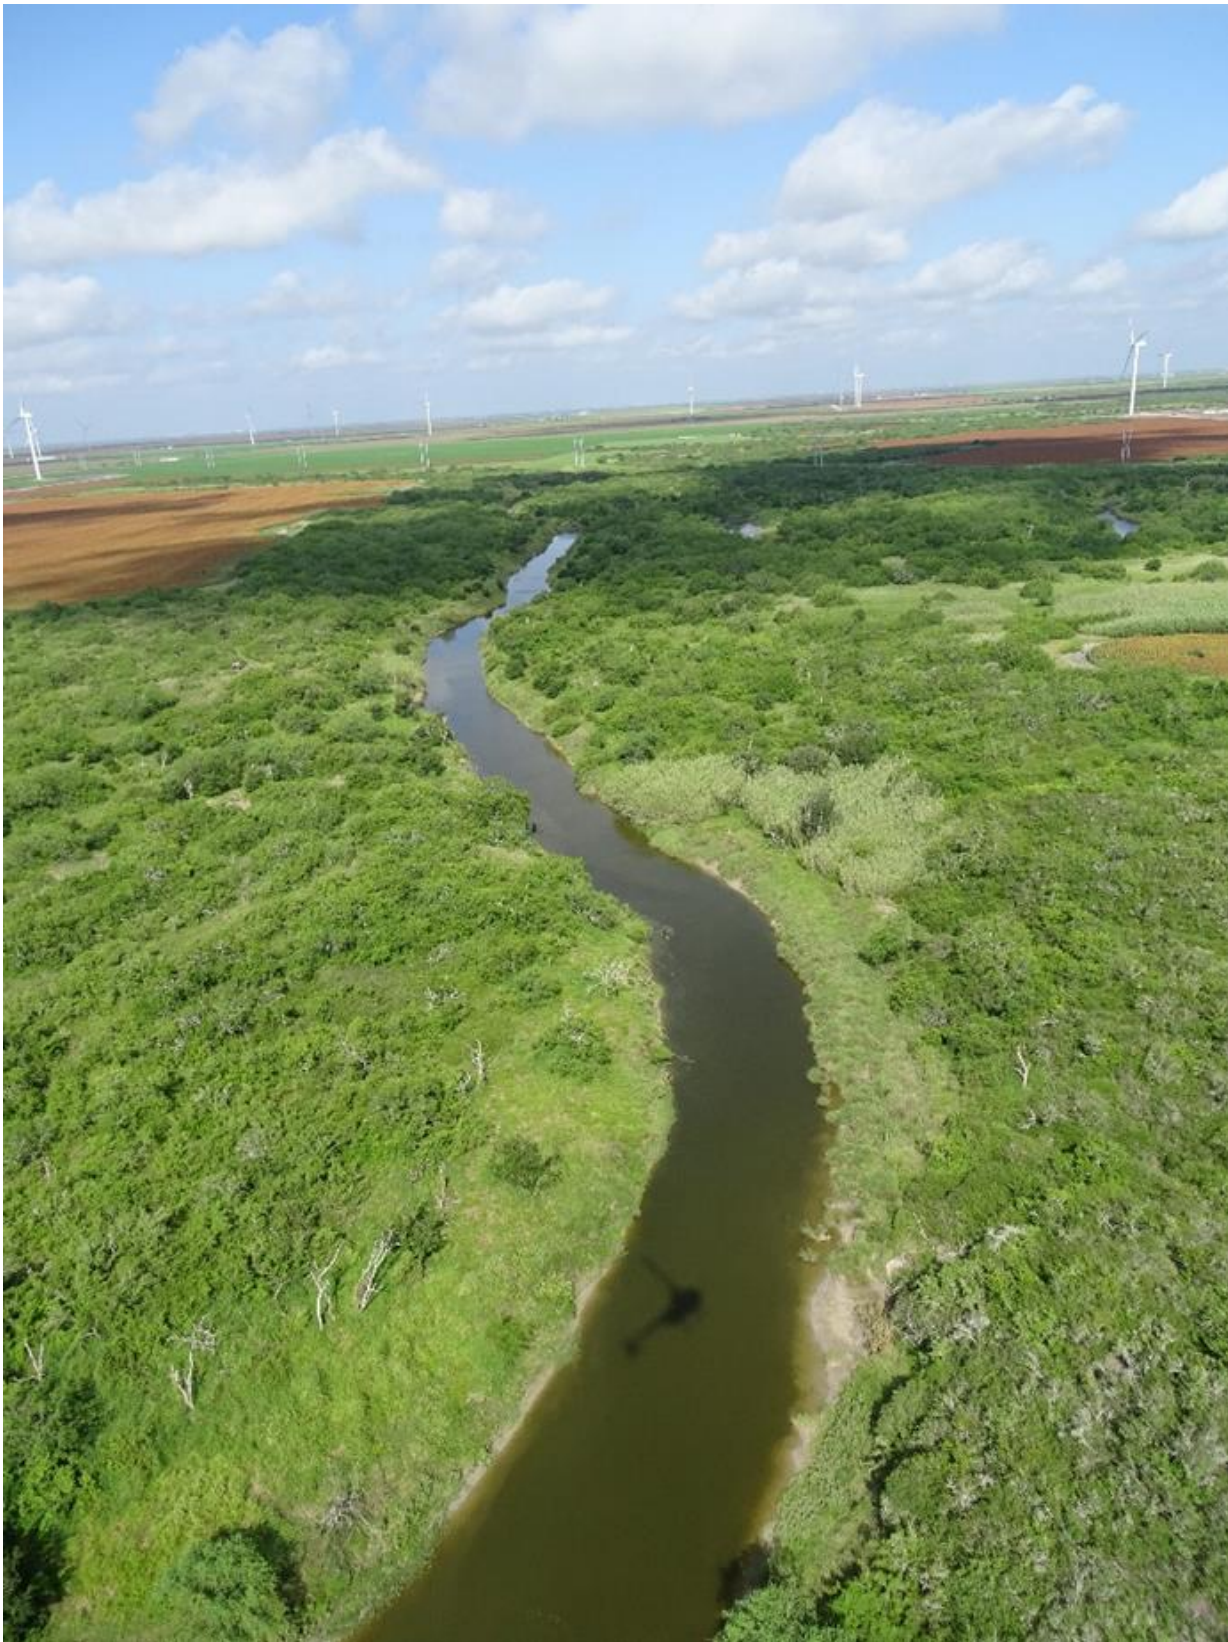
**Figure 73** Pictured here is the Lubby/Driscoll Reach of Petronila Creek with its well-vegetated banks and floodplain. Visible in this image is a healthy stand of what appears to be Cordgrass on the right bank and an abundance of large trees: Oak, Ash, Mesquite, Retama and others. Guinea grass and *Arundo donax* were also observed.

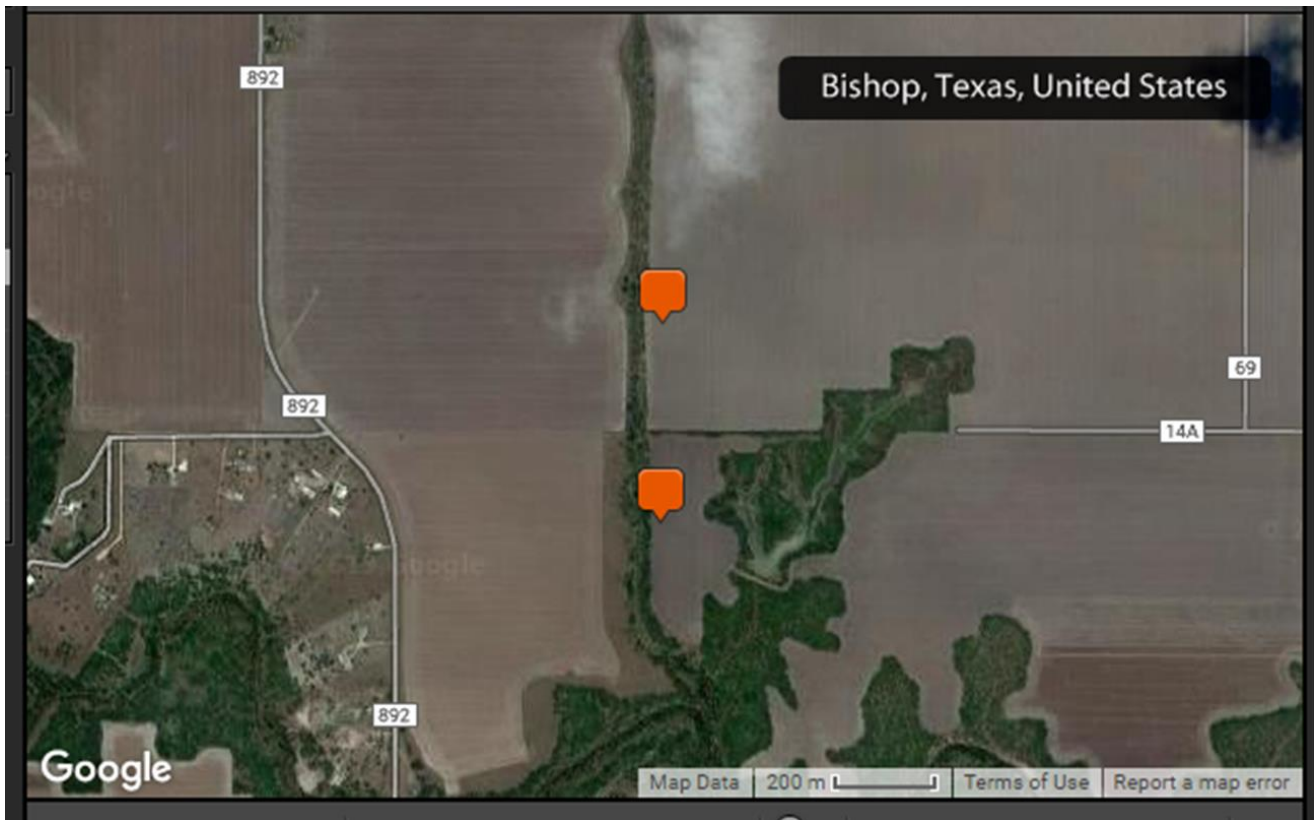
**Figure 76** Near FM 892, a drain enters the creek from the north. It was not identified for evaluation as part of this project. This GoogleEarth™ image shows the location of this drain and with orange flags, where the images in Figure 76 were taken.

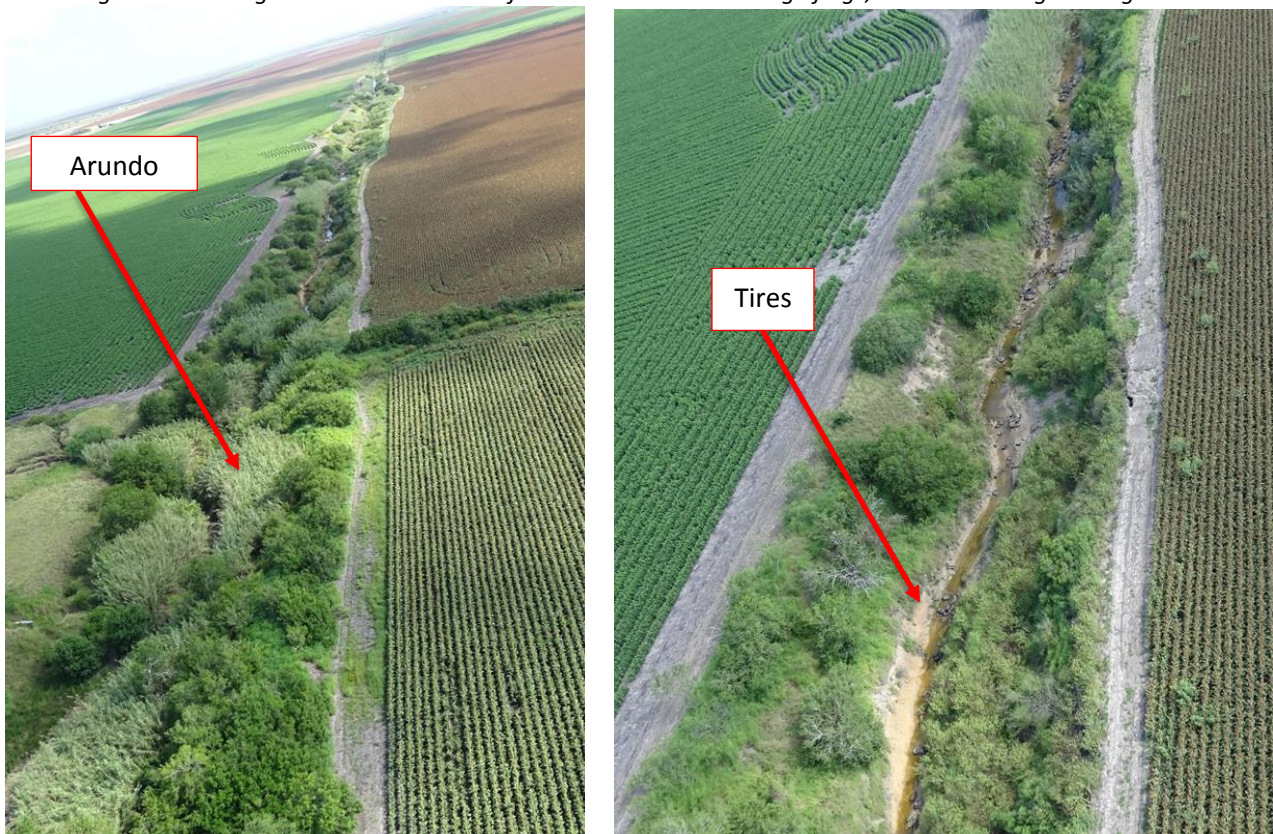
**Figure 77** This image shows the small drain entering Petronila is littered with large quantity of dumped tires and covered with the highly invasive plant, *Arundo donax*.

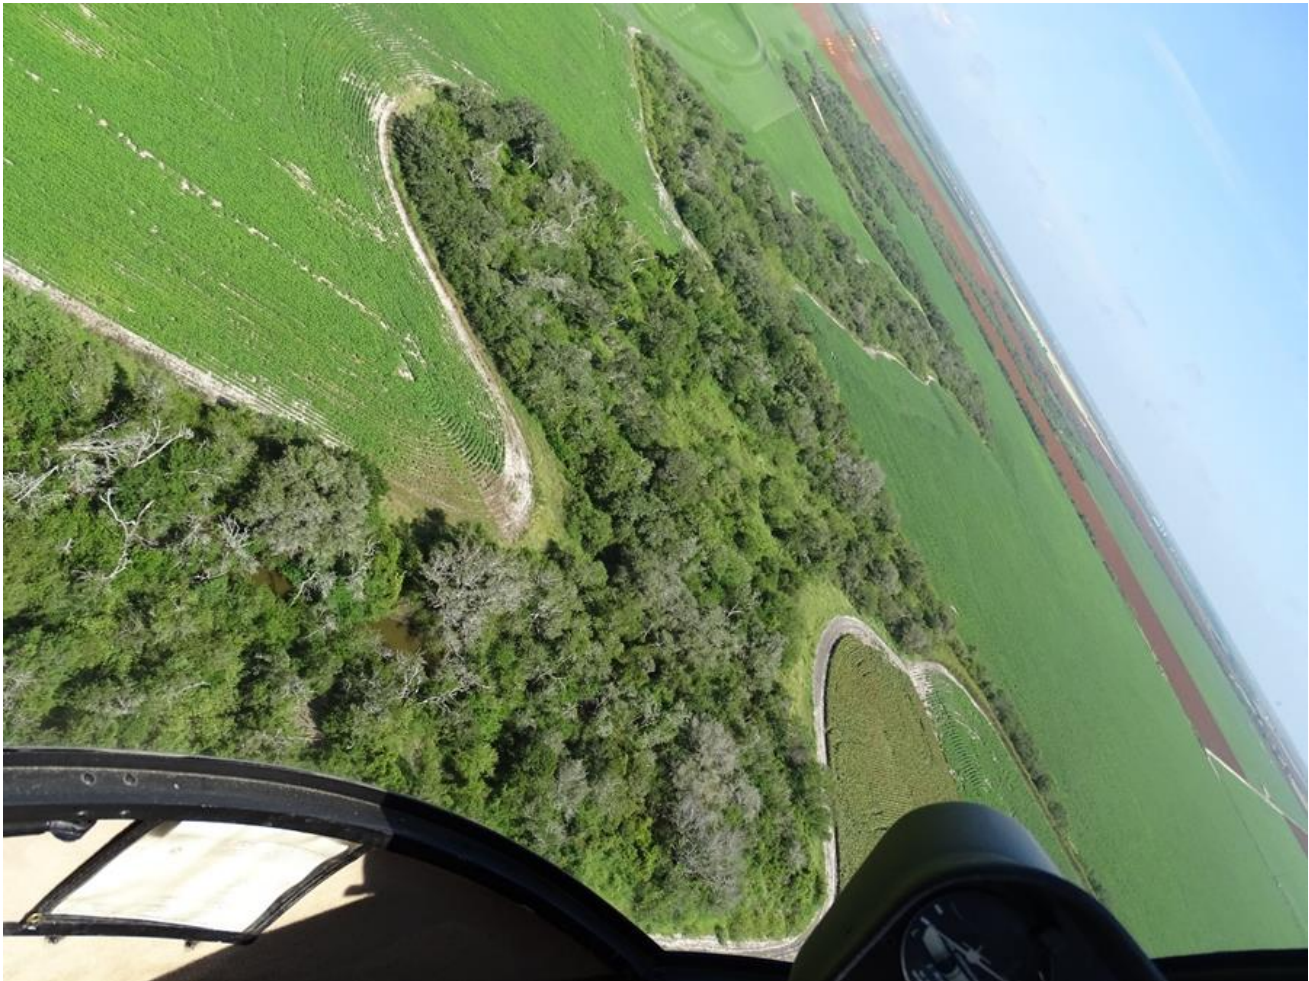
**Figure 81** This image shows the heavily wooded and functional condition of the riparian area along most of the Banquete reach of Petronila Creek.

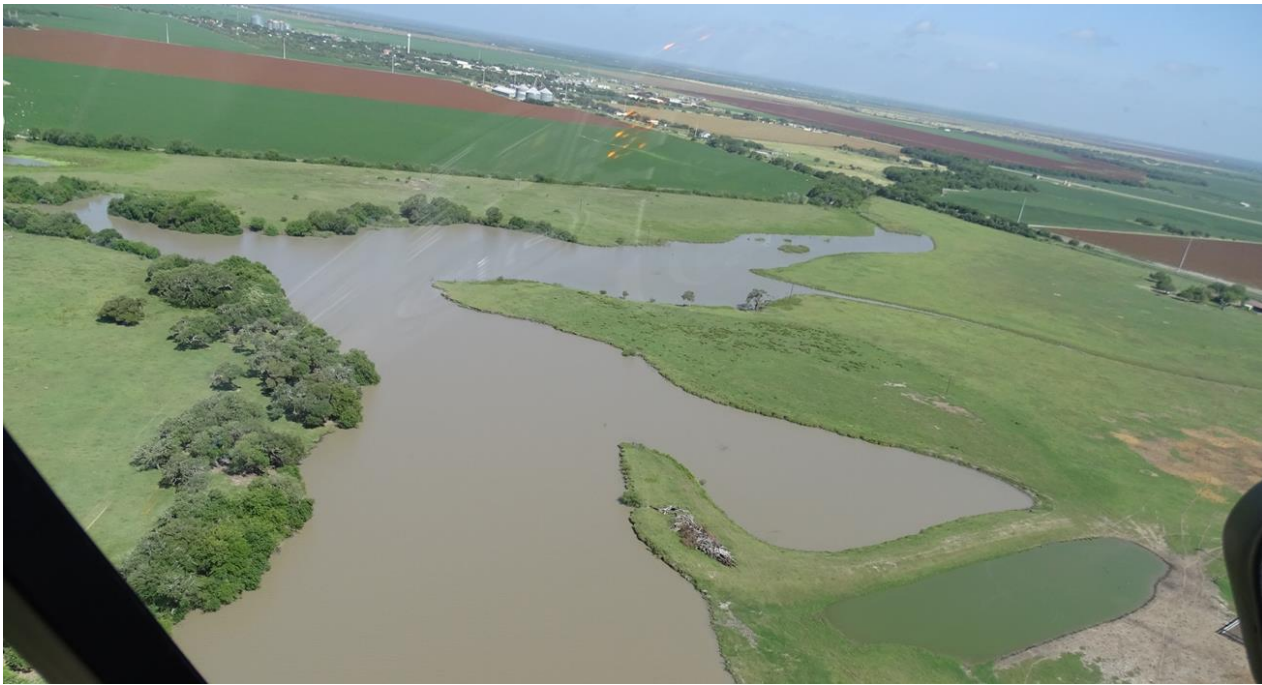
**Figure 84** Manicured and grazed riparian area at the top of the reach. The water's color at this location has become turbid and milky brown.

- 1) Work with landowners to address identified hindrances that could include a setback of pasture manicuring and an initially rest from grazing pressure on the creek banks to allow riparian plants to recover.
- 2) Without creating additional hindrances, engage the communities within the neighborhoods and the detention center in water quality and riparian issues surrounding the creek in their area.
