# Riparian Evaluation Report: Tributaries of Baffin Bay

August 30, 2019

**Water Body:** Baffin Bay 2492 Tributaries

**Contract No:** CBBEP 1907

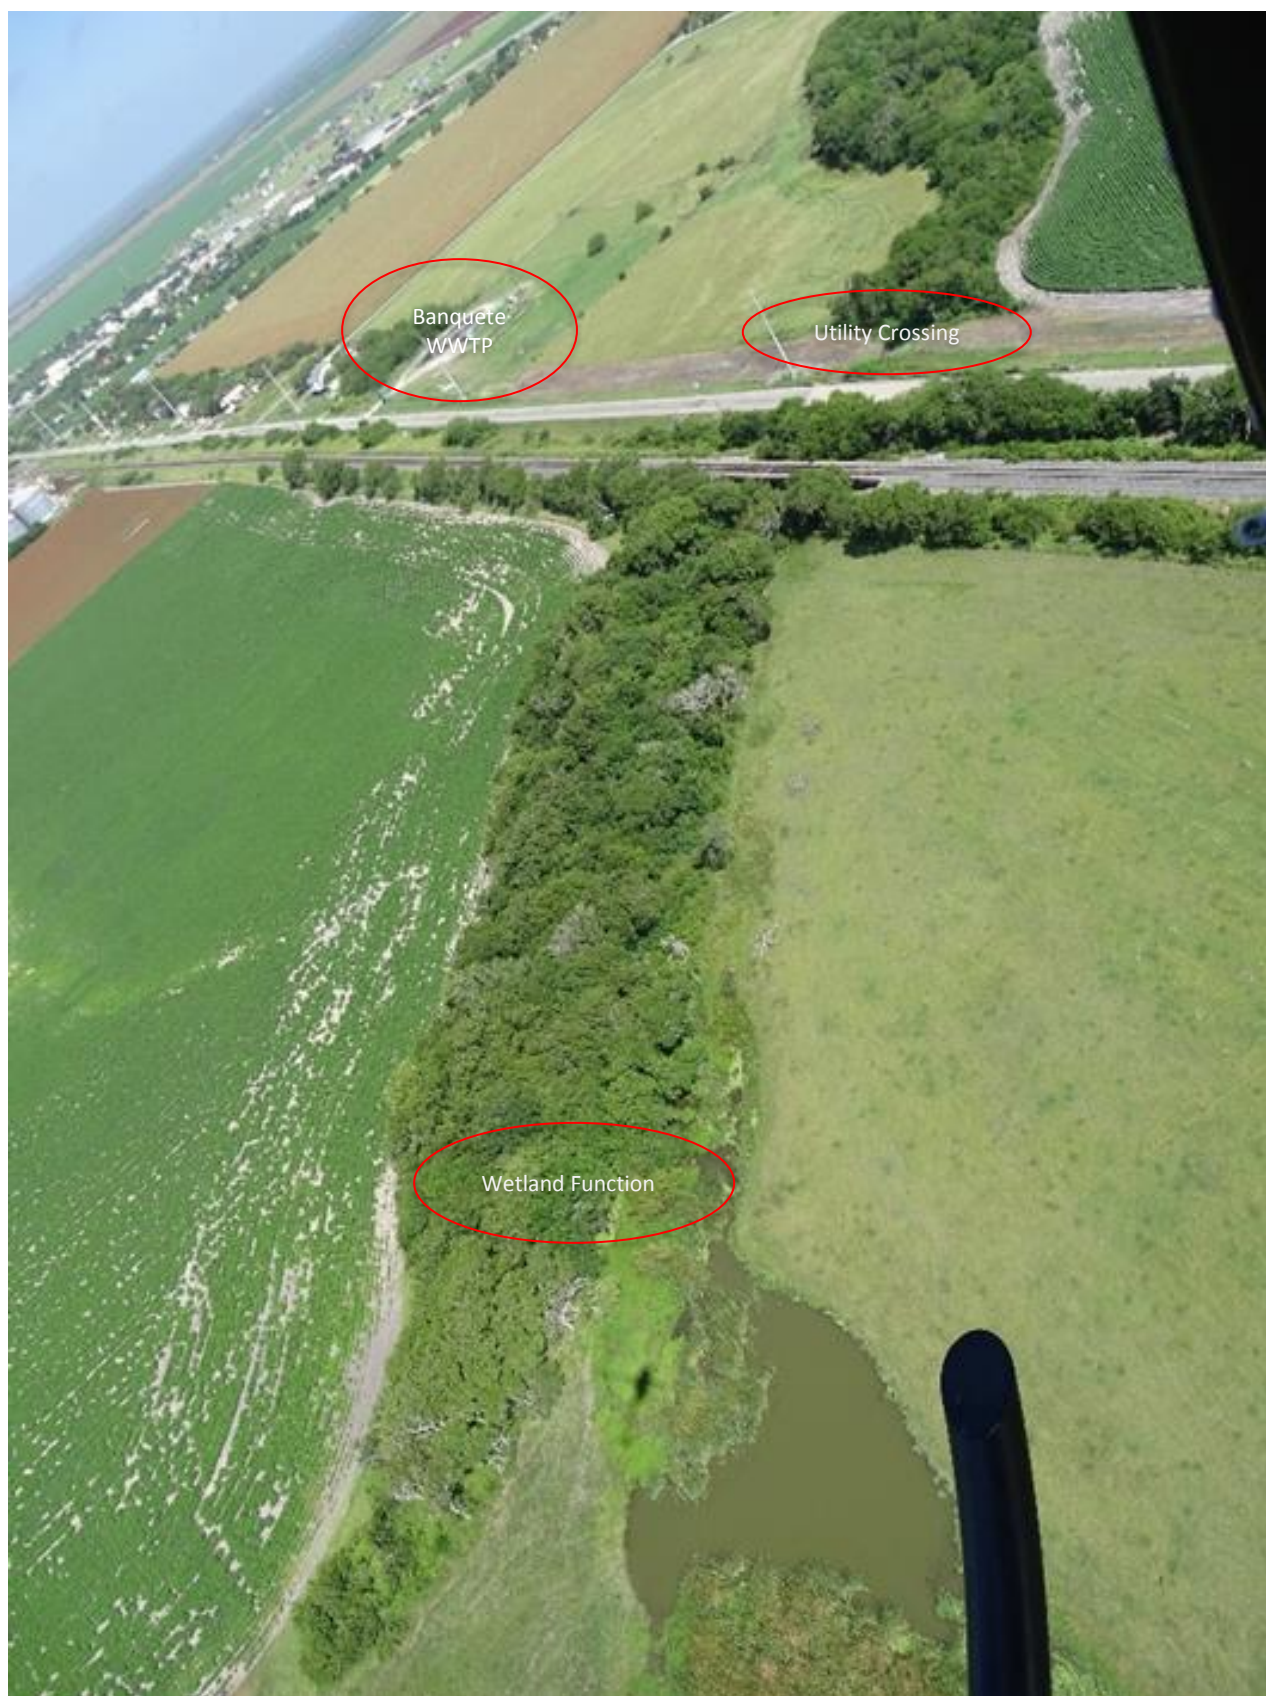
**Figure 88** Image illustrates the wetland-like conditions observed at the mouth of Banquete Creek about .1 mile below TX Hwy 40.

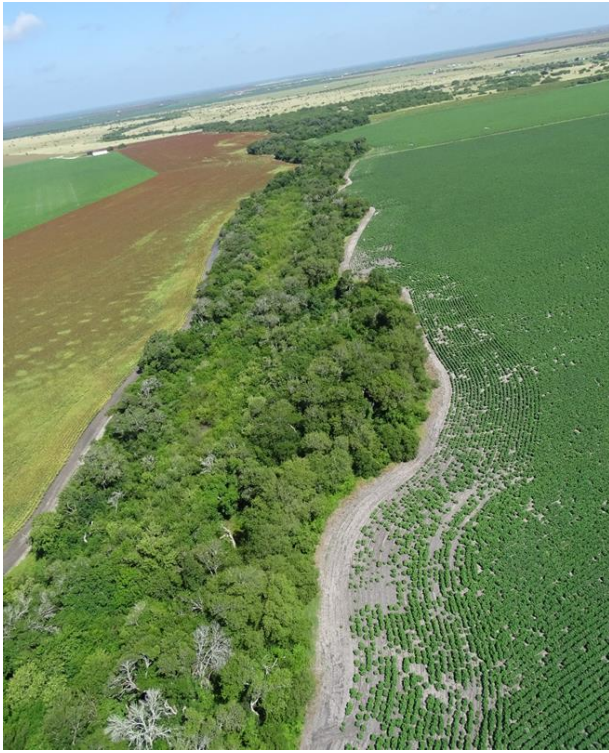
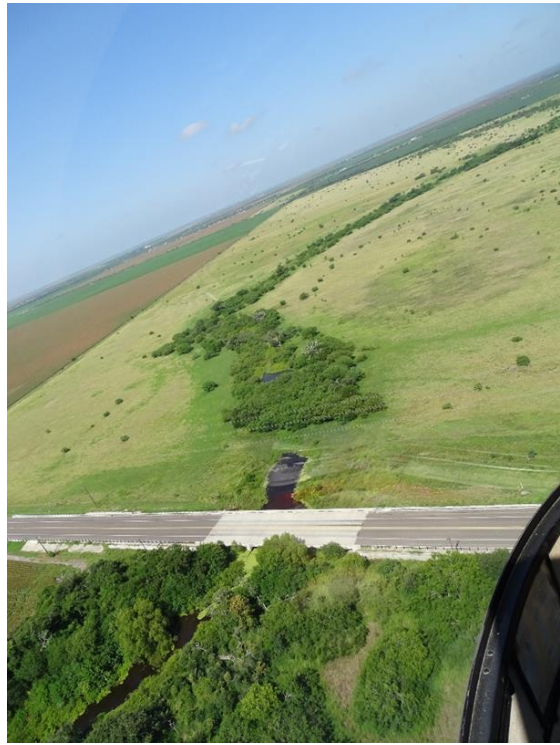
**Figure 89** Heavily wooded riparian area and water color within this functional area are pictured here. About 1.5 miles of wooded functional riparian area was observed over the 7.4 mile-long Banquette Creek.

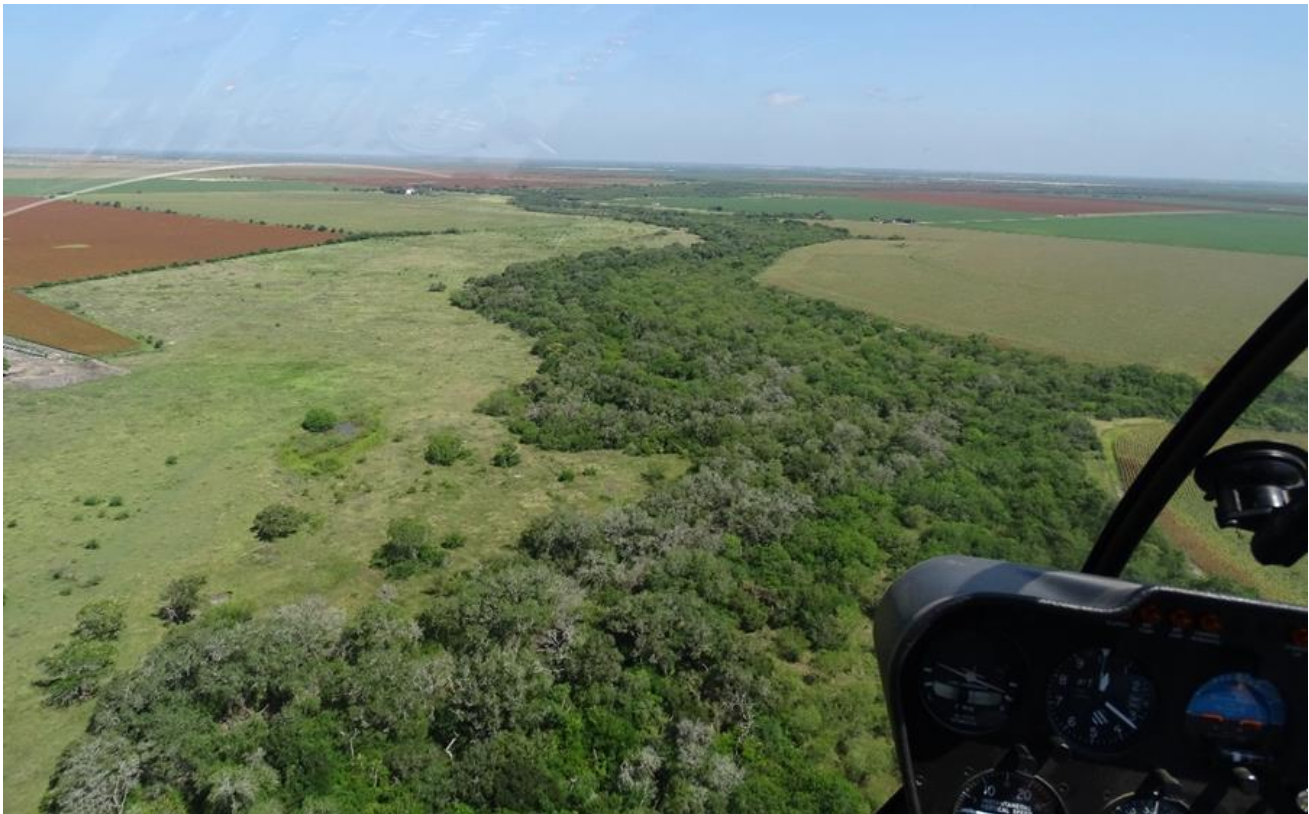
**Figure 94** This image shows the wide, forested and functional riparian area along lower reach of Aqua Dulce Creek.

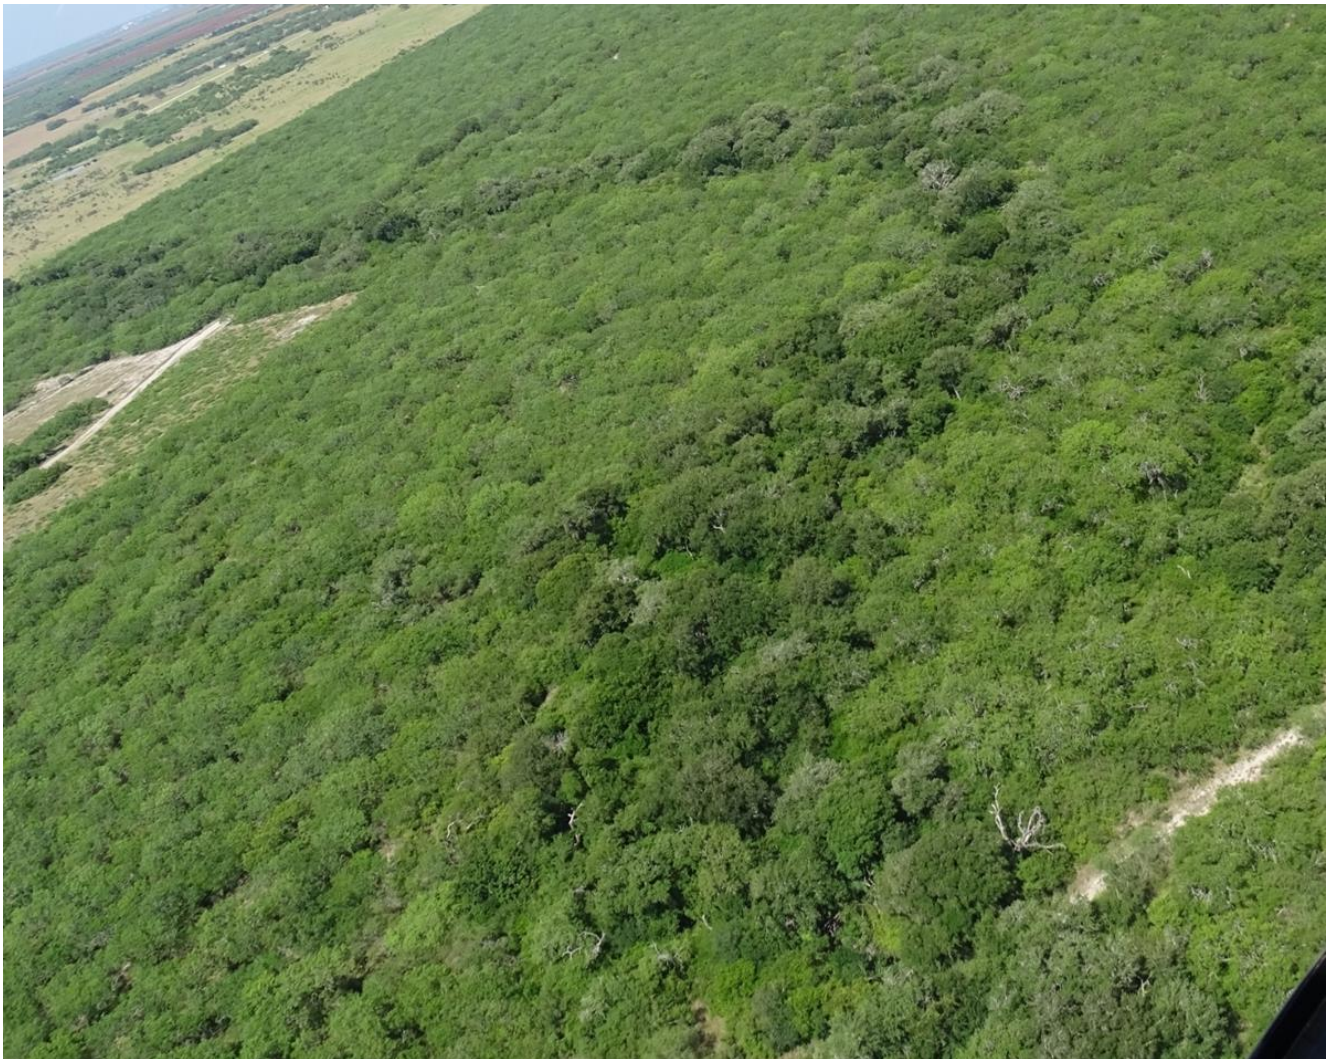
**Figure 97** Near the head of Aqua Dulce lower reach, the stream is completely shrouded in large woody plants. The creek water is not visible from the air.

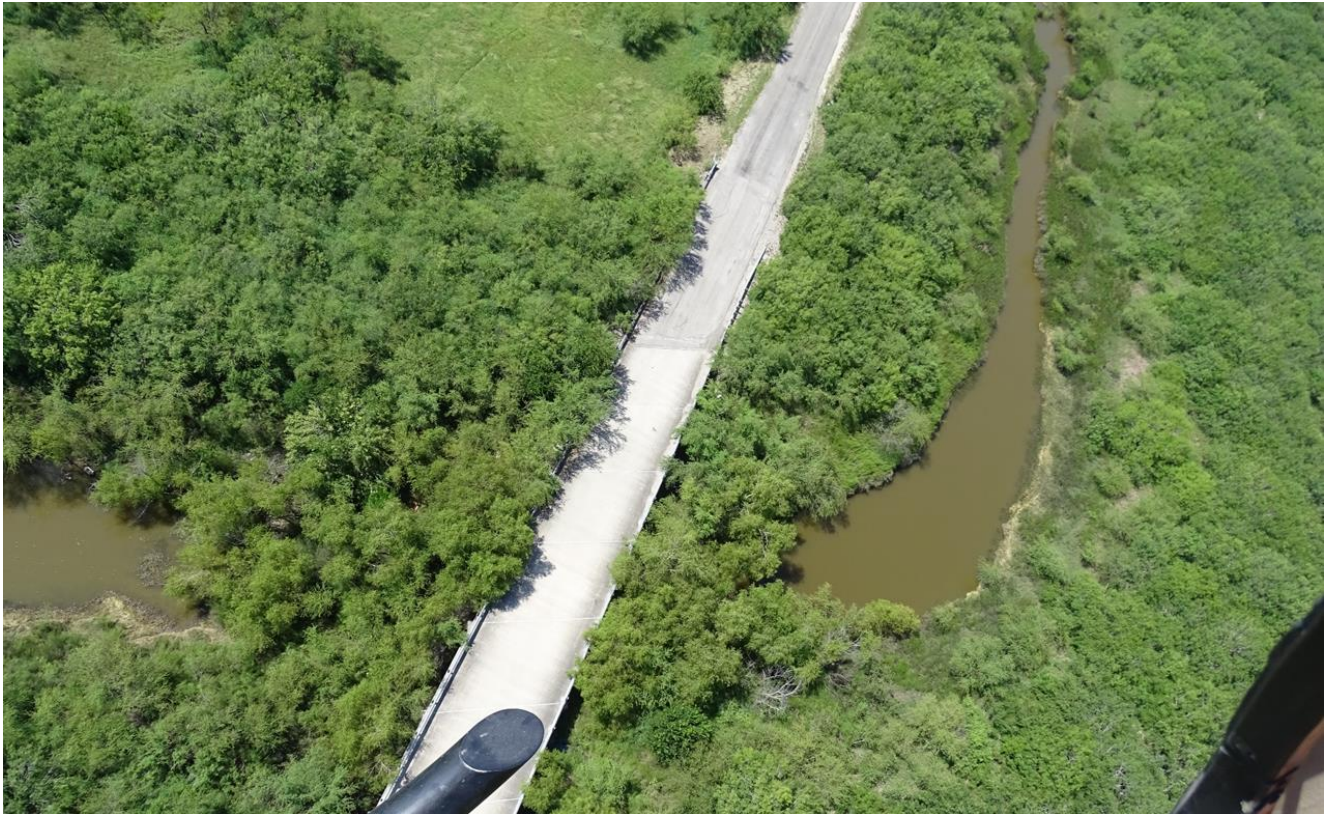
**Figure 102** Image shows the riparian condition on Pintas Creek at Texas Hwy 85 crossing. The creek is heavily wooded and riparian area highly functional.

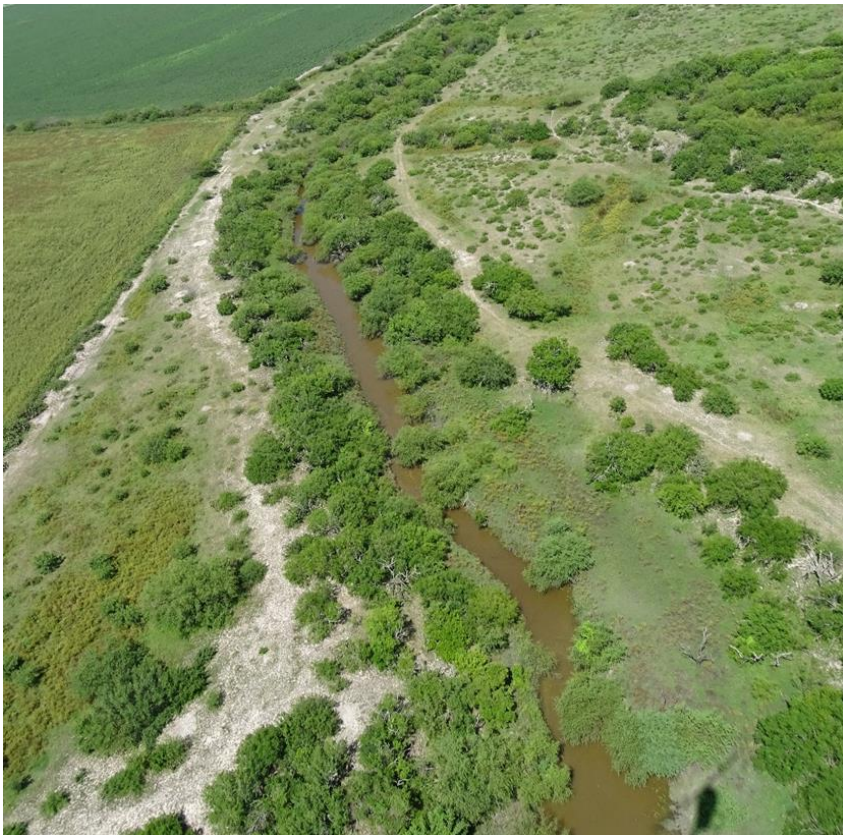
**Figure 103** Image illustrates the riparian condition along most of Pintas Creek.

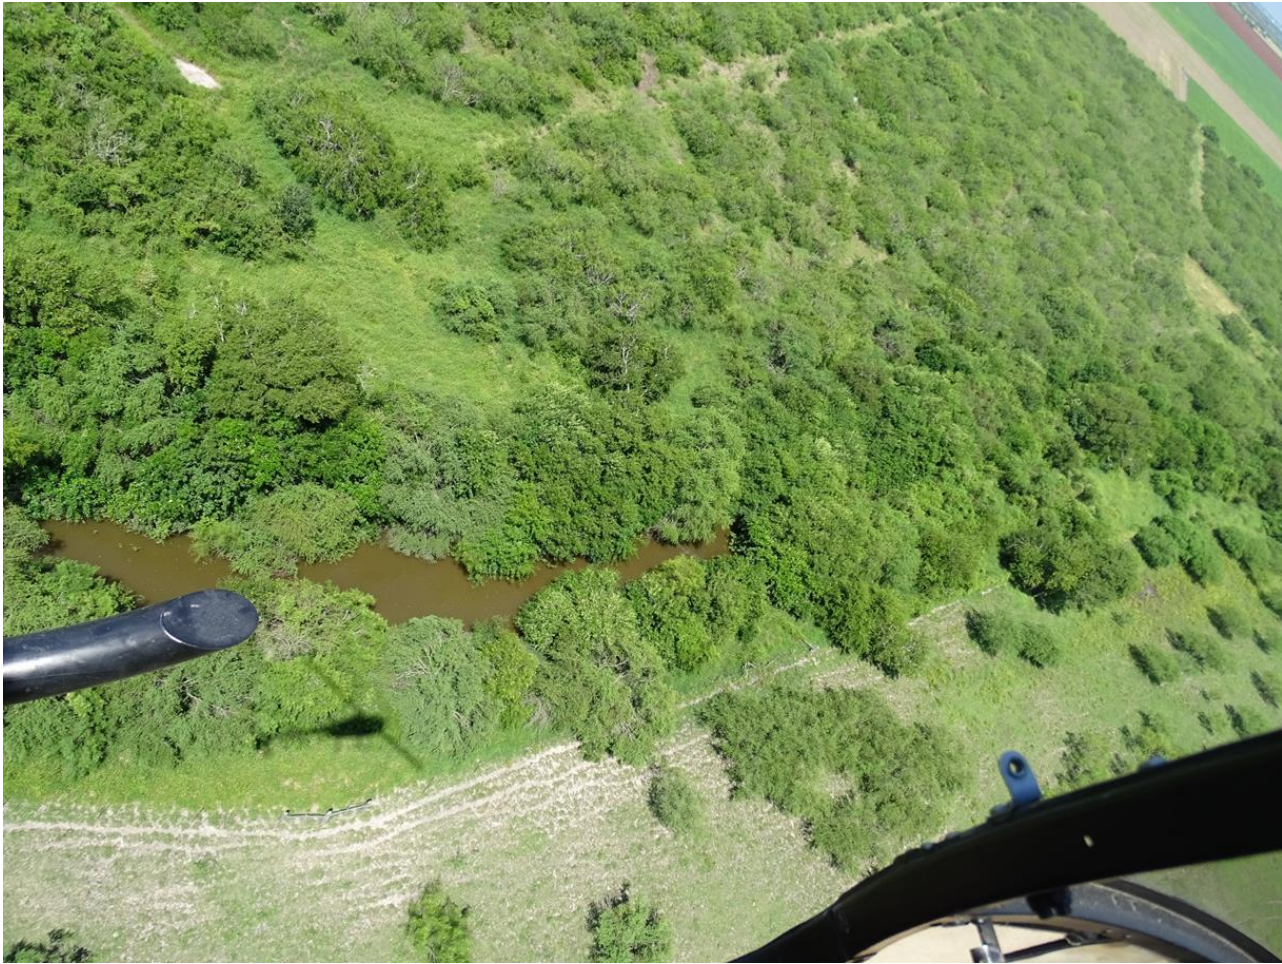
**Figure 104** This image illustrates the management of the riparian area along Pintas Creek to keep grazing livestock from hindering the riparian function along the creek.

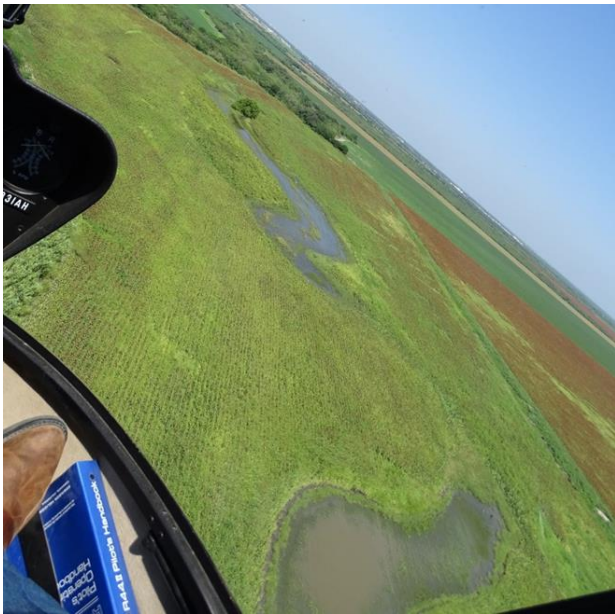
**Figure 105** This image shows an abandoned or secondary over-flow channel of Pintas Creek. Overflow channels with high functioning riparian areas can provide water quality benefits by capturing and incorporating sediments from floodwaters. The over-flow channel pictured here does not offer much riparian benefit.

- 1) Work with landowners to reward the current stewardship; protect and document the functional riparian condition along Pintas Creek.
- 2) Work with willing landowners to convert farmland to functional wetlands/riparian areas where abandoned or alternative flow paths cross existing fields.

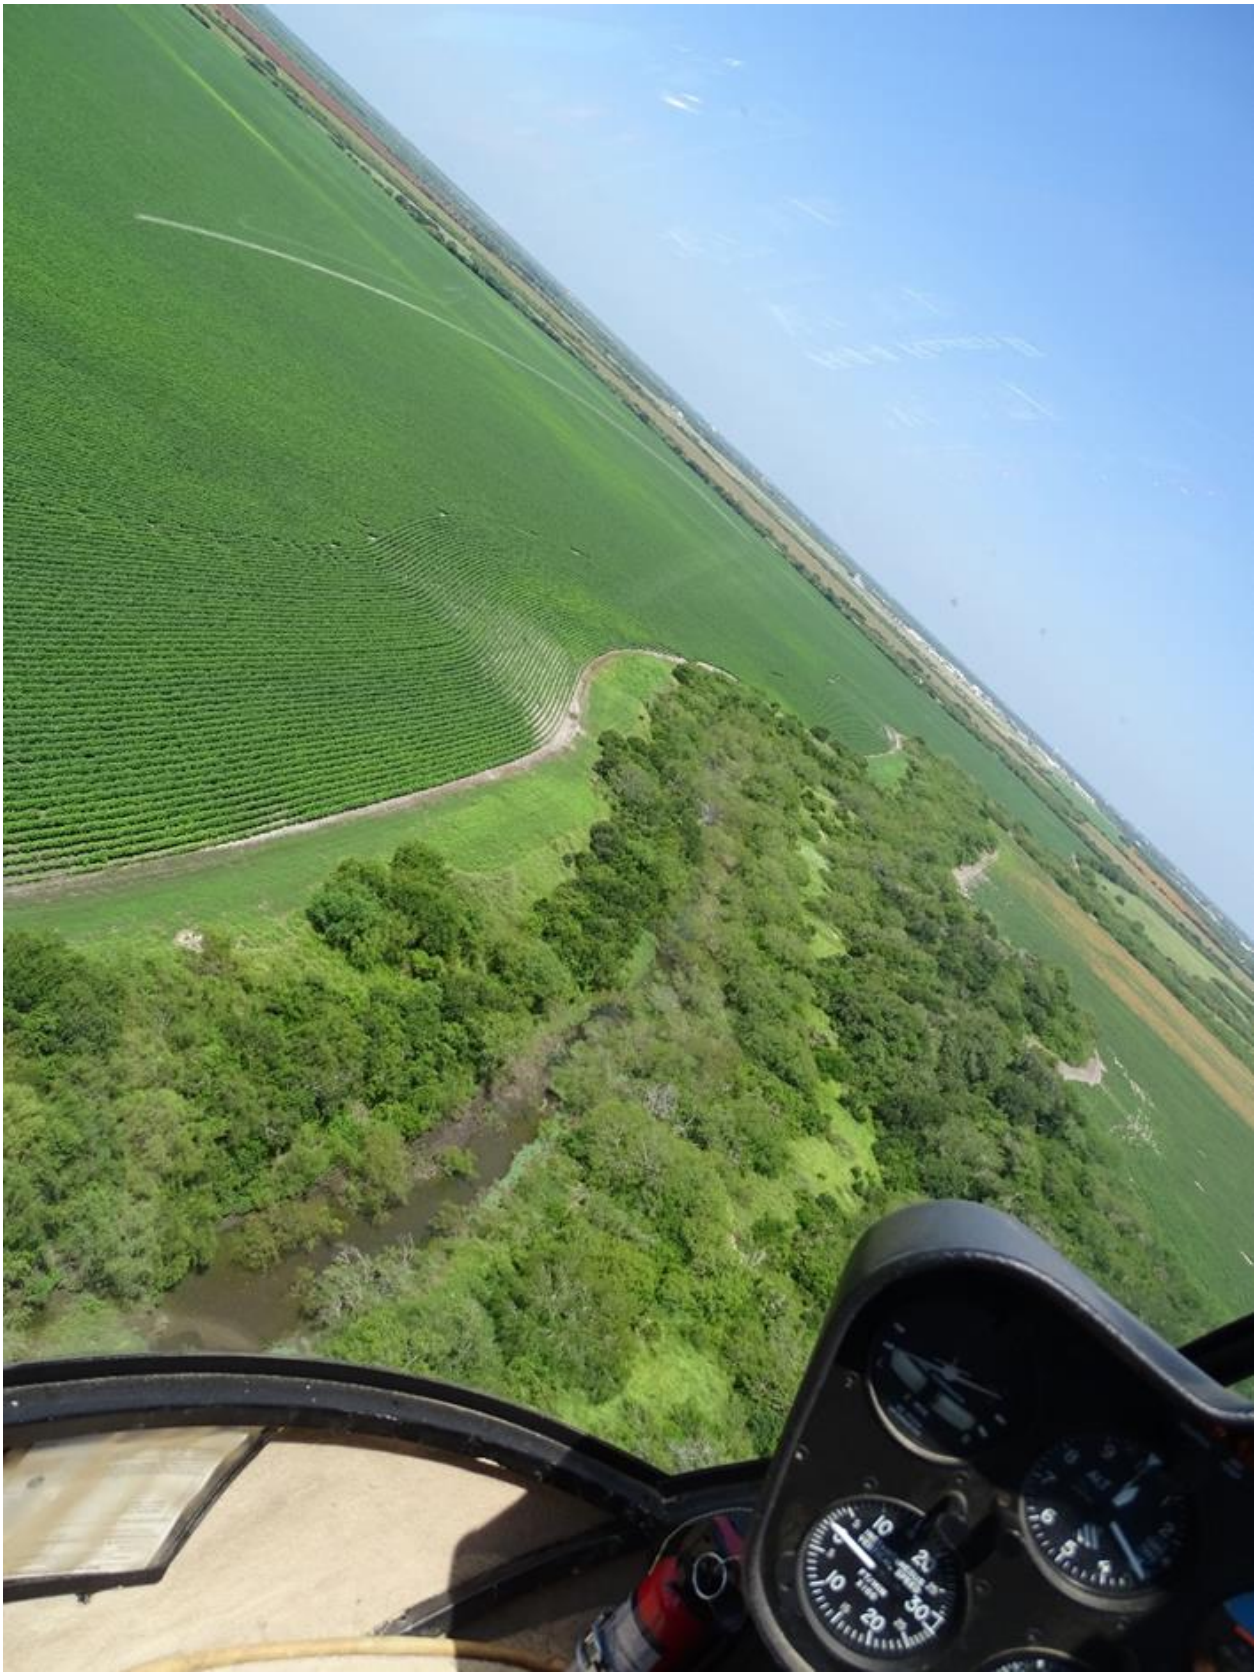
**Figure 106** Near the top of Pintas Creek the riparian area retains its woody functional condition.

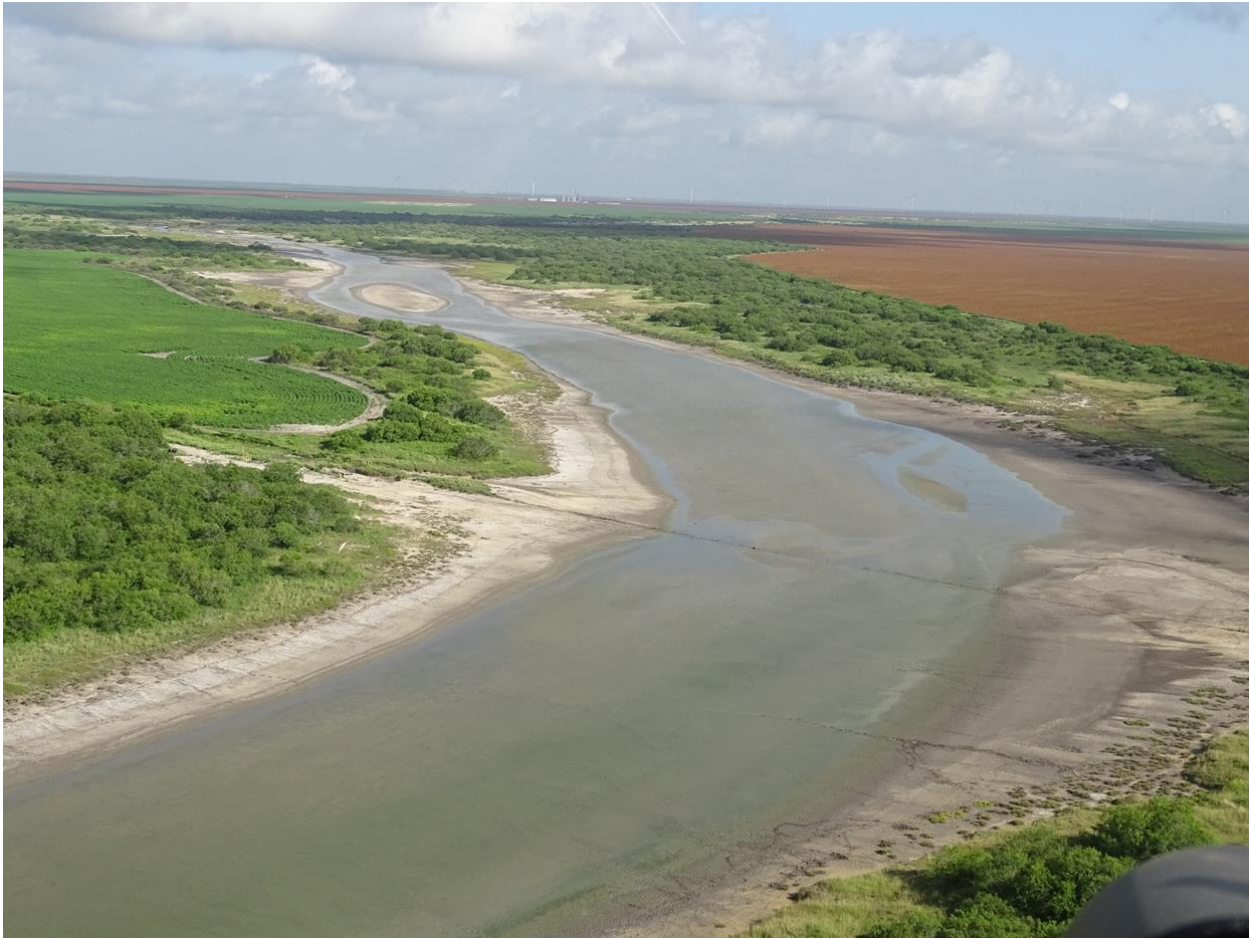
**Figure 109** Image shows wide functional riparian area flanking Los Tunas Creek at its mouth in the Cayo del Mazon. Farming activities are set back from the creek, and the wide floodplain is well vegetated.

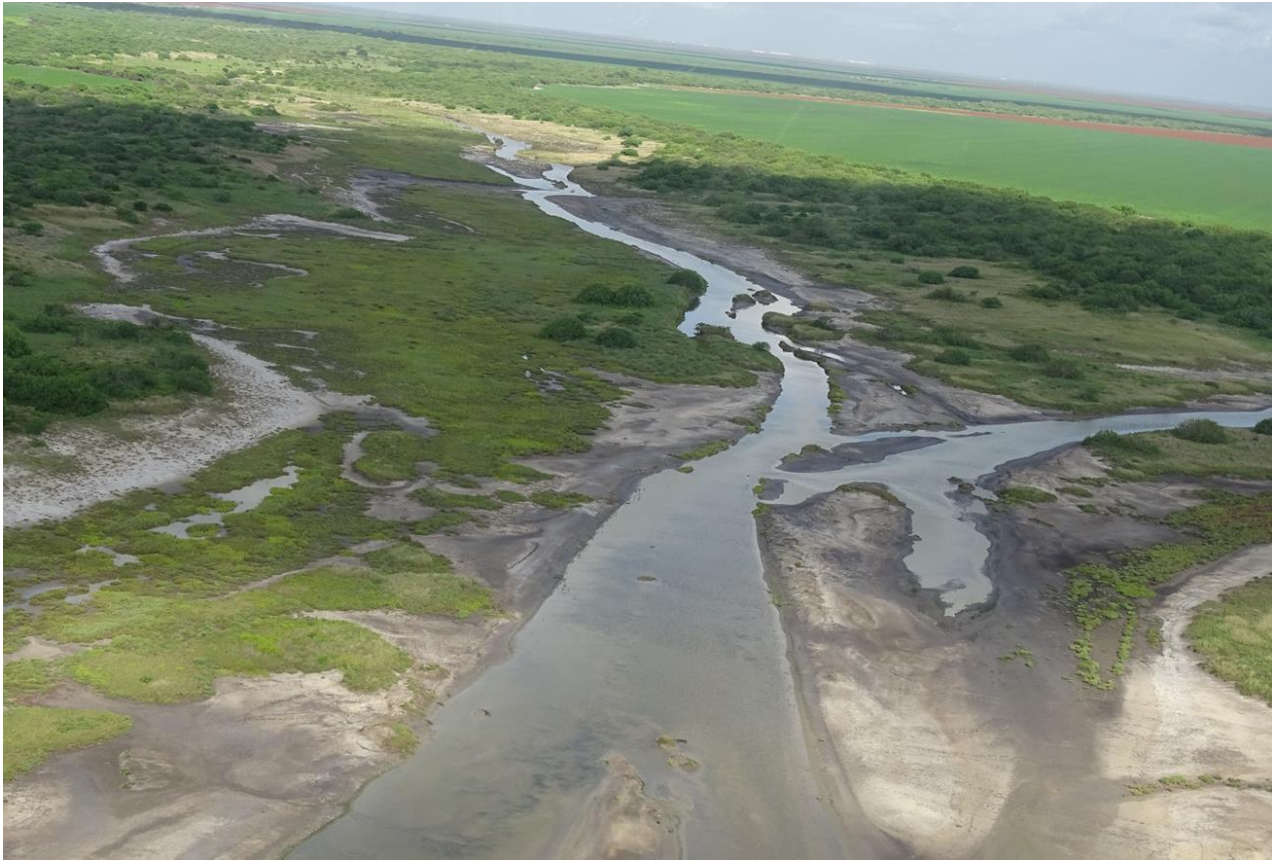
**Figure**

**110** Image shows wide functional riparian area flanking Los Tunas Creek at the confluence of Chiltipin Creek. Farming activities are set back from the creek, and the wide floodplain is well vegetated.

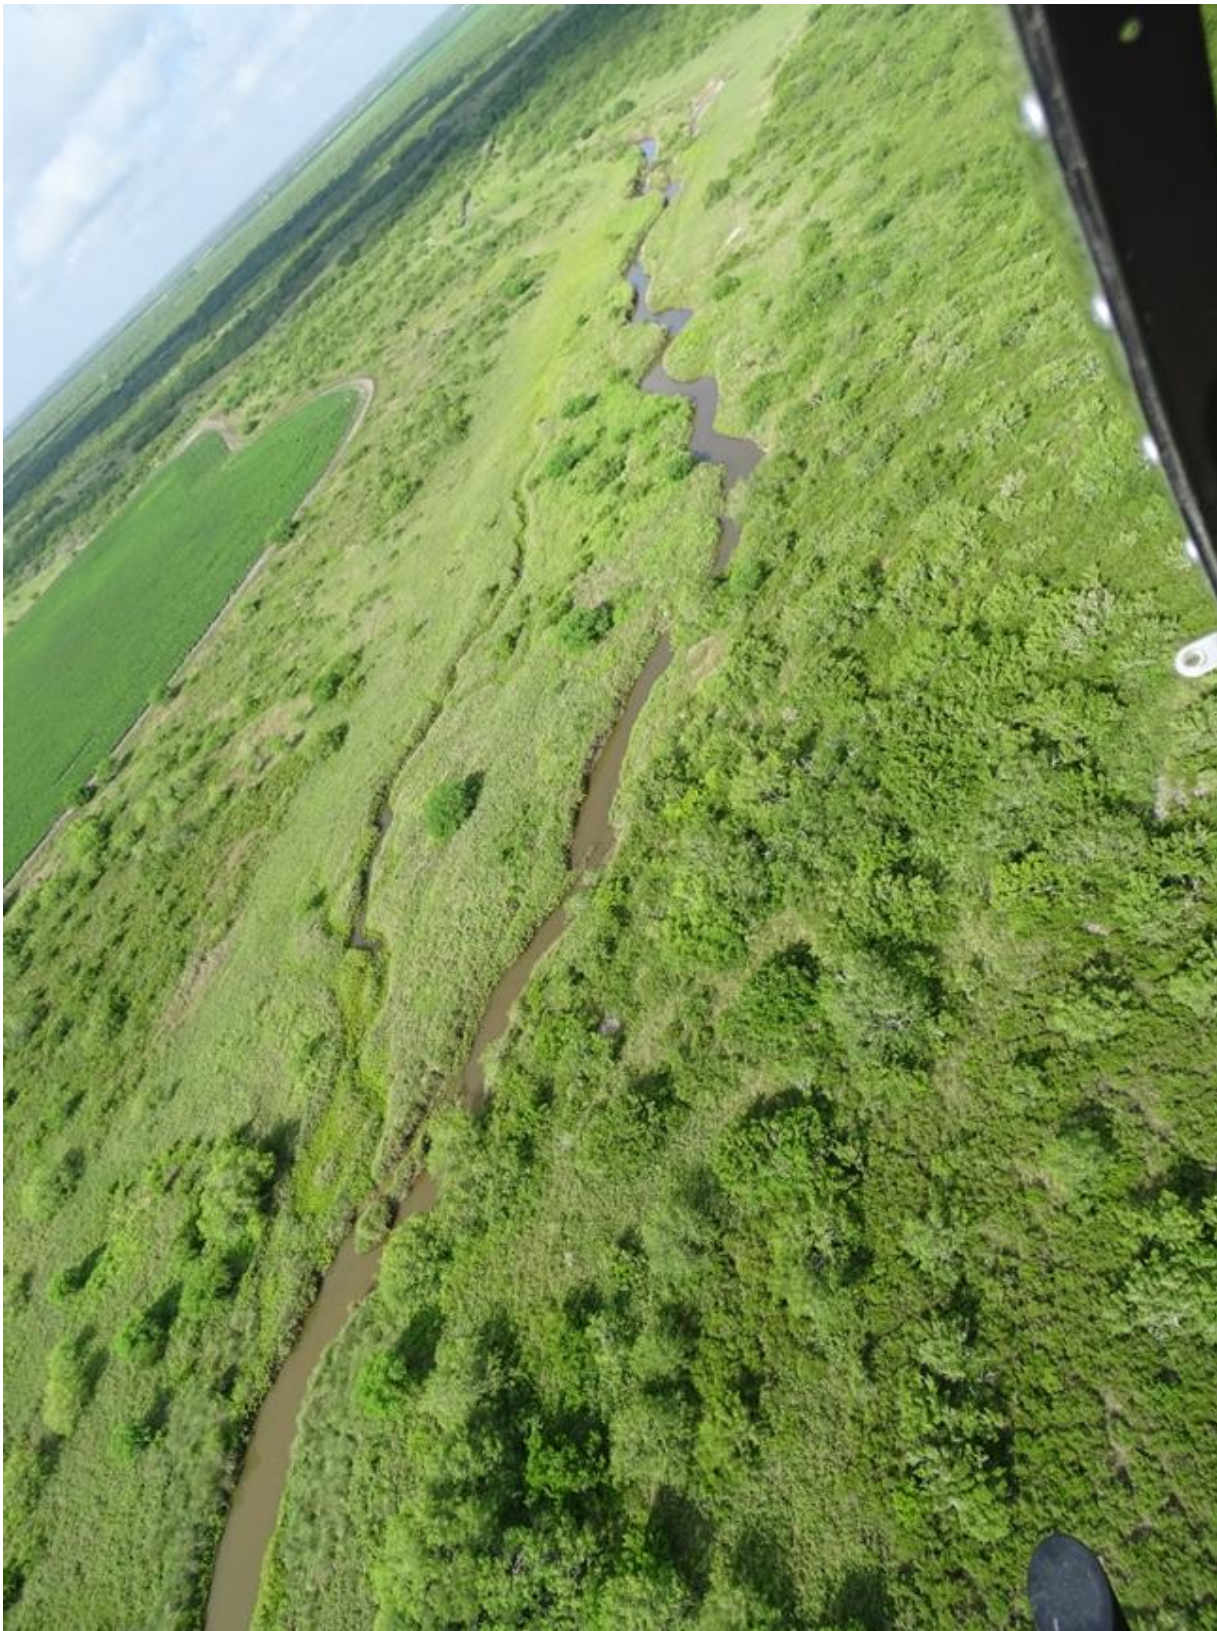
**Figure 111** Image shows wide functional riparian area flanking Los Tunas Creek further upstream. Cordgrass and other native riparian plants form a thick water-holding, sediment-trapping matt across a more than 2,000-foot-wide riparian area. Farming activities are set back from the creek and its floodplain.

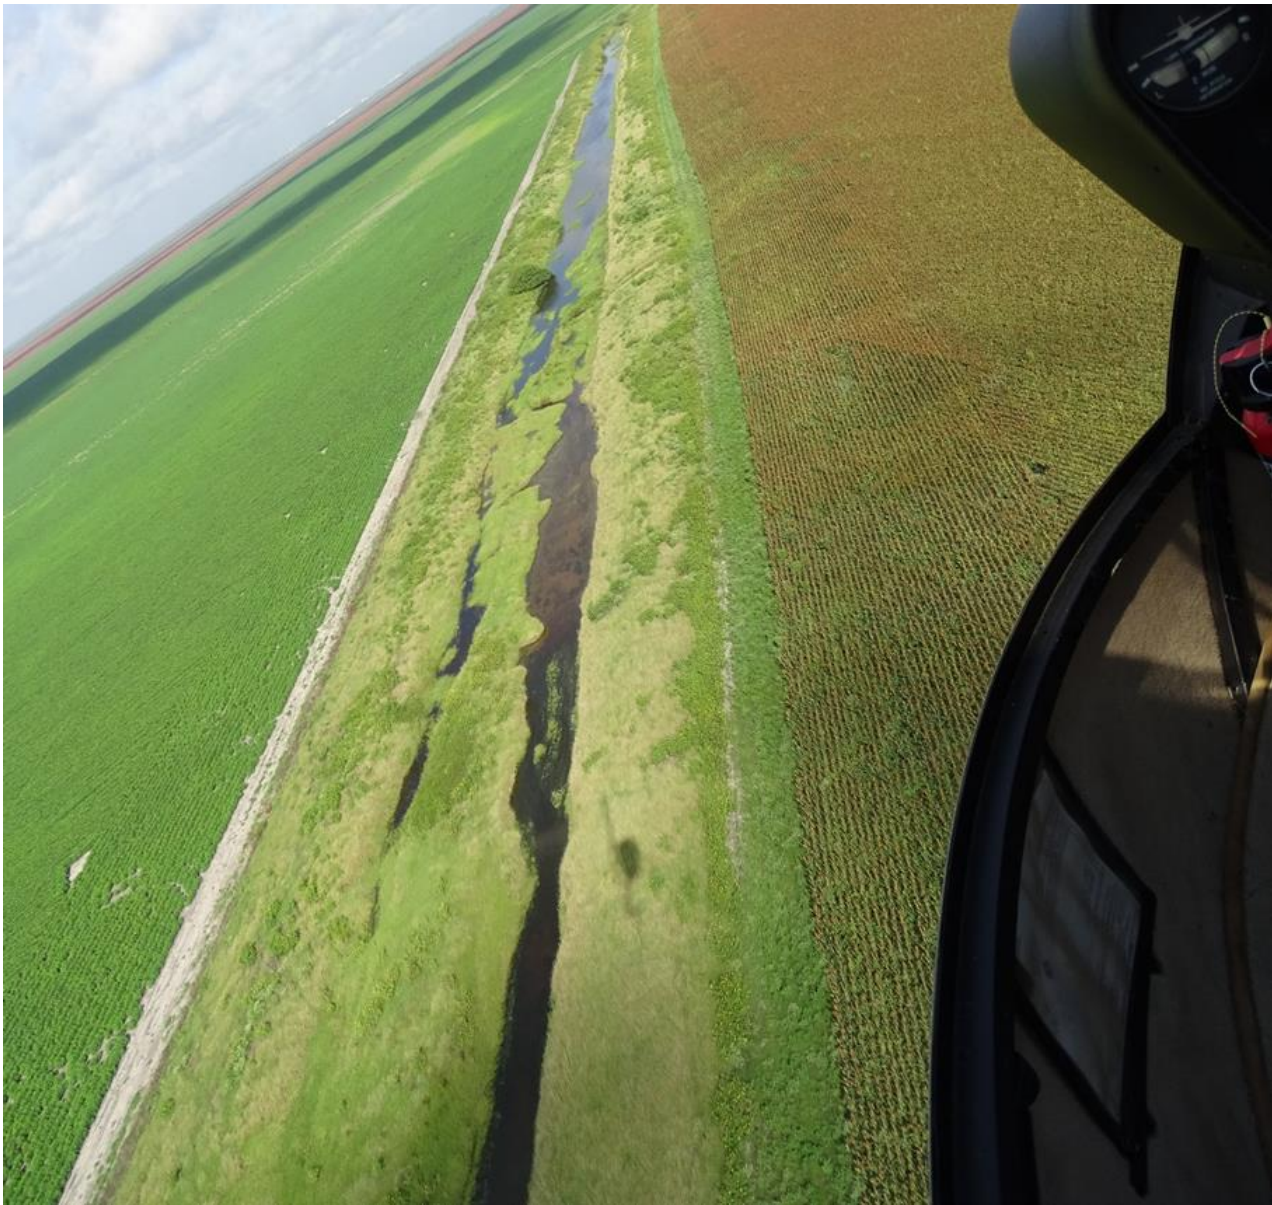
**Figure 113** Despite channelization, the creek retains some of its riparian function with floodplain access and stabilizing vegetation covering the banks.

- 1) Work with landowners to reward the current stewardship; protect and document the functional riparian condition along Los Tunas Creek.
- 2) Work with willing landowners to expand the setback along the upper six miles of the creek to allow for the development of meander.
- 3) Work with landowners to replace/restore road crossings to allow for energy dissipation, gradient equalization, and the free transport of sediment.

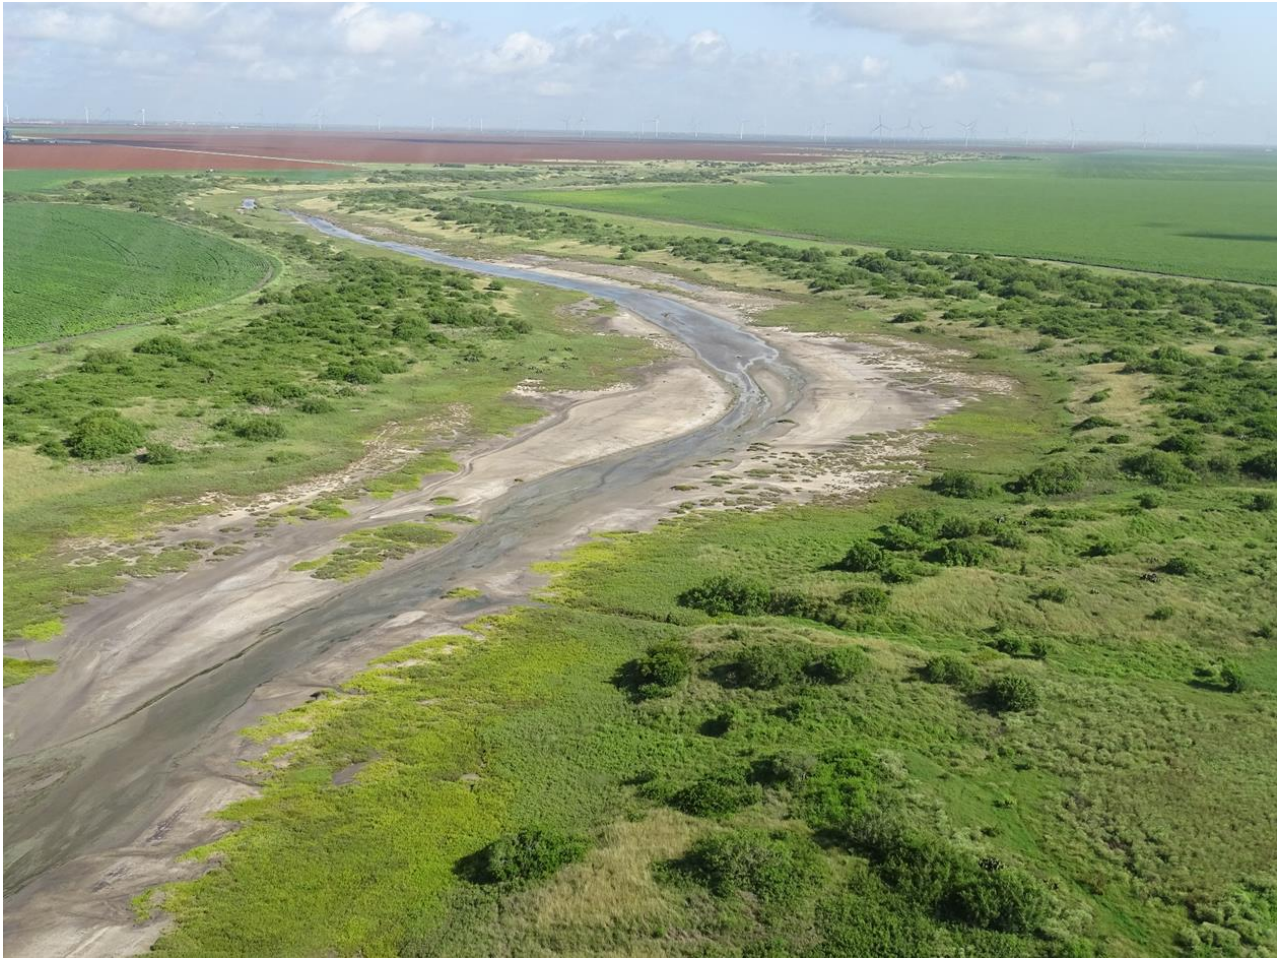
**Figure 116** Image shows wide functional riparian area flanking Chiltipin Creek near its confluence with Los Tunas Creek. Farming activities are set back from the creek, and the wide floodplain is well vegetated.

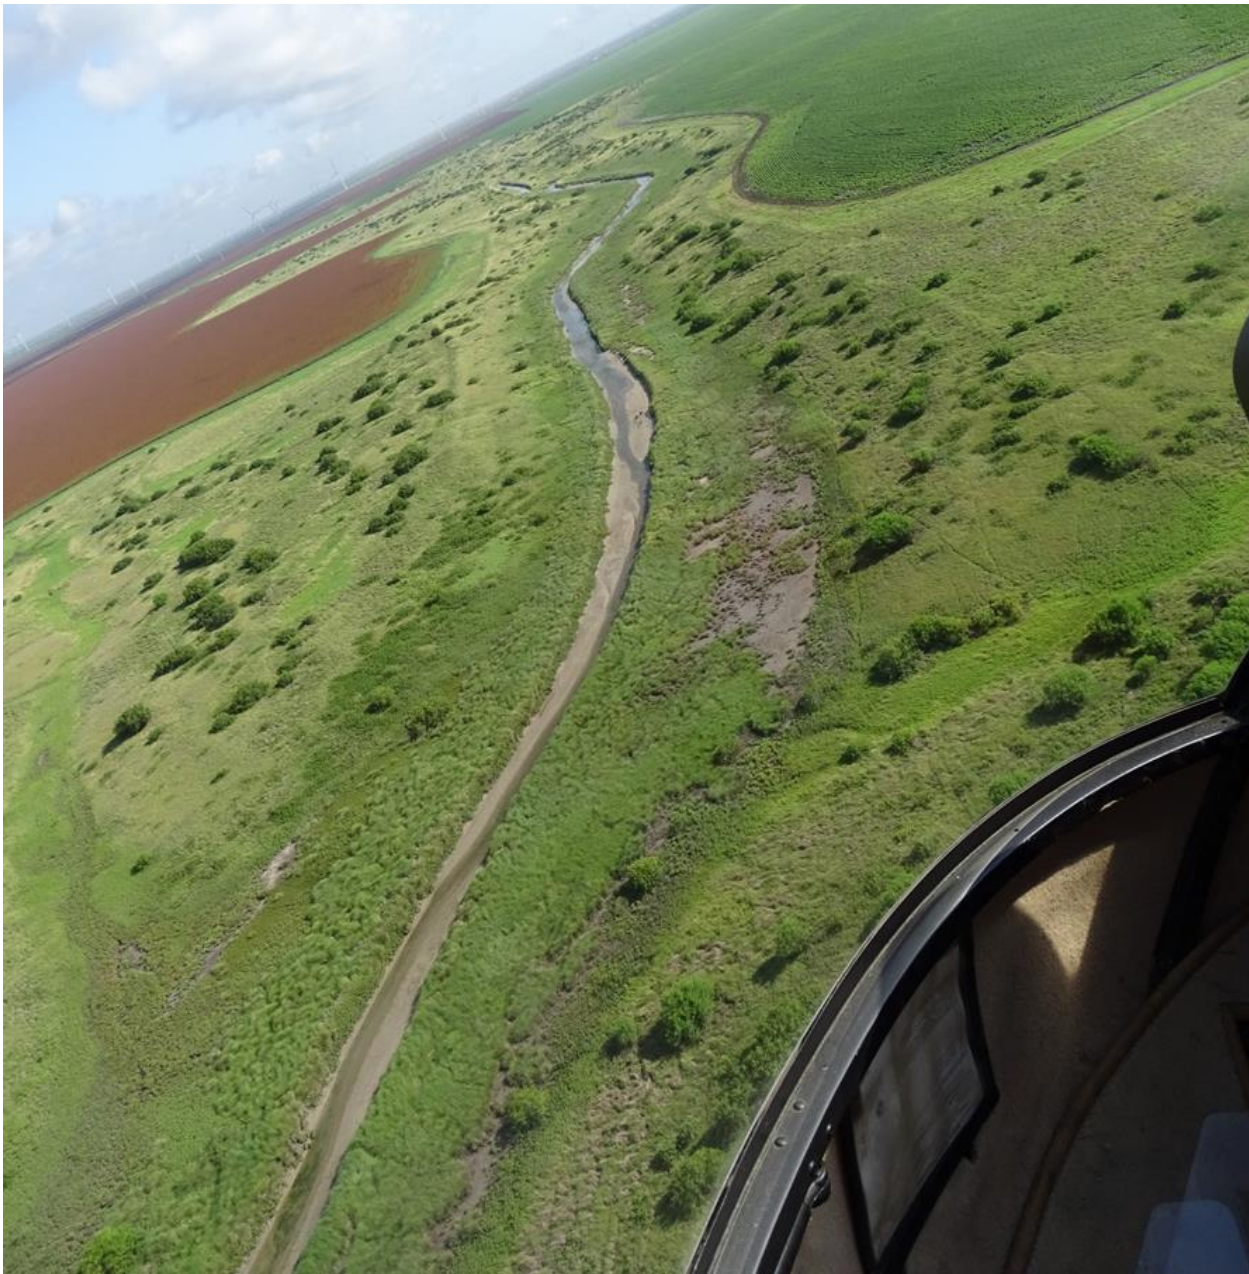
**Figure 117** Further upstream the riparian area becomes narrower. Farming activities are closer to the creek but the floodplain remains well vegetated.

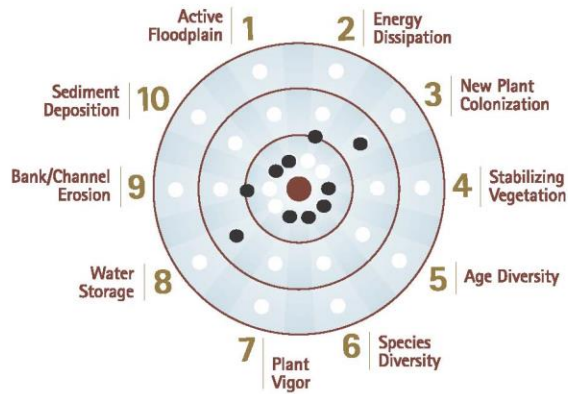
**Figure 120** Bull's-Eye evaluation target for Chiltipin Creek.

1. **Floodplain access.** The creek appears to have access to its floodplain.
2. **Energy dissipation.** An abundance of energy-dissipating features were observed in the channel and on the banks in the lower section of the creek, but upstream energy dissipation is reduced.

3. **New plant colonization.** In some areas new sediments are present and are being colonized.
4. **Stabilizing vegetation.** The creek has an abundance of stabilizing riparian vegetation (Spiny aster SR8, Cordgrass SR9), but woody plants are missing from the upper channelized reaches.

- 1) Work with landowners to reward the current stewardship; protect and document the functional riparian condition along Chiltipin Creek.
- 2) Work with willing landowners to expand the setback along the upper six miles of the creek to allow for the development of meander.
- 3) Work with landowners to replace/restore road crossing to allow for energy dissipation, gradient equalization, and the free transport of sediment.

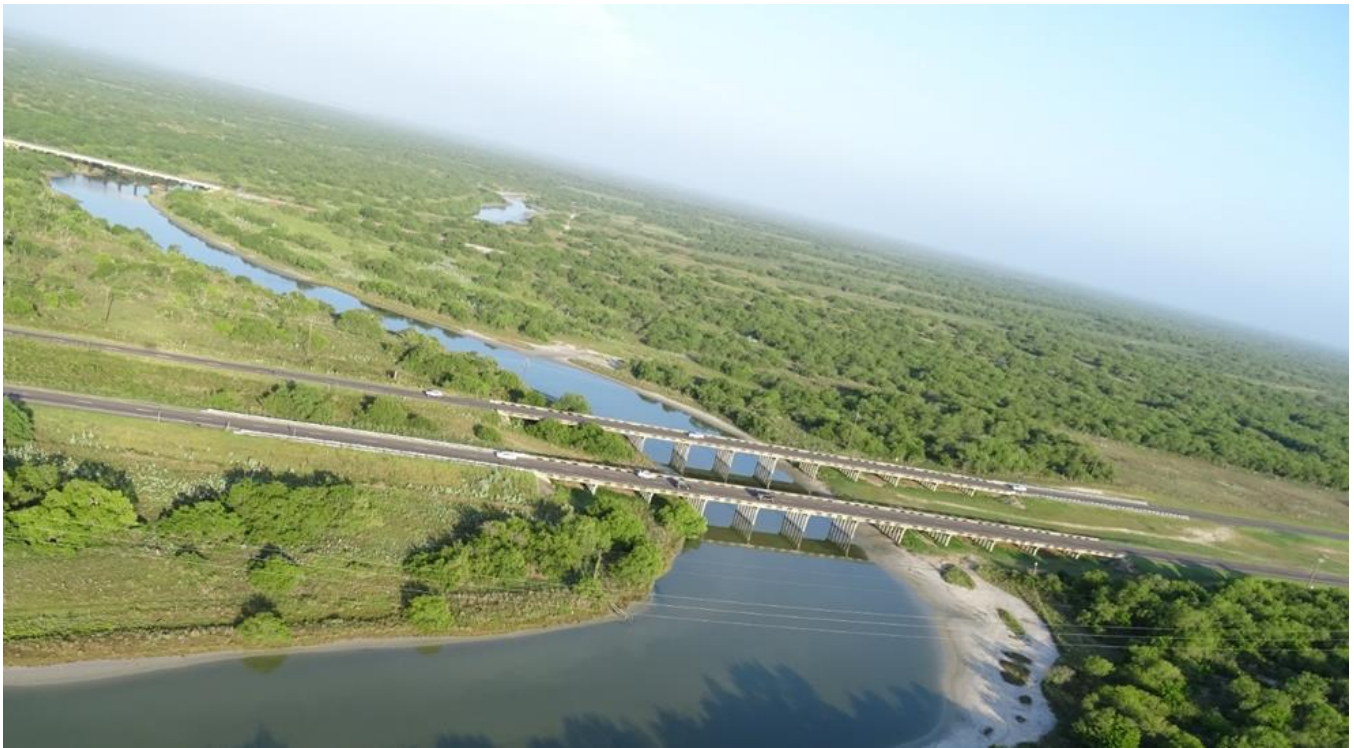
**Figure 122** Image shows wide functional riparian area flanking the lower reach of Los Olmos Creek at the U.S. Hwy 77. Livestock grazing activities are set back from the creek, and the wide floodplain is well vegetated.

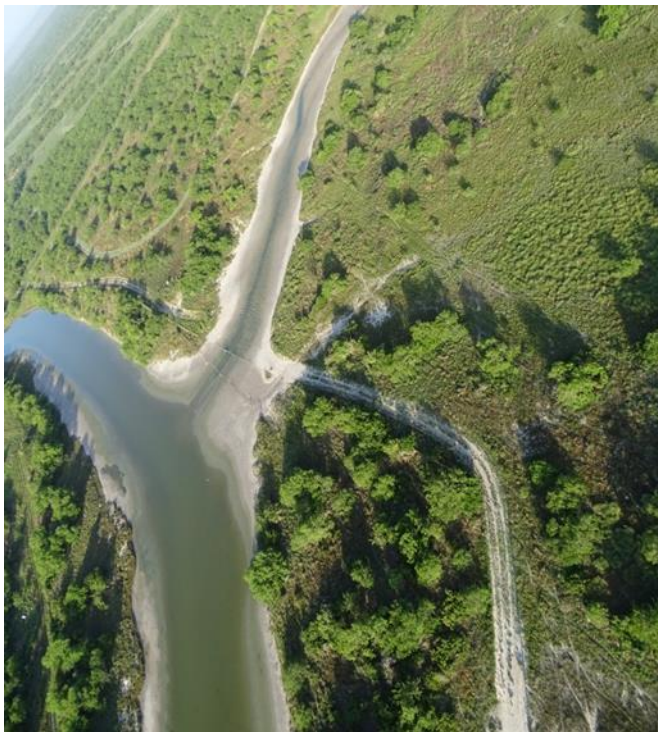
**Figure 123** Image show highly functional riparian areas along the lower reach of Los Olmos Creek at the confluence of Salado Creek. Banks are well vegetated in what appears to be Cordgrass with Retama and Mesquite. A fringe of algae is visible along the channel edge.

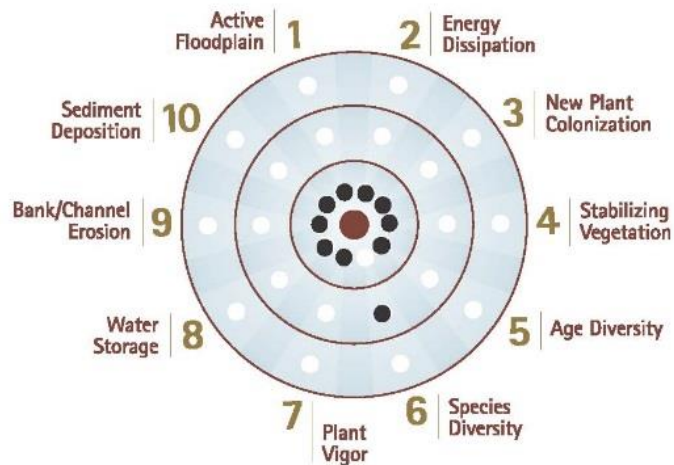
**Figure 124** Bull's-Eye evaluation target for lower reach of Los Olmos Creek.

3. **New plant colonization.** New plants were observed colonizing fresh sediments at the channel margins.
4. **Stabilizing vegetation.** Banks are covered with stabilizing vegetation. (Marshhay/Gulf cordgrass SR9, Retama SR6)

9. **Bank and channel erosion.** Erosion and deposition appear balanced, and channel size and shape appear of size and depth to manage sediment.
10. **Sediment deposition.** Normal and balanced sediment deposition were observed within this reach.

Work with landowners to reward the current stewardship; protect and document the functional riparian condition along the lower reach of Los Olmos Creek.
