# Riparian Evaluation Report: Tributaries of Baffin Bay

August 30, 2019

**Water Body:** Baffin Bay 2492 Tributaries

**Contract No:** CBBEP 1907

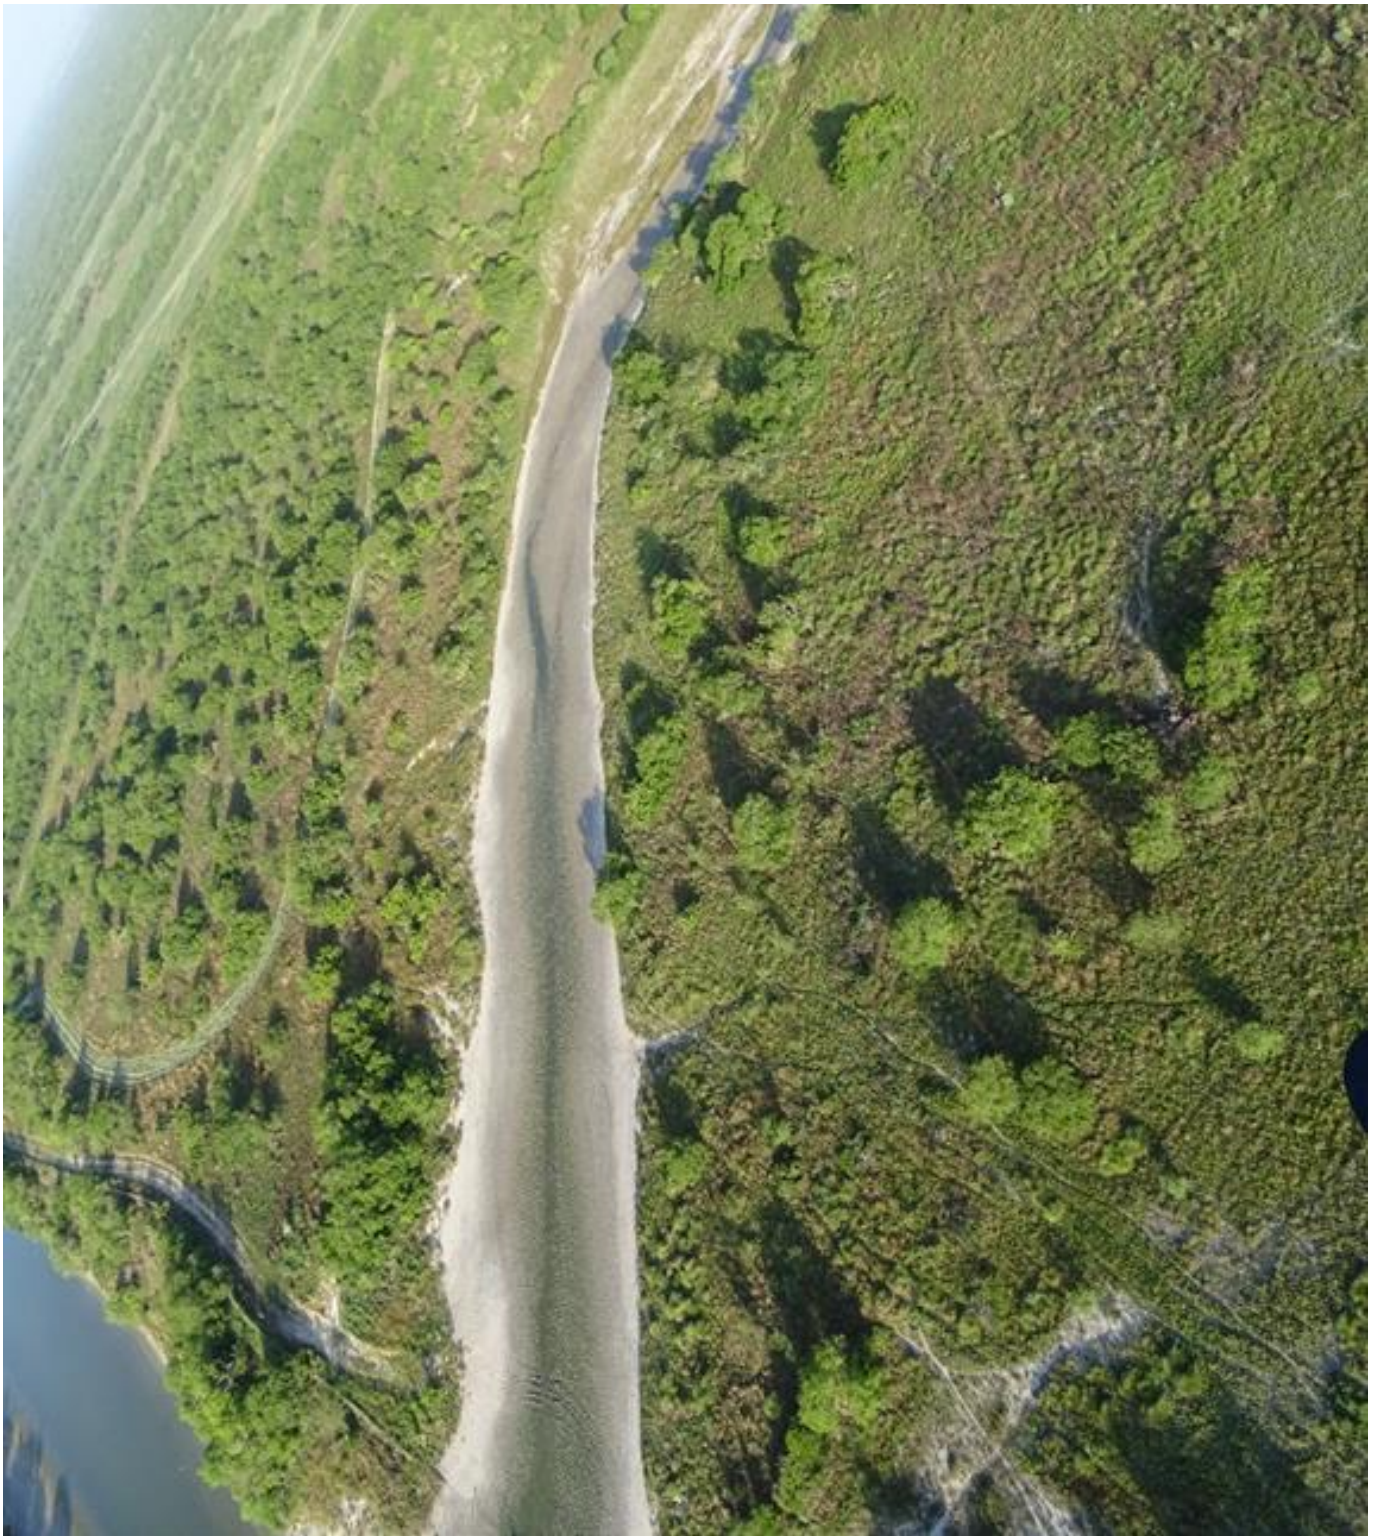
**Figure 126** In this image you can see the Salado Creek near its confluence with Los Olmos. The creek appears to be attempting to recover by growing vegetation, trapping sediments, and holding water but may be hindered by livestock and/or wildlife grazing. In the image, animal trails on the lower right corner and the condition of plant vigor are clues to the presence of a hindrance.

7. **Plant vigor.** Riparian plants appear trampled with some signs of heavy grazing and browsing in the area.
8. **Water storage.** A few OBL and FACW plant species were observed both at the water's edge and on the floodplain. (Marshhay/Gulf cordgrass FACW/OBL, Spiny aster FACW, Retama FACW)

- 1) Work with landowners to control grazing in the riparian areas along Salado Creek and allow vegetation to grow along the entire length of the creek.
- 2) Work with the community of Rivera to focus on the WWTP discharge as a valuable resource to be utilized for wildlife and water quality benefit. Consider possible off-channel wetlands for tertiary treatment for the purpose of improving water quality in the creek before it reaches the bay.

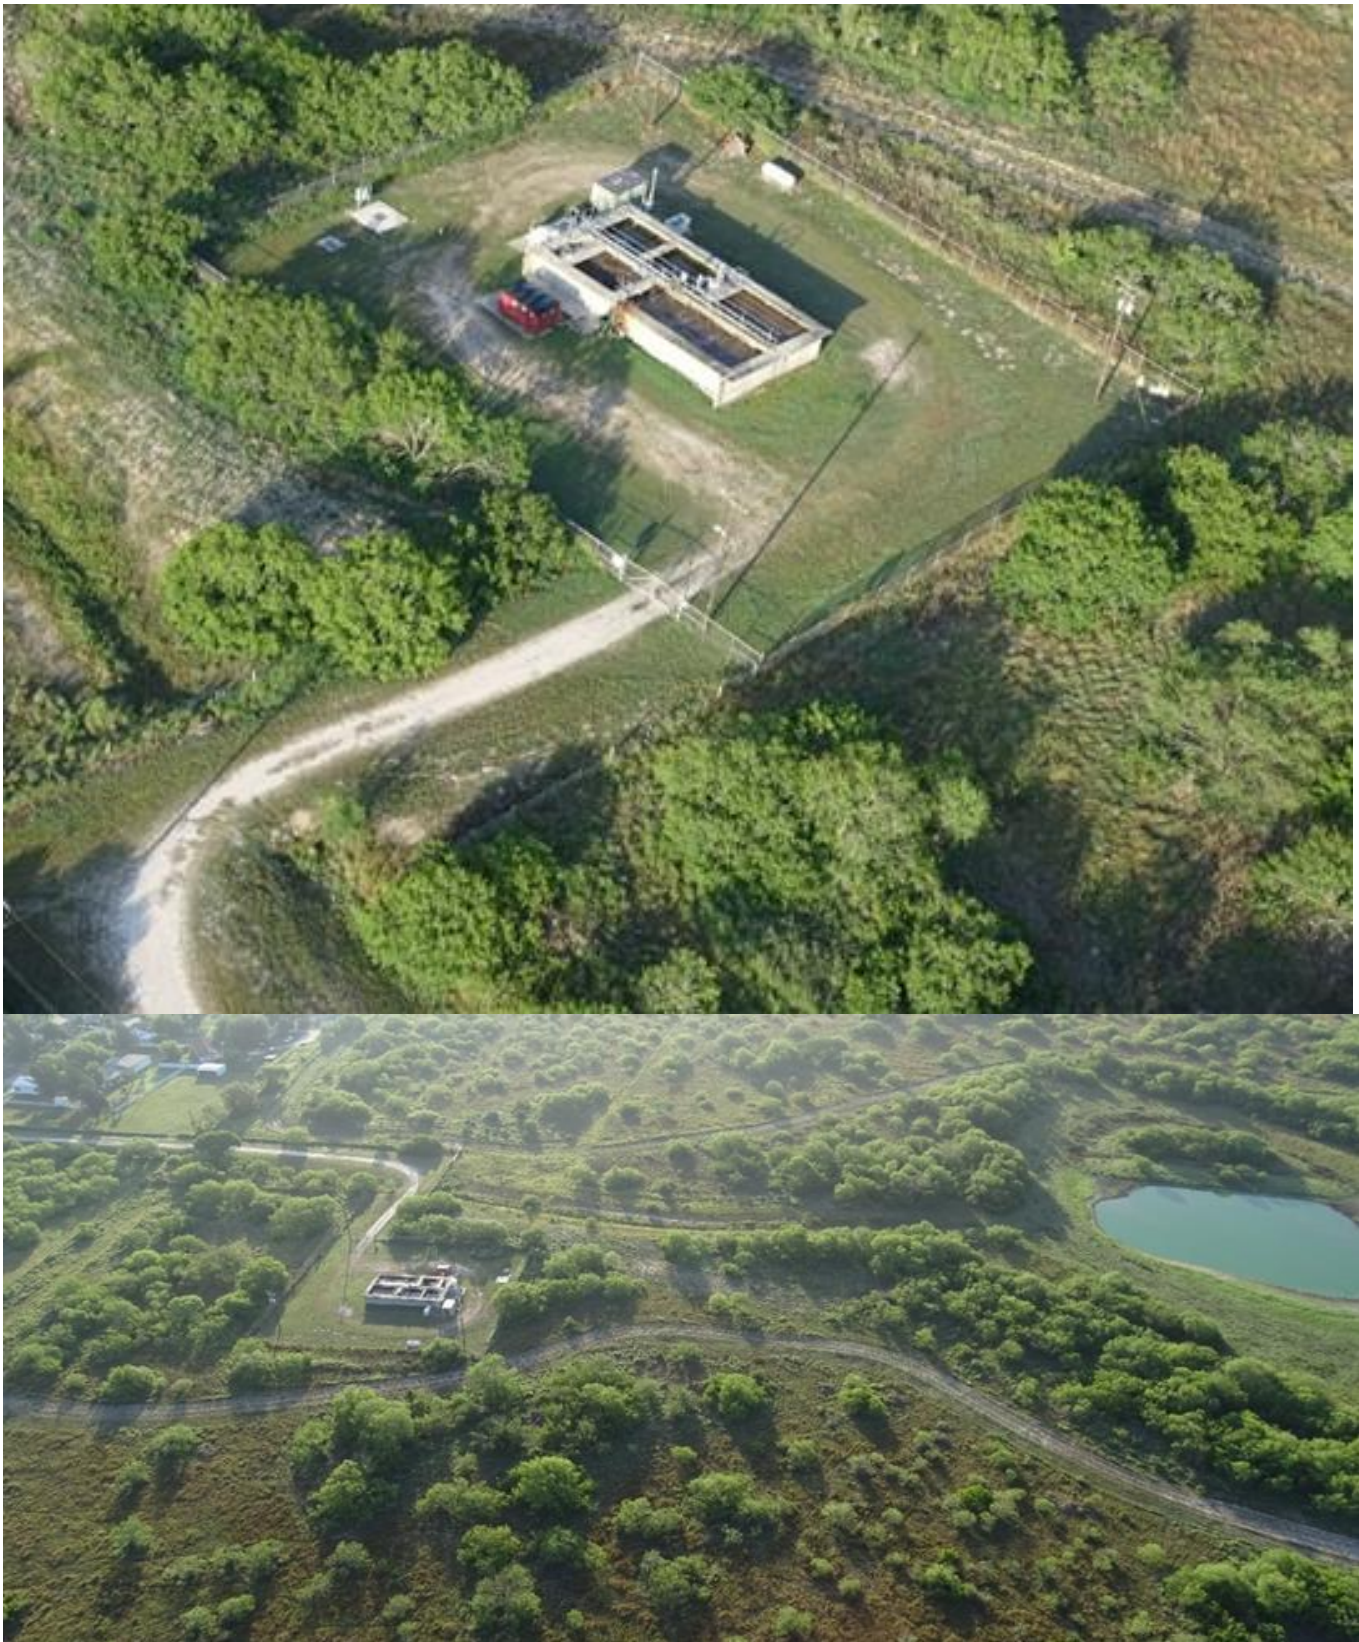
**Figure 128** In this image the WWTP and a pond are shown. It is difficult to tell the relationship of the pond to Salado Creek as the creek's floodplain and channel appear to have been highly altered. Installed wetlands and riparian enhancement offer potential for improved water quality in Salado Creek prior to its confluence with Los Olmos Creek.

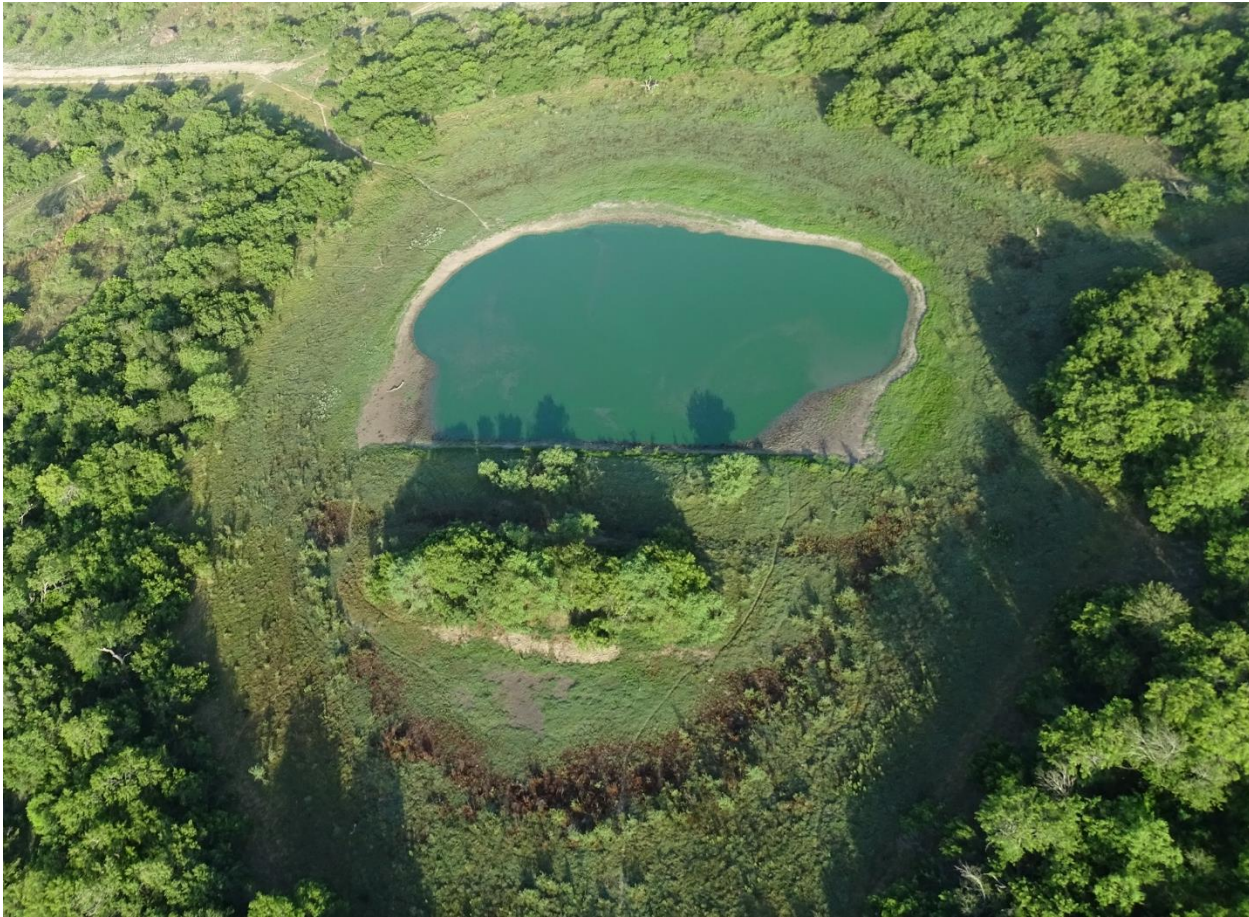
**Figure 129** The pond shown in this image appears to be nutrient-rich and may be in communication with Salado Creek.

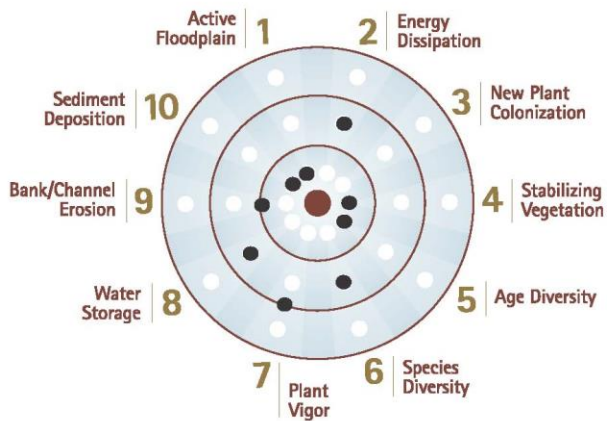
**Figure 130** Bull's-Eye evaluation target for Salado Creek.

1. **Floodplain access.** The creek appears to have unimpeded access to its floodplain throughout the reach.
2. **Energy dissipation.** The channel, banks and floodplain host an abundance of energy-dissipating features, but their energy-dissipating ability has been impaired by reduced vigor.
3. **New plant colonization.** NA No sediment deposition was observed.

4. **Stabilizing vegetation.** Banks are covered with stabilizing vegetation. (Marshhay/Gulf cordgrass SR9, Spiny aster SR8)
5. **Age diversity and reproduction of riparian vegetation.** The riparian grasses noted may be remnants of older populations. Young cordgrass and even aster can be palatable.
