# Nueces River Authority Steering Committee and Stakeholder Update #8 (8<sup>th</sup> Quarter of FY 2018-2019) June - August 2019

### August 28th, 2019

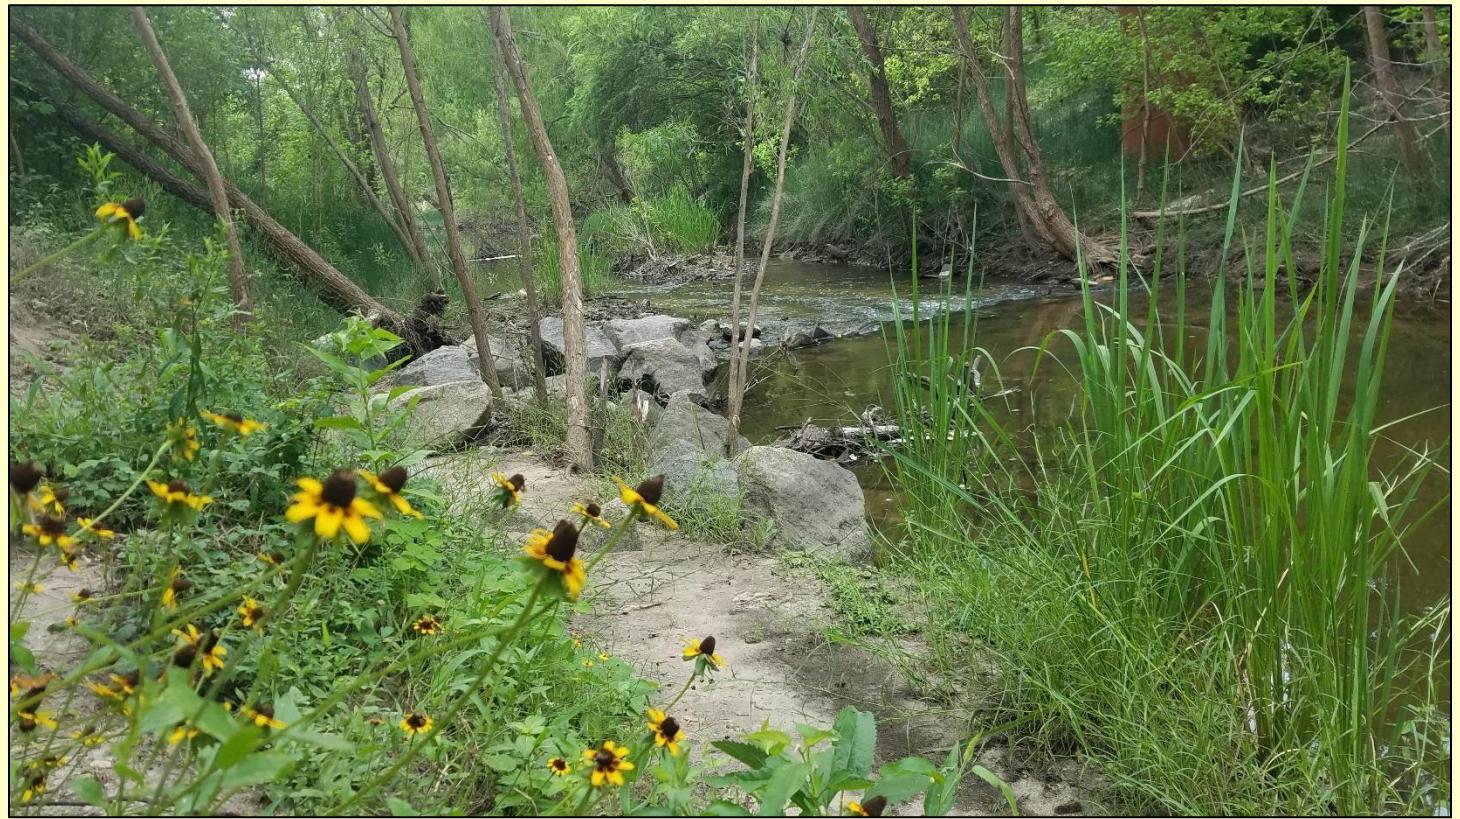
The Mission River at US 77 in Refugio (Station 12944) was monitored in early June. Water quality parameters were all in the healthy range. Bacteria concentrations were low, and the riparian vegetation looked very healthy.

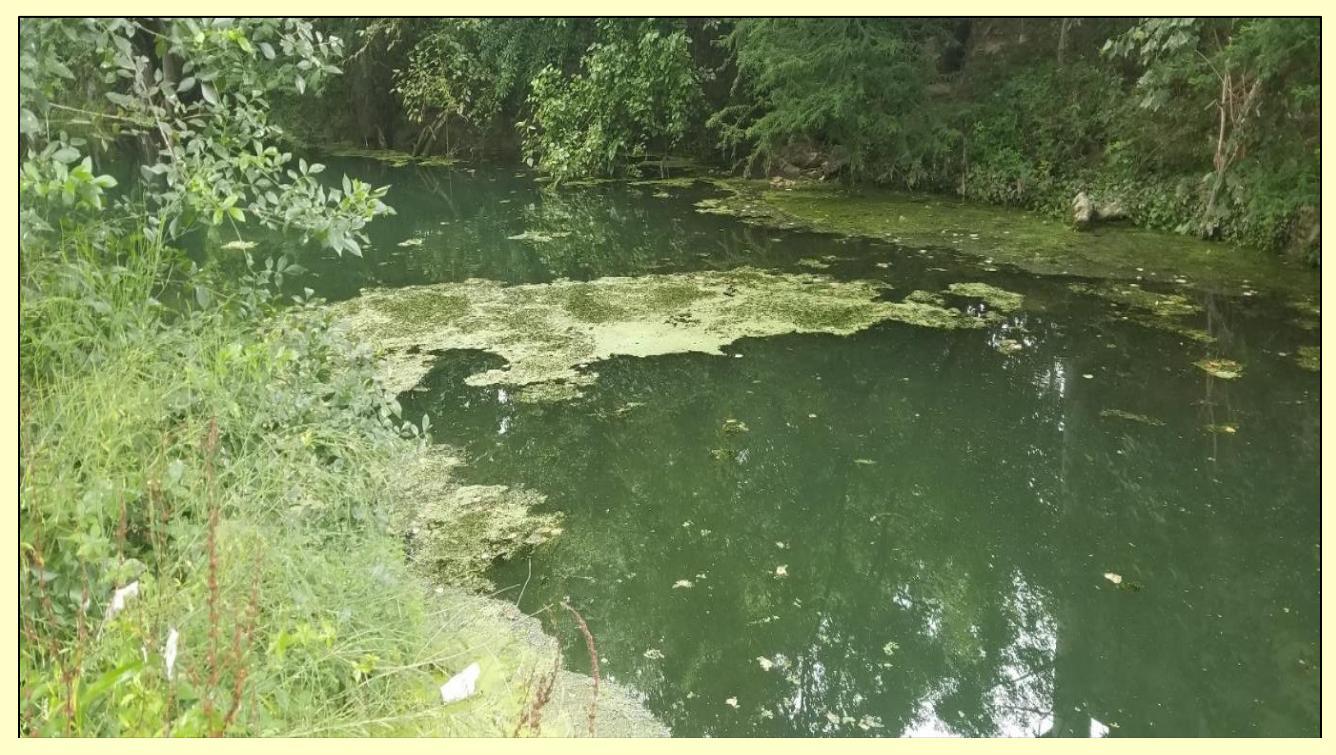
Lately, water quality has been the topic of discussion with some residents of the City of Sabinal after a series of elevated bacteria concentrations at the sampling location (Station ID 12993) at the bridge crossing at US 90 in Sabinal. Residents are concerned about excessive nutrients and the source of bacteria following a reading of more than 800 colony forming units/100mL (the standard is 126 cfu/100mL) in May. Elevated bacteria levels are associated with an increased risk of gastrointestinal illness. At the request of the residents of Sabinal, NRA will be conducting some additional water quality monitoring in the river.

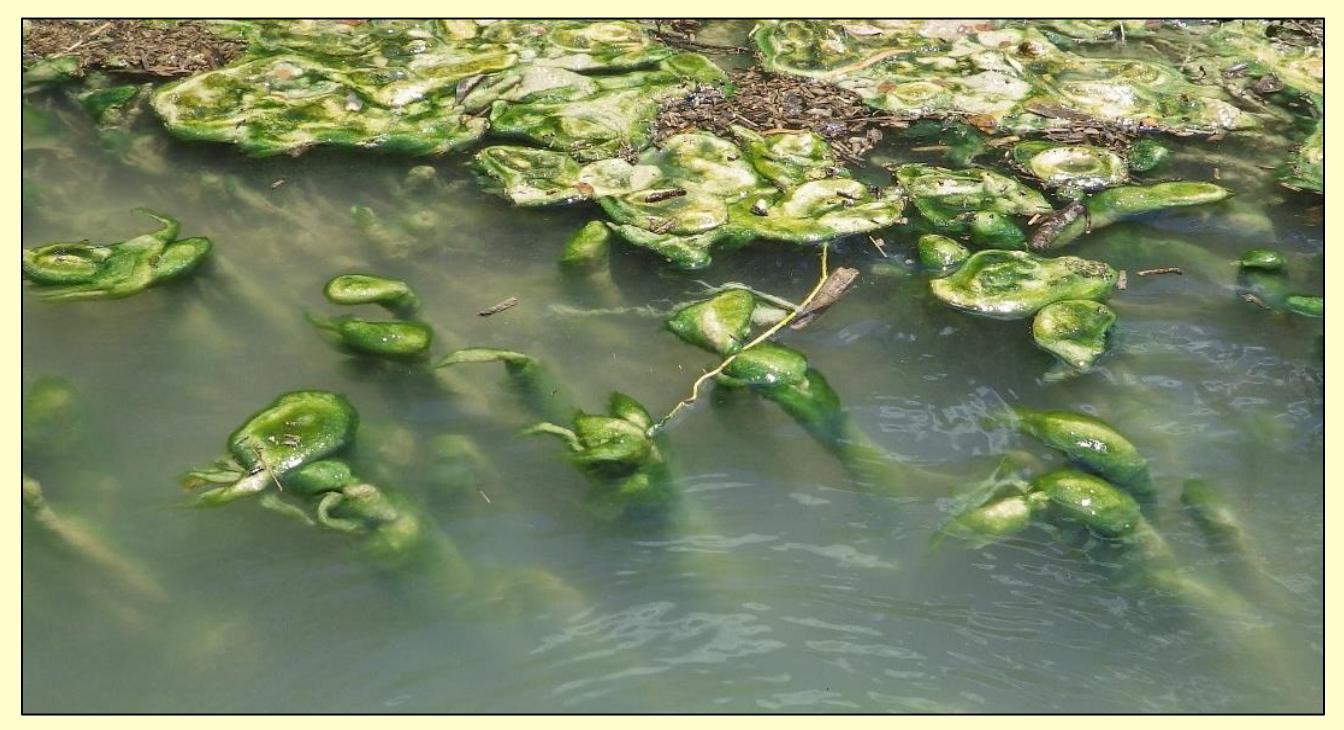
While out conducting the ALM, Nueces River Authority field staff observed an interesting algae specimen along the banks of the Nueces River at FM 1042 (Station 12972). A sample was obtained and taken to the Center for Coastal Studies at Texas A&M-CC for identification. Dr. Zimba identified the algae to be a filamentous cyanobacteria called *Phormidium* (a blue green algae). Dr. Zimba took a few photos of the cyanobacteria under the microscope to show the filaments and sheath. *Phormidium* is found in streams and rivers of all sorts of water quality.

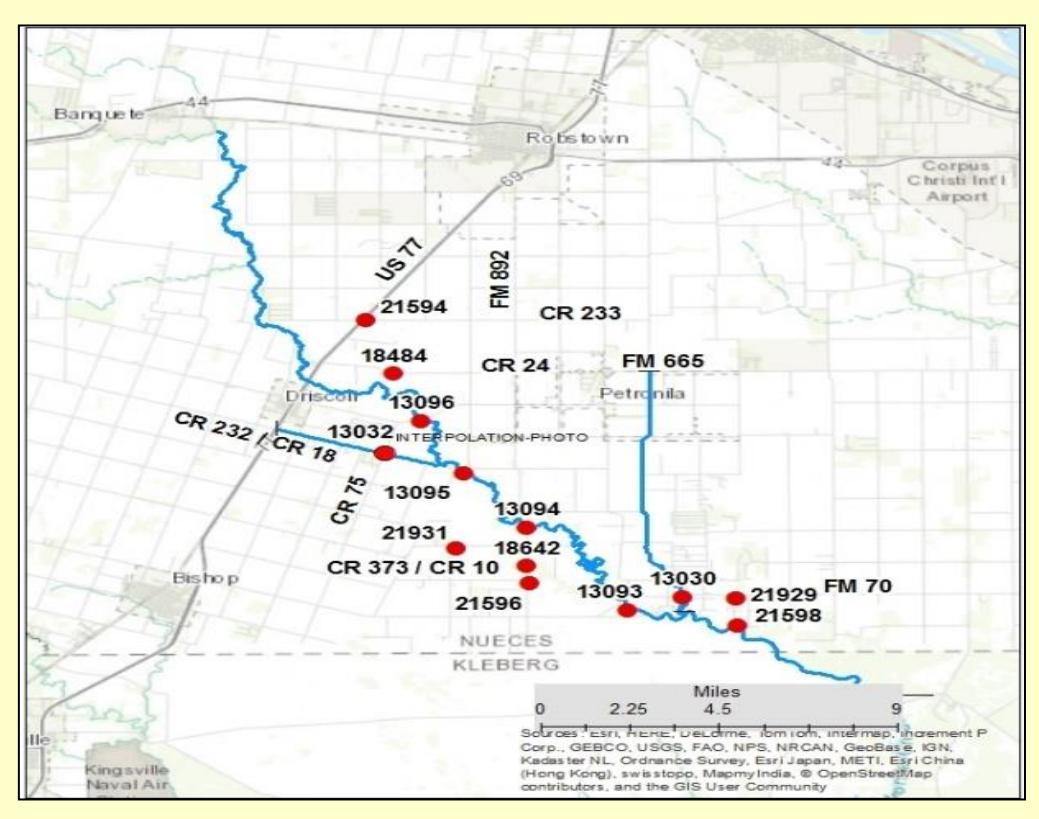
Since FY 2013-2014, the TCEQ has contracted with NRA to conduct monthly water quality monitoring to identify chloride, sulfate, and TDS contributions from tributaries of Petronila Creek, including drainage ditches. For FY 2019, NRA is conducting monthly monitoring at 13 sites. Four sites are located on the main stem of Petronila Creek (13096, 13095, 13094, and 13093 – data is in bold on the graph). (Disclaimer – Data has not been validated or input into the SWQMIS Database.)

Site #	June (µmhos)	July (µmhos)	August (µmhos)	
21594	<b>21594</b> 5,830		3,520	
18484	<b>18484</b> 24,800		34,700	
13032	4,870	dry	dry	
13096	4,840	20,000	23,300	
13095	5,740	20,800	23,100	
21931	11,700	dry	dry	
13094	6,600	21,600	24,400	
18642	11,300	dry	dry	
21596	3,150	dry	8,160	
13093	2,800	8,260	16,700	
13030	5,000	18,100	33,100	
21929	35,600	41,700	65,800	
21598	30,200	64,000	67,300

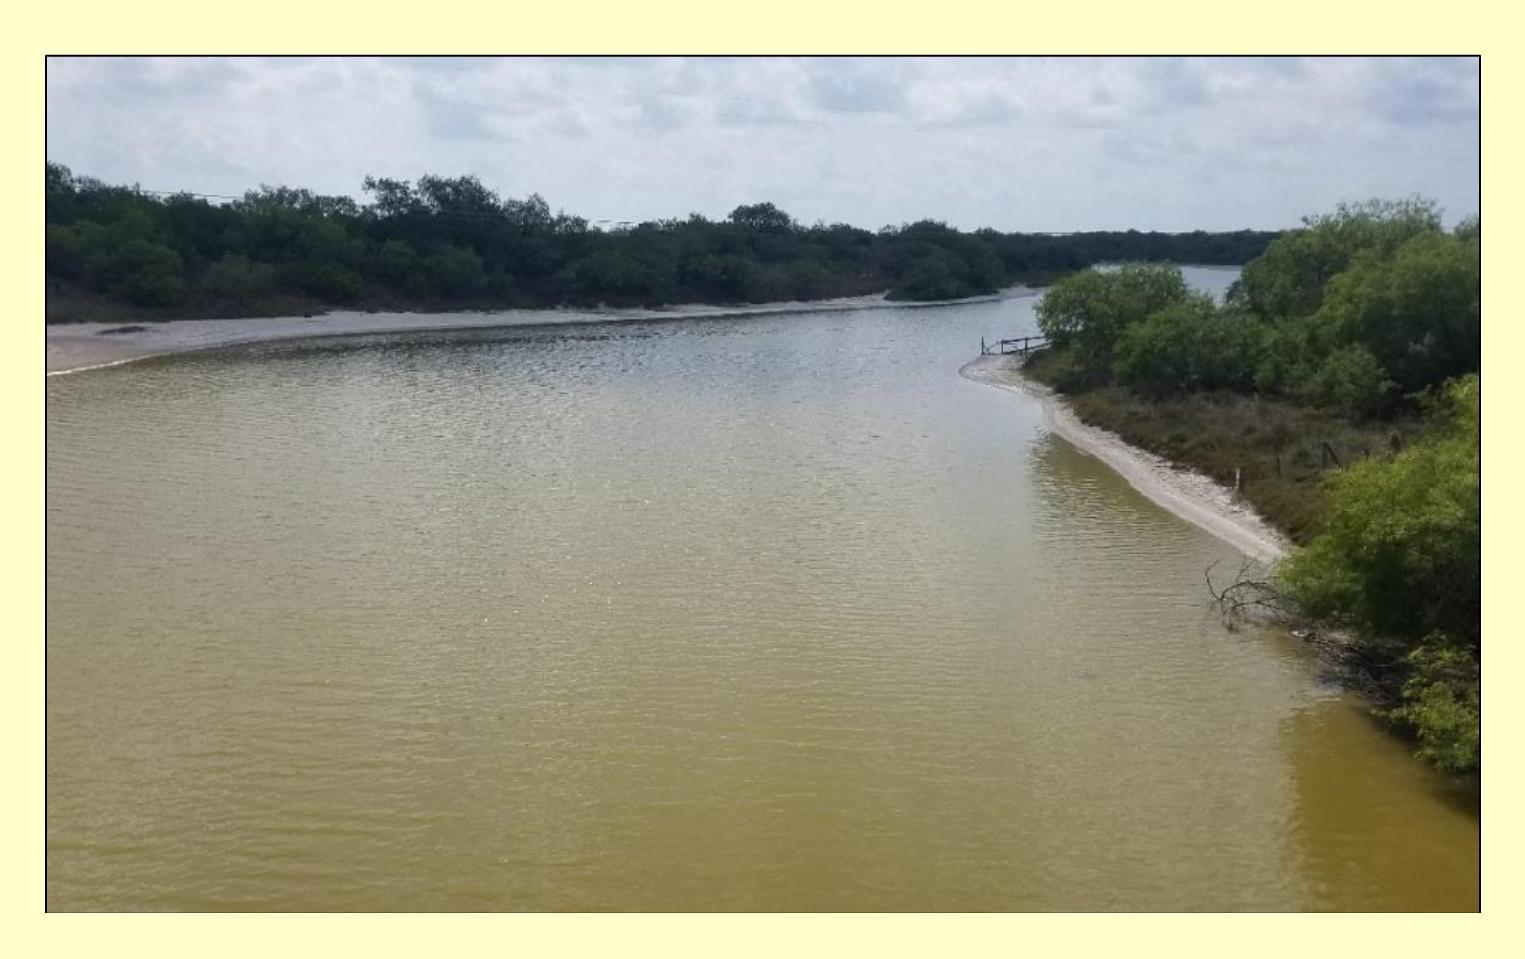
Los Olmos Creek runs 71 miles from southern Duval County to its confluence with Laguna Salada, and inlet of Baffin Bay. The creek is a new site (Station ID 13034) for FY2019, located at the bridge crossing at US 77 near Riviera. NRA field staff visited the site on July 16<sup>th</sup>. The creek lives up to its name (Salty Lagoon) with salinity values around the 60 PSU range. Nutrient and bacteria concentrations were very high for this limited circulation and shallow waterbody. (Disclaimer – Data has not been validated or input into the SWQMIS Database.)
