Nueces River Authority Steering Committee and Stakeholder Update for Q7 March - May 2021

Basin 20 - San Antonio-Nueces Coastal Basin

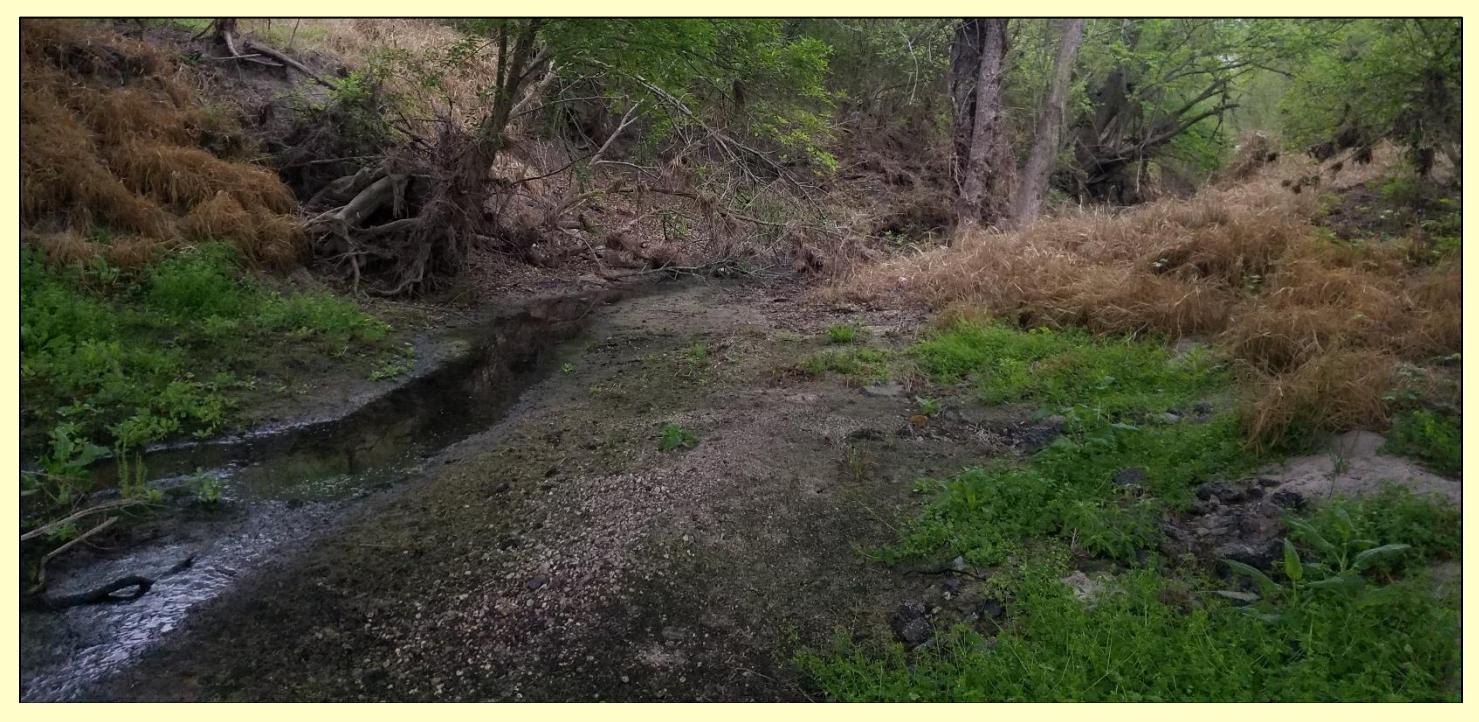
Nueces River Authority conducts routine water quality monitoring at 7 locations in the Mission/Aransas watershed (map of sampling sites on page 8). For FY 2021, one site located on Aransas River Tidal at US 77 (Station 12948) was discontinued due to the completion of the TMDL monitoring project by TWRI. An existing TCEQ site, located on Chiltipin Creek Tidal at the end of FM 631, was added in its place. The new site, located on private property, includes bi-annual metals monitoring. Six sites were visited on March 16th. Station 12941, located on Aransas Creek at US 181 near Skidmore (pictured below), did have enough water to sample this quarter (E. coli was 47 MPN/100mL).

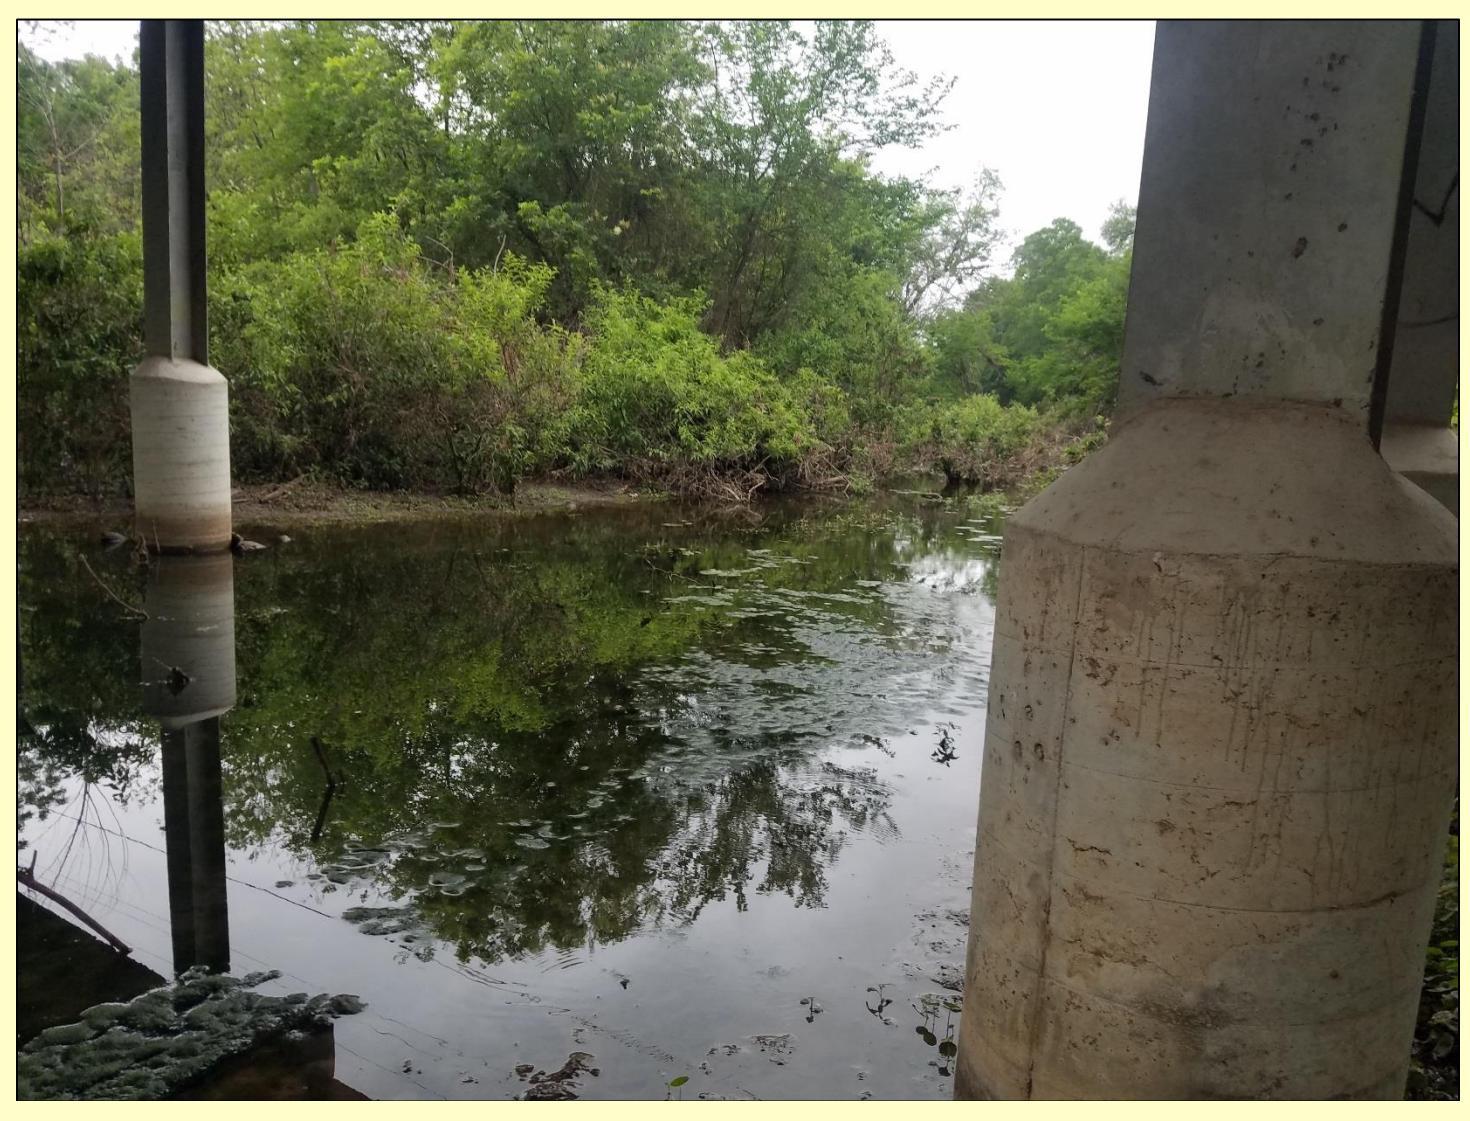
Nueces River Authority conducts twenty-four hour dissolved oxygen monitoring at 3 locations in the Nueces River Basin (see map of sampling locations on page 9). Dissolved oxygen monitoring was conducted on the Leona River at FM 140 (Station 18418) on May 24-25th.

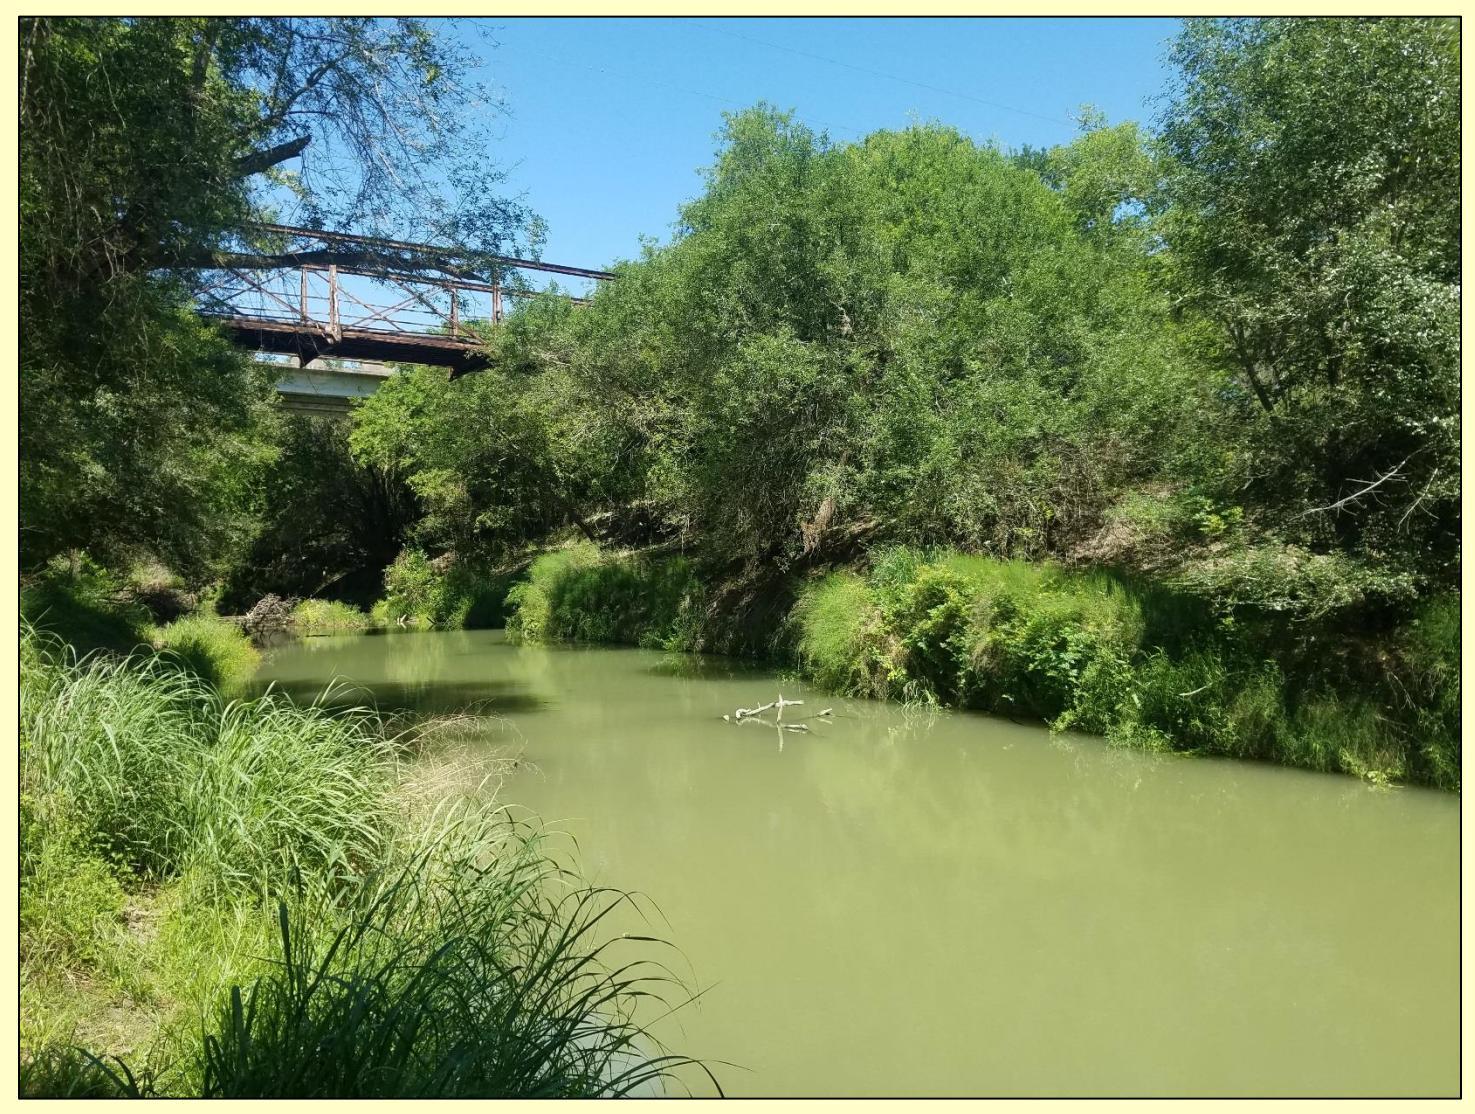
Nueces River at FM 1042 (Simmons Crossing)

Nueces River Authority recently added metals sampling at 5 locations upstream of the reservoir system (Choke Canyon Reservoir and Lake Corpus Christi). Monitoring sites include Atascosa River at FM 99 (Station 12980), Choke Canyon Reservoir at FM 99 (Station 17389), San Miguel Creek at SH-16 (Station 12983), Frio River at SH-16 (Station 13023) and the Nueces River at FM 1042 (Station 12972). These station were monitored for dissolved and total metals on May 5th alongside routine water quality parameters (See map of stations on page #9).

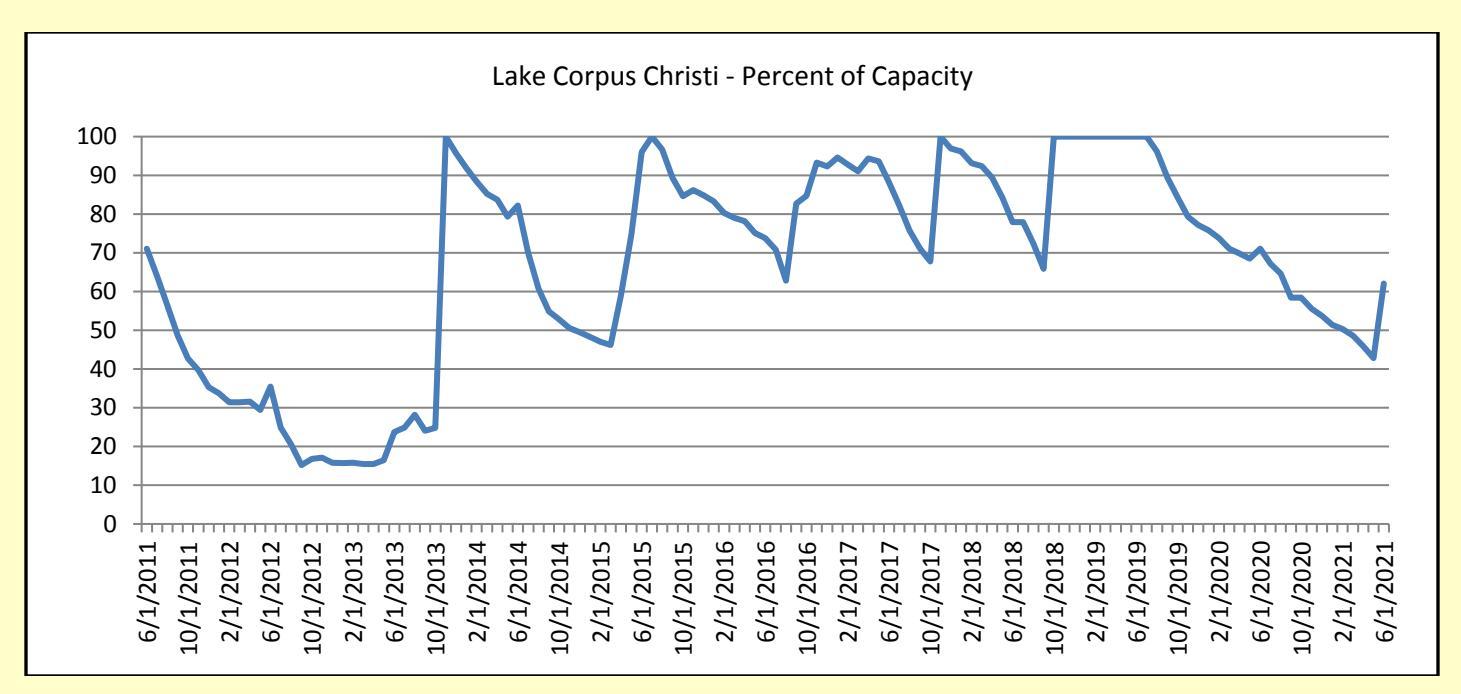
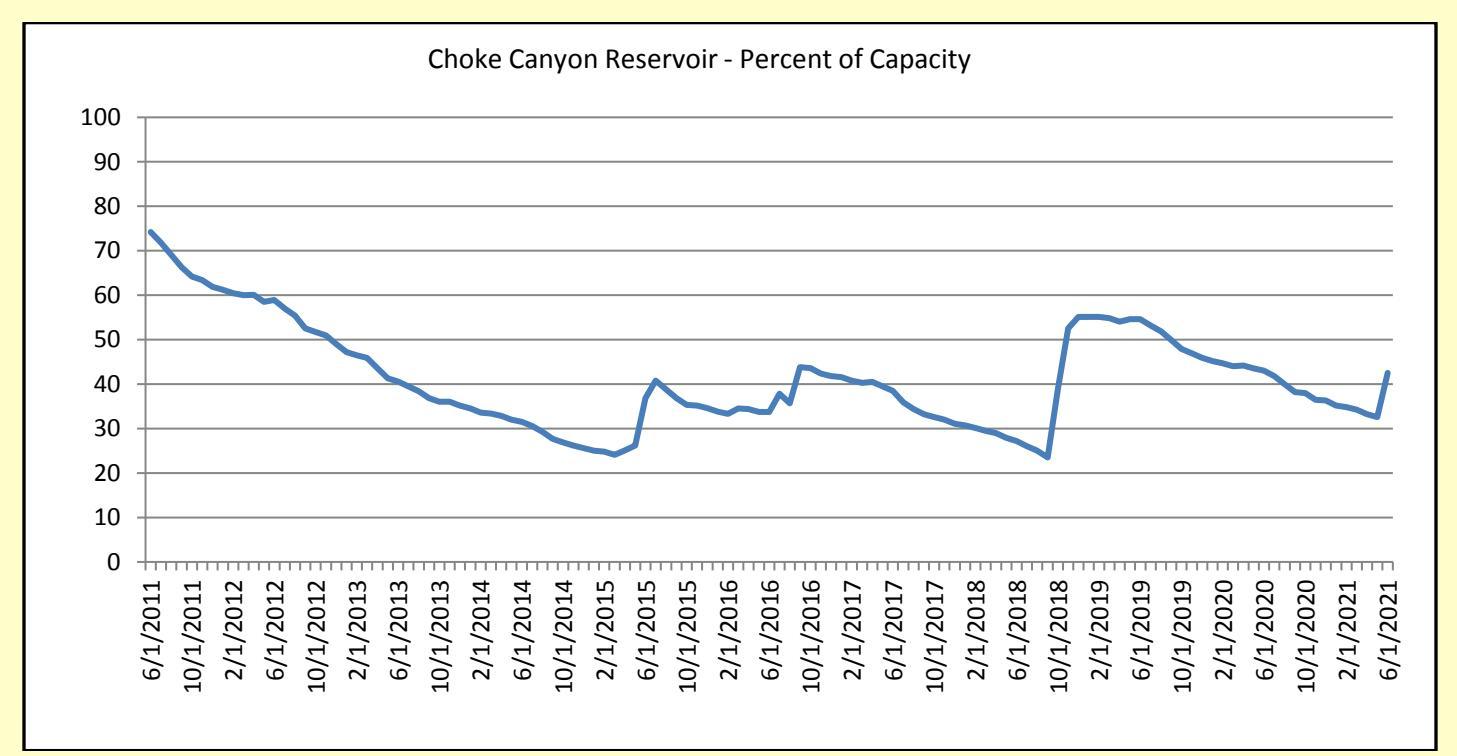
The middle Nueces River Watershed caught some rain in May. Reservoir System Combined lake levels for the reservoir system started off the quarter (March 1st) at 38.2% and rose to 48.0% by the end of May. The pass-thru for May was entirely supplied by runoff from below Lake Corpus Christi and did not come from the lake. For the Daily Reservoir System and Pass-Thru Status Report, please visit the website <u>https://www.nueces-ra.org/CP/CITY/passthru/index.php</u>.

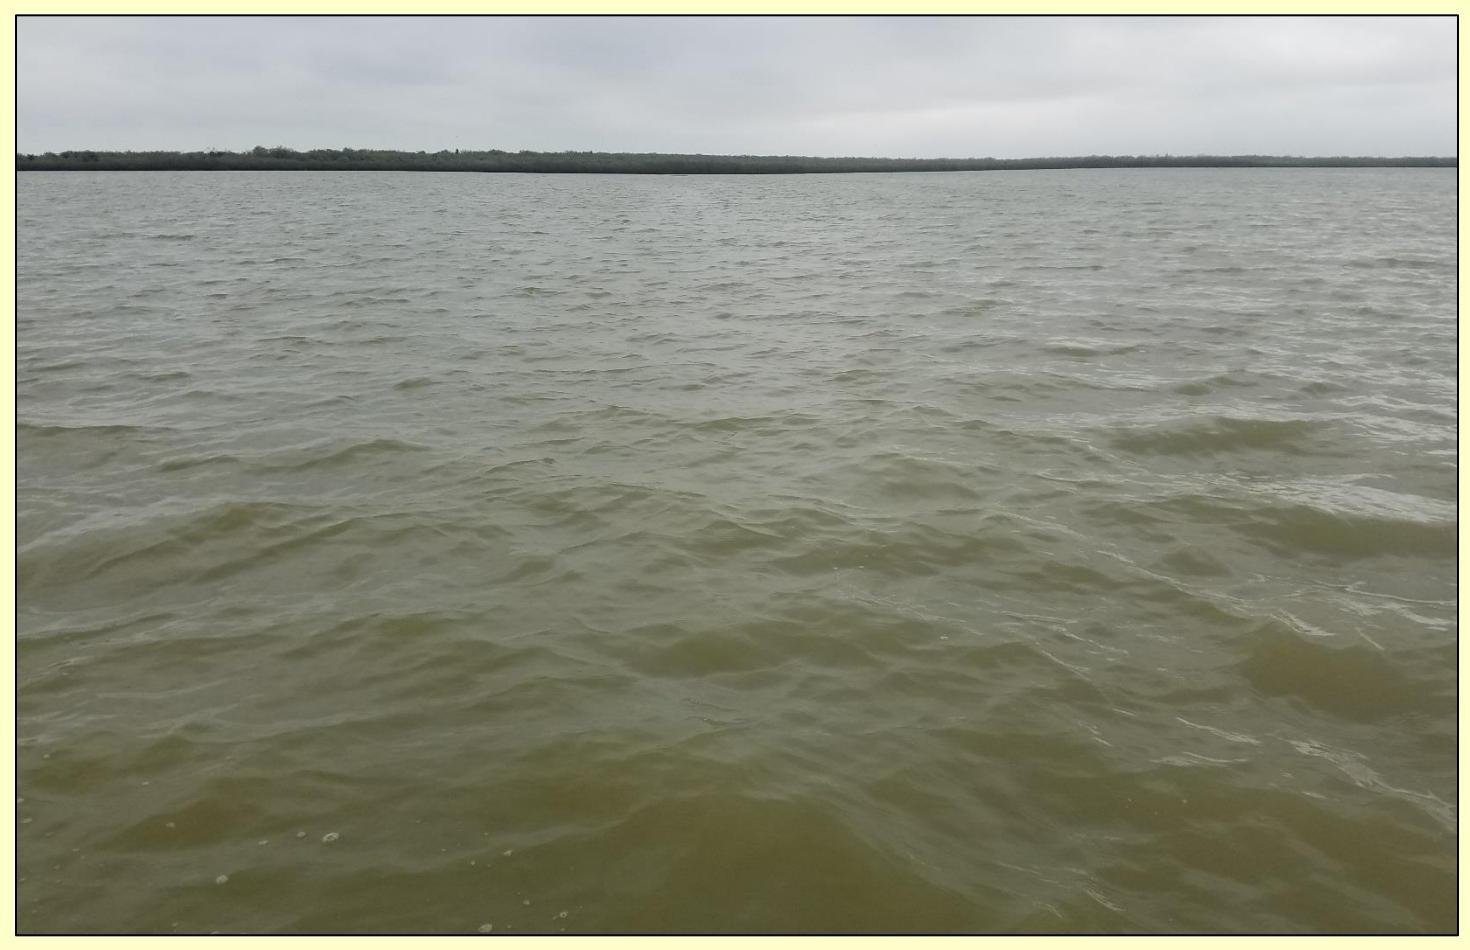
San Martin Lake system is located off the Brownsville Ship Channel in the Lower Rio Grande Valley. NRA field staff rented a bat from UTRGV to travel up the shallow waterway on May 6th. The site was monitored on an outgoing tide about a week after a high flow event in the LRGV. Enterococcus bacteria levels were elevated during the site visit (>2400 MPN). If you would learn more about the project, visit the website: <u>http://www.co.cameron.tx.us/llmbsc/</u>

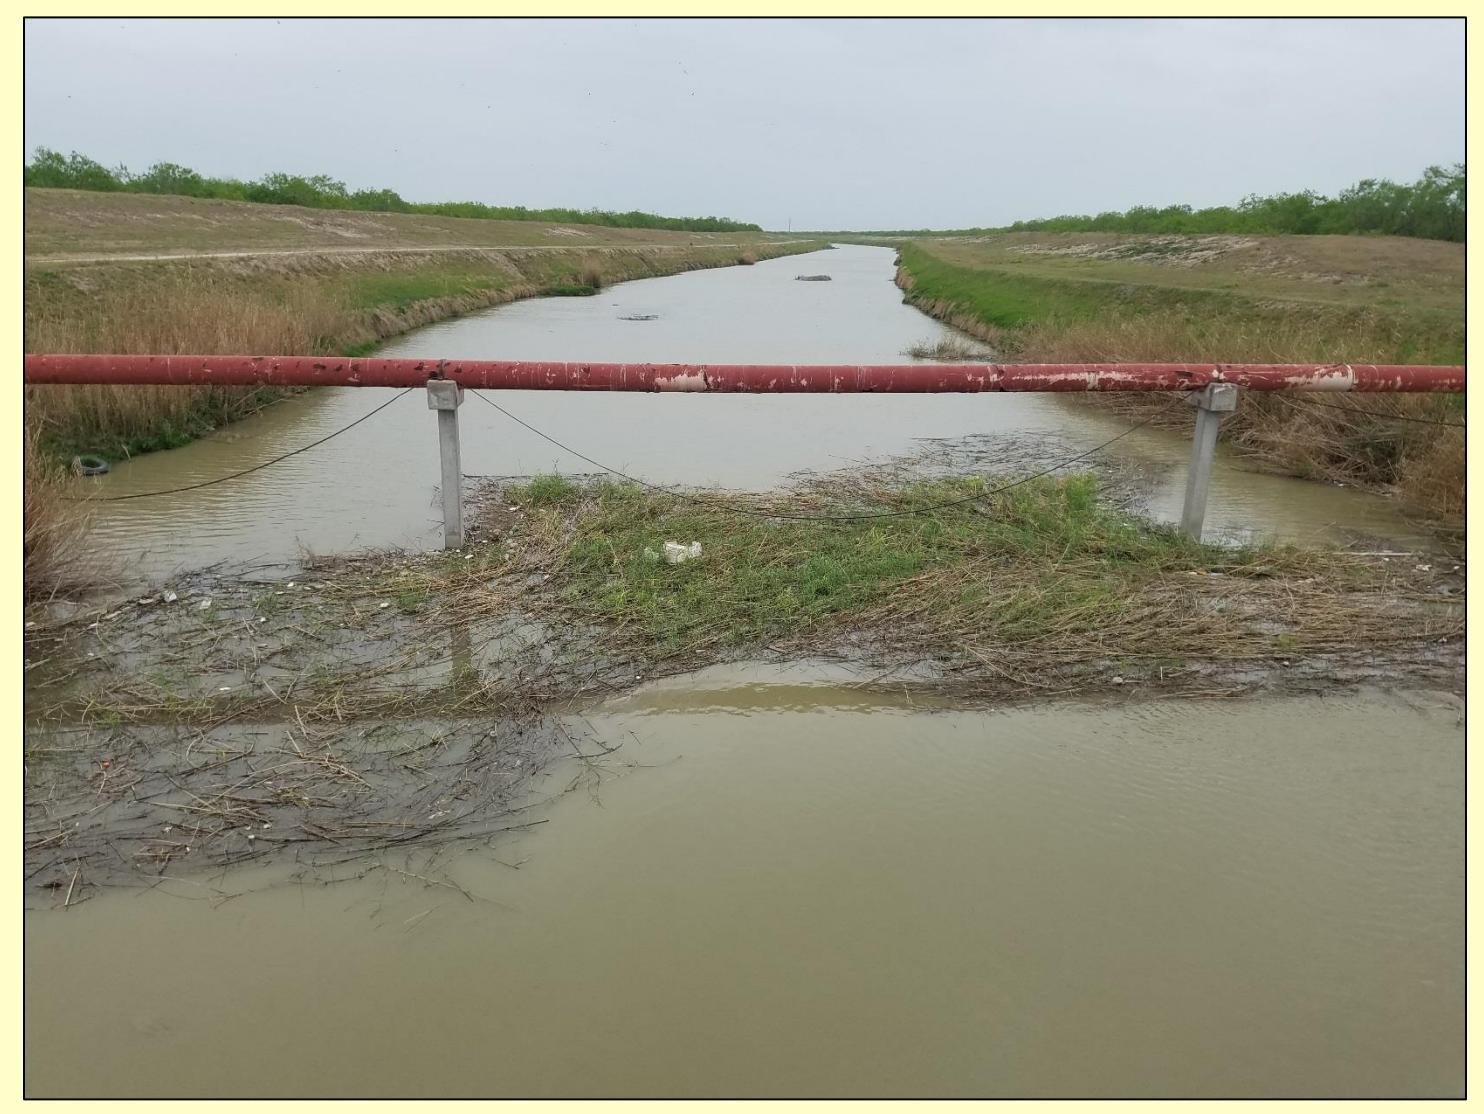
The Hidalgo Main (Station ID 22003) and Raymondville Drains (Station ID 22004) are tributaries of the Lower Laguna Madre (Segment 2491). These two sites are located east of US-77 and were added to the CRP Monitoring Schedule back in 2018. Both sites were visited on April 1st. The Hidalgo Drain had a floating mat of vegetated debris across the drain that was present the last few quarters. No flow measurements were recorded at the Raymondville Drain. Bacteria levels on the Hidalgo Main and Raymondville Drain were 110 MPN and 220 MPN (standard is 126 MPN) respectively. (Disclaimer – Data has not been validated or input into the SWQMIS Database.)

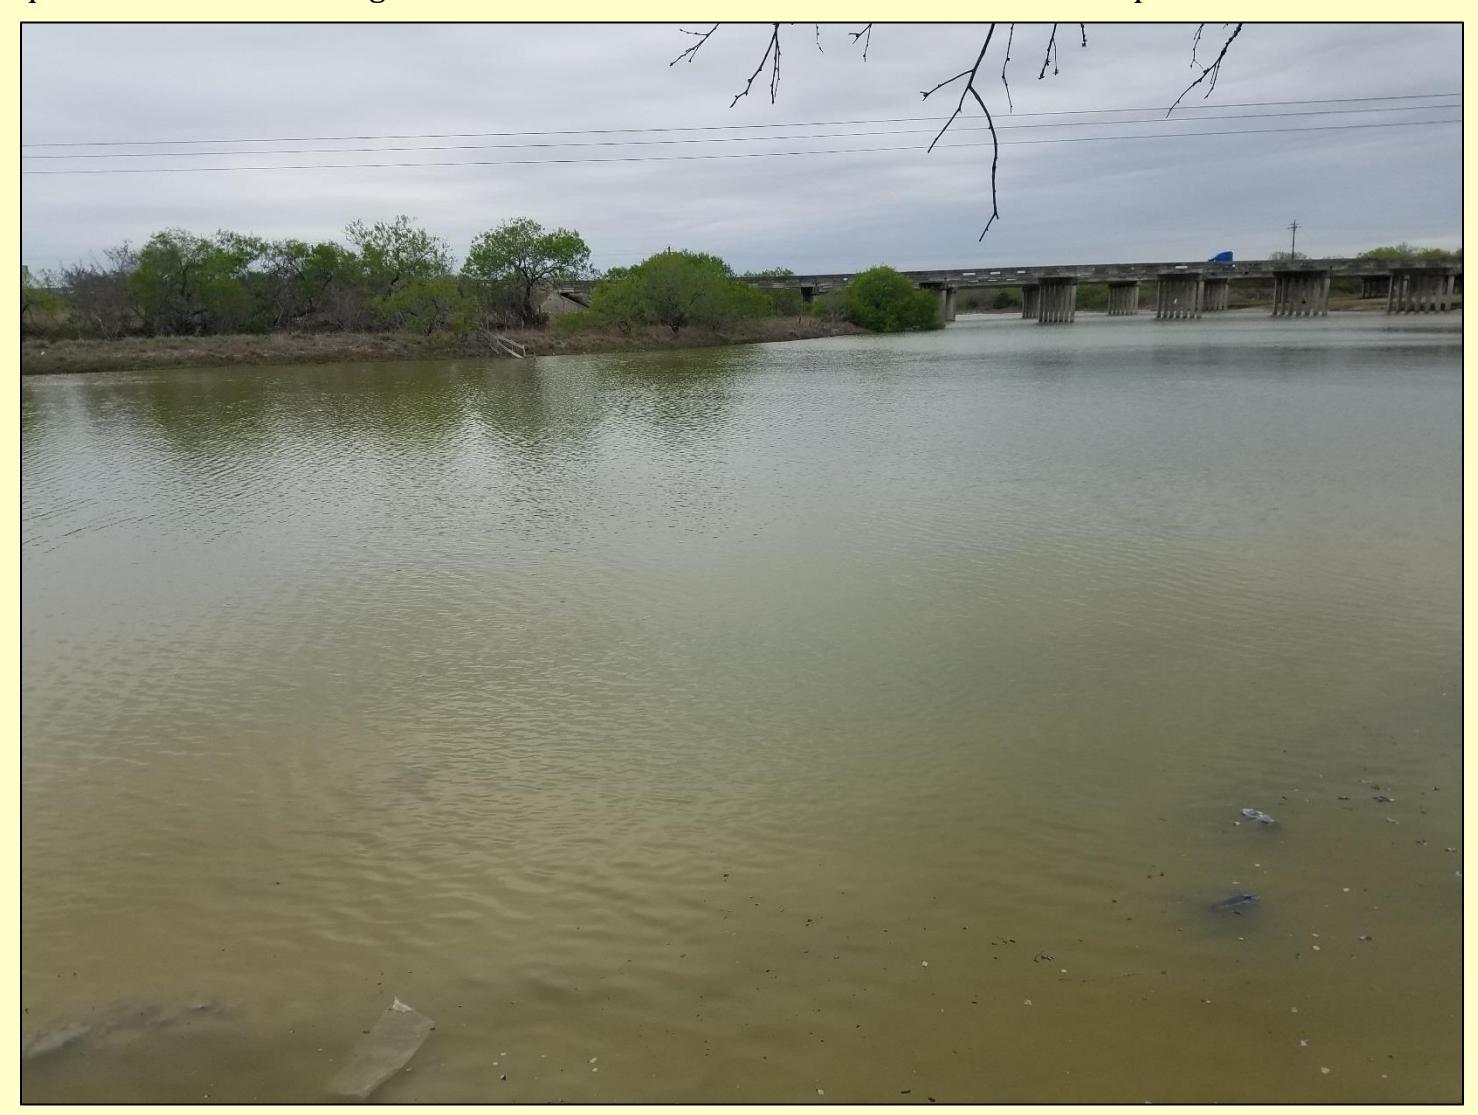
Los Olmos Creek at US 77 near Riviera

Los Olmos Creek runs 71 miles from southern Duval County to its confluence with Laguna Salada, an inlet of Baffin Bay. The creek was a new site (Station ID 13034) for FY2019, located at the bridge crossing at US 77 south of Riviera. NRA field staff visited the site on April 1st. Salinity values were 70.1 PSU (seawater is around 35 PSU) and the shallow waterbody (about 1 foot deep). Bacteria concentrations were very high on the site visit (>2,400 MPN), same as the last 6 quarters. The creek did get some fresh water from storms at the end of the quarter.
