Nueces River Authority

2012 Basin Highlights Report

June 2012

**Prepared in cooperation with the Texas Commission on Environmental Quality
Clean Rivers Program**

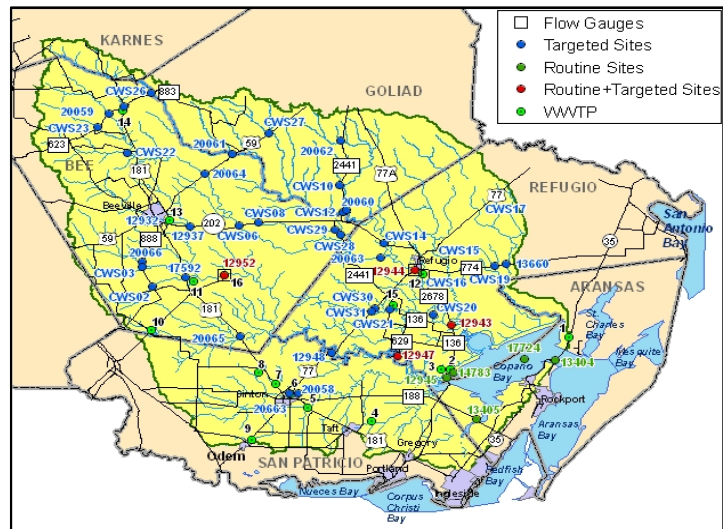
Figure 3-3. Copano Project Monitoring Sites

To provide data for the Copano TMDL, NRA, under contract with TSSWCB, conducted monitoring throughout the entire watershed at stream crossings and at WWTPs from October 2007 through January 2011. A total of 14 river/creek monitoring sites were monitored along with 12 WWTPs to determine concentrations of all 3 indicator bacteria (*E.coli*, *Enterococcus*, and Fecal Coliform), TSS, and turbidity. Table 3.1 lists all of the monitoring sites, the number of individual samples collected from October 2007 through January 2011, and the geometric mean for each of the indicator bacteria. Values shown in red/bold indicate that the standard was exceeded. The standard for fecal coliform is 200 cfu, for *E. coli* is 126 cfu, and for *Enterococcus* is 35 cfu. See appendix C for complete data.

Through January 2011, 33 sampling events took place. The program was initially designed to try and capture up to four run-off events a year and sample during the July and September months to get samples representative of dry/low flow events. Each sampling event was to be conducted for three consecutive days. But Mother Nature had a different idea, and we had over a year of no significant rainfall events – except for when we were trying to conduct the dry weather sampling. The project evolved and we began sampling the stream sites twice a month, one day only, and once month at the WWTPs.

During the course of the study, site 20058 on Chiltipin Creek was discontinued due to construction activities at the bridge crossing; it was replaced with site 20663. Data from both stations is included in table 3.1.

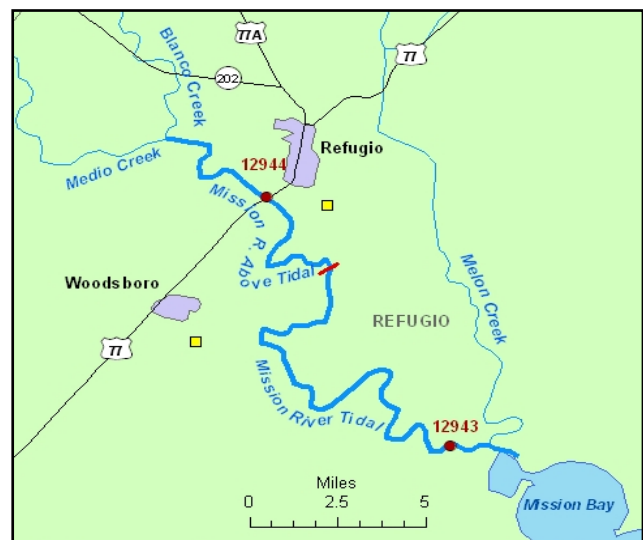
Figure 3-4. Segments 2001 and 2002

The above tidal segment flows 9 miles from the confluence of Blanco Creek and Medio Creek to a point 4.6 miles downstream of US 77 in Refugio County. The area is predominately ranch and farm land. The Town of Refugio is the only community in the watershed.

All assessed parameters met the standards in this segment.

2001: Mission River Tidal (Figure 3-4)

2002: Mission River Above Tidal (Figure 3-4)

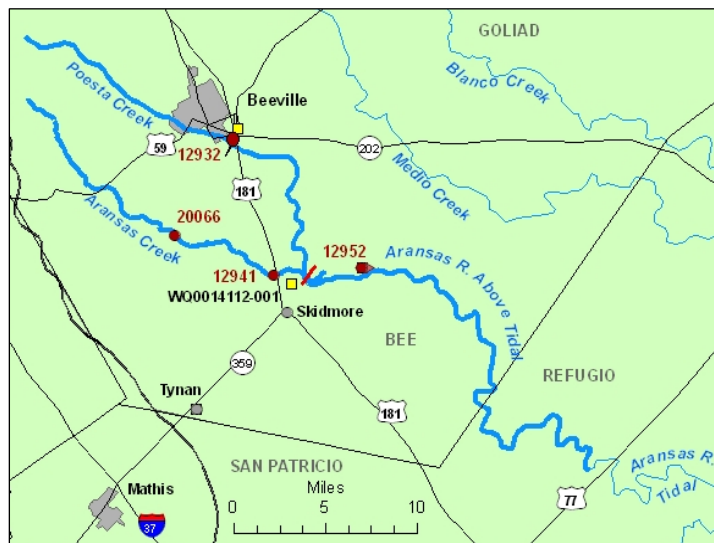
Figure 3-6. Segments 2004, 2004A, and 2004B

The area is predominately ranchland. Beeville is the only community in the watershed.

Only DO was assessed in this segment. The data set was determined not to be temporally representative. Additional data are needed to fully assess this segment.

2004: Aransas River Above Tidal (Figure 3-6)

2004A: Aransas Creek (Figure 3-6)

2004B: Poesta Creek (Figure 3-6)

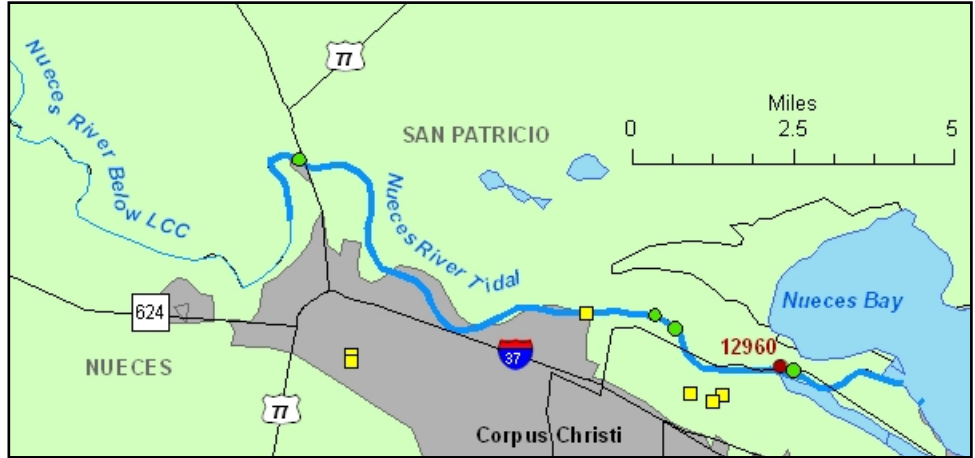
Figure 3-8. Segment 2101

The segment is listed as having a concern for chlorophyll-a. One possible explanation is that the tidal portion is not flushed on a regular basis. In general, the amount of water released from Lake Corpus Christi for freshwater inflows into the Nueces Estuary is based on the amount of water that has flowed into the reservoir system. Except during times of major flooding, the water more or less sloshes back and forth with tides. The Rincon Bayou Pipeline diverts some of the freshwater inflows to the upper delta instead of being passed down the river. This may also contribute to less frequent flushing of the river.

The Lon C. Hill Power Plant discharge permit was recently re-issued for 1,098,000 gpd.

2101: Nueces River Tidal (Figure 3-8)

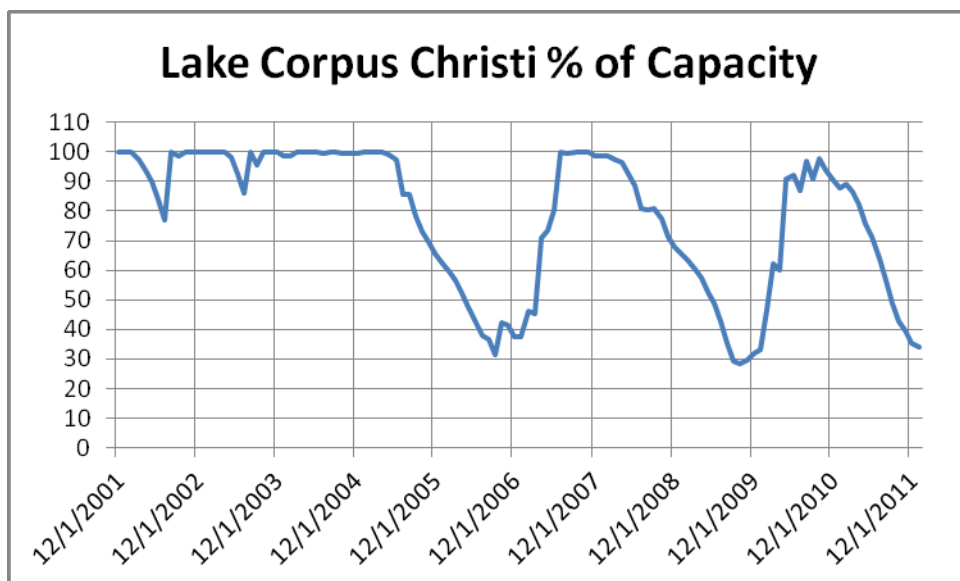
Figure 3-11. Lake Corpus Christi % Capacity
December 1, 2001 – December 1, 2011

For 2011, the most significant factor affecting water quality throughout the Nueces River Basin, San Antonio-Nueces Coastal Basin, and Nueces-Rio Grande Coastal Basin was the drought. Although moderate droughts in this region of Texas are quite common, the extent of the drought was exceptional. In the upper portion of the Nueces River Basin, spring flows were down significantly with many creeks and rivers at historical lows or completely dry. Popular recreation spots such as Concan and Garner State Park on the Frio River did not have enough water to support primary recreation activities such as tubing and swimming; typical flow rates in the 30-60 cfs range were reduced to near zero cfs at these locations. Decreased flows in the middle portions of the basin resulted in elevated conductivities. Notably high conductivity values in the 9,000 μmhos range on the Frio River at Fowlerton were observed in the second half of the year. Reduced flows also had a negative impact on reservoir levels. At the end of 2011, Choke Canyon was at 61.5% of capacity and Lake Corpus was at 33.9% of capacity, down from 80.2% and 87.6% respectively.

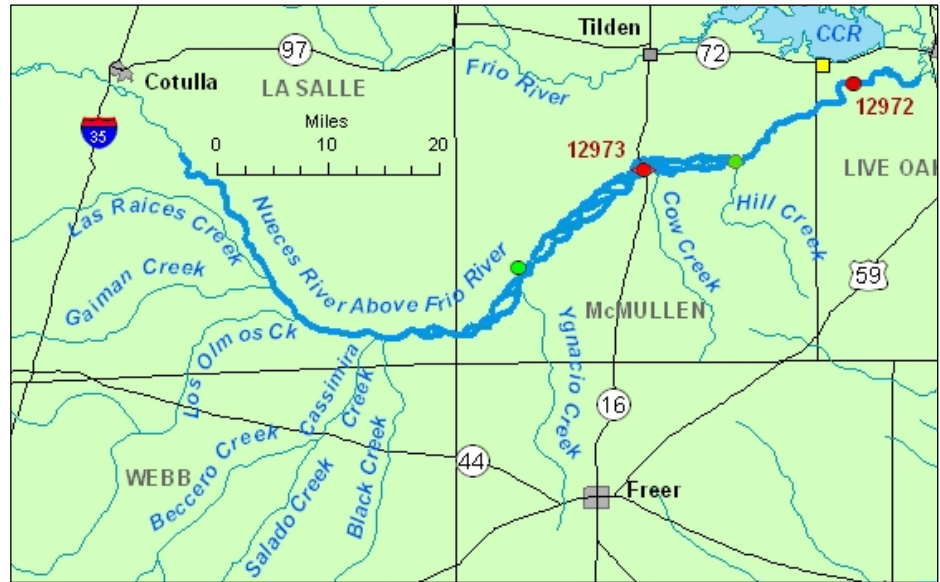
Figure 3-12. Segment 2104

AU_01 has listed impairments for impaired fish community and impaired macrobenthic community as a result of the 2010 Assessment. AU_02 and AU_03 have concerns for impaired fish community. The segment was listed as impaired for depressed DO in the 1999 Assessment. A TMDL was

conducted from 2002 to 2004 to address this issue. The study documented that 24-Hr DO measurements were meeting the standard and the segment was de-listed with respect to DO in the 2008 Assessment. The TMDL also provided for collection of biological, physical, and chemical data, which resulted in the current impairments and concerns. The TMDL reports can be accessed at http://www.tceq.state.tx.us/implementation/water/tmdl/31-sc_bacox_project.html.

2104: Nueces River Above Frio River (Figure 3-12)

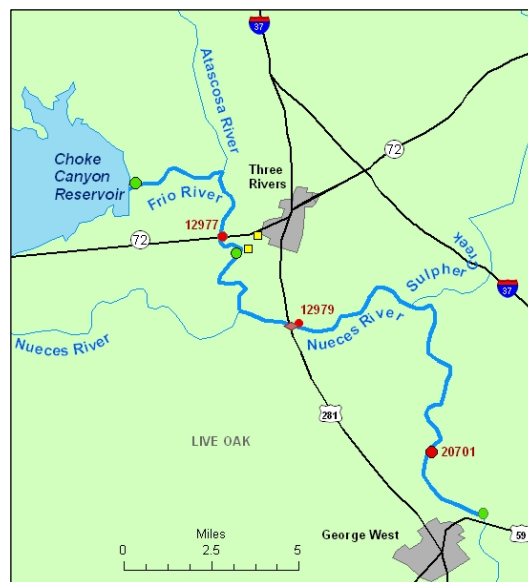
Figure 3-14. Segment 2106

Station 12978 was replaced with 20701 because the river levels are influenced by the elevation of Lake Corpus Christi when the lake is near capacity. The influence has been seen as far north as Airport Road.

Standards revisions are also being proposed for chloride and sulfate in the segment. Again, the standard is based on the average of all values. For AU_01, chloride would increase from 250 mg/l to 350 mg/l and sulfate would decrease from 250 mg/l to 165 mg/l. For AU_02, chloride would increase from 250 mg/l to 285 mg/l and sulfate would decrease from 250 mg/l to 145 mg/l.

Both AUs are also listed as having a concern for chlorophyll-a.

2106: Nueces River / Lower Frio River (Figure 3-14)

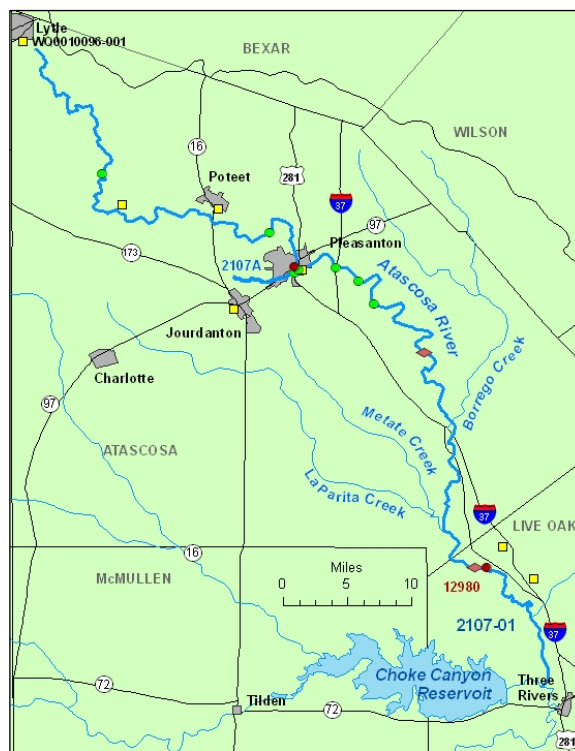
Figure 3-15. Segment 2107

AU_02 and AU_03 are listed for impairments for impaired fish community and impaired macrobenthic community. The impaired fish community was first listed in the 2006 Assessment and the impaired macrobenthic community was added in the 2010 Assessment. These are a result of the data collected during the TMDL. AU_02 and AU_03 have concerns for impaired habitat.

Chlorophyll-a is a concern in AU_01 and AU_03. Nitrate, DO, and OP are concerns in AU_02.

2107: Atascosa River (Figure 3-15)

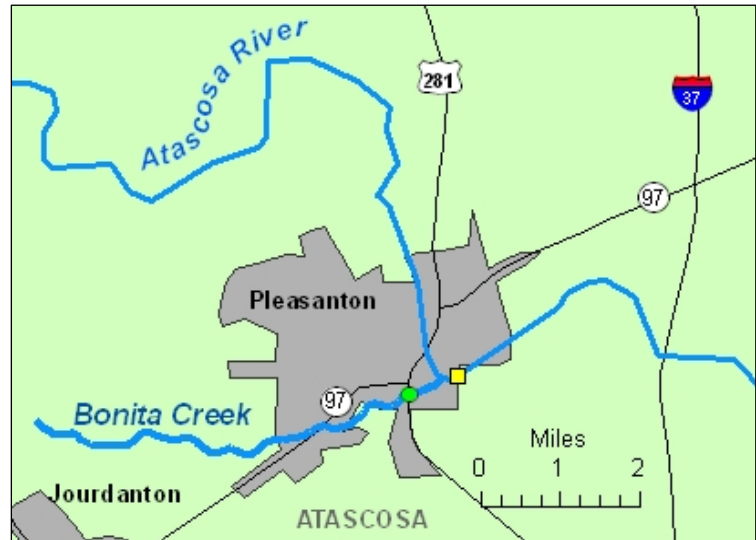
Figure 3-16. Segment 2107A

The segment flows about 5 miles from the headwaters upstream of CR 433 to the confluence with the Atascosa River in Pleasanton. Only field measurements were collected during the Atascosa TMDL. Only TDS was assessed and met the standard. DO was not assessed since the measurements were collected over a short time period and not considered to be temporally representative.

2107A: Bonita Creek (Figure 3-16)

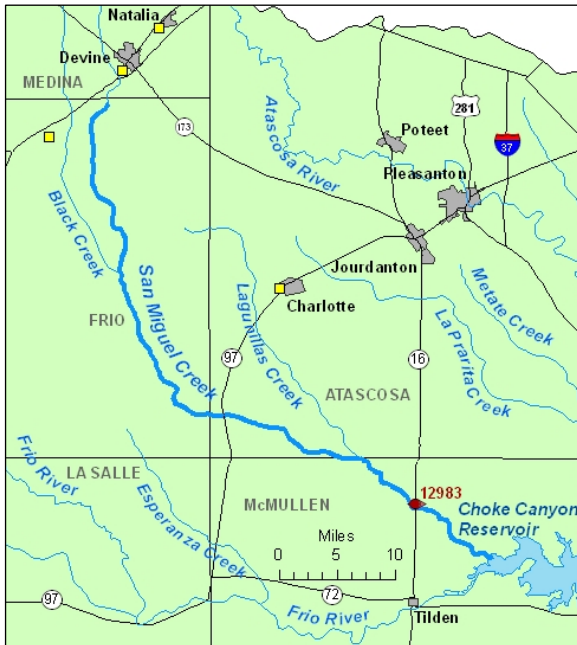
Figure 3-17. Segment 2108

AU_01 has been listed as being impaired for bacteria for contact recreation since the 2006 Assessment.

The segment also has concerns for depressed DO and chlorophyll-a.

2108: San Miguel Creek (Figure 3-17)

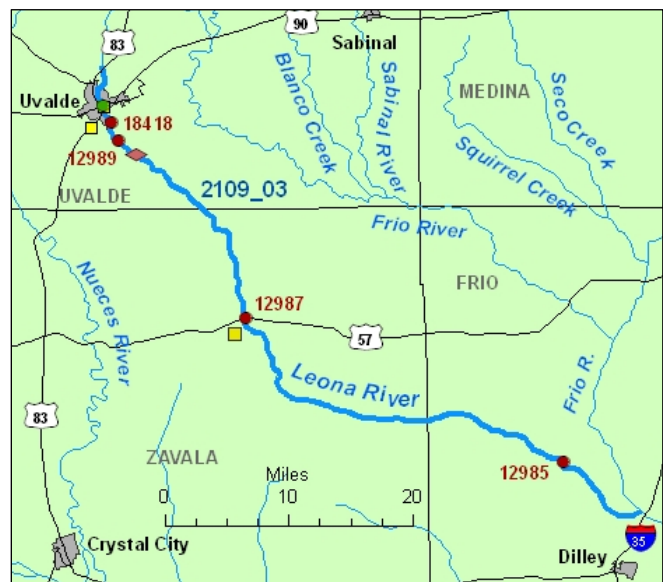
Figure 3-18. Segment 2109

The segment was first listed as being impaired for bacteria for contact recreation as a result of the 2006 Assessment. An RUAA is currently being conducted by Texas Institute for Applied Environmental Research (TIAER) at Tarleton State University.

There is also a concern for nitrates for all AUs. The values tend to increase from upstream to downstream.

2109: Leona River (Figure 3-18)

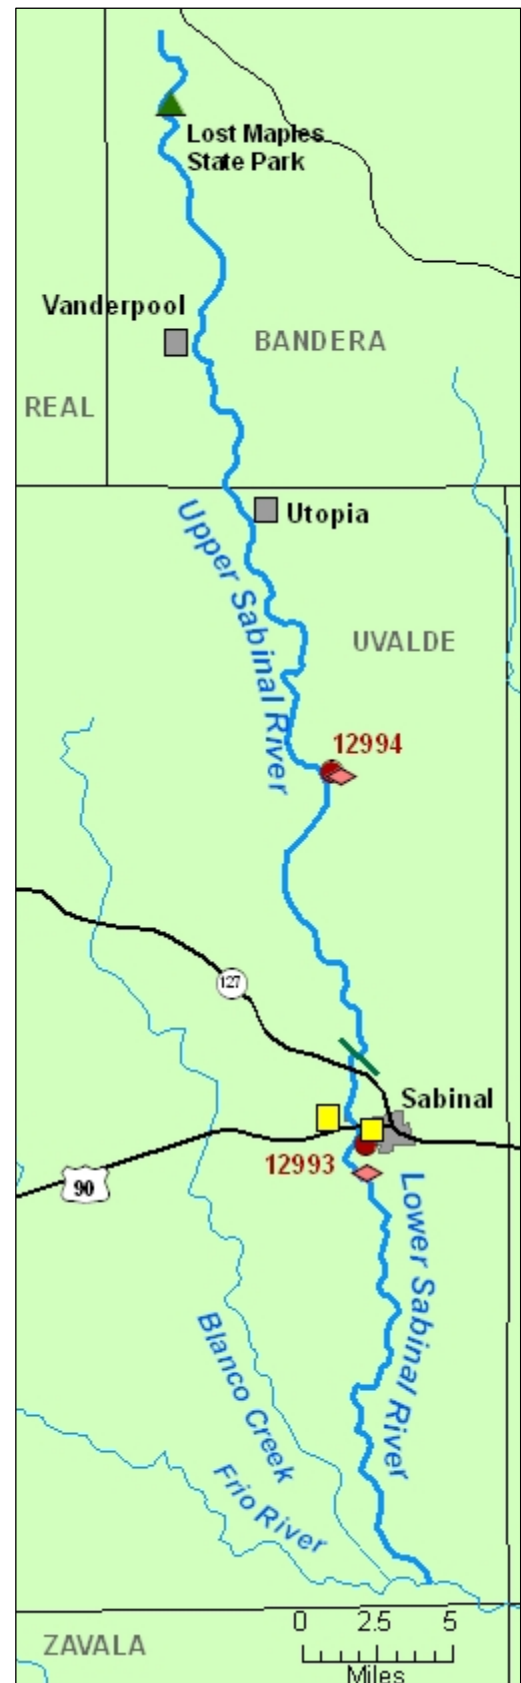
Figure 3-19. Segments 2110 and 2111

The Cities of Utopia and Vanderpool are the only communities in the watershed. Lost Maples State Park is near the headwaters.

All assessed parameters met the standards.

2110: Lower Sabinal River (Figure 3-19)

2111: Upper Sabinal River (Figure 3-19)

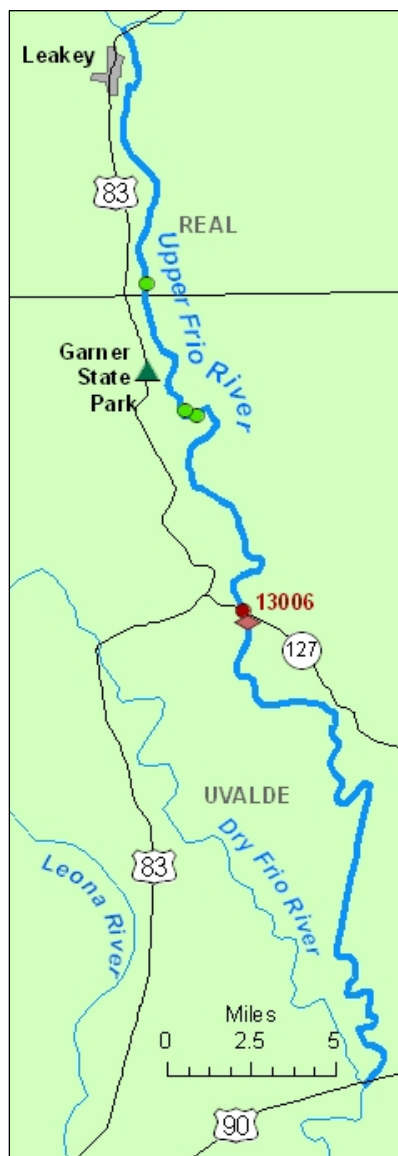
Figure 3-21. Segment 2113

The segment flows 47 miles from the confluence with the West Frio River and the East Frio River in Real County to a point 100m upstream of US 90 in Uvalde County. It is divided into two AUs; from the downstream end to the confluence with Bear Creek (AU_01), and from the confluence with Bear Creek to the upstream end.

AU_01 has impairments for impaired fish community and impaired macrobenthic community as a result of the 2006 Assessment and a concern for impaired habitat. AU_02 has concerns for impaired habitat and impaired fish community. The impaired fish community in AU_02 had previously been listed as impaired but the data were reassessed with more valid procedures.

2113: Upper Frio River (Figure 3-21)

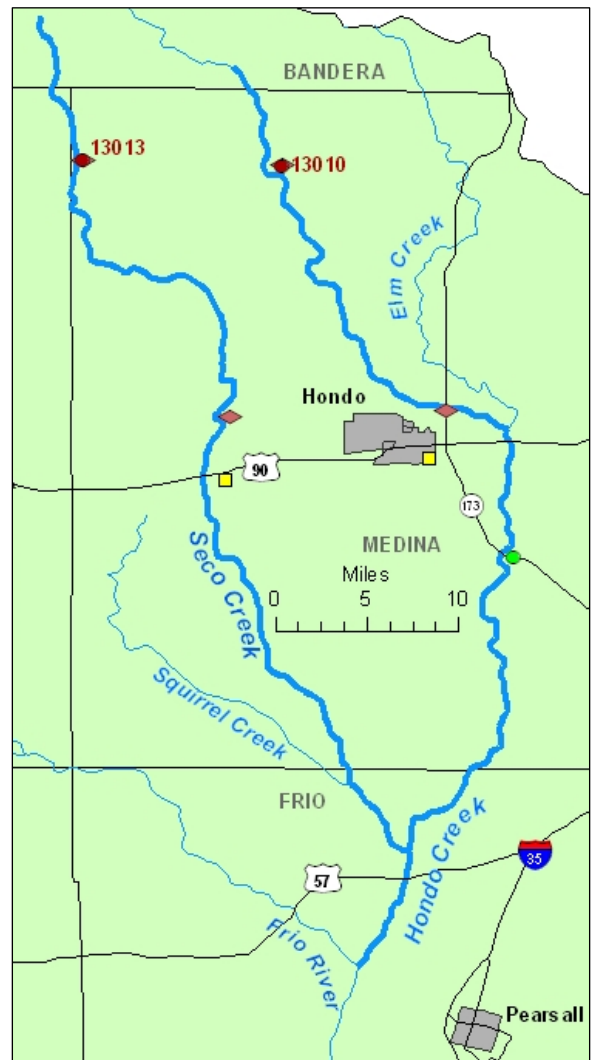
Figure 3-22. Segments 2114 and 2115

(http://waterdata.usgs.gov/tx/nwis/uv/?site_no=08201500) and north of US 90 (http://waterdata.usgs.gov/tx/nwis/uv/?site_no=08202700).

All assessed parameters met the standards.

2114: Hondo Creek (Figure 3-22)

2115: Seco Creek (Figure 3-22)

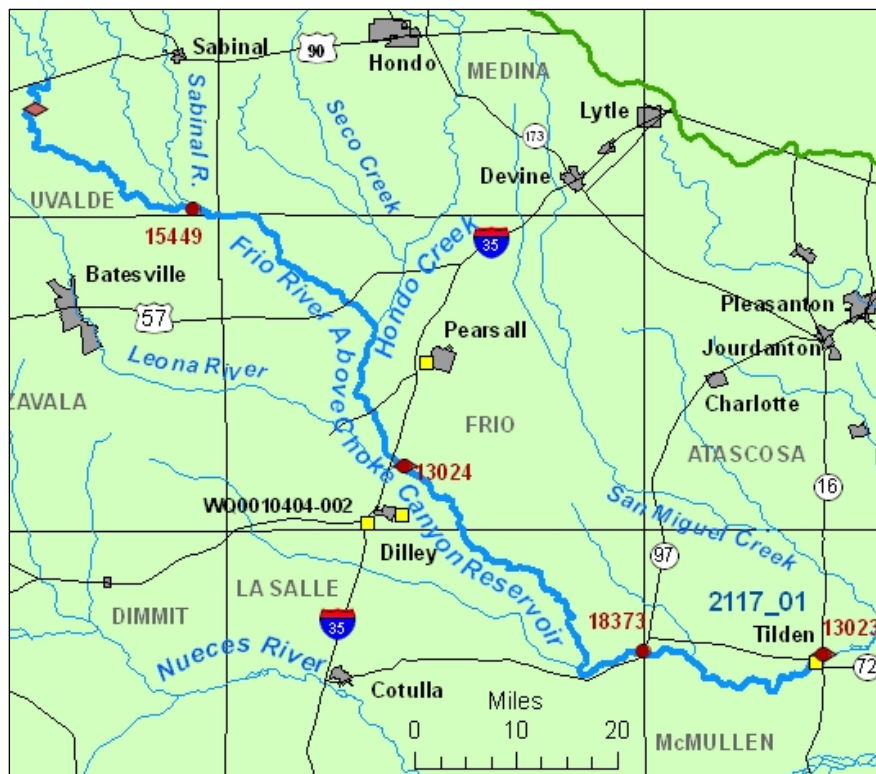
Figure 3-25. Segment 2117

AU_02 was first listed as being impaired for bacteria for contact recreation as a result of the 2008 Assessment.

AU_01 through AU-05 have a concern for nitrates. Although there are no sampling sites in AU_04, it was assumed that it would also be impacted since the AUs on either side have high levels. The values decrease from upstream to downstream.

2117: Frio River Above Choke Canyon Reservoir (Figure 3-25)

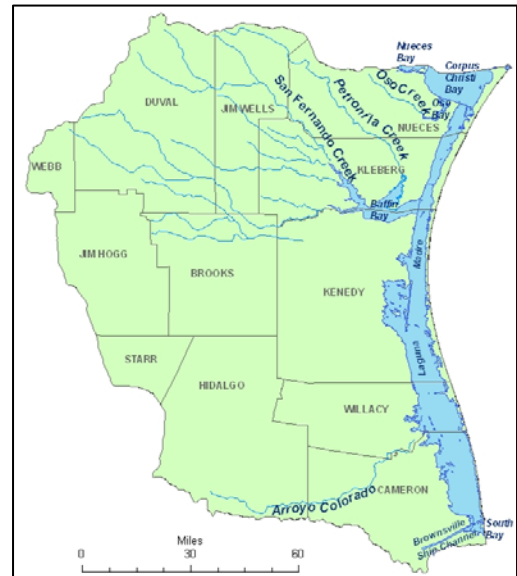
Figure 3-26: Nueces – Rio Grande

Several TMDLs and special studies have been conducted in the basin. Specific results and findings are discussed in the individual segment summaries: Segment 2201, Arroyo Colorado Tidal, for depressed DO, Segment 2202, Arroyo Colorado Above Tidal, for bacteria, and Segment 2204, Petronila Creek, for TDS, chloride, and sulfate.

3.2.3 NUECES – RIO GRANDE COASTAL BASIN (Figure 3-26)

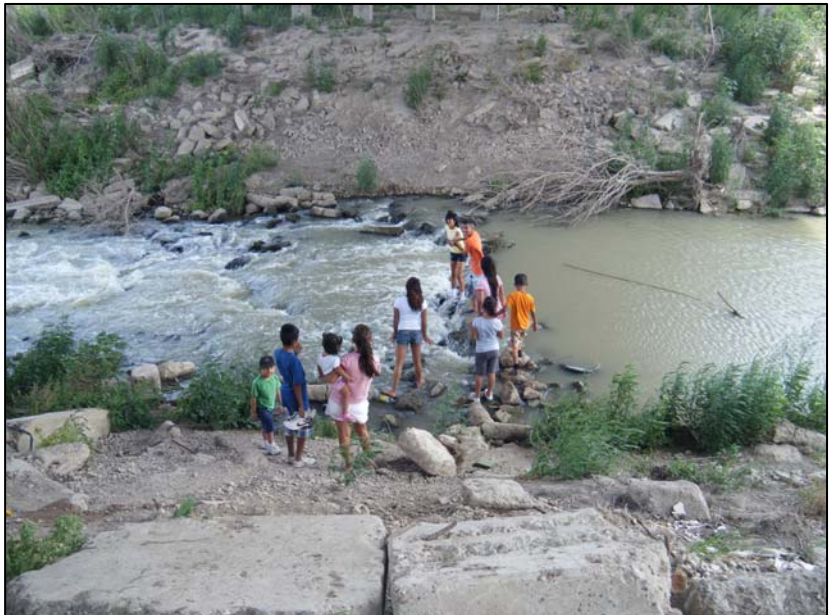
Figure 3-30. Primary Contact Recreation

Beginning in 2010, Nueces River Authority began work conducting a Comprehensive Recreational Use Attainability Analyses (RUAA) in this segment to determine the proper contact recreation designation. Data from 23 locations was compiled along with photographic records of the types of recreation witnessed during the survey. Typically, surveys occur during holidays such as Easter, Memorial Day and 4th of July, when people are most likely to be recreating. A number of youths were observed recreating along with family members while gathered for a picnic on Easter Sunday 2011. (See Section 3.1 for information concerning Recreational Use Designations and RUAA's).

In order to determine the appropriate designation, a Recreational Use Attainability Analysis (RUAA) must be conducted. An RUAA is designed to: capture information of the types of recreational uses occurring in a water body; document physical stream characteristic that affect recreational uses; and document observed, historical, and anecdotal recreational uses. The information is obtained via questionnaires, field surveys, and research. Until an RUAA is conducted and a designation other than primary contact recreation is found to be more appropriate, a segment will continued to be assessed using the primary contact recreation criteria. Information on the above tidal (segment 2202) Arroyo Colorado RUAA is detailed on page 24.

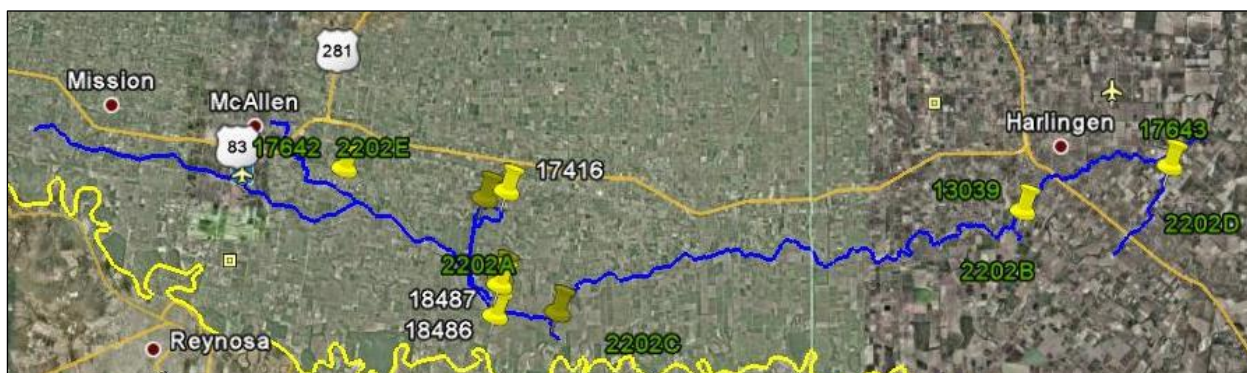
Figure 3-31. Segments 2202A, 2202B, 2202C, 2202D and 2202E

The segment is an off-channel irrigation reservoir pumped from the Rio Grande River near the City of Donna.

There are no active monitoring sites on the segment.

2202A: Donna Reservoir (Figure 3-31)

2202B: Unnamed Drainage Ditch Tributary to Arroyo Colorado (Figure 3-31)

2202C: Unnamed Drainage Ditch Tributary to Arroyo Colorado (Figure 3-31)

2202D: Unnamed Drainage Ditch Tributary to Arroyo Colorado (Figure 3-31)

2202E: Unnamed Drainage Ditch Tributary to Arroyo Colorado (Figure 3-31)

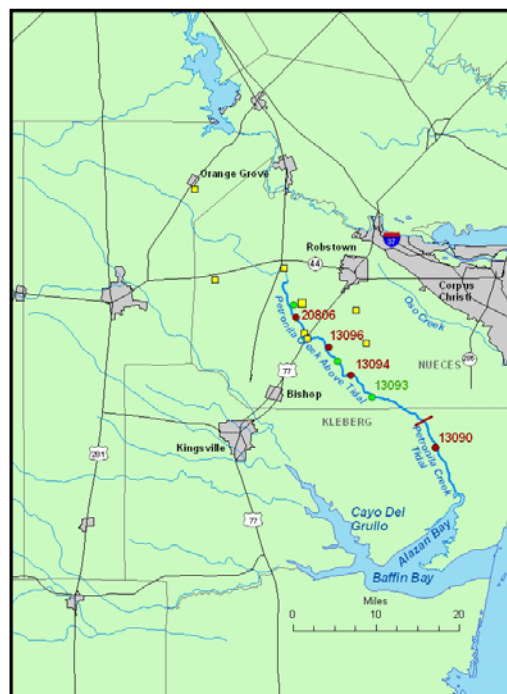
Figure 3-32. Segments 2203 and 2204

There are a number of WWTPs that discharge to this segment. The 2010 Assessment did not identify bacteria as an impairment but did as a concern. There is also a storm water discharge permit for a hazardous waste landfill.

The segment has been impaired for chloride, total dissolved solids (TDS), and sulfates since 1999. A TMDL was conducted and concluded that the impairments were the result of historic oil and gas operations. A continuous water quality monitoring (CWQM) station was installed by TCEQ at the location of Station 13093 at FM 70. NRA performs the routine maintenance. The CWQM data is assessable at http://www.tceq.state.tx.us/cgi-bin/compliance/monops/water_daily_summary.pl?cams=731.

The segment also has a concern for chlorophyll-a in AU_01 and AU_02 and a concern for bacteria in AU_02.

2203: Petronila Creek Tidal (Figure 3-32)

2204: Petronila Creek Above Tidal (Figure 3-32)

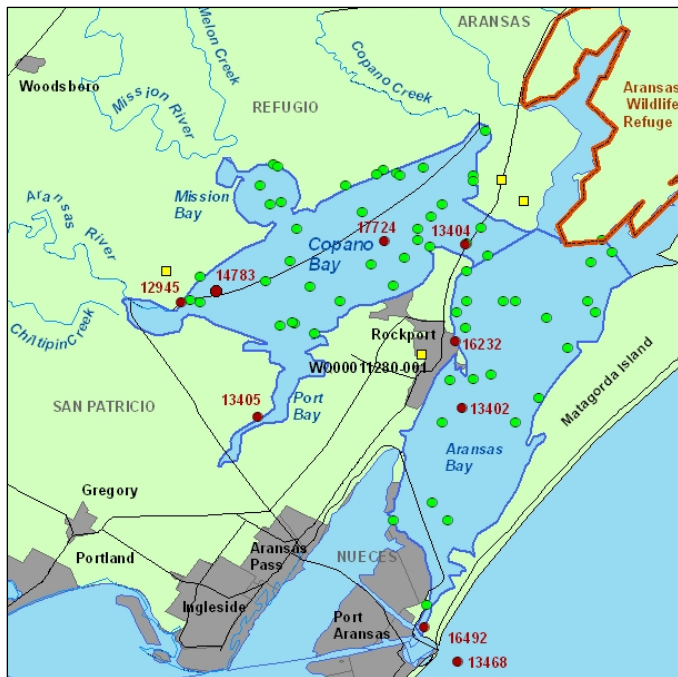
Figure 3-35. Segments 2471 and 2472

The City of Rockport is along the western shore of the bay and the uninhabited Matagorda Island is on the east. The Aransas Wildlife Refuge is to the north.

Beach Watch data have identified Rockport Beach Park as having a concern for bacteria for contact recreation.

2471: Aransas Bay (Figure 3-35)

2472: Copano Bay / Port Bay / Mission Bay (Figure 3-35)

2473: St. Charles Bay (Figure 3-35)

2501: Gulf of Mexico (Figures 3-35 and 3-45)
